## VEHICLE INSPECTION REPORT

**LN67WMV**

### Ford Transit 350 2.0 TDCi 130ps

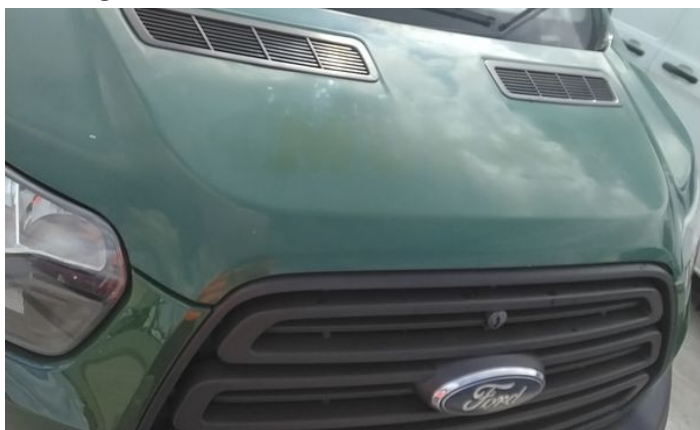
1: Bonnet  
Chipped  
Multiple Chips

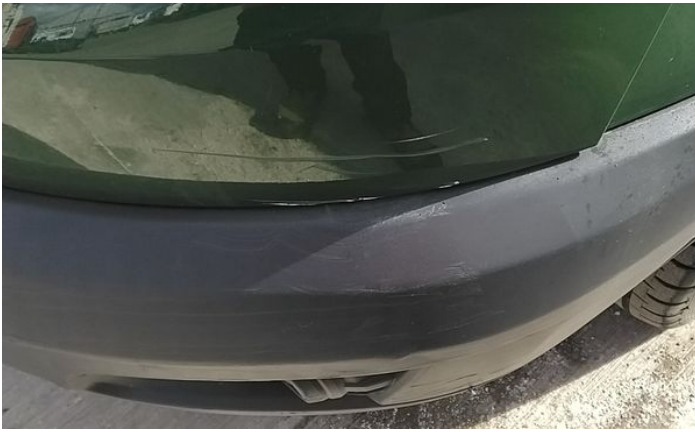
3: Panel Front  
Scratched  
Over 25mm Thru Paint

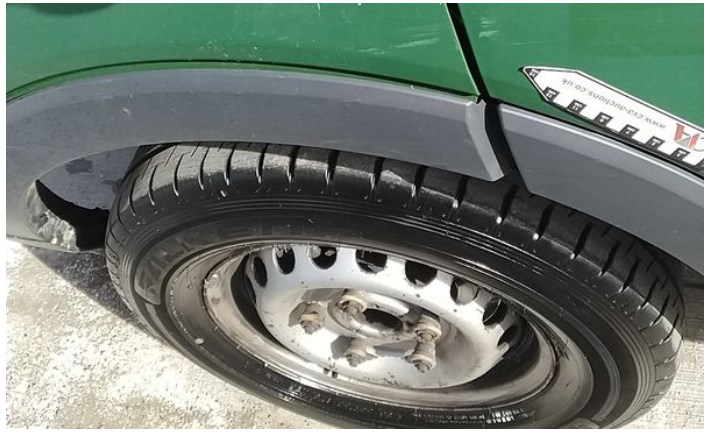
4: Wing nsf  
Scratched  
Over 25mm Thru Paint

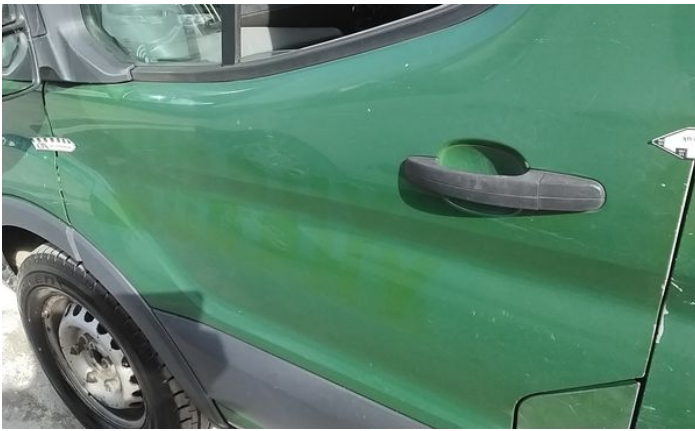
5: Door nsf  
Scratched  
Over 25mm Thru Paint

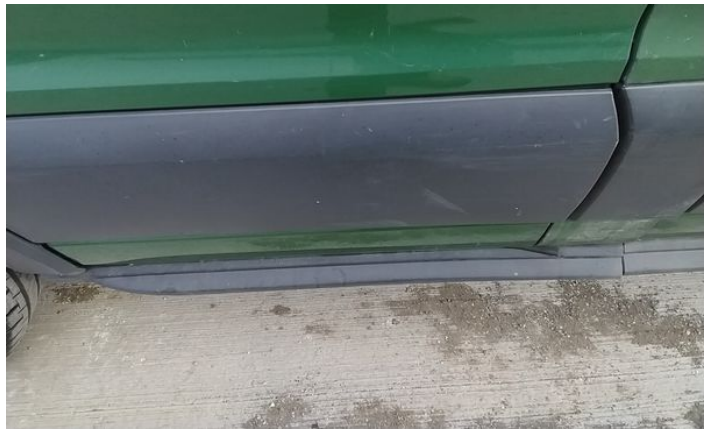
6: Door Moulding nsf  
Scuffed (Unpainted)  
Over 100mm

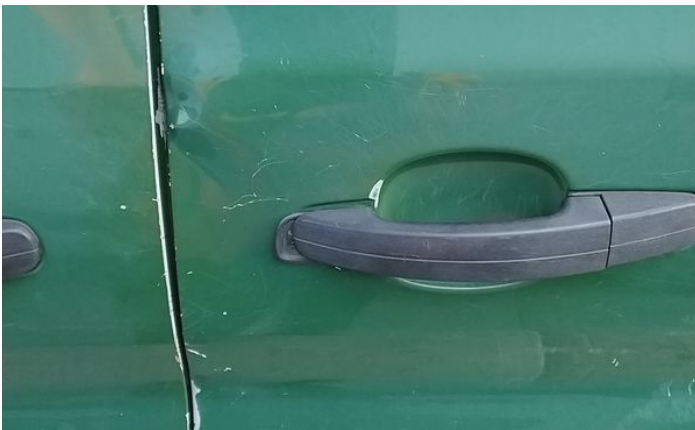
7: Qtr Panel nsr  
Dented  
With Paint Damage

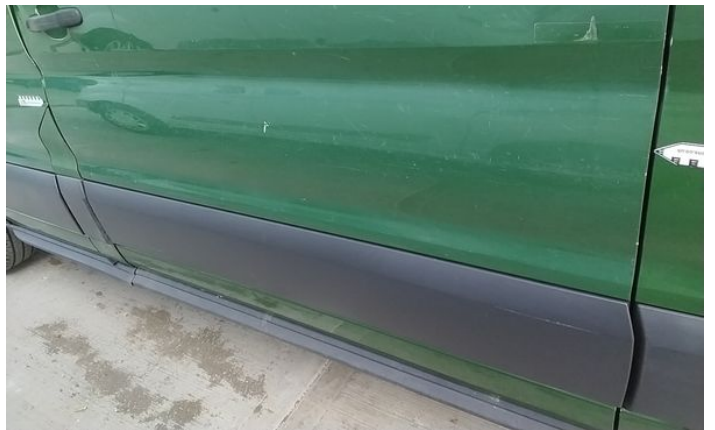
8: Qtr Panel nsr  
Scratched  
Over 25mm Thru Paint

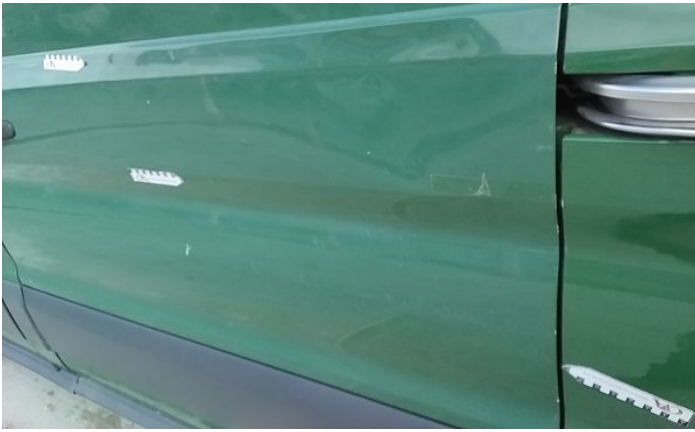
9: Qtr Panel nsr  
Dented  
Over 30mm

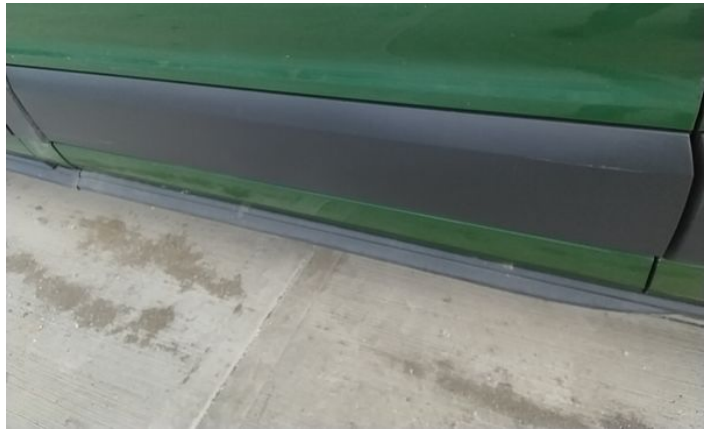
10: Qtr Panel Moulding ns  
Scuffed (Unpainted)  
Over 100mm

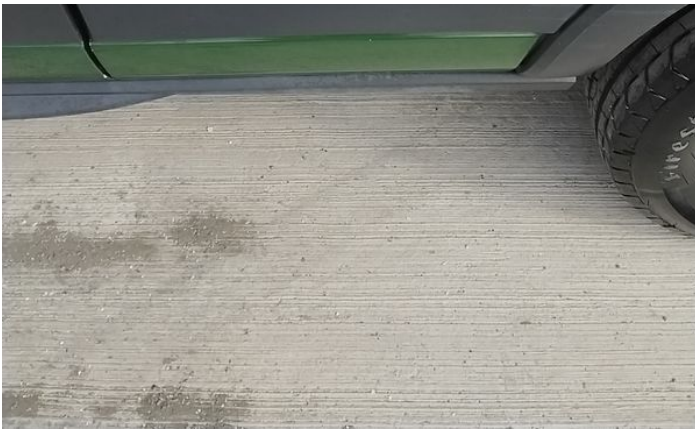
11: Qtr Panel Moulding ns  
Scuffed (Unpainted)  
Over 100mm

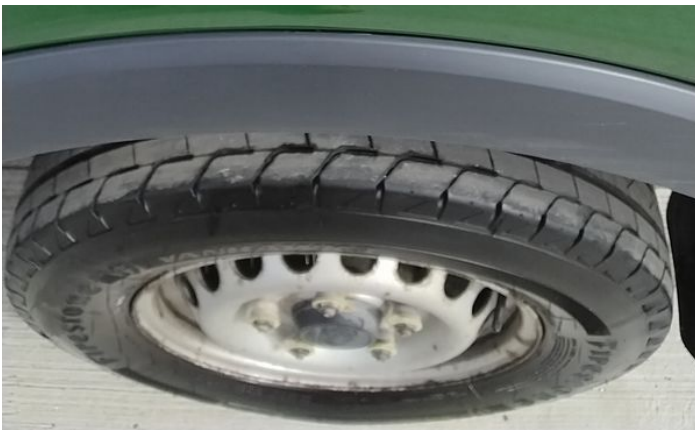
13: Qtr Panel nsr  
Scratched  
Over 25mm Thru Paint

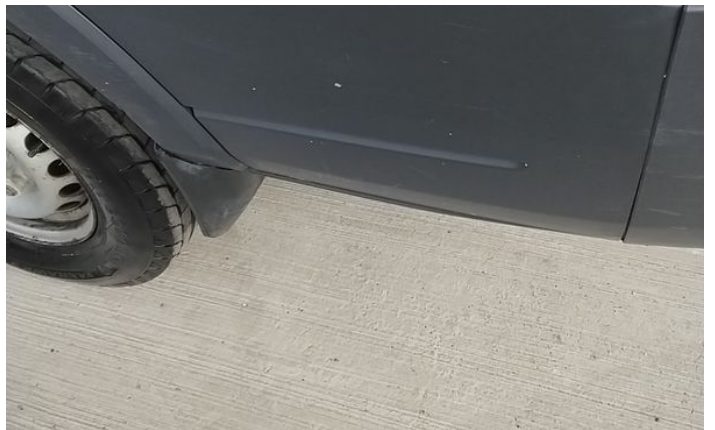
14: Qtr Panel Moulding ns  
Scuffed (Unpainted)  
Over 100mm

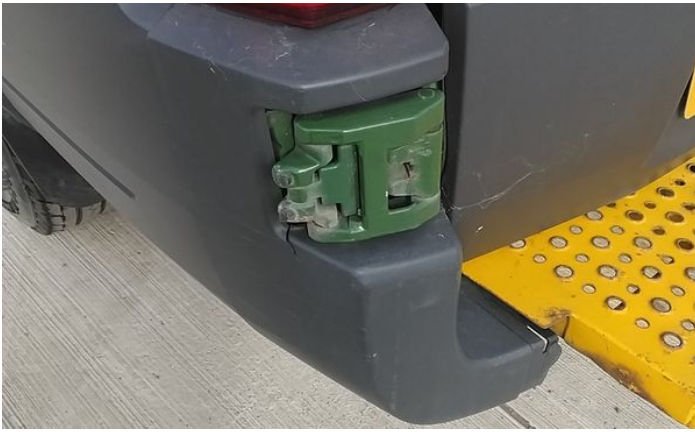
15: Bumper Rear Moulding  
Broken  
Replace

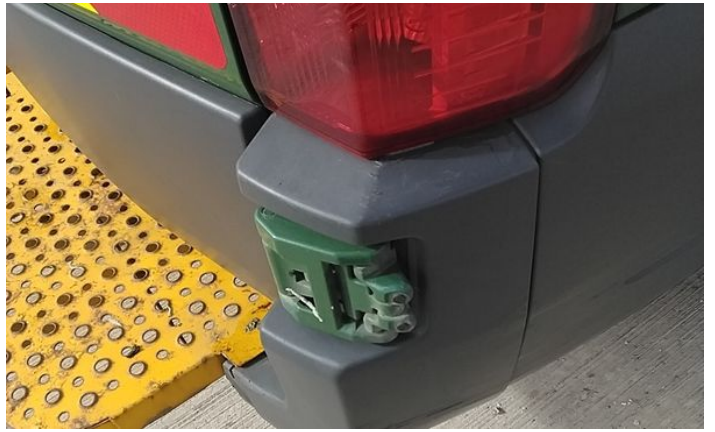
16: Bumper Rear Moulding  
Scuffed (Unpainted)  
Over 100mm

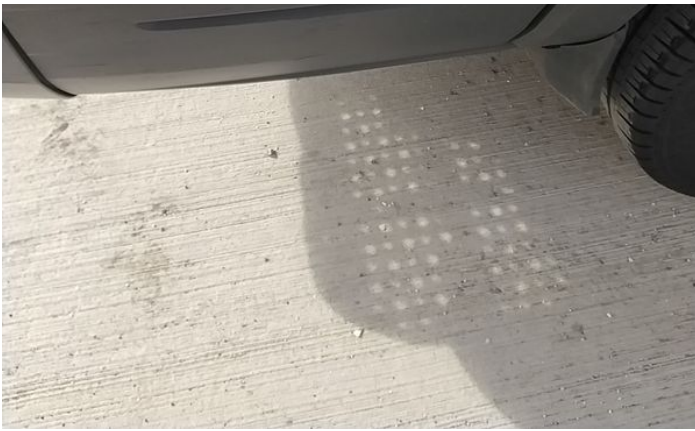
17: Qtr Panel Moulding os  
Scuffed (Unpainted)  
Over 100mm

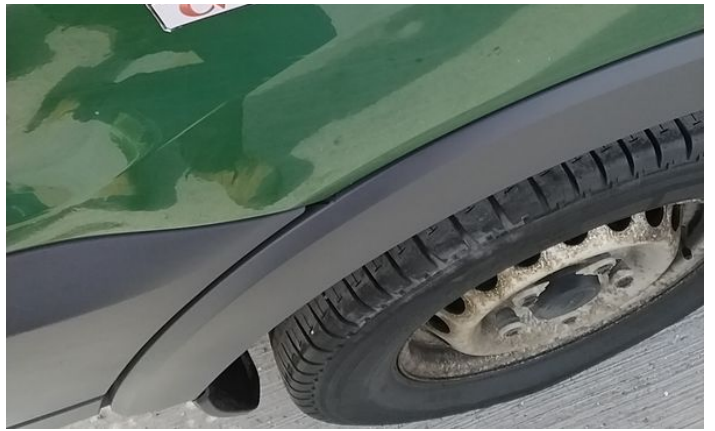
18: Qtr Panel osr  
Scratched  
Over 25mm Thru Paint

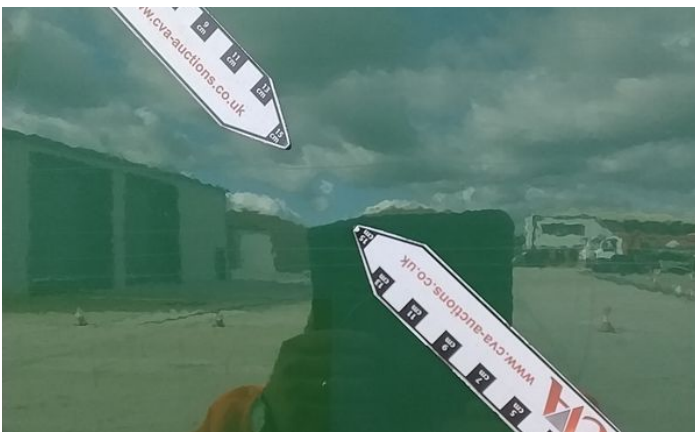
19: Qtr Panel osr  
Dented  
Over 30mm

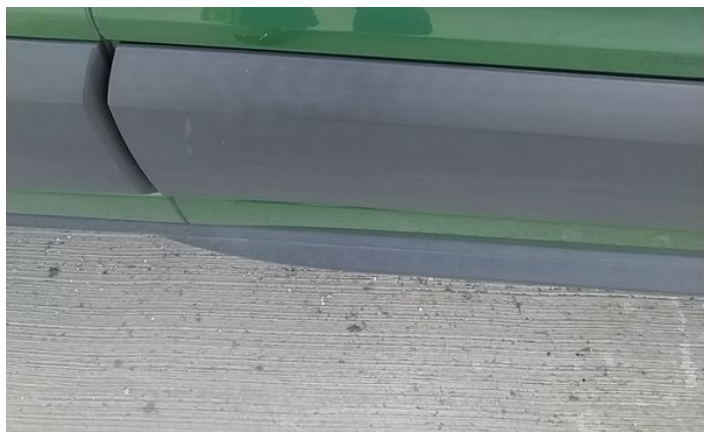
20: Qtr Panel osr  
Scratched  
Over 25mm Thru Paint

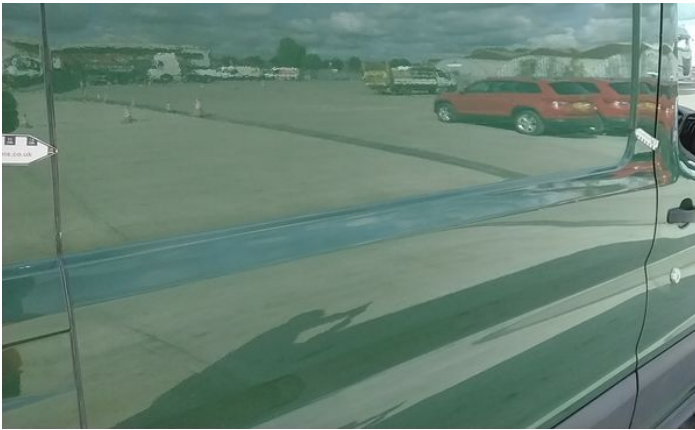
21: Qtr Panel osr  
Scratched  
Over 25mm Thru Paint

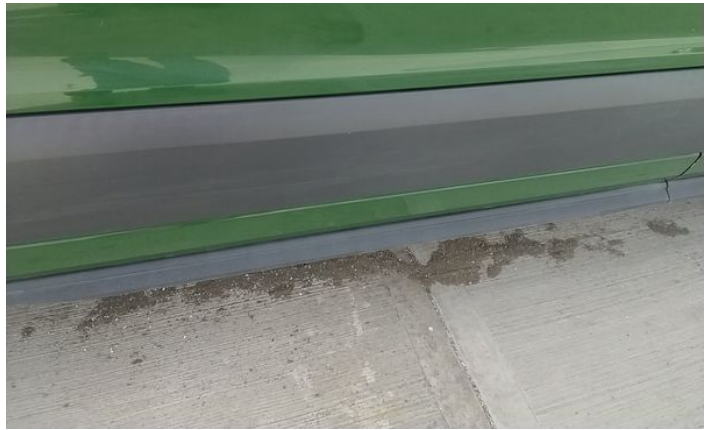
22: Qtr Panel Moulding os  
Scuffed (Unpainted)  
Over 100mm

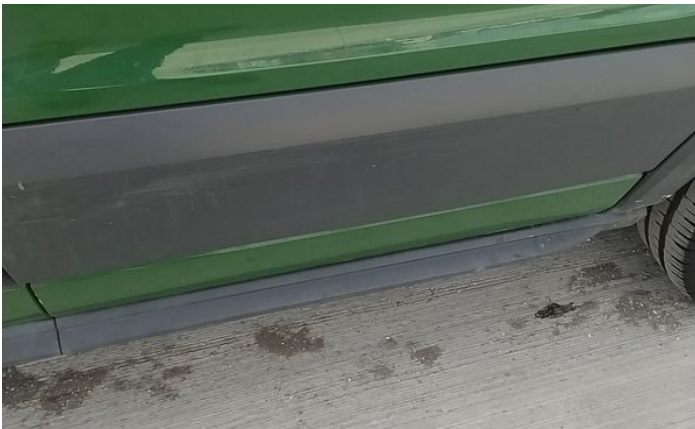
23: Door Moulding osf  
Scuffed (Unpainted)  
Over 100mm

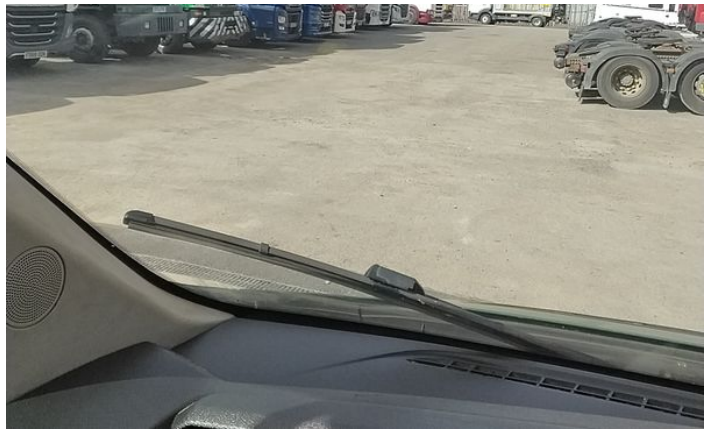
24: Screen Front  
Chipped  
Over 10mm

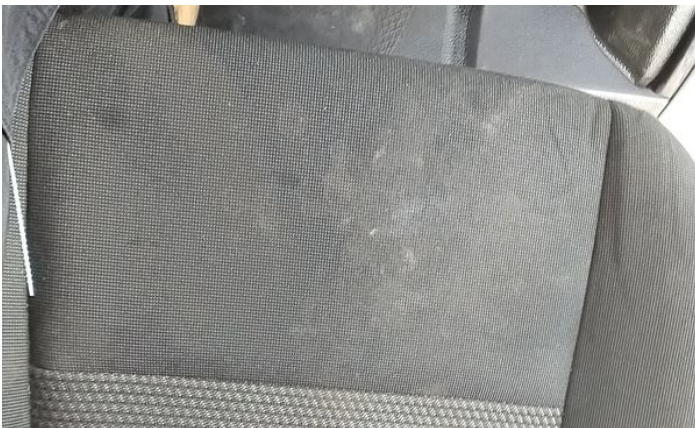
25: Seat Base Cover osf  
Soiled  
Heavy

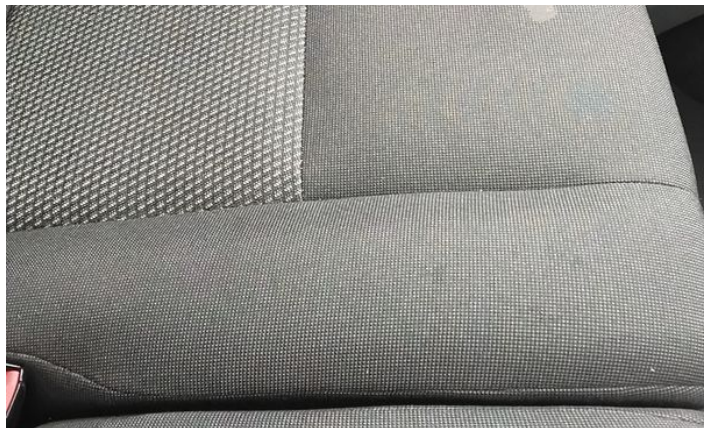
26: Seat Base Cover nsf  
Soiled  
Heavy
