# VEHICLE INSPECTION REPORT

**WV20HNX**

## Fiat Ducato 35 2.3 MULTIJET 140PS

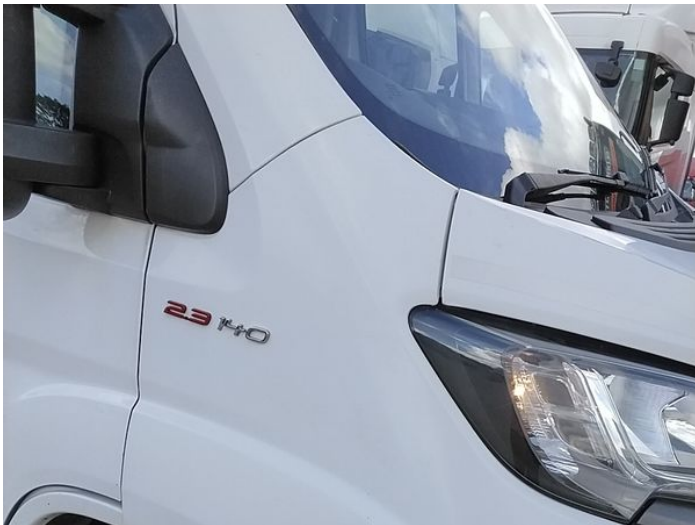
1: Wing and door  
Chipped  
1 To 5

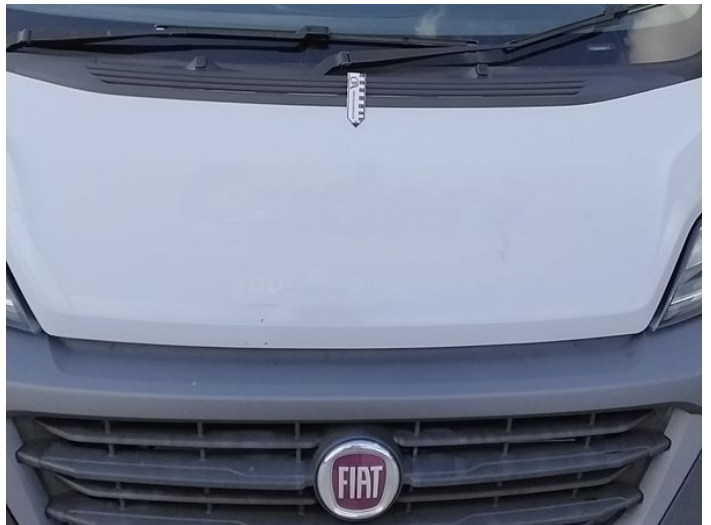
2: Bonnet  
Chipped  
Multiple Chips

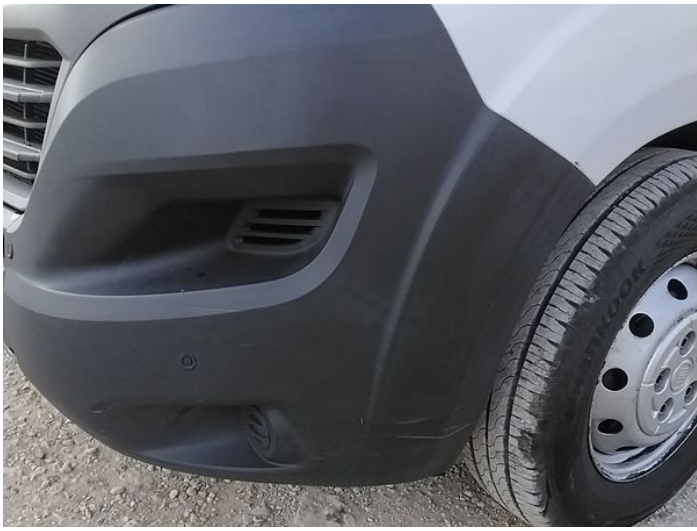
3: Bumper Front Moulding  
Scuffed (Unpainted)  
UpTo 100mm

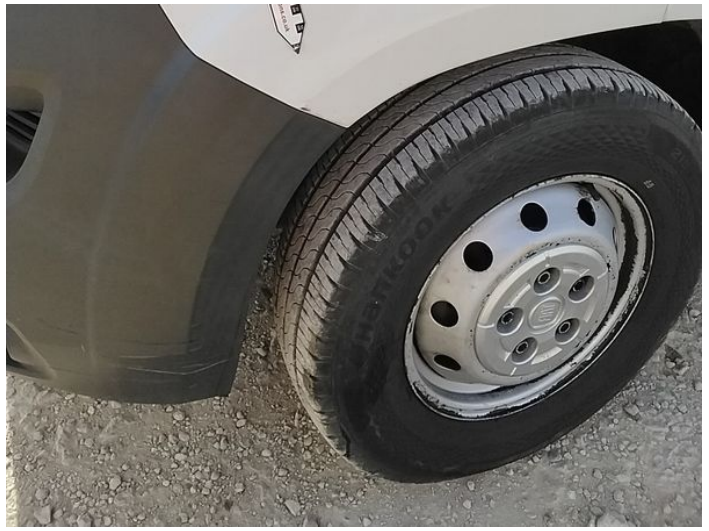
4: Wing nsf  
Scratched  
UpTo 25mm Thru Paint

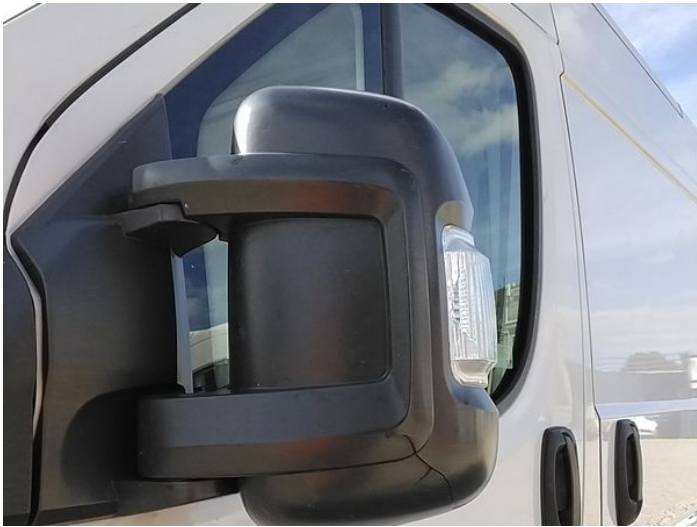
5: Door Mirror Assy nsf  
Broken  
Replace

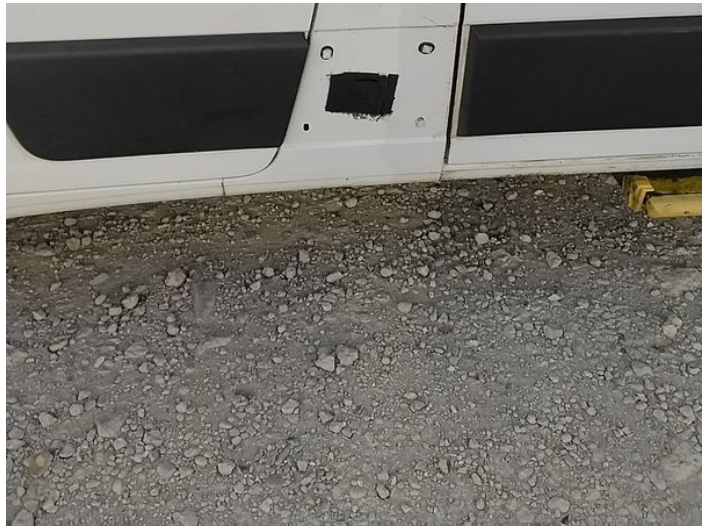
6: Qtr Panel Moulding ns  
Missing  
Replace

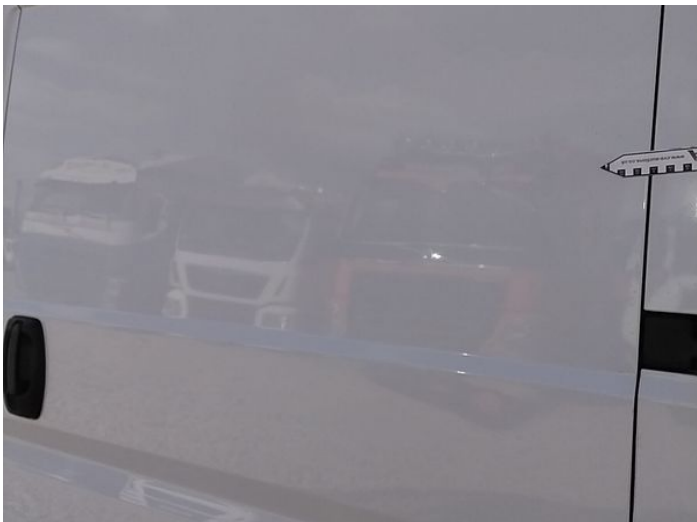
7: Door nsr  
Dented  
Over 30mm

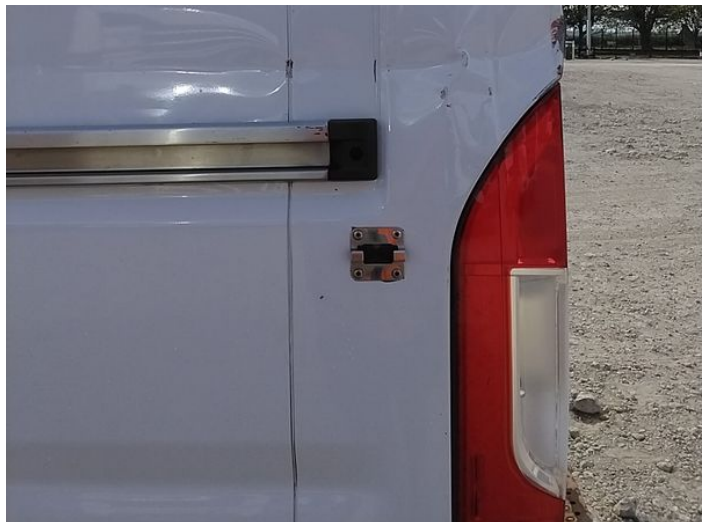
8: Qtr Panel nsr  
Dented  
With Paint Damage

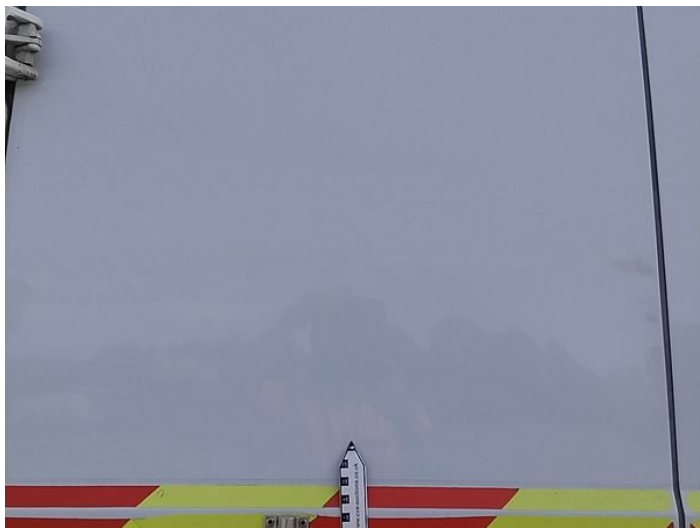
9: Door nsr  
Dented  
Over 30mm

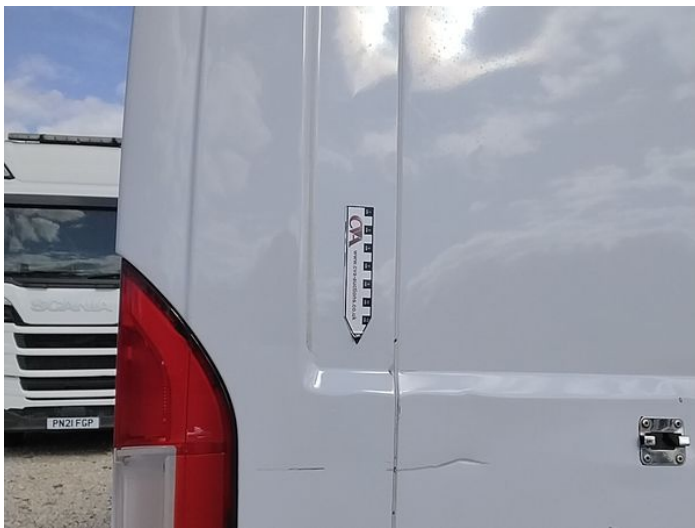
10: Qtr Panel osr  
Scratched  
Over 25mm Thru Paint

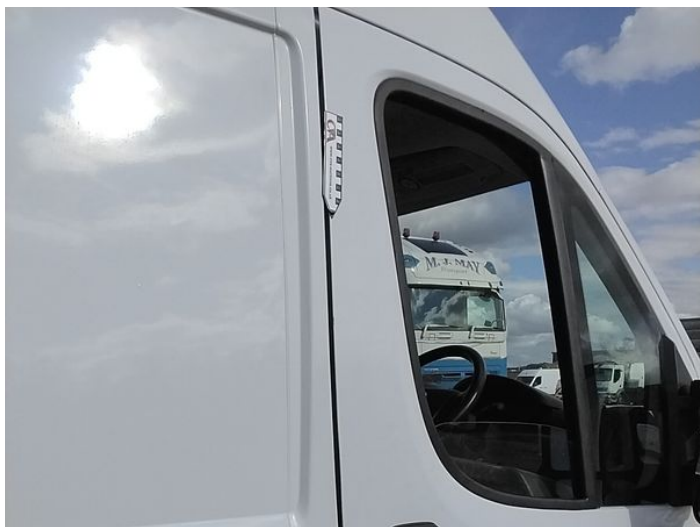
11: Door osf  
Chipped  
Edge Chip

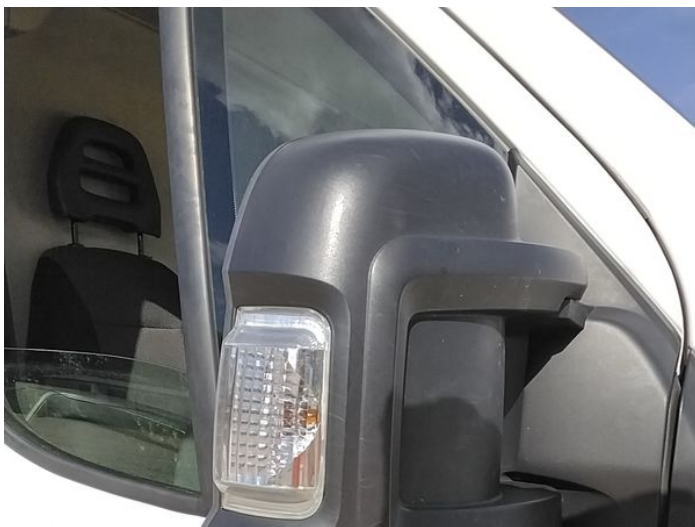
12: Door Mirror Assy osf  
Scuffed (Unpainted)  
Over 100mm

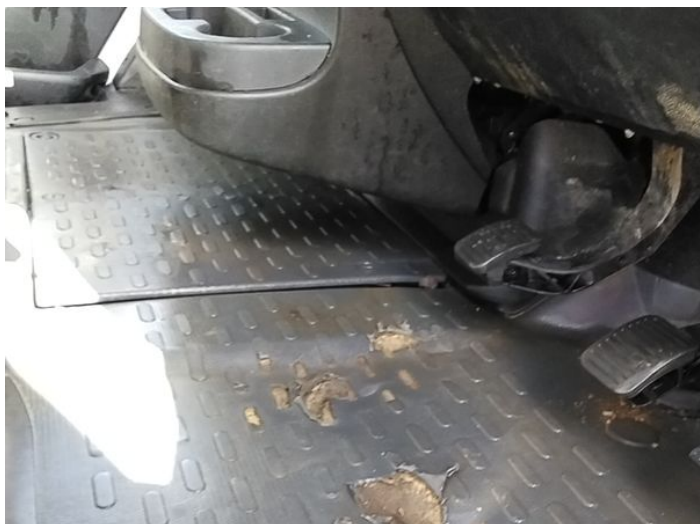
13: Carpets Front  
Holed  
Over 3mm

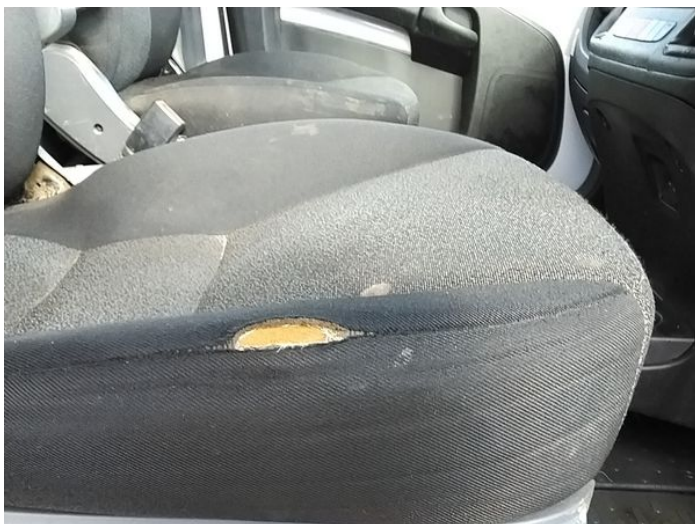
14: Seat Base Cover osf  
Holed  
Over 3mm
