# VEHICLE INSPECTION REPORT

**WX20KNZ**

## Fiat Ducato 35 2.3 MULTIJET 140PS

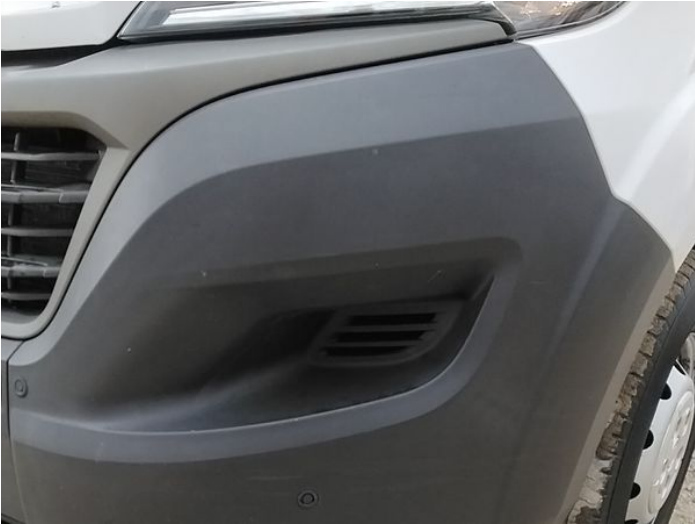
1: Bumper Front Moulding  
Scuffed (Unpainted)  
UpTo 100mm

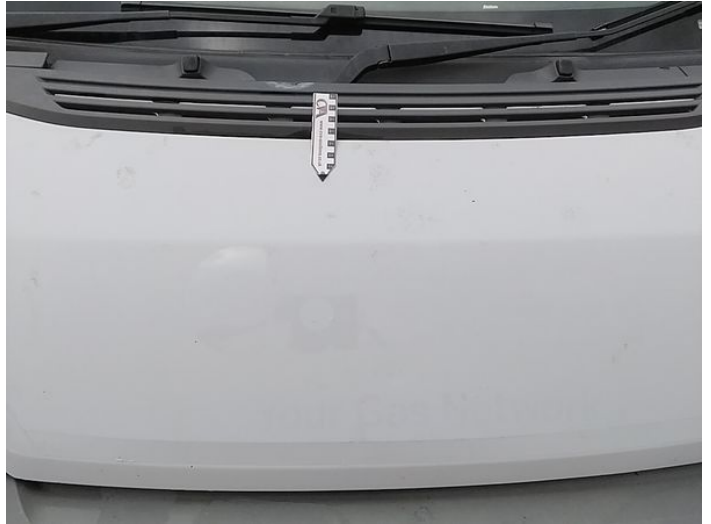
2: Bonnet  
Scratched  
Over 25mm Thru Paint

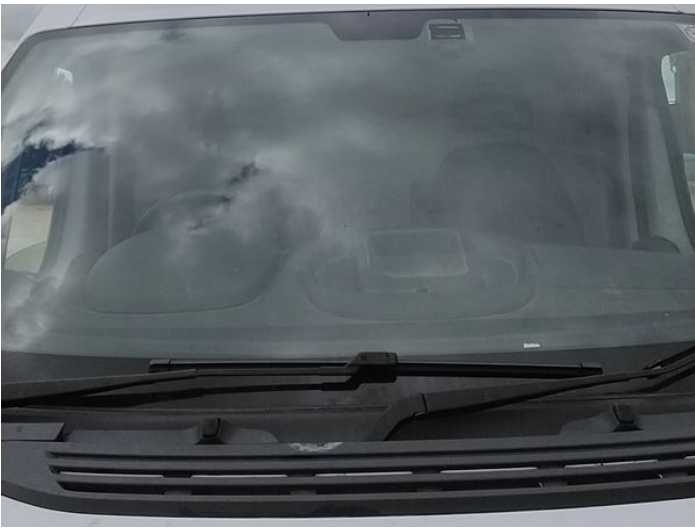
3: Screen Front  
Chipped  
Over 10mm

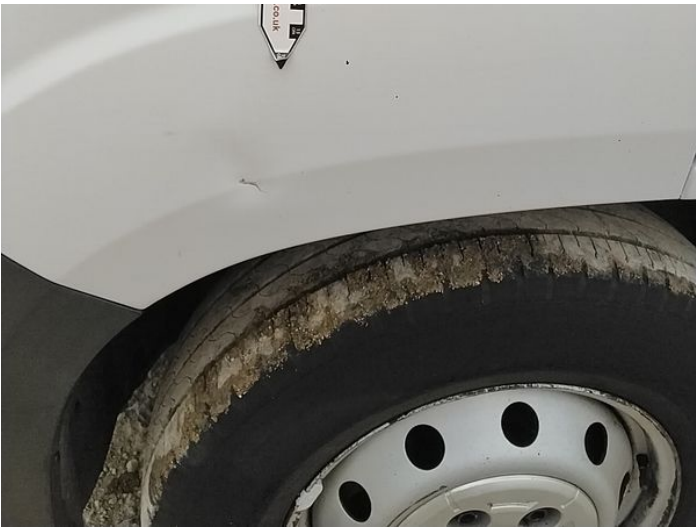
4: Wing nsf  
Scratched  
UpTo 25mm Thru Paint

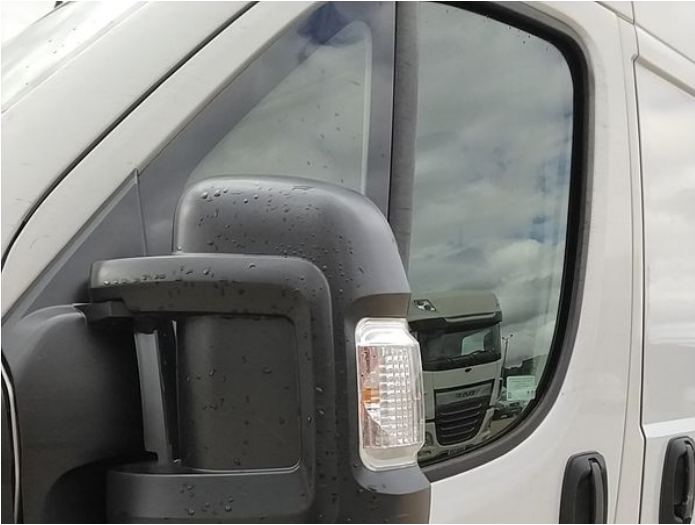
5: Door Mirror Assy nsf  
Scuffed (Unpainted)  
UpTo 100mm

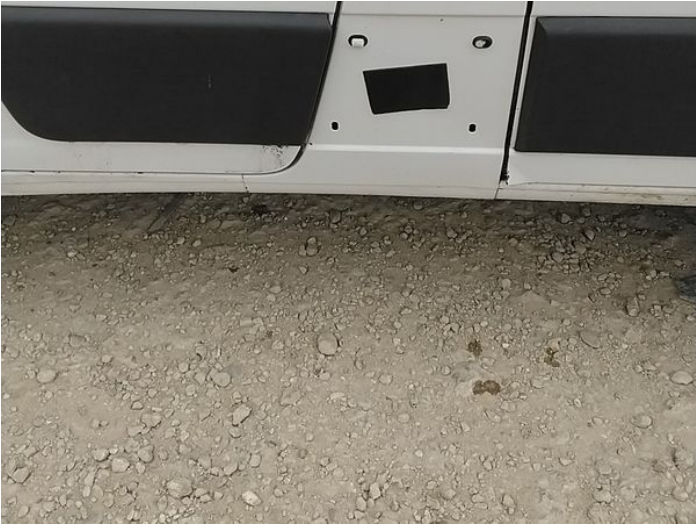
6: Qtr Panel Trim ns  
Missing  
Replace

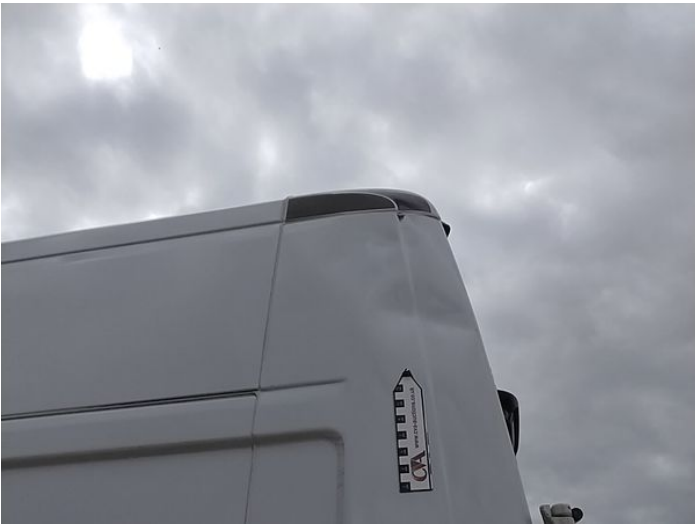
7: Qtr Panel nsr  
Dented  
Over 30mm

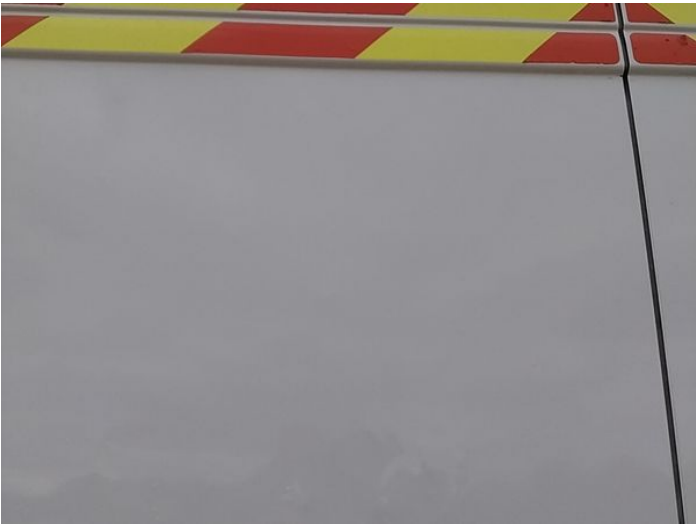
8: Door nsr  
Dented  
Over 30mm

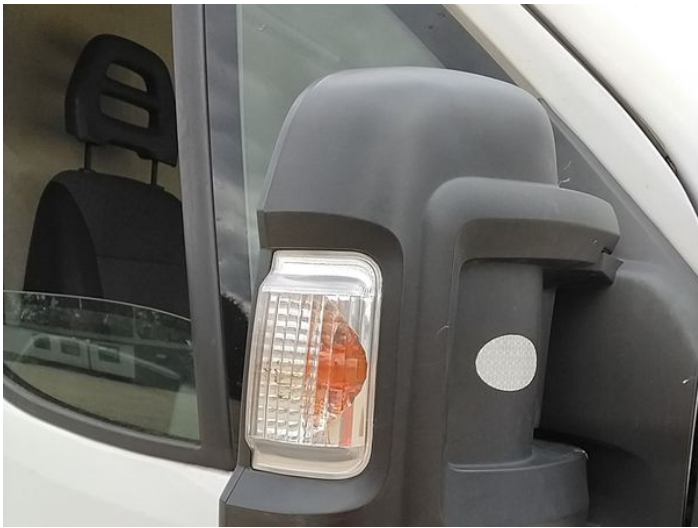
9: Door Mirror Assy osf  
Scuffed (Unpainted)  
UpTo 100mm

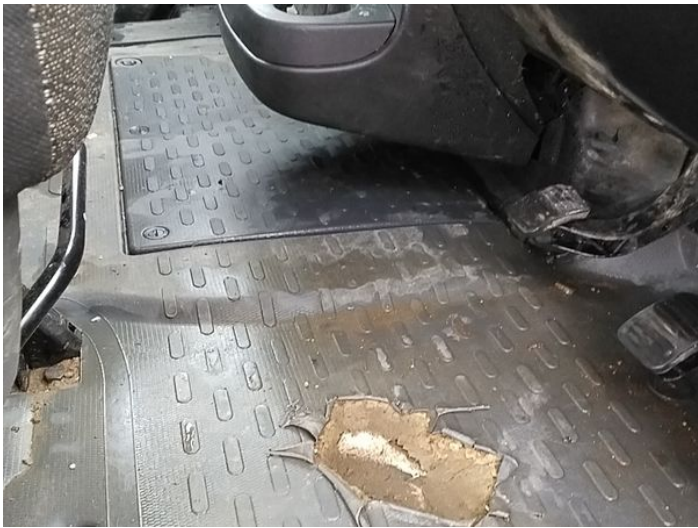
10: Carpets Front  
Holed  
Over 3mm
