# VEHICLE INSPECTION REPORT

**NX16VTN**

## Man TGM 18.250

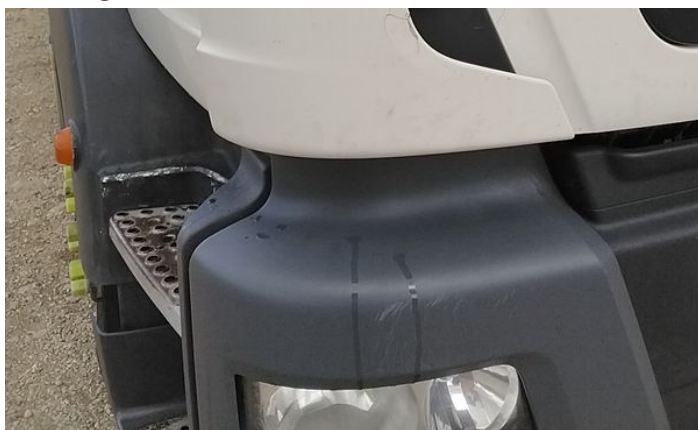
1: Wing of  
Cracked  
Replace

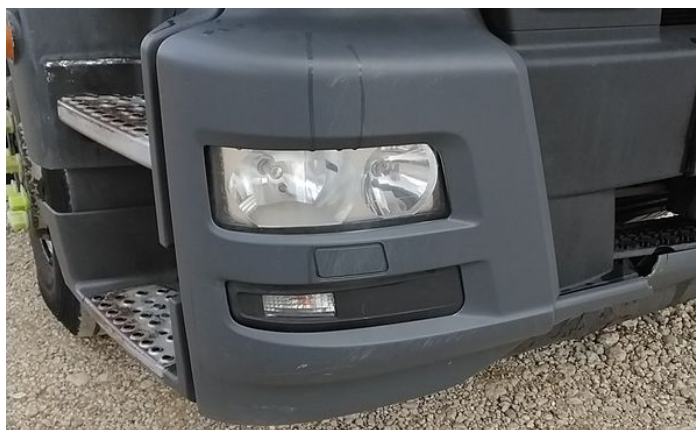
2: Bumper Front Moulding  
Scuffed (Unpainted)  
Over 100mm

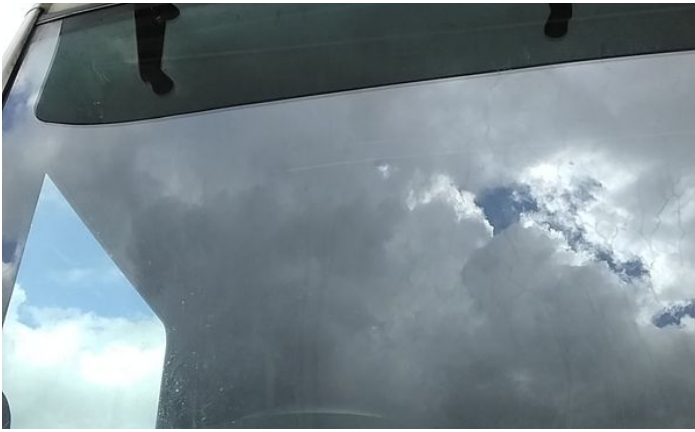
3: Screen Front  
Chipped  
UpTo 10mm

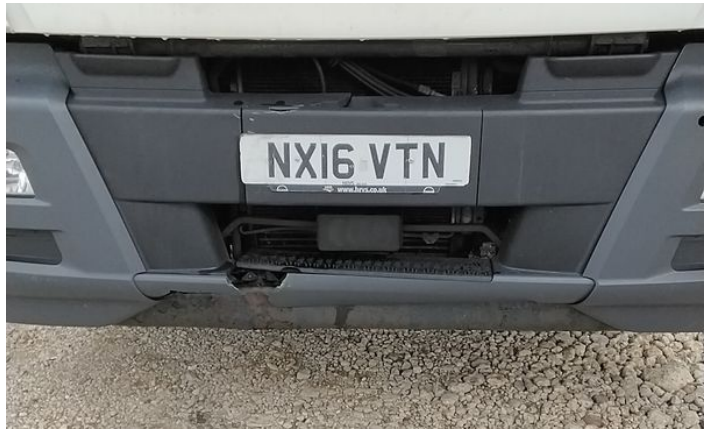
4: Bumper Front  
Cracked  
Over 25mm

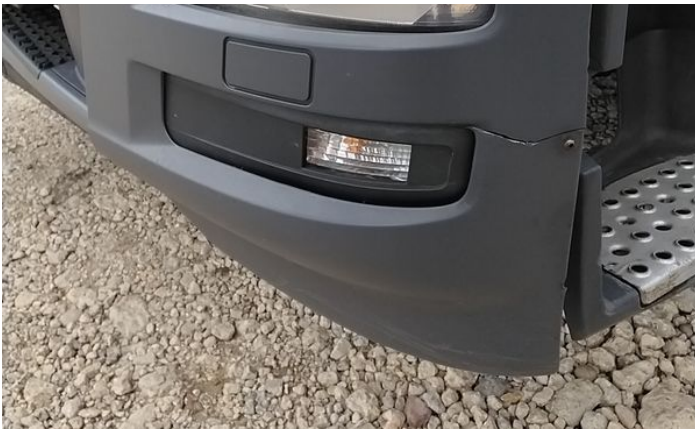
5: Bumper Front  
Cracked  
Over 25mm

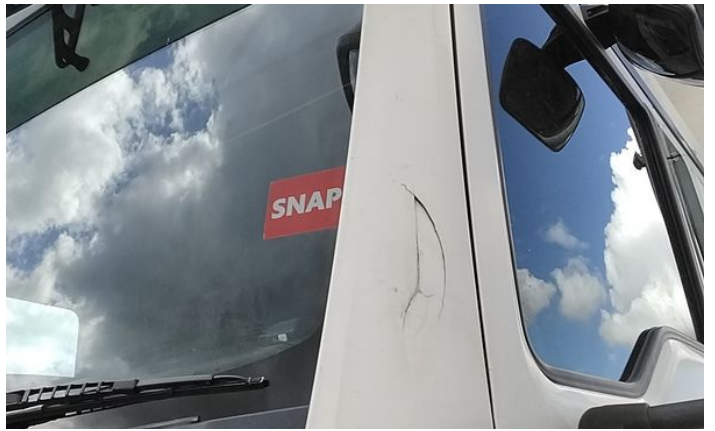
6: A Post ns  
Cracked  
Replace

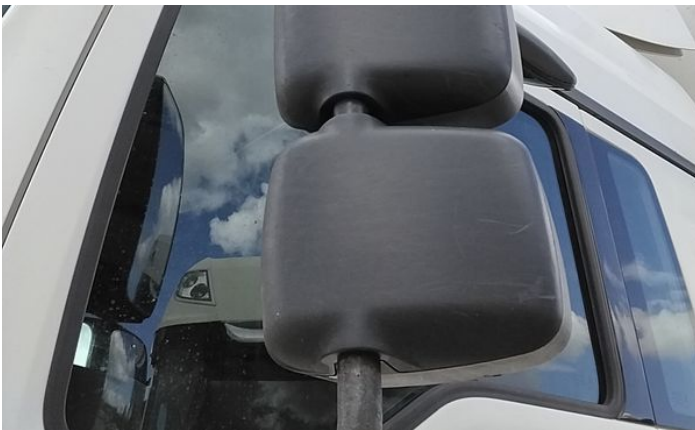
7: Door Mirror Assy nsf  
Scuffed (Unpainted)  
Over 100mm

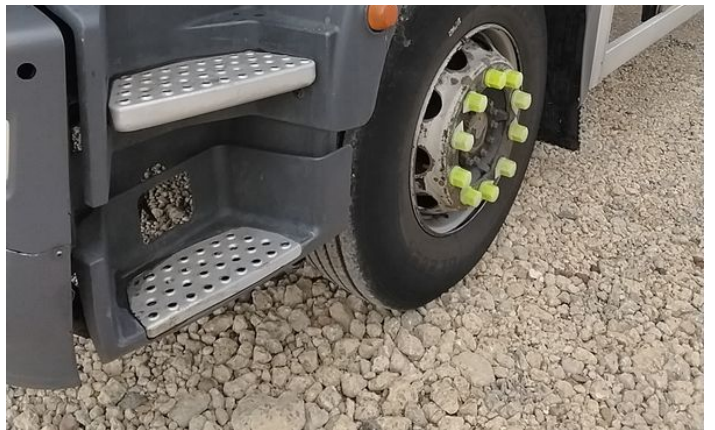
8: Wing Front Arch Extension ns  
Broken  
Replace

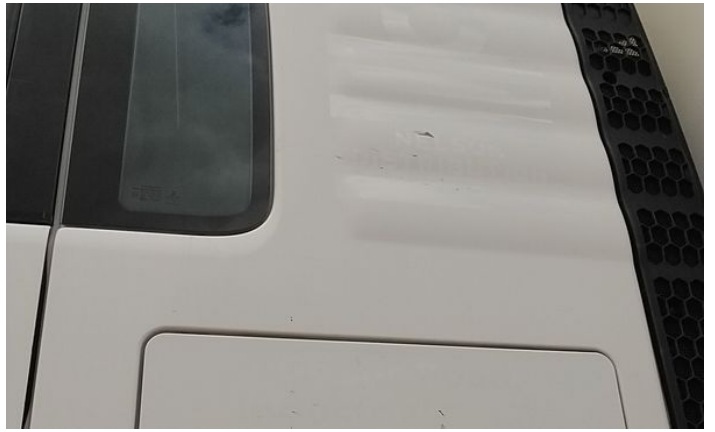
10: Qtr Panel nsr  
Scratched  
Over 25mm Thru Paint

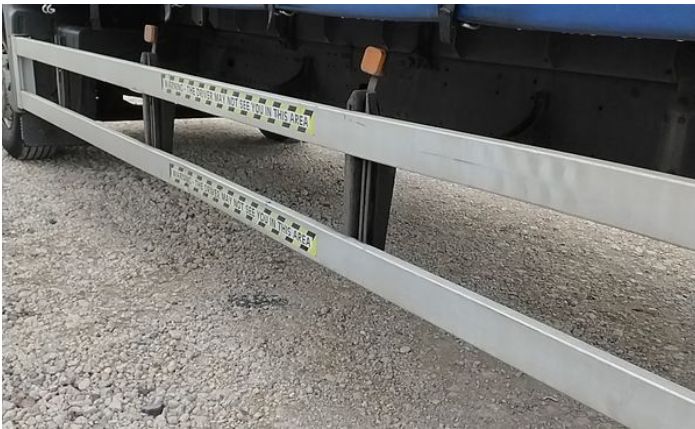
11: Qtr Panel nsr  
Dented  
Over 30mm

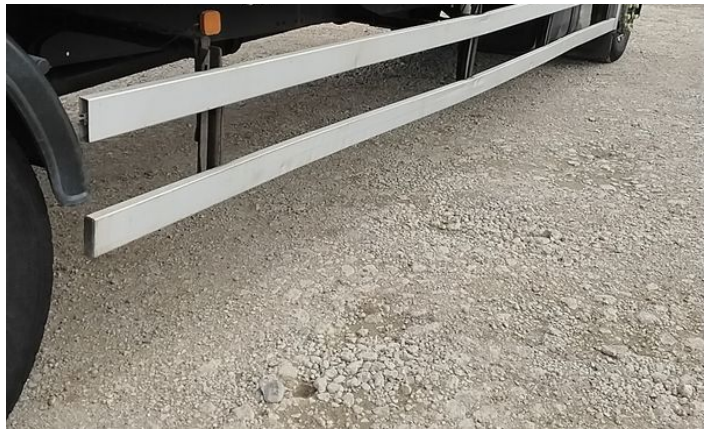
12: Qtr Panel osr  
Dented  
Over 30mm

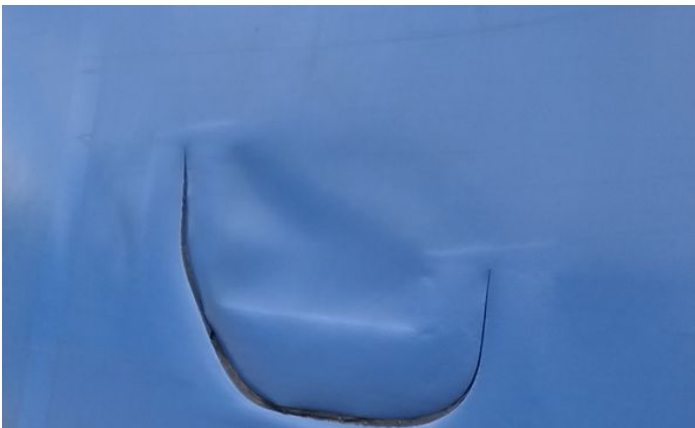
13: Qtr Panel osr  
Hole  
Over 10mm

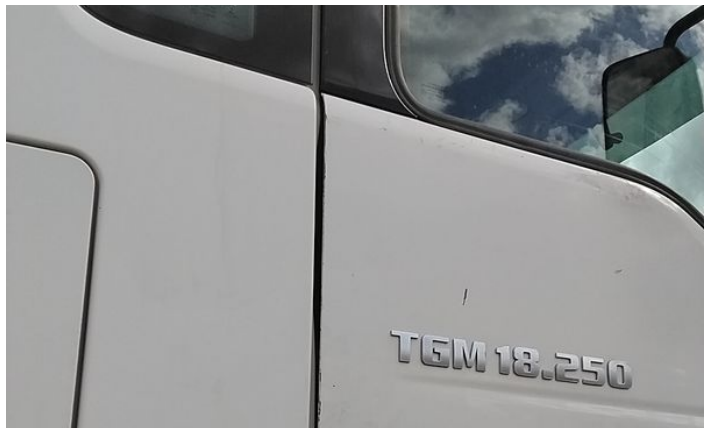
14: Door osf  
Chipped  
Edge Chip

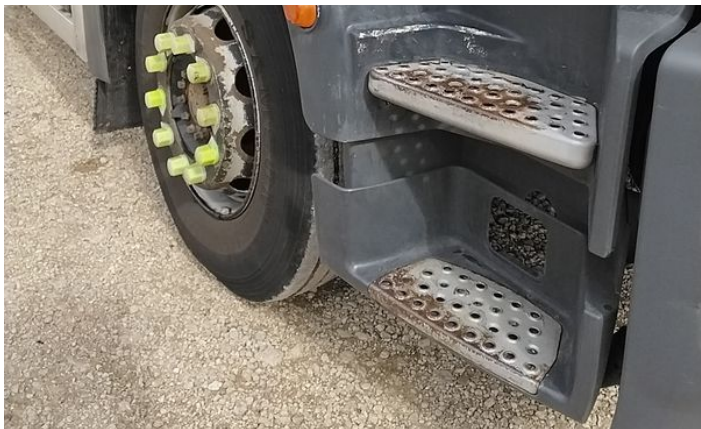
15: Wing Front Arch Extension os  
Scuffed (Unpainted)  
Over 100mm

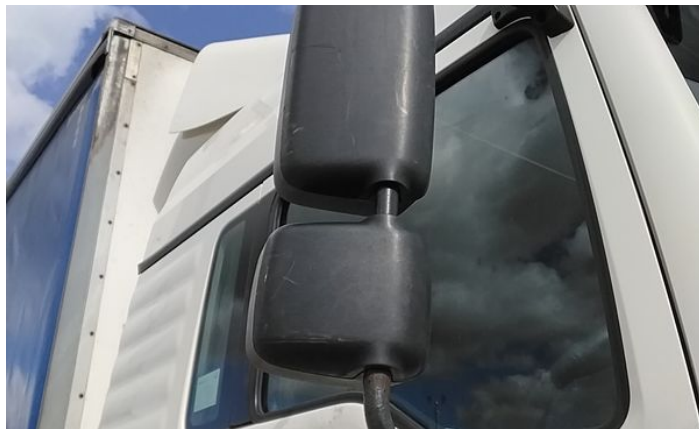
16: Door Mirror Assy osf  
Scuffed (Unpainted)  
Over 100mm

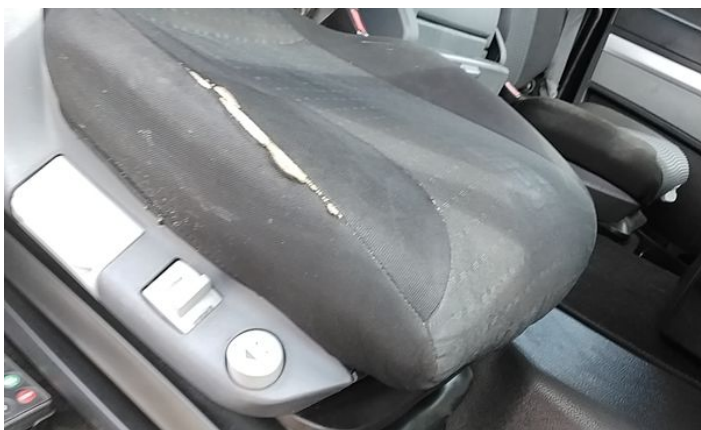
17: Seat Base Cover osf  
Torn  
Over 3mm

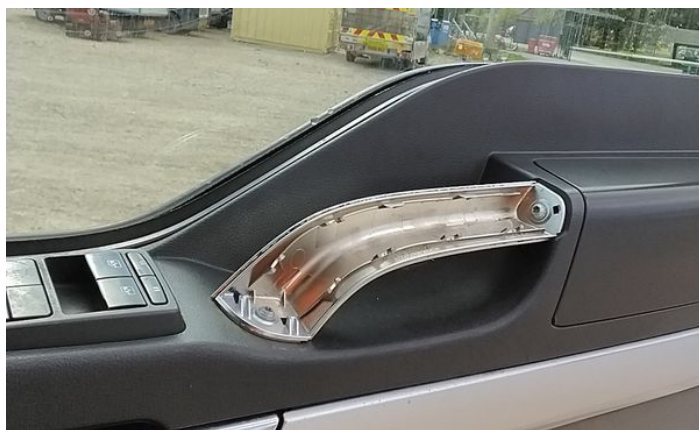
18: Handle Inner osf  
Damaged  
Replace
