# VEHICLE INSPECTION REPORT

**NX67RNZ**

## Man TGM 18.250

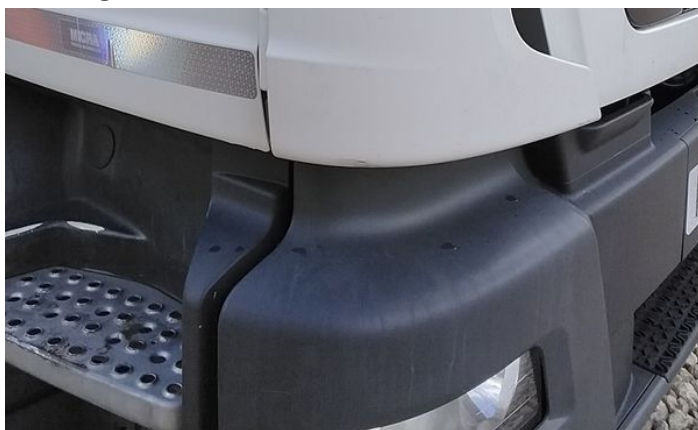
1: Wing osf  
Scratched  
Over 25mm Thru Paint

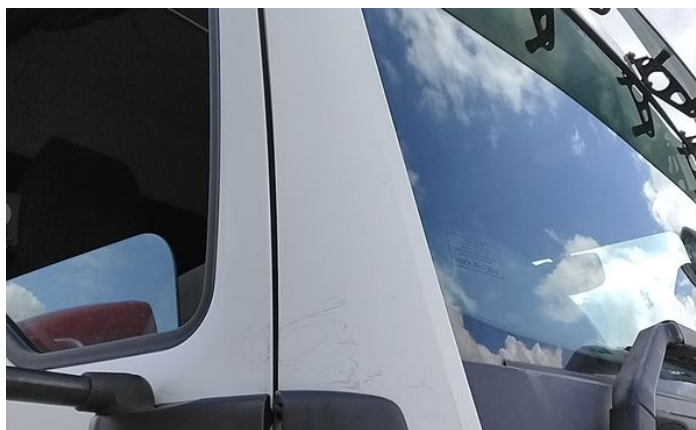
2: A Post os  
Scratched  
Over 25mm Not Thru Paint

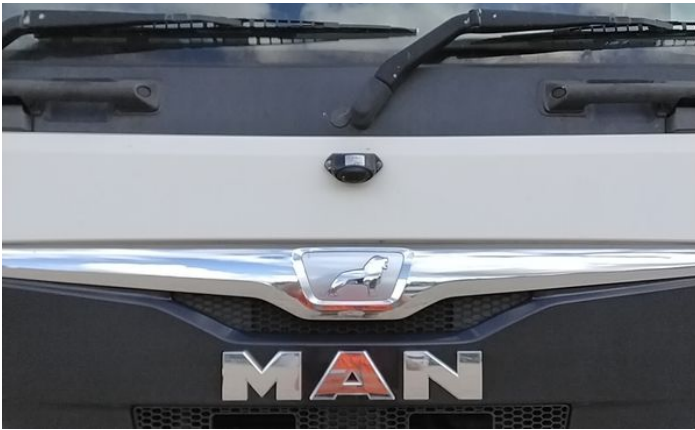
3: Bonnet  
Chipped  
Multiple Chips

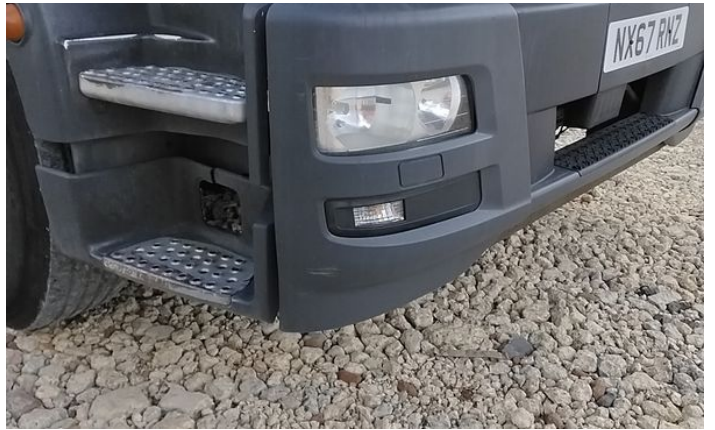
4: Bumper Front Moulding  
Scuffed (Unpainted)  
Up To 100mm

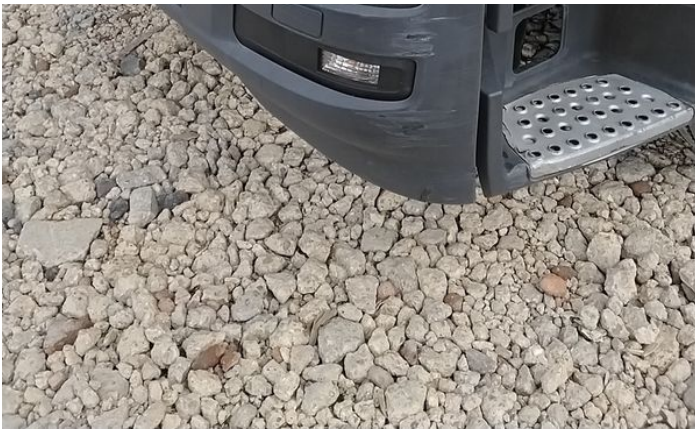
5: Bumper Front Moulding  
Scuffed (Unpainted)  
Over 100mm

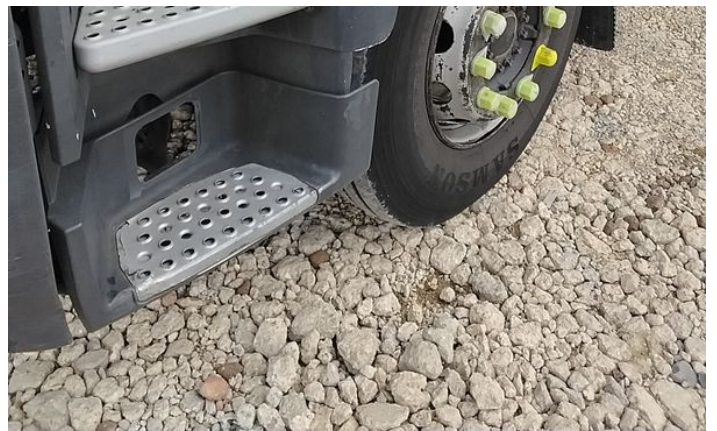
6: Wing Front Arch Extension ns  
Scuffed (Unpainted)  
Over 100mm

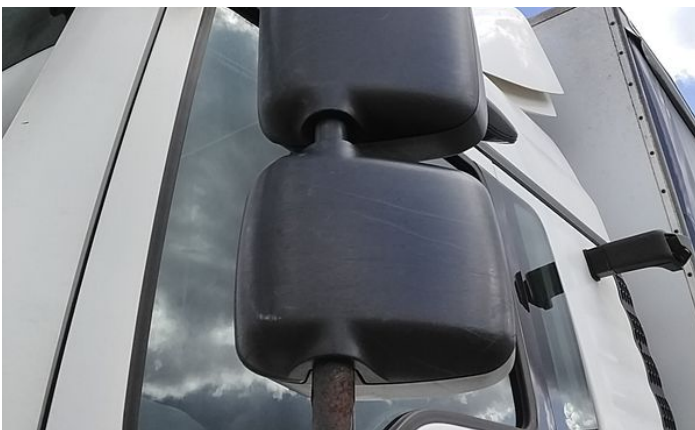
7: Door Mirror Assy nsf  
Scuffed (Unpainted)  
Over 100mm

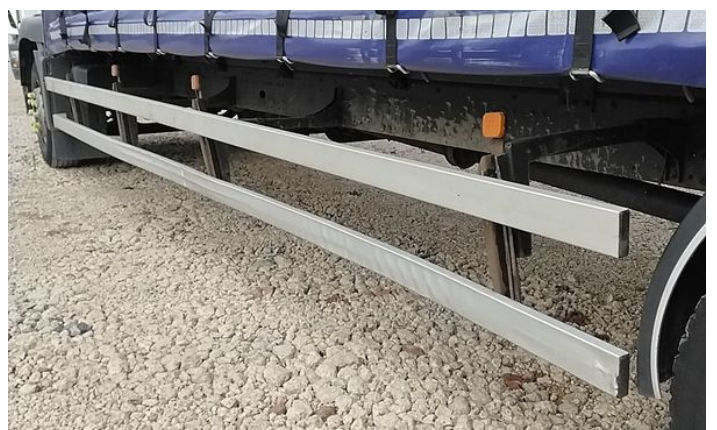
8: Qtr Panel nsr  
Dented  
Over 30mm

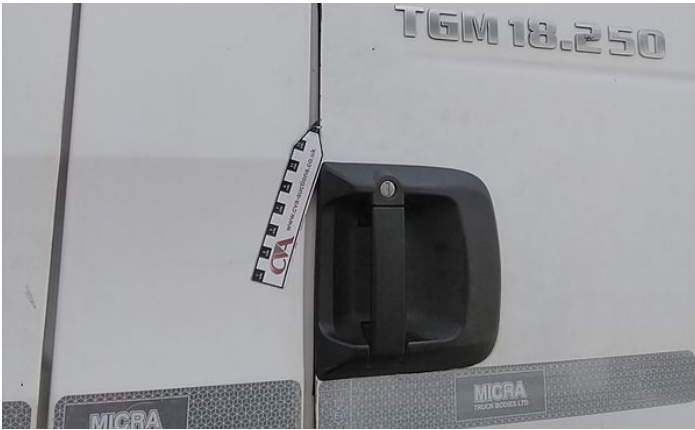
9: Door osf  
Chipped  
Edge Chip

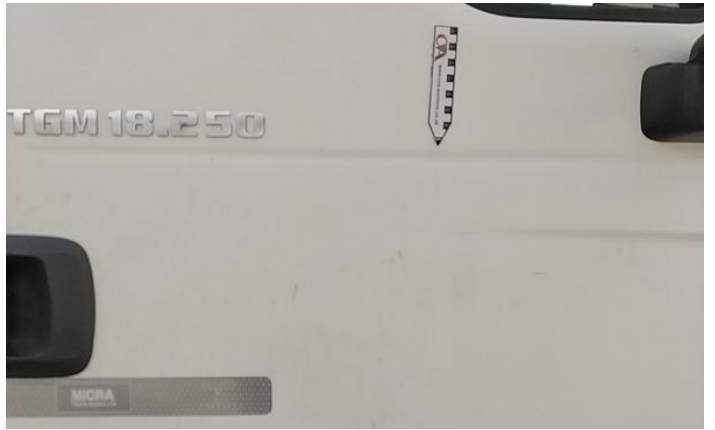
10: Door osf  
Scratched  
Over 25mm Thru Paint

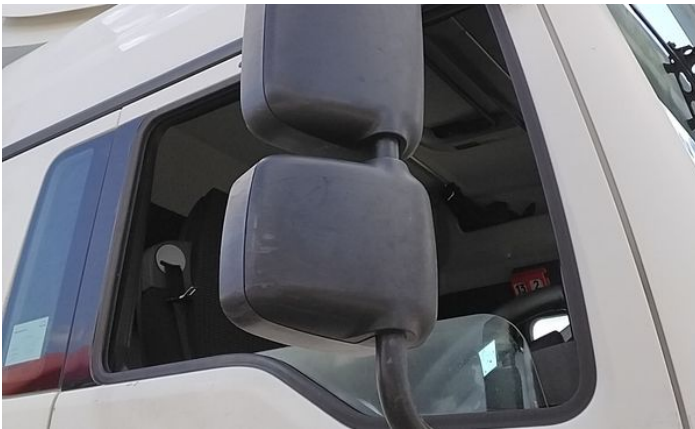
11: Door Mirror Assy osf  
Scuffed (Unpainted)  
Over 100mm

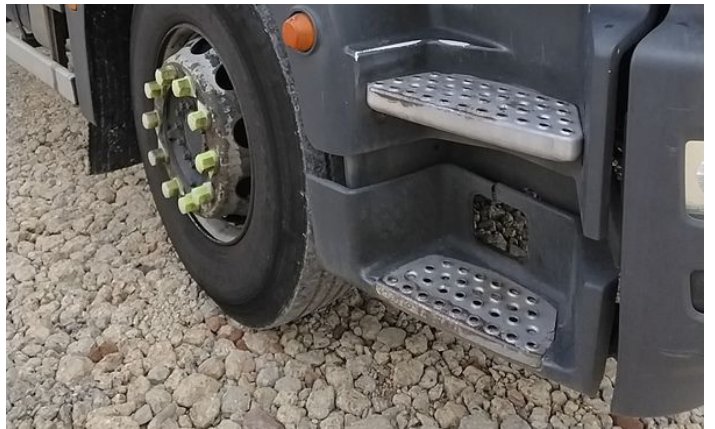
12: Qtr Panel Arch Extension os  
Scuffed (Unpainted)  
Over 100mm

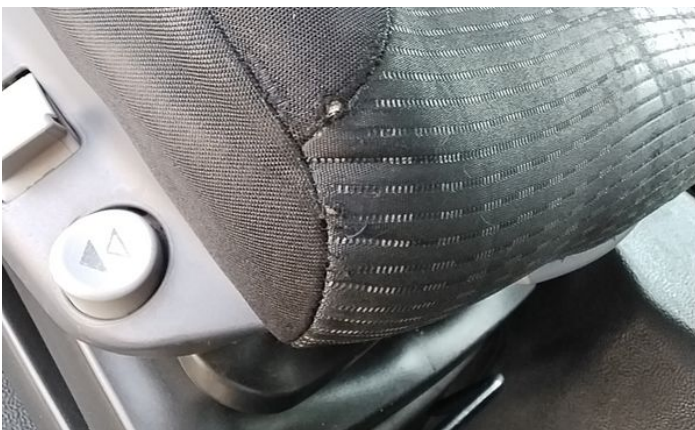
13: Seat Base Cover osf  
Holed  
Over 3mm
