## VEHICLE INSPECTION REPORT

**LP69NLY**

### Volkswagen Crafter 2.0 TDI 140PS Trendline

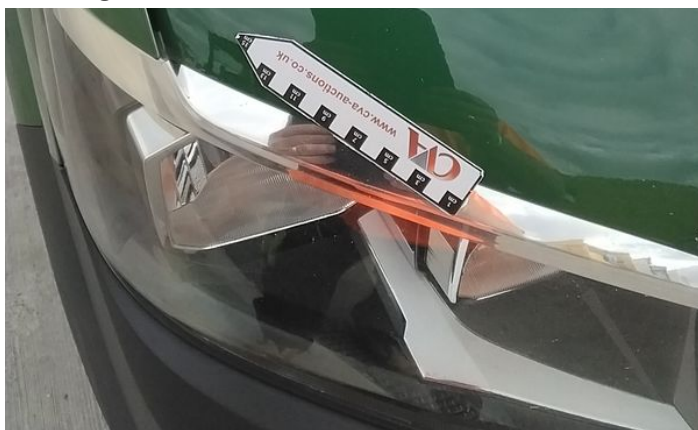
1: Bonnet  
Dented  
With Paint Damage

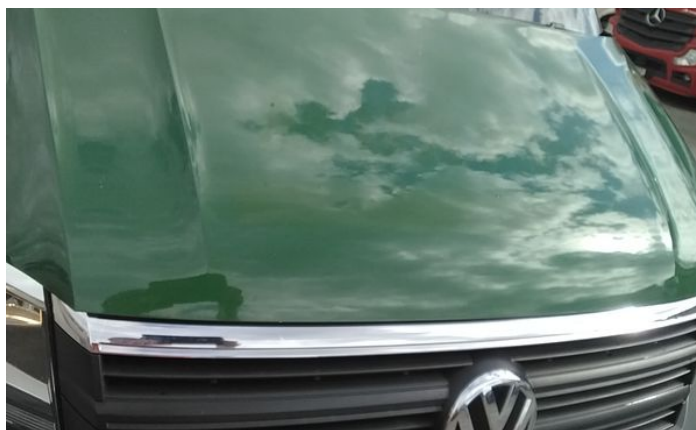
2: Bonnet  
Chipped  
Multiple Chips

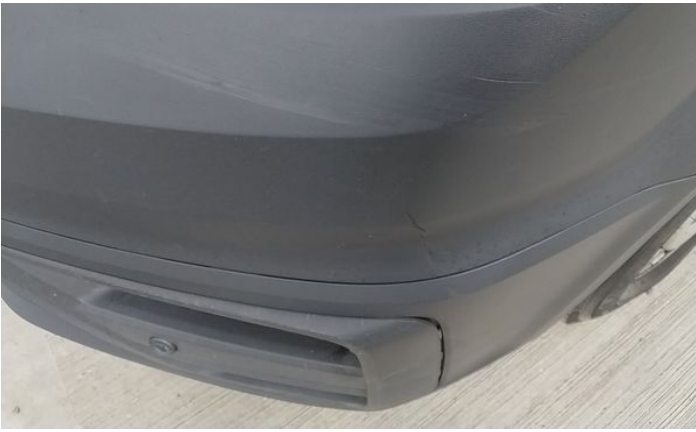
3: Panel Front  
Cracked  
Replace

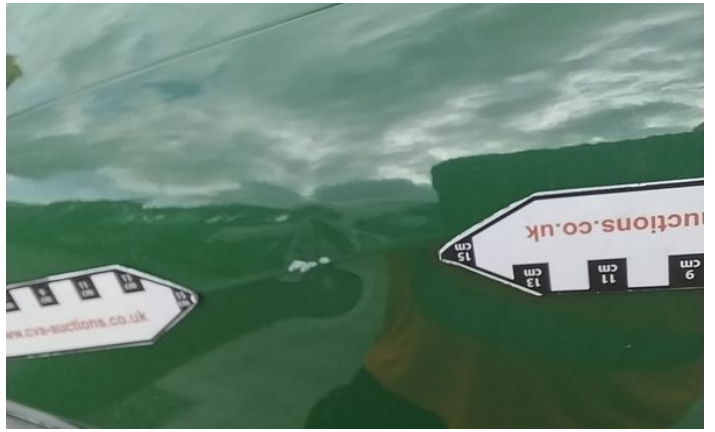
4: Wing nsf  
Dented  
With Paint Damage

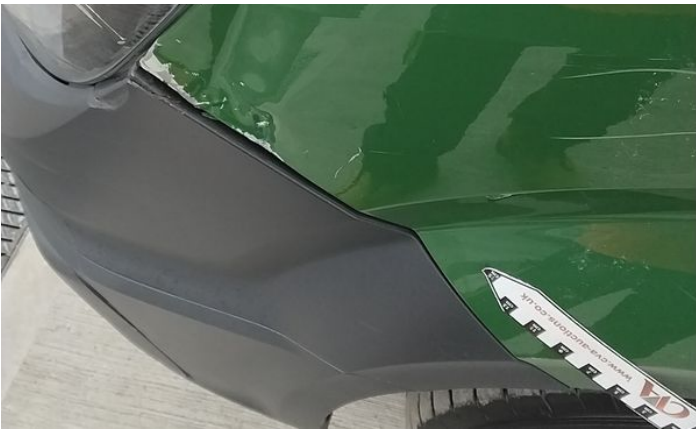
5: Wing nsf  
Dented  
With Paint Damage

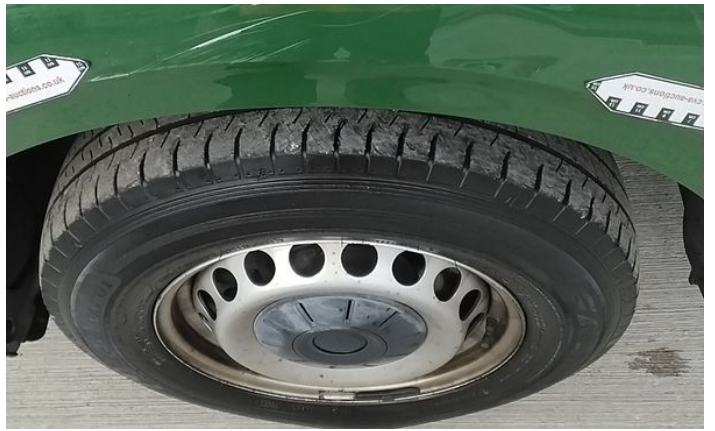
6: Wing nsf  
Dented  
With Paint Damage

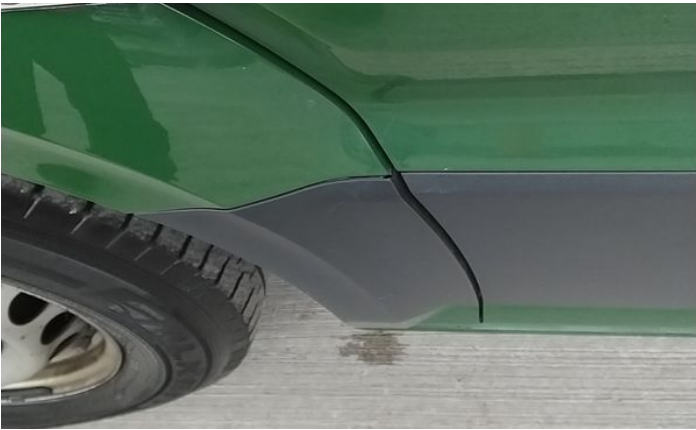
7: Door nsf  
Dented  
With Paint Damage

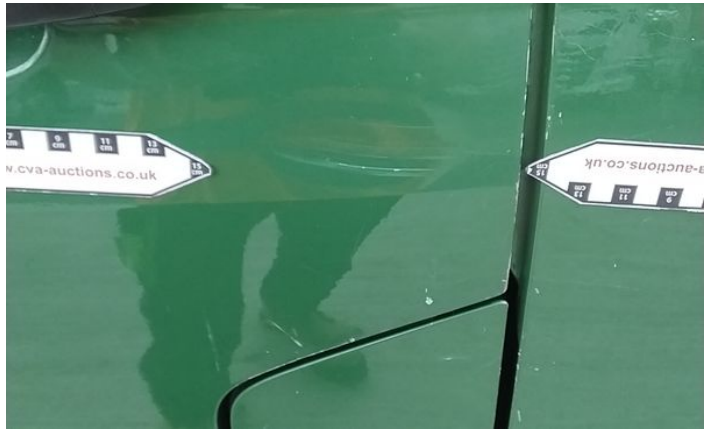
8: Door nsf  
Dented  
With Paint Damage

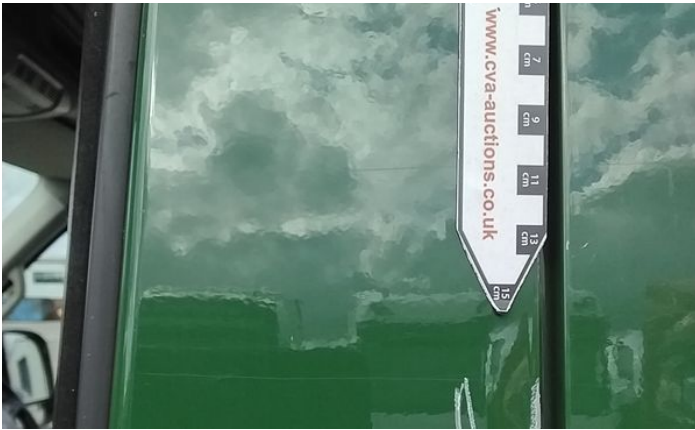
9: Door nsf  
Dented  
With Paint Damage

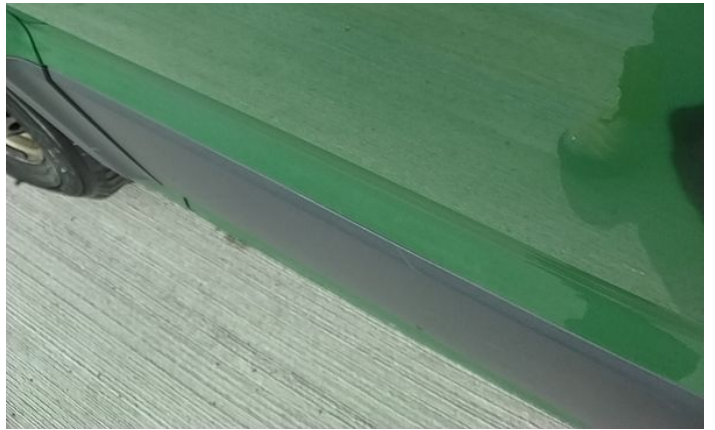
10: Door nsf  
Dented  
Over 30mm

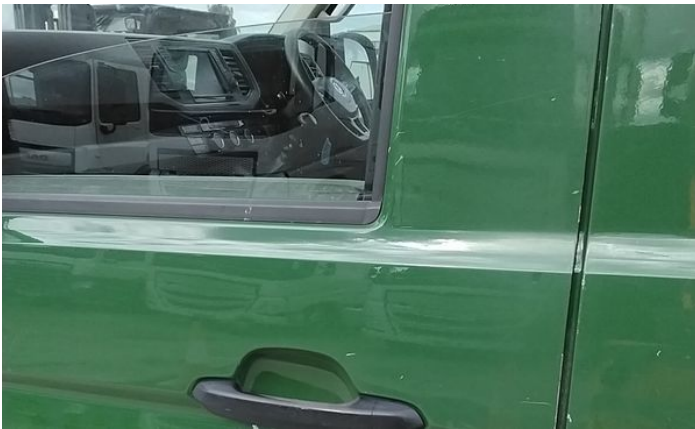
11: Door nsf  
Scratched  
Over 25mm Thru Paint

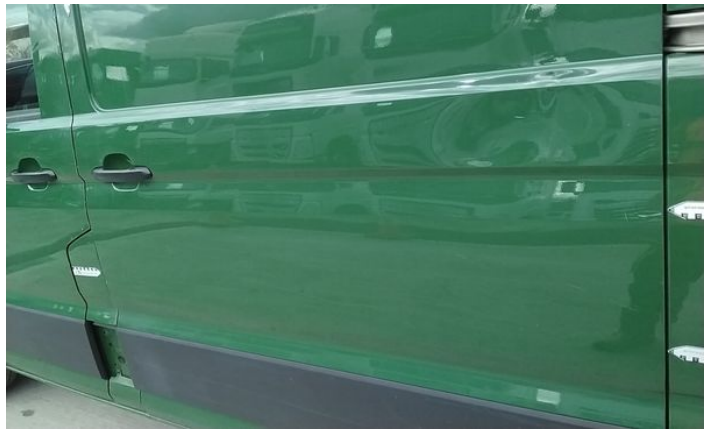
12: Qtr Panel nsr  
Scratched  
Over 25mm Thru Paint

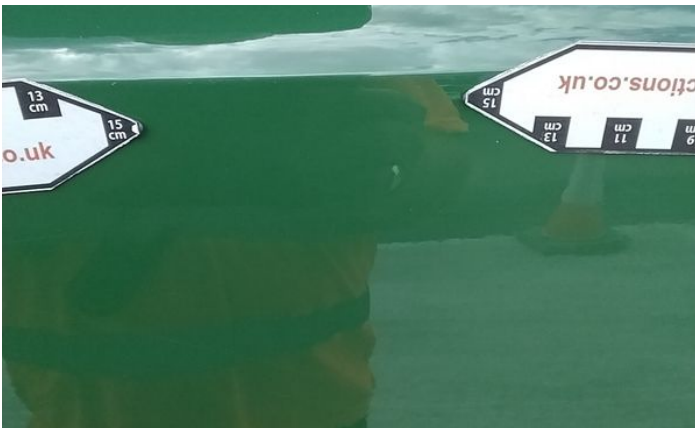
13: Qtr Panel nsr  
Dented  
Over 30mm

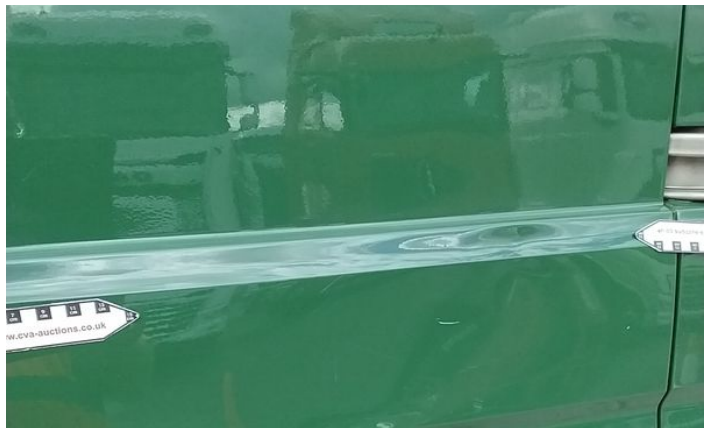
14: Qtr Panel nsr  
Dented  
With Paint Damage

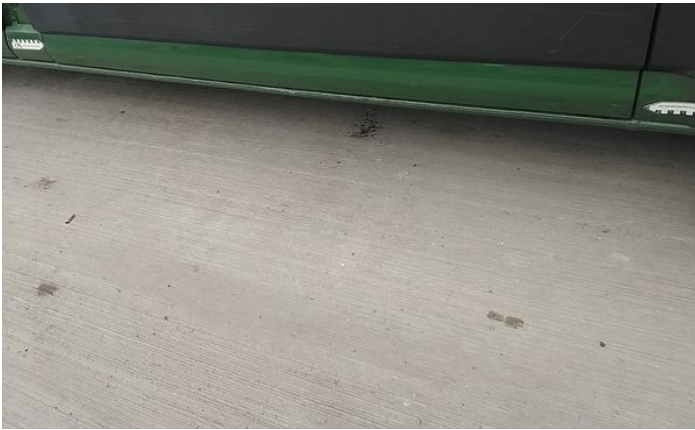
15: Qtr Panel nsr  
Scratched  
Over 25mm Thru Paint

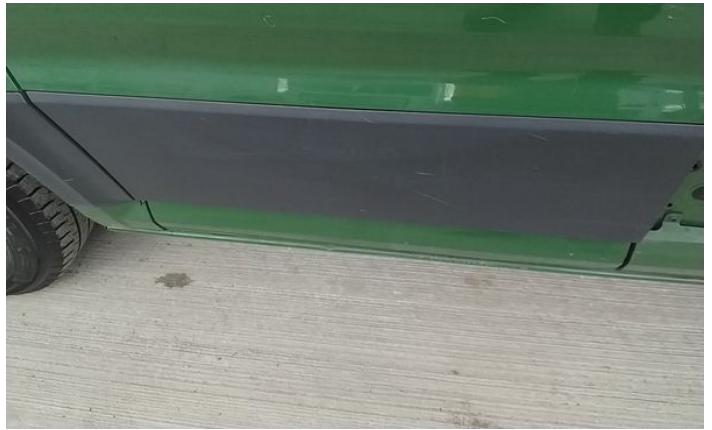
16: Door Moulding nsf  
Scuffed (Unpainted)  
Over 100mm

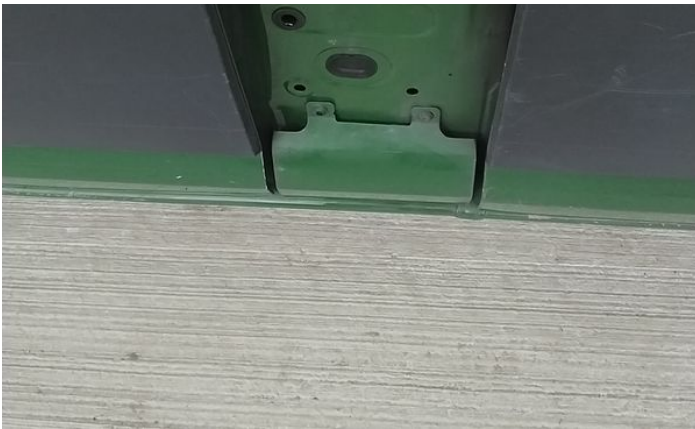
17: Door Moulding nsf  
Missing  
Replace

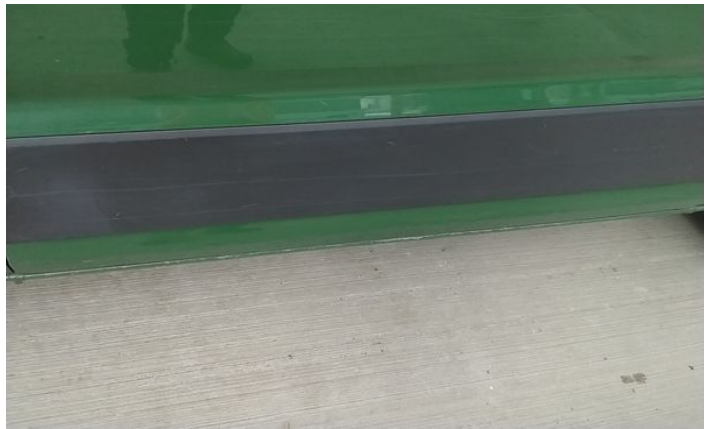
18: Qtr Panel Moulding ns  
Scuffed (Unpainted)  
Over 100mm

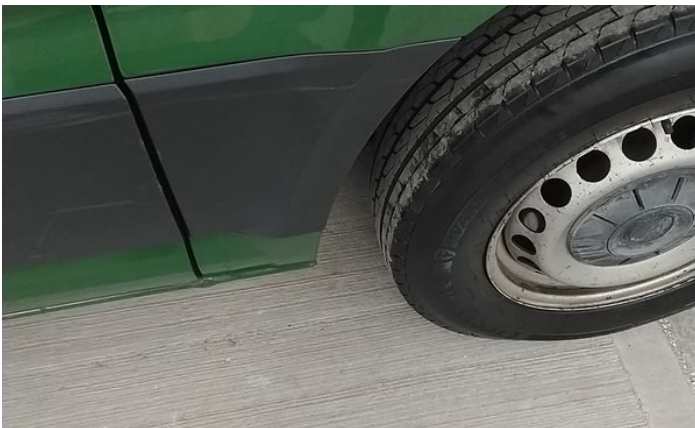
19: Qtr Panel Moulding ns  
Scuffed (Unpainted)  
Over 100mm

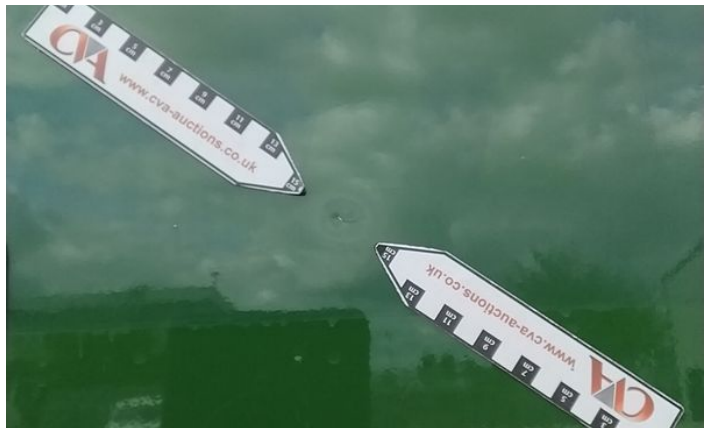
20: Door osr  
Dented  
With Paint Damage

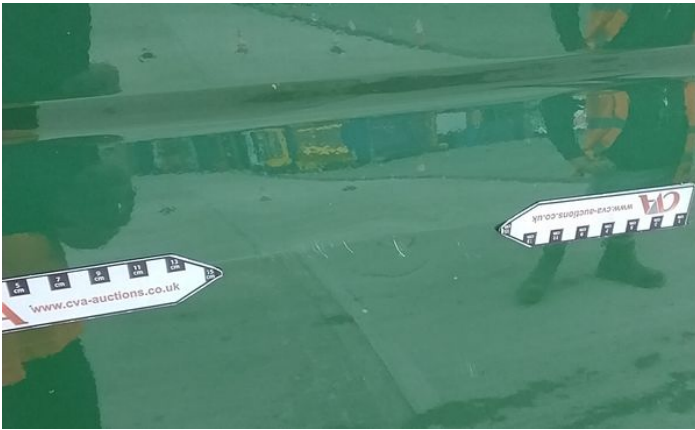
21: Qtr Panel osr  
Dented  
With Paint Damage

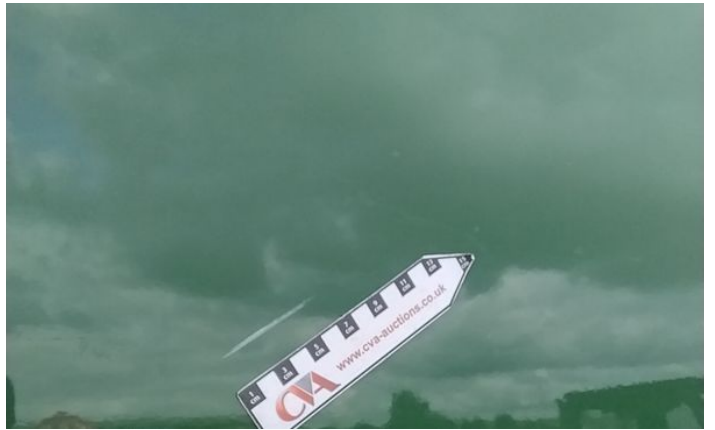
22: Qtr Panel osr  
Scratched  
Over 25mm Thru Paint

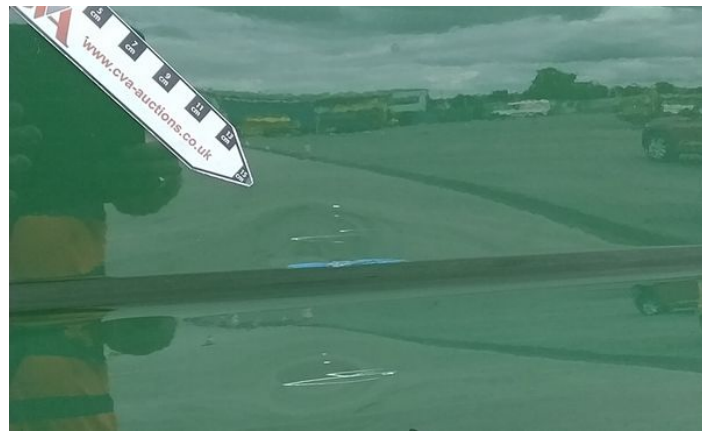
23: Qtr Panel osr  
Dented  
With Paint Damage

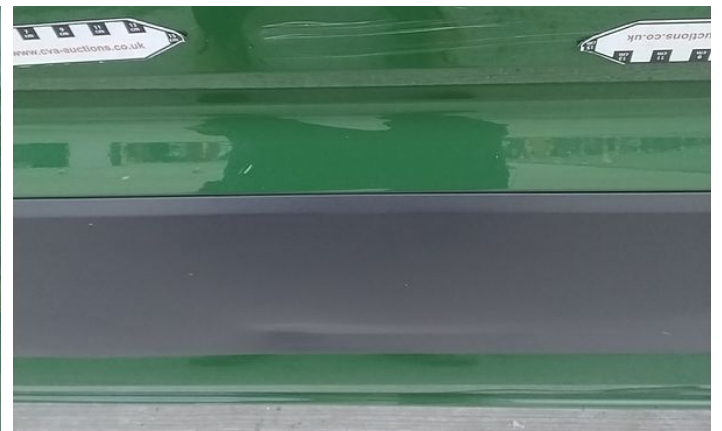
24: Qtr Panel osr  
Dented  
With Paint Damage

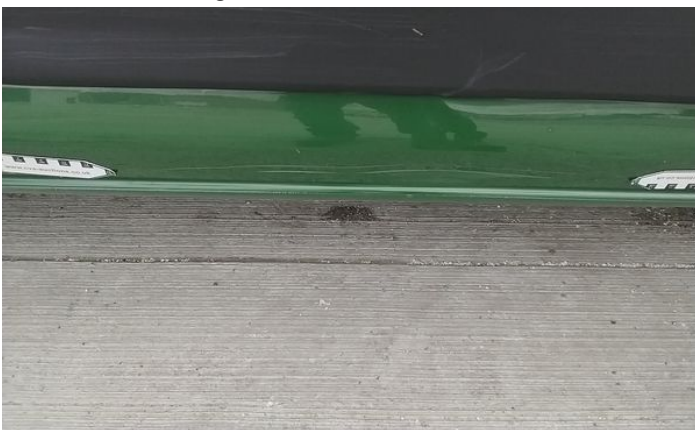
25: Qtr Panel osr  
Dented  
With Paint Damage

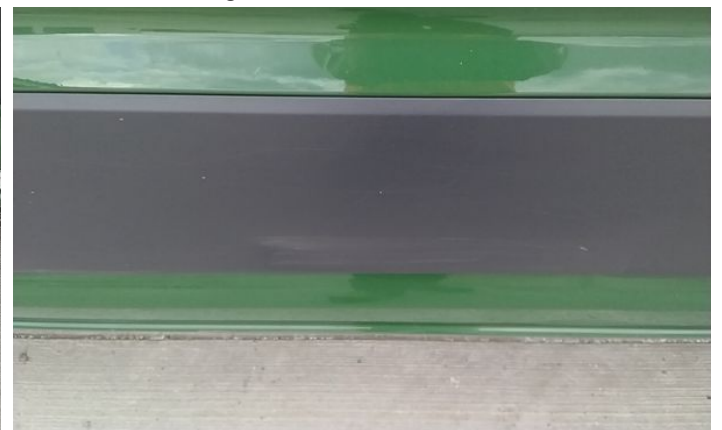
26: Qtr Panel Moulding os  
Scuffed (Unpainted)  
Over 100mm

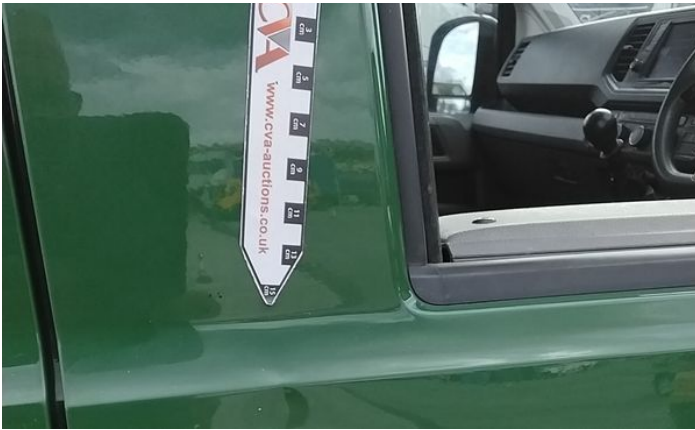
27: Door osf  
Dented  
With Paint Damage

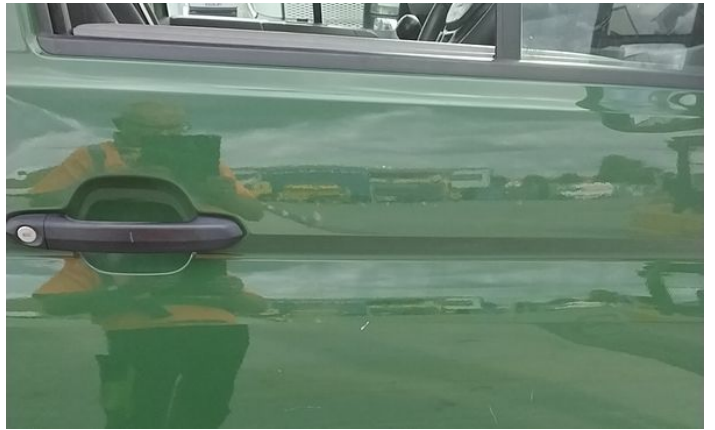
28: Door osf  
Chipped  
Multiple Chips

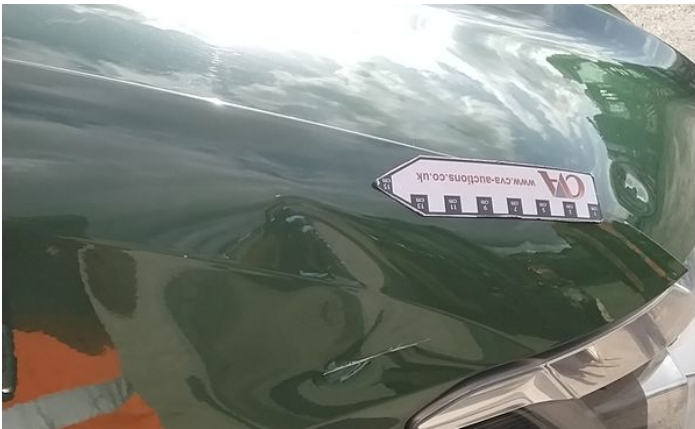
29: Wing osf  
Dented  
With Paint Damage

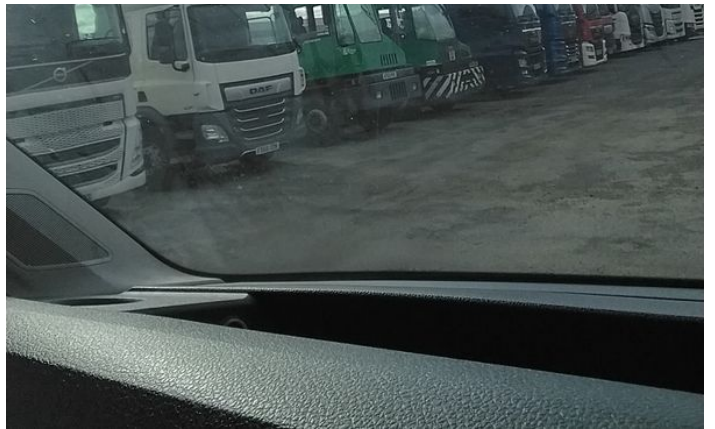
30: Screen Front  
Cracked  
Replace

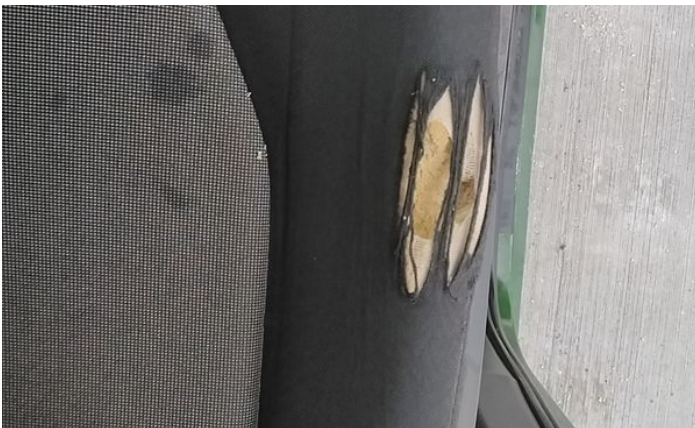
31: Seat Base Cover osf  
Holed  
Over 3mm
