# VEHICLE INSPECTION REPORT

**FJ17RFK**

## Mercedes-Benz Actros 1824

**Non Runner**

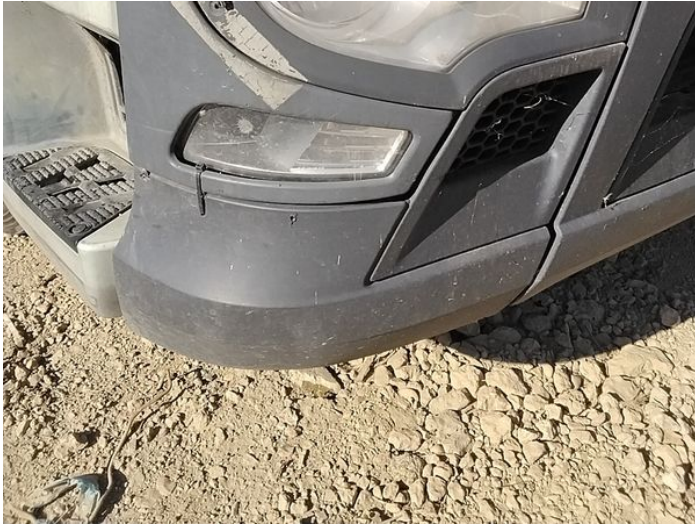
1: Bumper Front Moulding  
Broken  
Replace

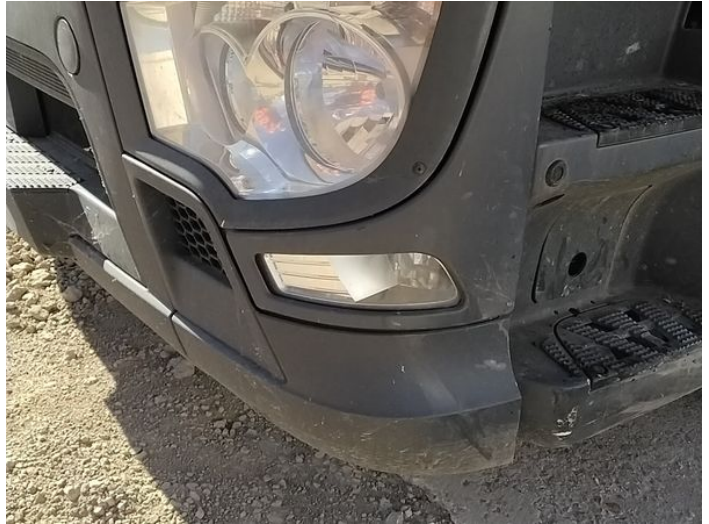
2: Bumper Front Moulding  
Scuffed (Unpainted)  
UpTo 100mm

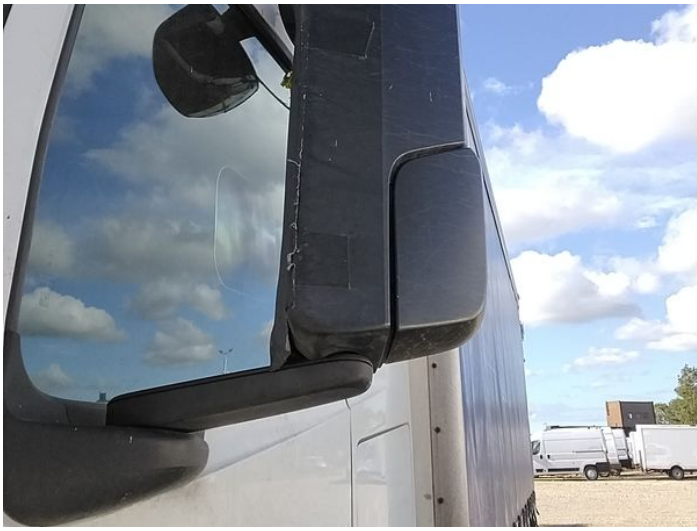
3: Door Mirror Assy nsf  
Broken  
Replace

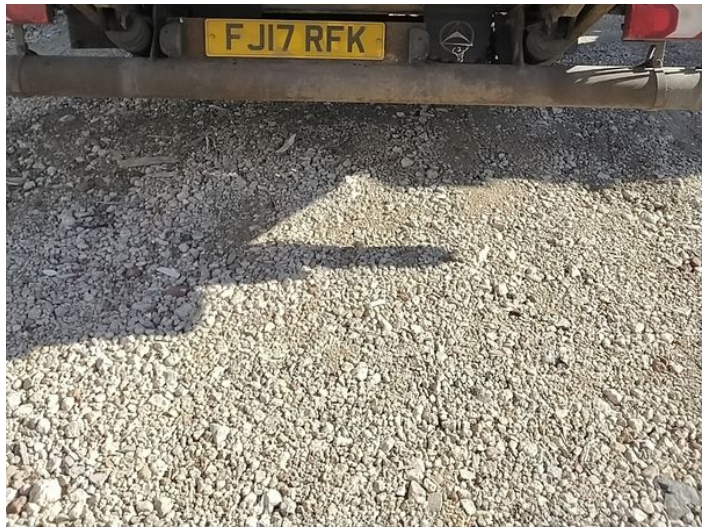
4: Bumper Rear  
Rusted  
Over 5mm

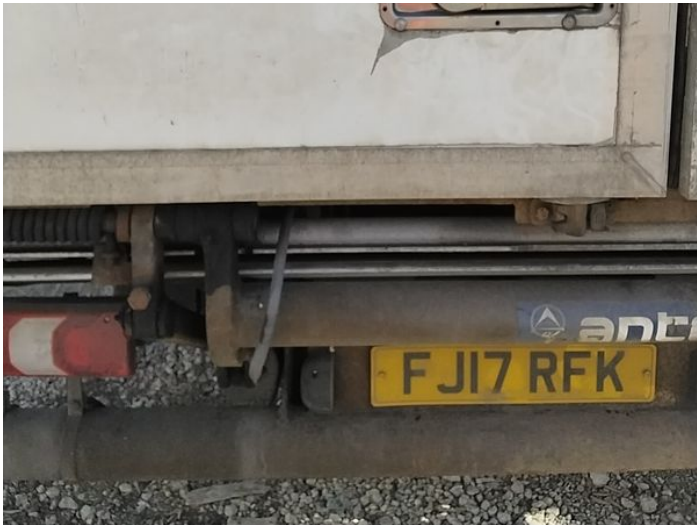
5: Door nsr  
Scratched  
Over 25mm Thru Paint

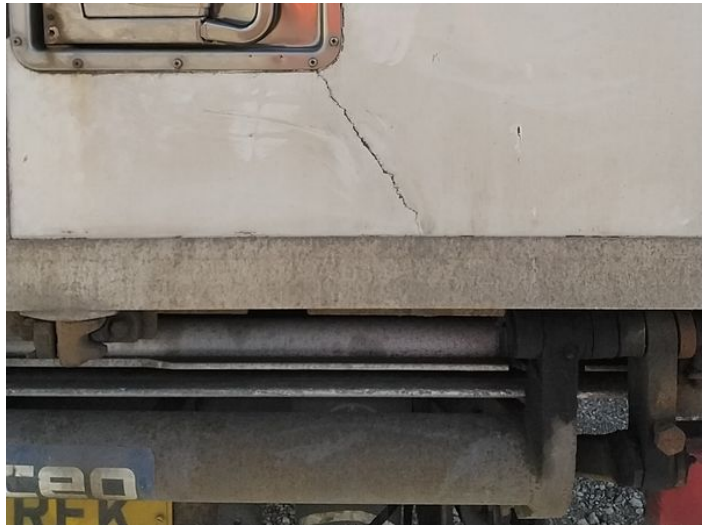
6: Door osr  
Cracked  
Replace

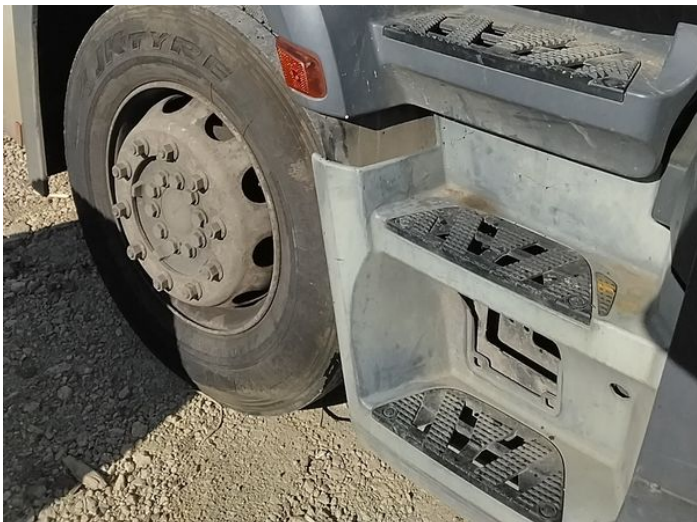
7: Wing Front Arch Extension os  
Scuffed (Unpainted)  
Over 100mm

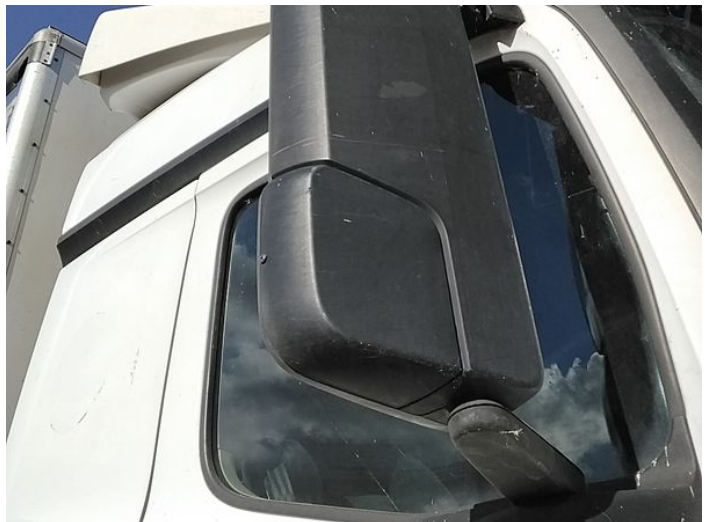
8: Door Mirror Assy osf  
Scuffed (Unpainted)  
UpTo 100mm

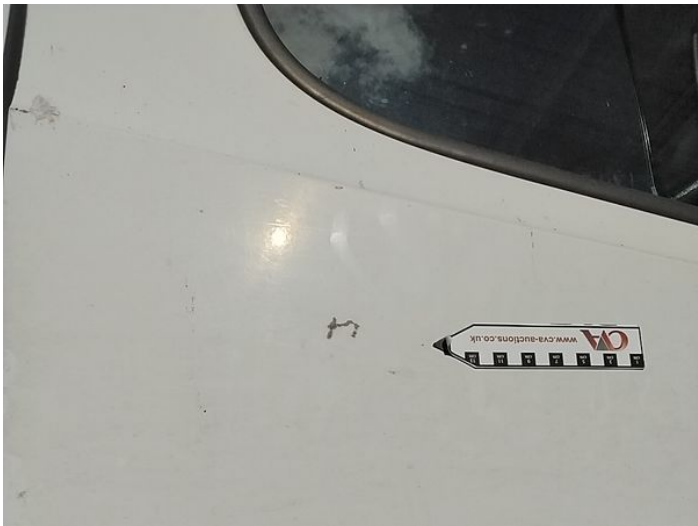
9: Door osf  
 Scratched  
 UpTo 25mm Thru Paint

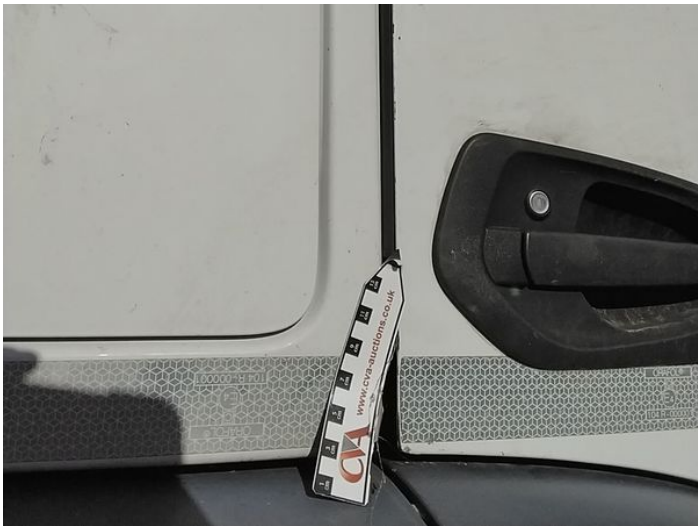
10: Door osf  
 Chipped  
 Edge Chip

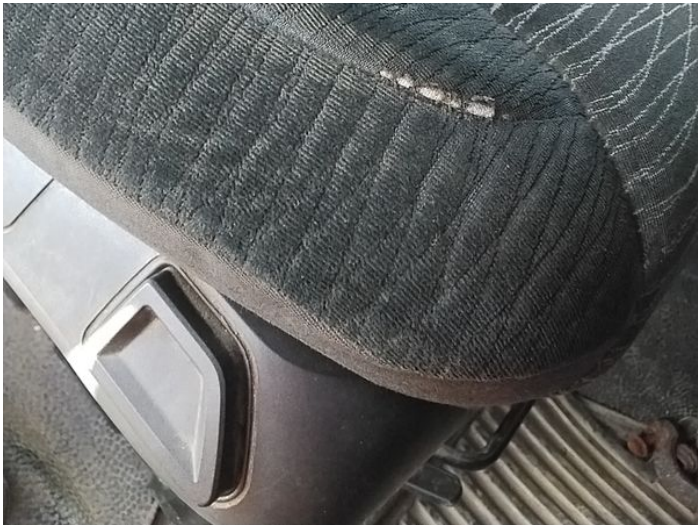
11: Seat Base Cover osf  
 Holed  
 Over 3mm

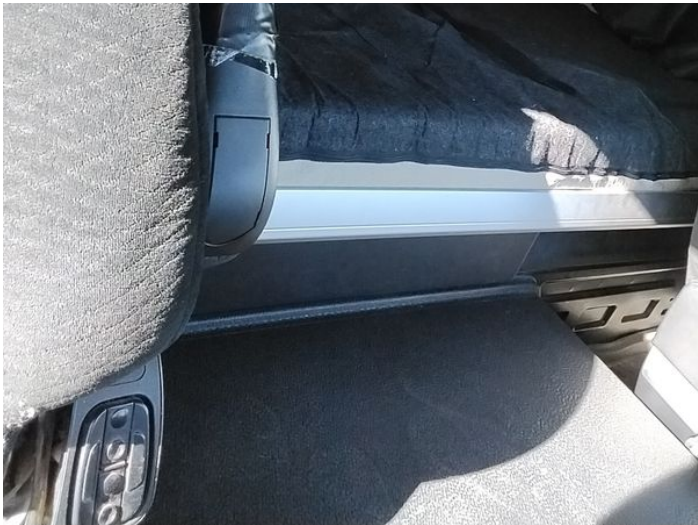
12: Seat Back Cover osf  
 Torn  
 Over 3mm
