# VEHICLE INSPECTION REPORT

**NK73YJX**

## Mercedes-Benz Sprinter 3.5t H2 Progressive Van

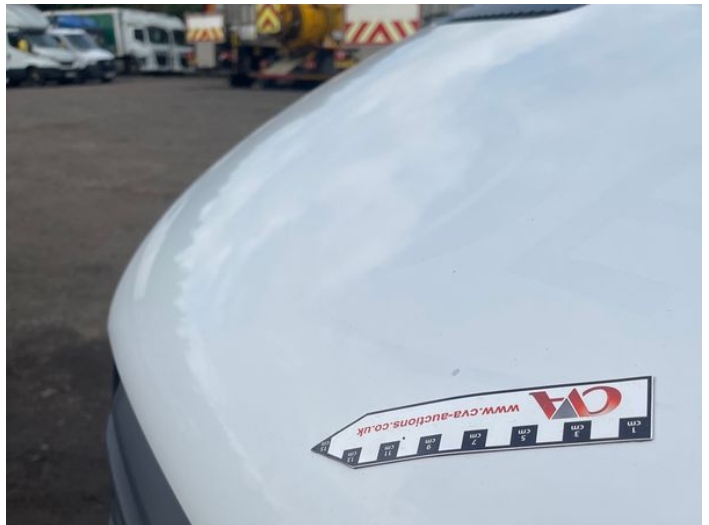
2: Bonnet  
Dented  
Over 30mm

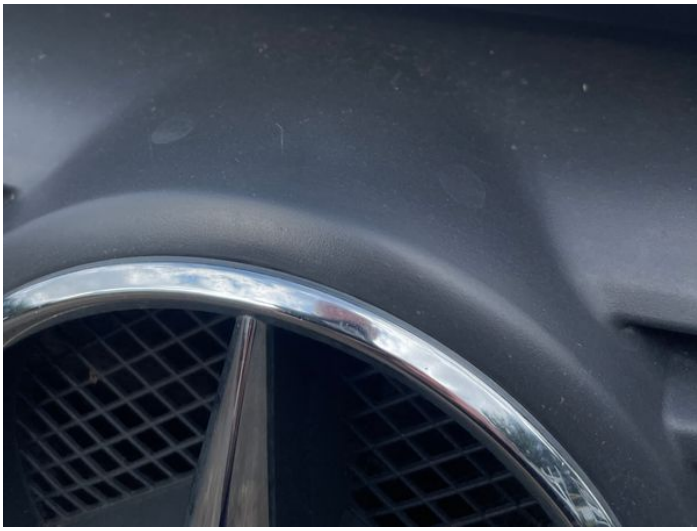
4: Bonnet  
Missing  
Replace

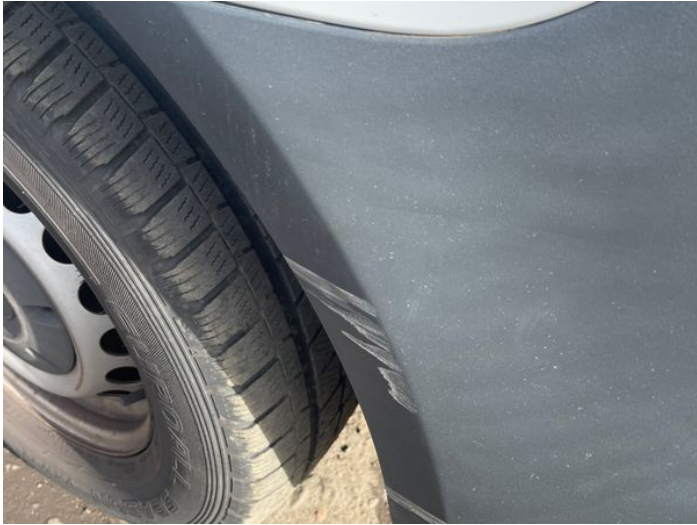
5: Bumper Front Moulding  
Scuffed (Unpainted)  
Over 100mm

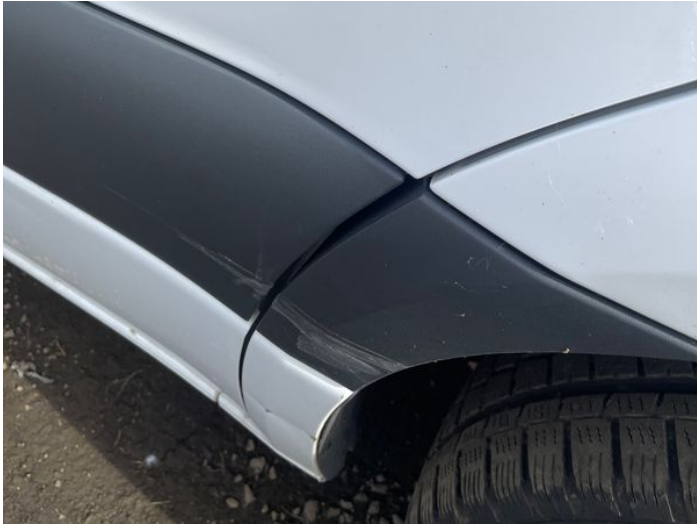
6: Door Moulding osf  
Scuffed (Unpainted)  
Over 100mm

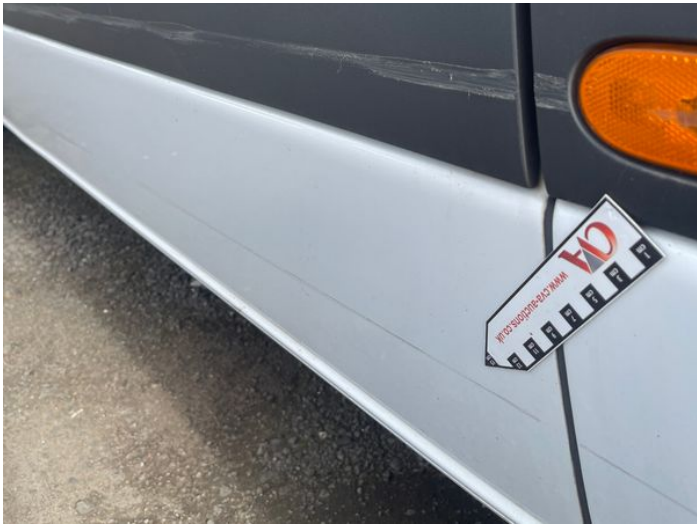
8: Qtr Panel Moulding os  
Scuffed (Unpainted)  
Over 100mm

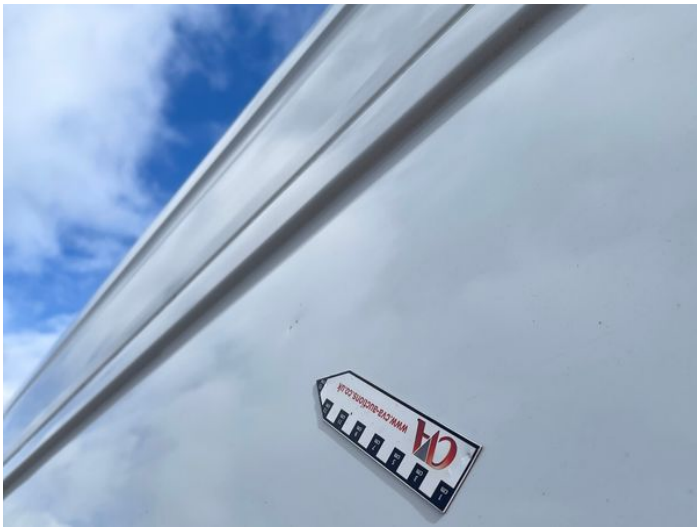
9: Qtr Panel osr  
Dented  
Over 30mm

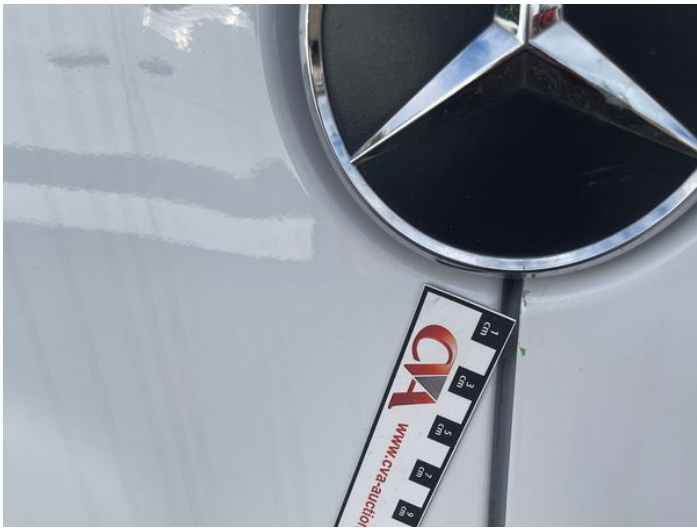
10: Tailgate  
Dented  
With Paint Damage

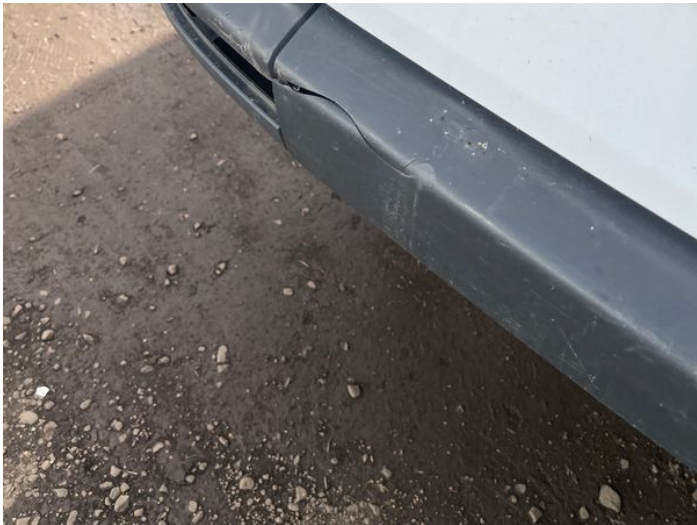
11: Bumper Rear Moulding  
Broken  
Replace

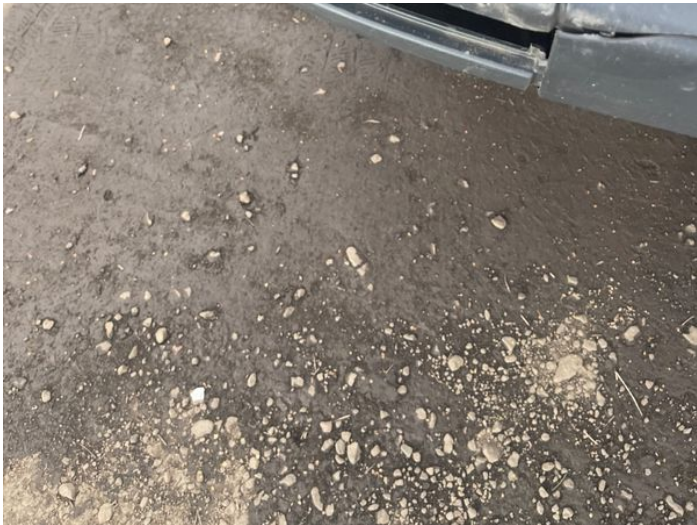
12: Bumper Reflector nsr  
Missing  
Replace

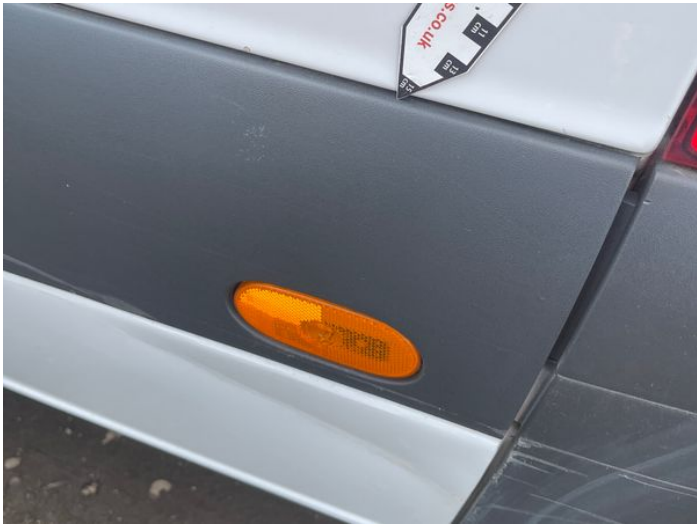
13: Qtr Panel nsr  
Dented  
With Paint Damage

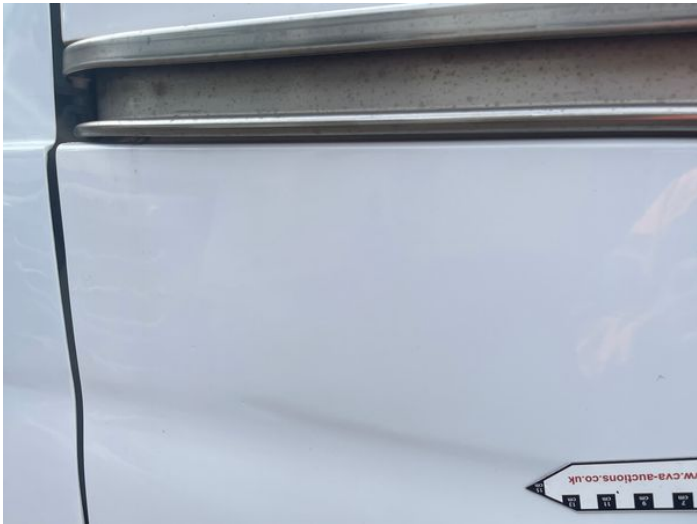
14: Qtr Panel nsr  
Dented  
With Paint Damage

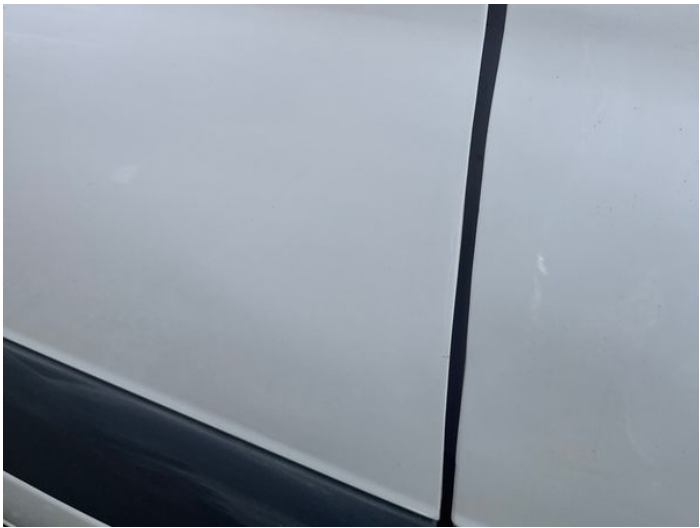
15: Door nsr  
Dented  
With Paint Damage
