# VEHICLE INSPECTION REPORT

**G25HNA**

## Land Rover Discovery 3.0 SDV6 HSE

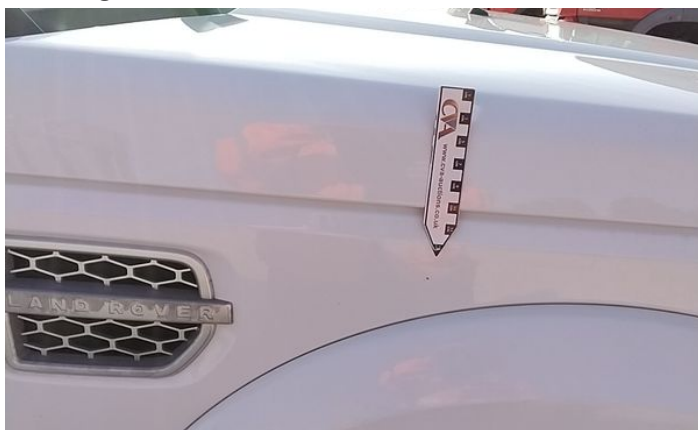
1: Wing osf  
Chipped  
1 To 5

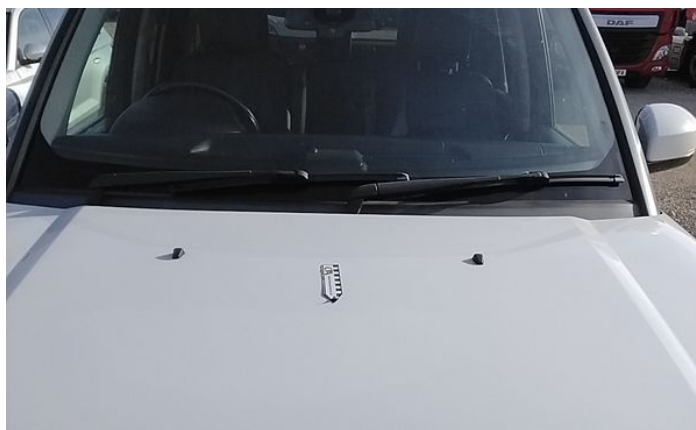
2: Bonnet  
Chipped  
Multiple Chips

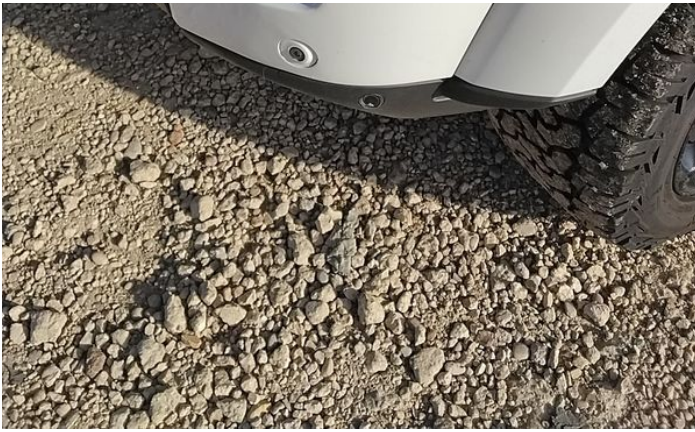
3: Bumper Front  
Scratched  
UpTo 25mm Not Thru Paint

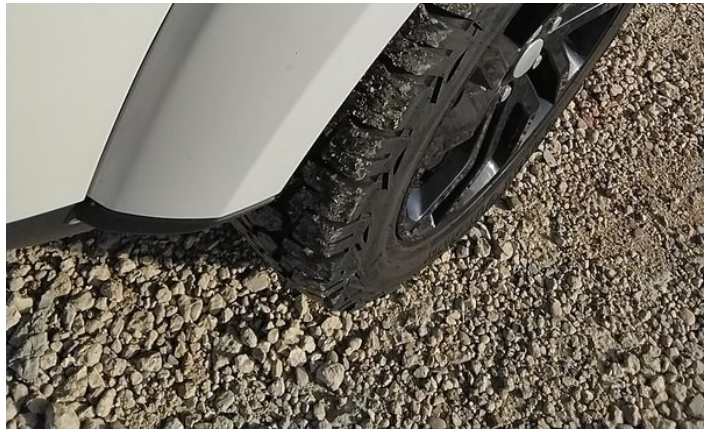
4: Wing Front Arch Extension ns  
Scratched (Painted)  
UpTo 25mm Thru Paint

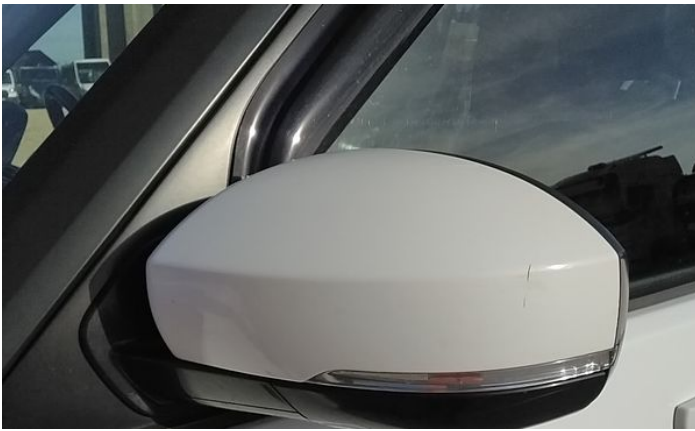
5: Door Mirror Assy nsf  
Scratched (Painted)  
UpTo 25mm Thru Paint

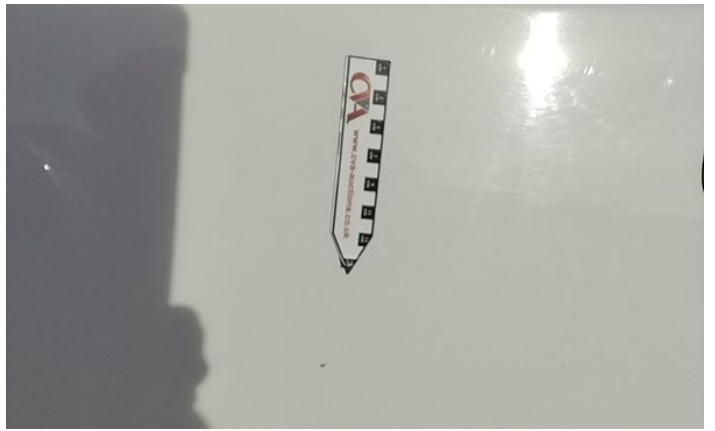
6: Door nsr  
Chipped  
1 To 5

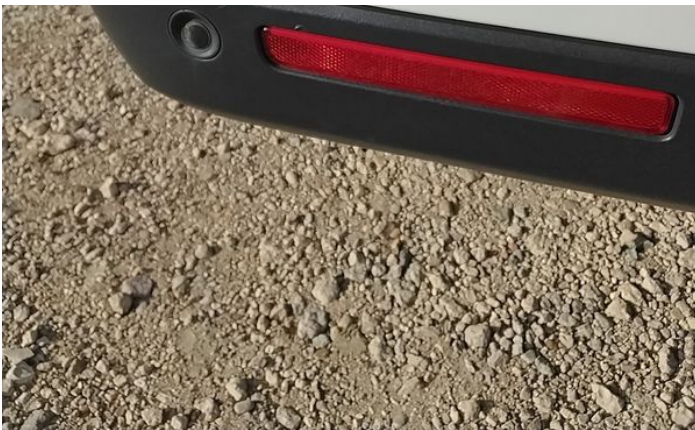
7: Bumper Rear  
Dented  
With Paint Damage

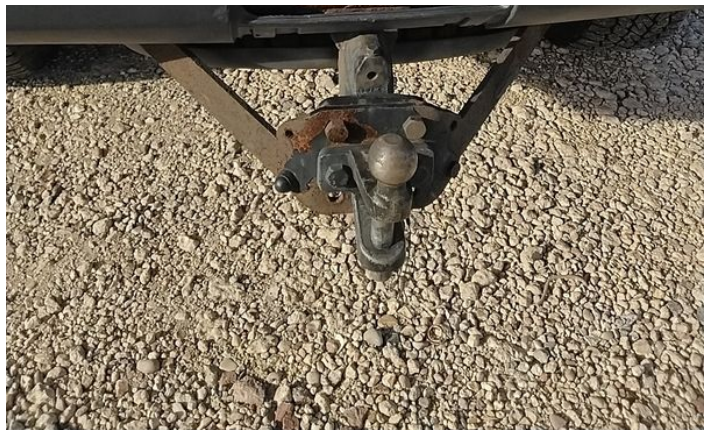
8: Rear TowEye Cvr  
Missing  
Replace

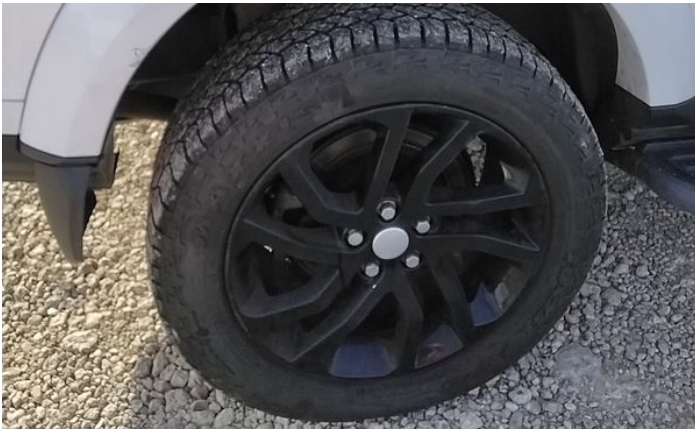
9: Qtr Panel Arch Extension os  
 Scratched (Painted)  
 Over 25mm Thru Paint

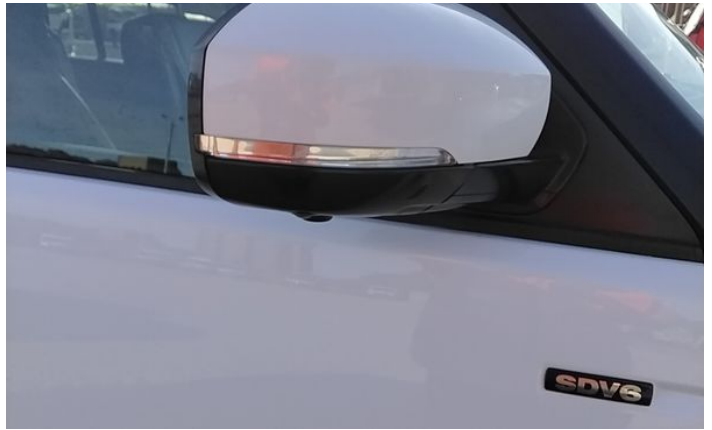
10: Door Mirror Assy osf  
 Scratched (Painted)  
 Over 25mm Not Thru Paint

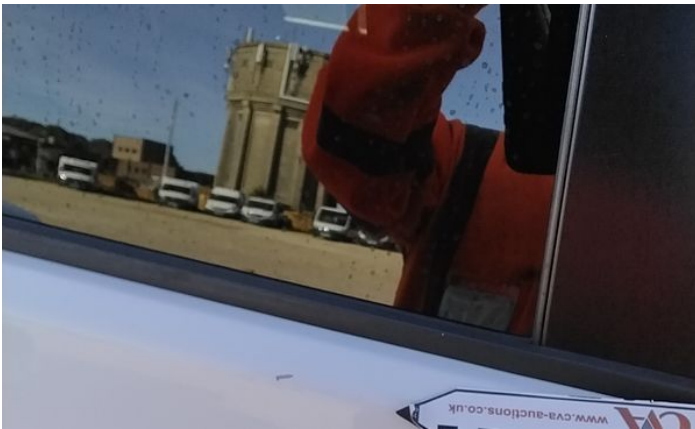
11: Door osr  
 Scratched  
 UpTo 25mm Thru Paint

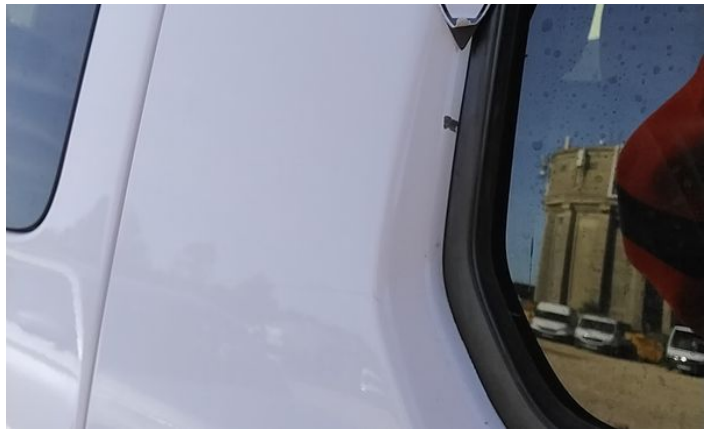
12: Door osr  
 Scratched  
 UpTo 25mm Thru Paint
