# VEHICLE INSPECTION REPORT

**BY67LNZ**

## Mercedes-Benz Antos 1824

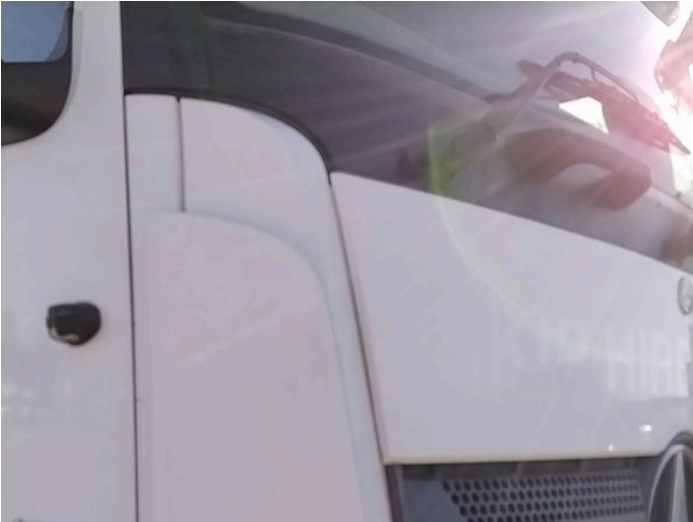
1: Wing of  
Scratched  
Over 25mm Not Thru Paint

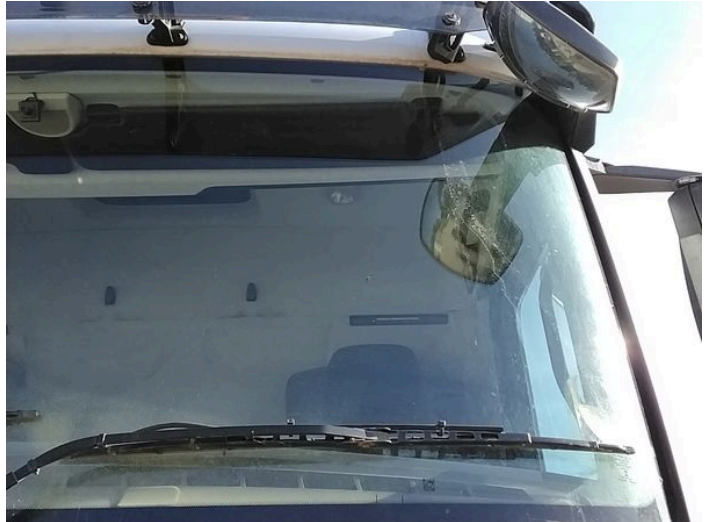
2: Screen Front  
Chipped  
Over 10mm

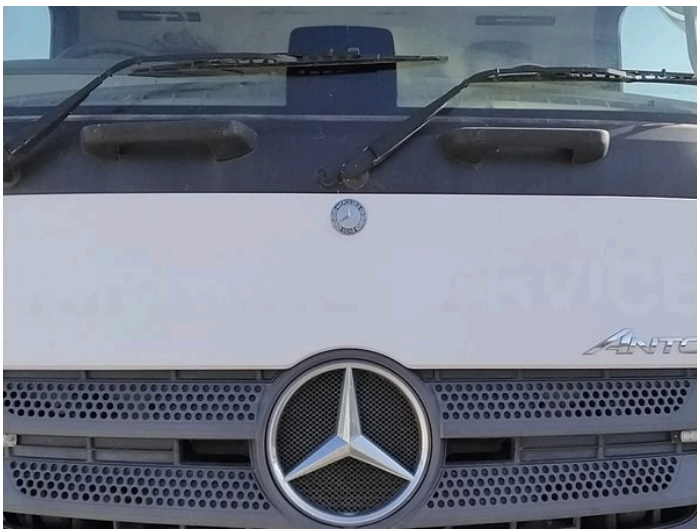
3: Bonnet  
Chipped  
Multiple Chips

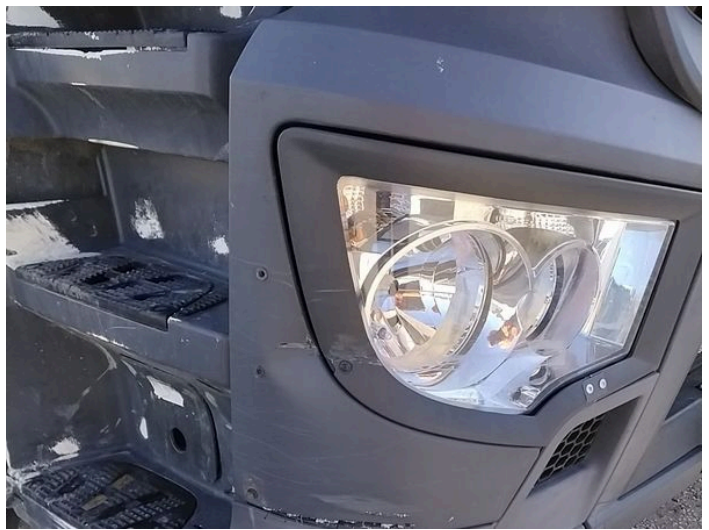
4: Bumper Front  
Dented  
With Paint Damage

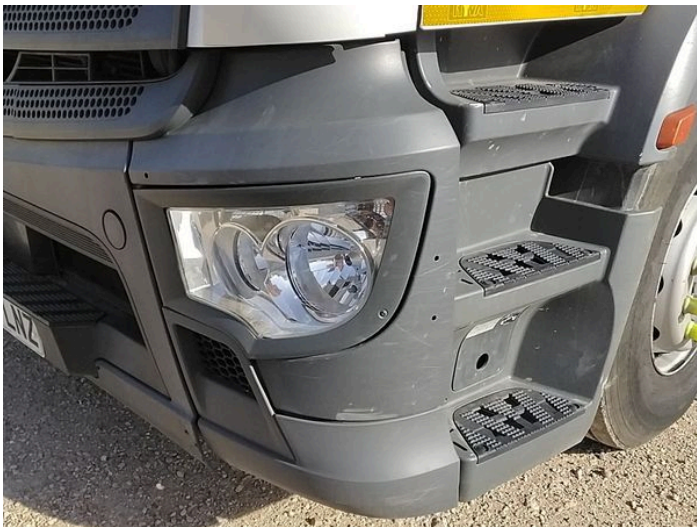
5: Bumper Front Moulding  
Scuffed (Unpainted)  
Over 100mm

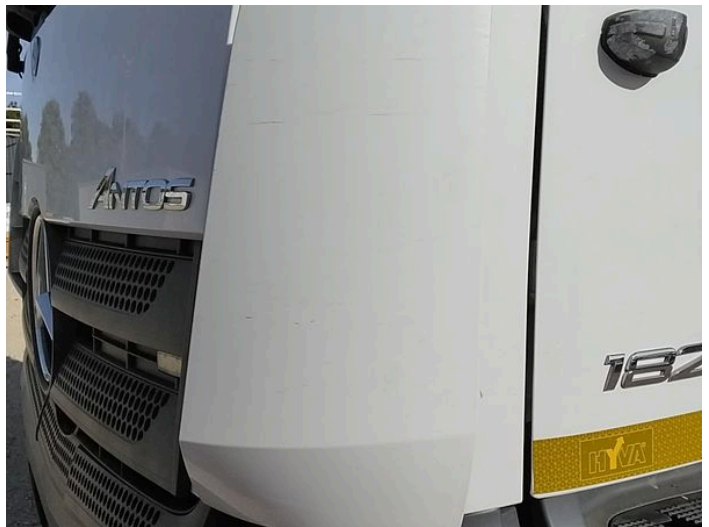
6: Wing nsf  
Scratched  
Over 25mm Not Thru Paint

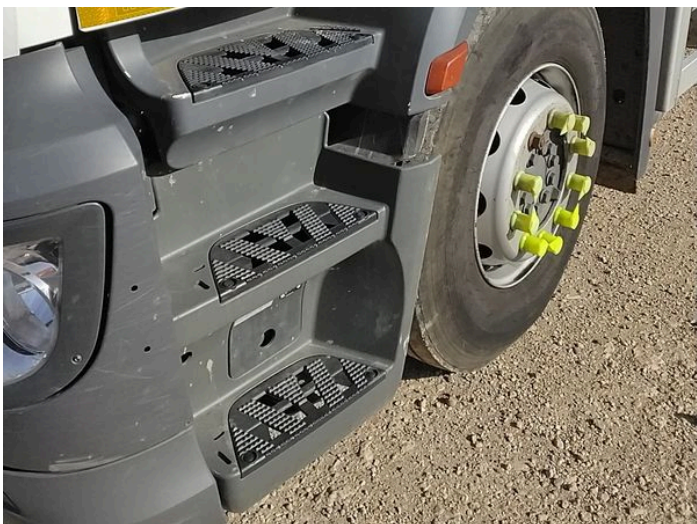
7: Wing Front Arch Extension nsf  
Scuffed (Unpainted)  
Over 100mm

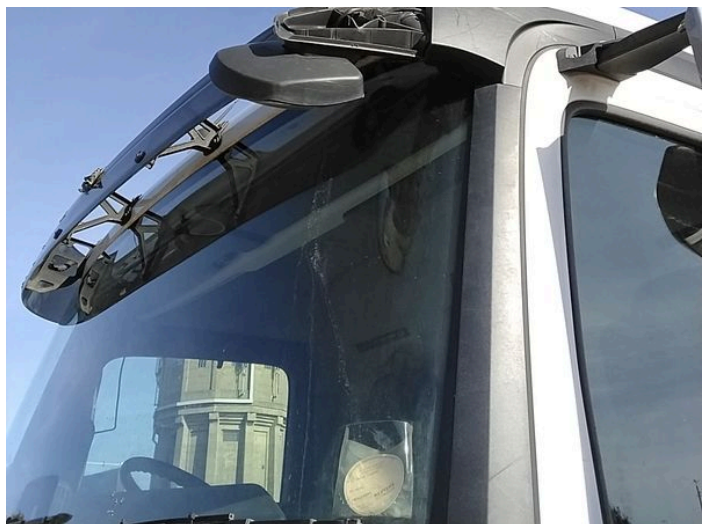
8: Door Mirror Assy nsf  
Broken  
Replace

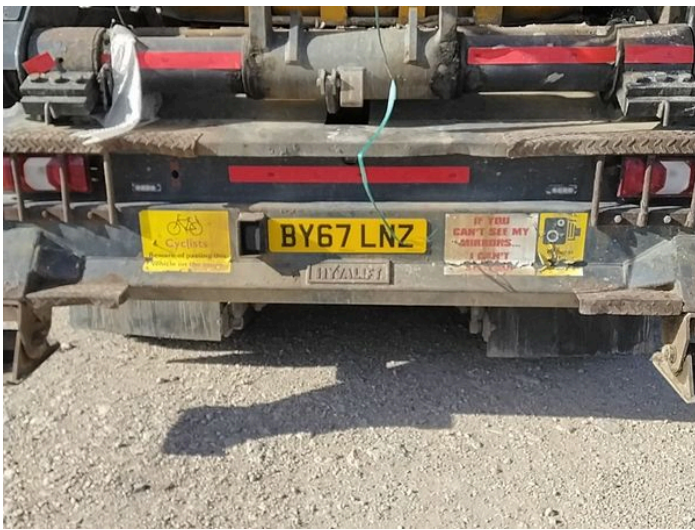
9: Bumper Rear  
Rusted  
Over 5mm

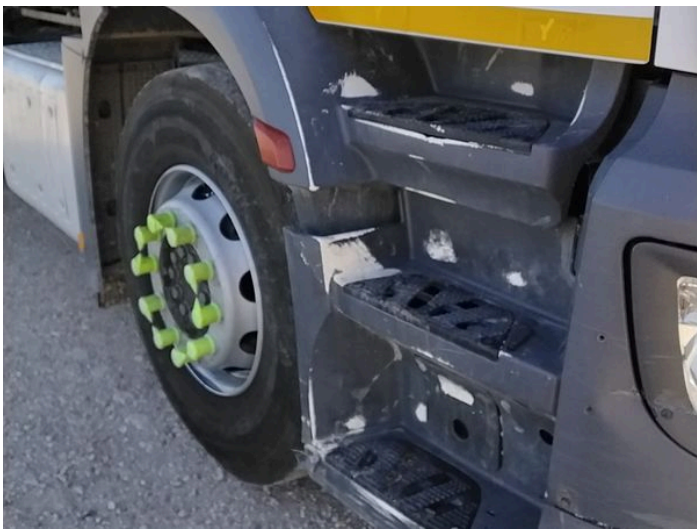
10: Wing Front Arch Extension os  
Scuffed (Unpainted)  
Over 100mm

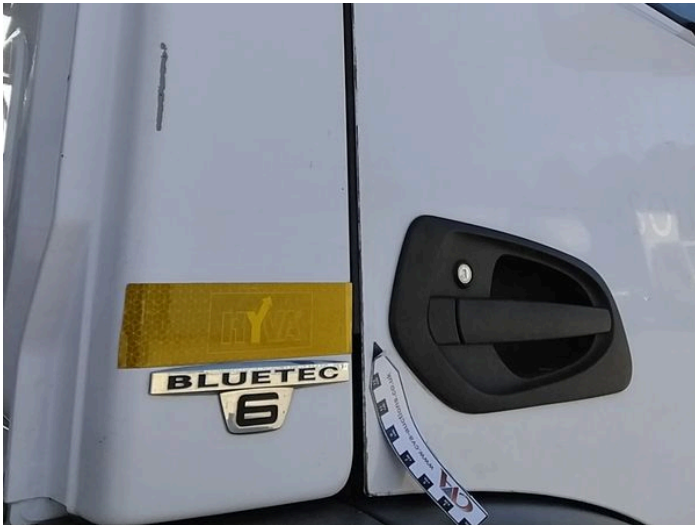
11: Door osf  
Chipped  
Multiple Chips

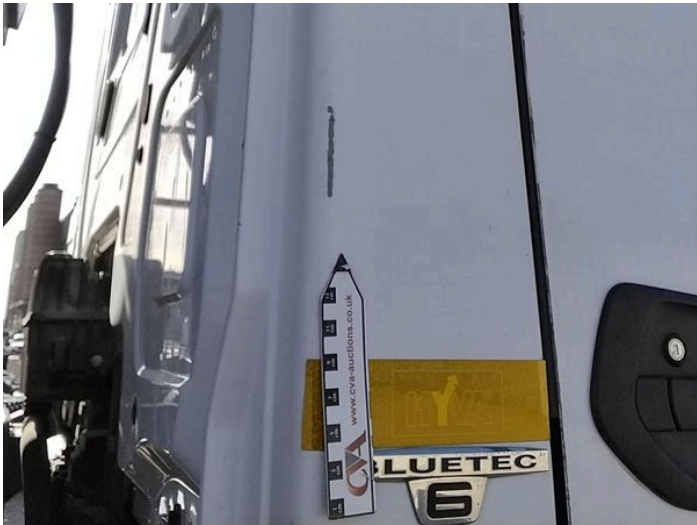
12: B Post os  
Scratched  
UpTo 25mm Thru Paint

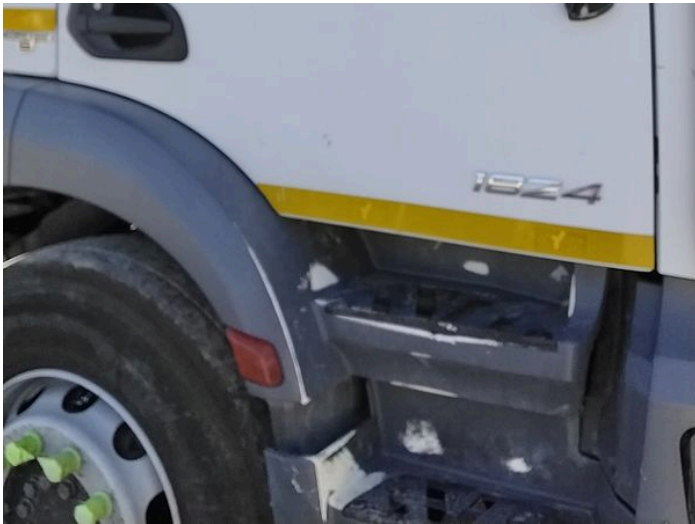
13: Door osf  
Scratched  
Over 25mm Not Thru Paint

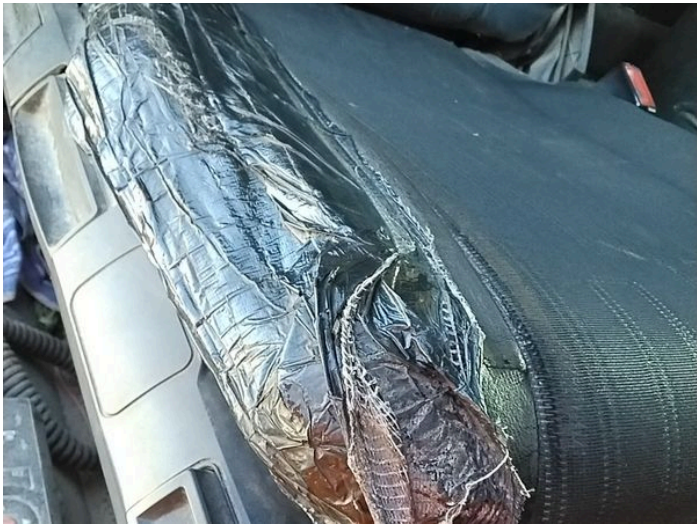
14: Seat Base Cover osf  
Torn  
Over 3mm
