# VEHICLE INSPECTION REPORT

**HN67NVE**

## Daf LF 230

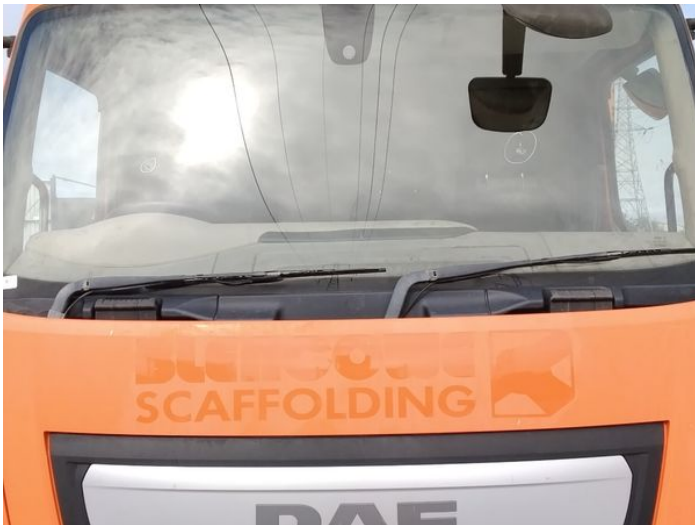
1: Screen Front  
Chipped  
Over 10mm

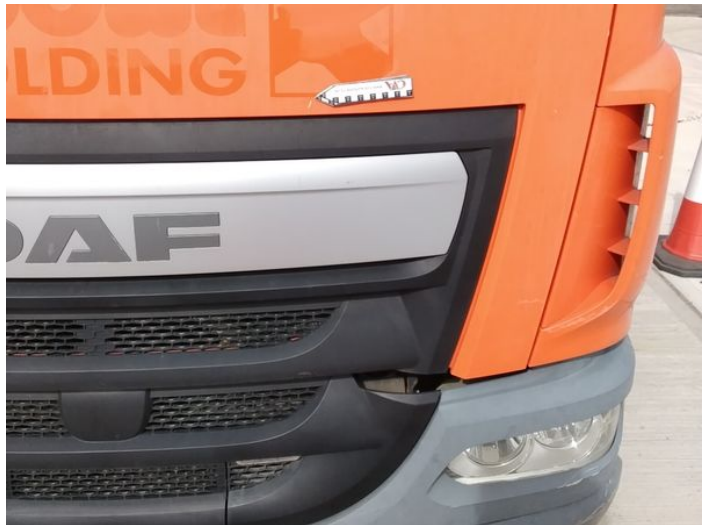
2: Bonnet  
Chipped  
Over 5mm

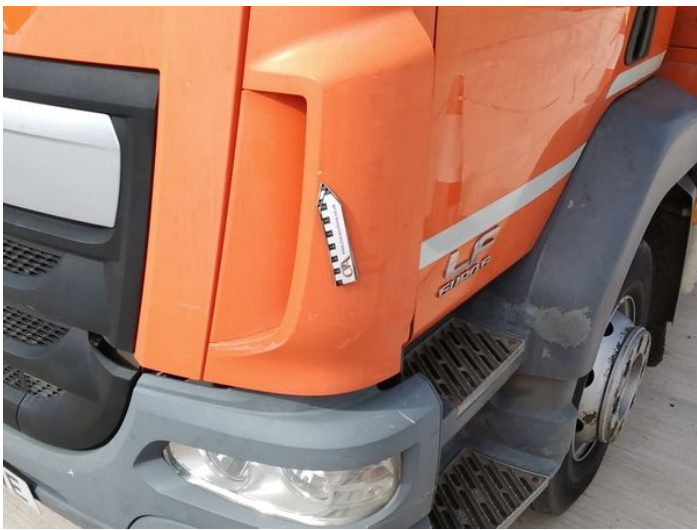
3: Moulding nsf Wing  
 Scratched (Painted)  
 Over 25mm Thru Paint

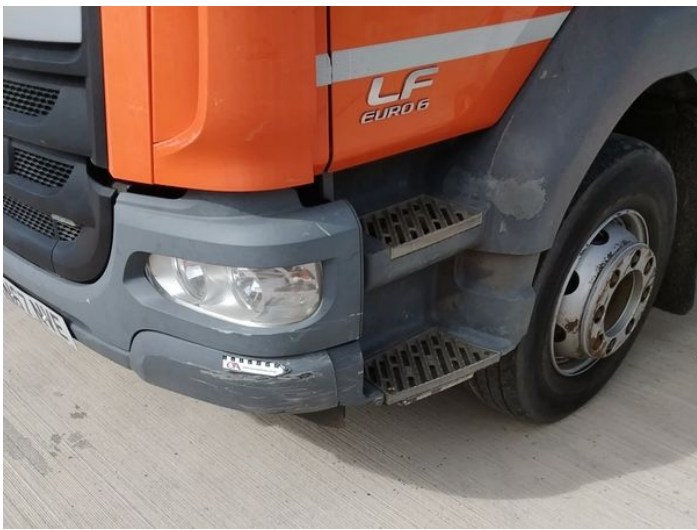
4: Bumper Front  
 Scratched  
 Over 100mm Thru Paint

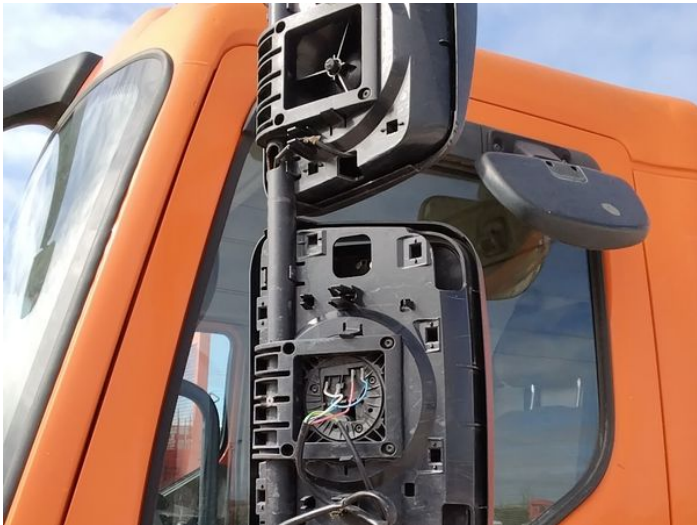
5: Door Mirror Assy nsf  
 Missing  
 Replace

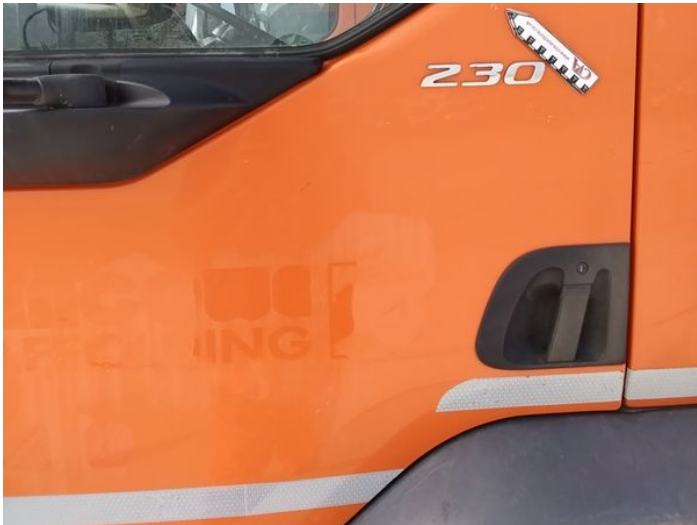
6: Door nsf  
 Chipped  
 Over 5mm

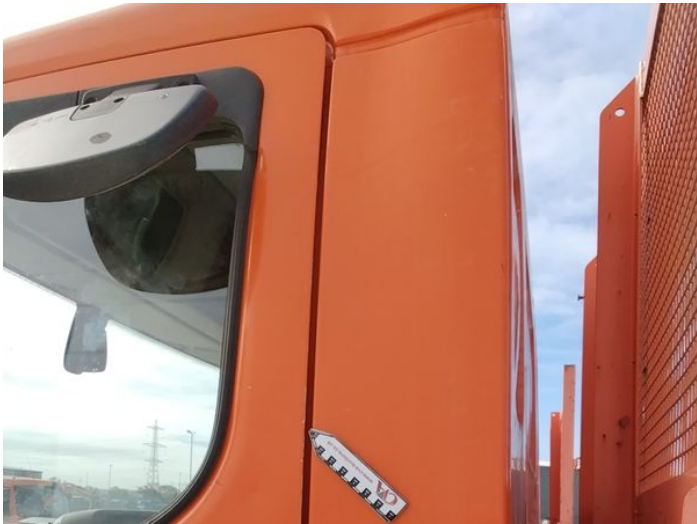
7: Door nsf  
 Chipped  
 Edge Chip

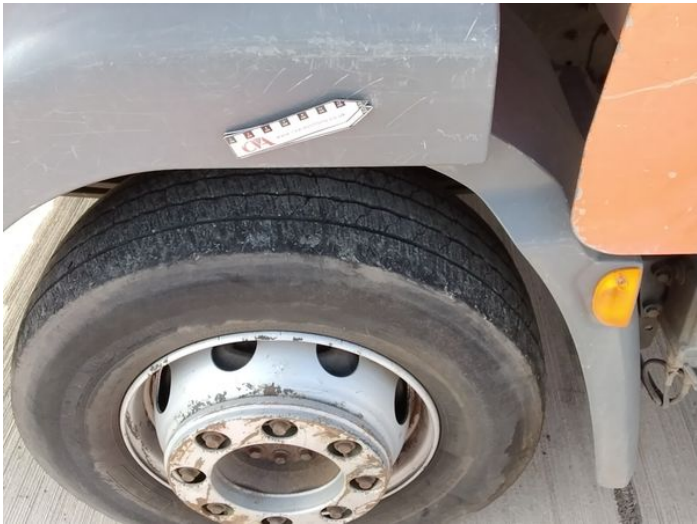
8: Qtr Panel Arch Extension ns  
 Scuffed (Unpainted)  
 Over 100mm

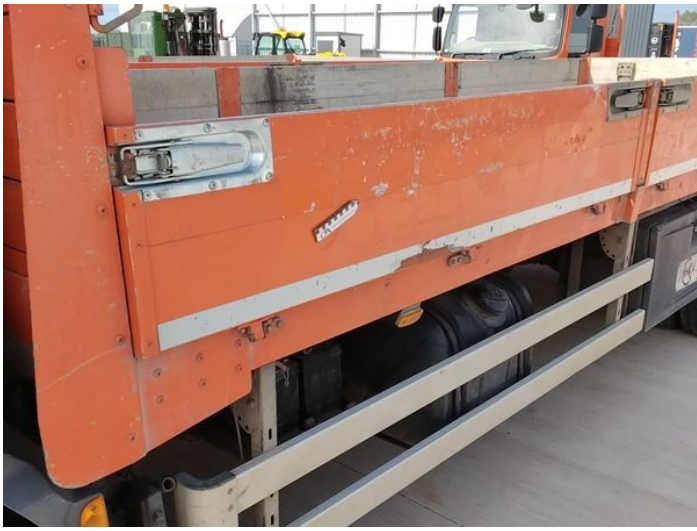
9: Qtr Panel nsr  
Chipped  
Over 5mm

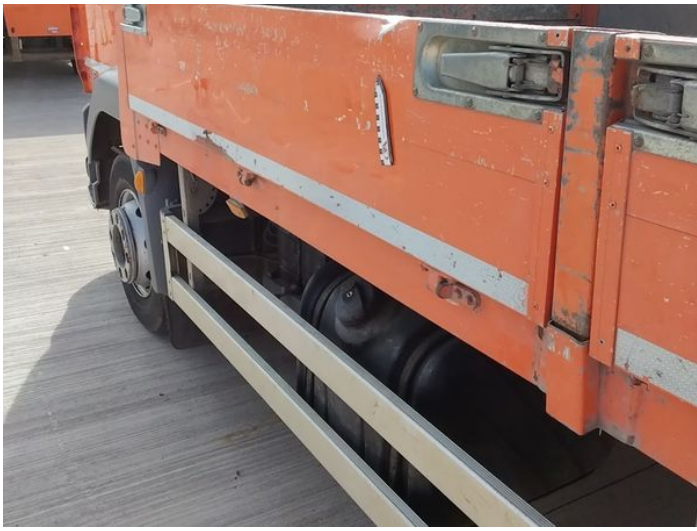
10: Qtr Panel nsr  
Dented  
Over 30mm

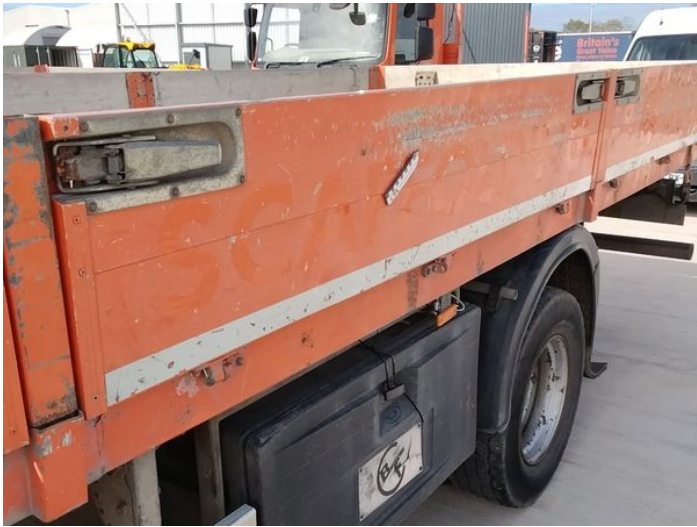
11: Qtr Panel nsr  
Chipped  
Over 5mm

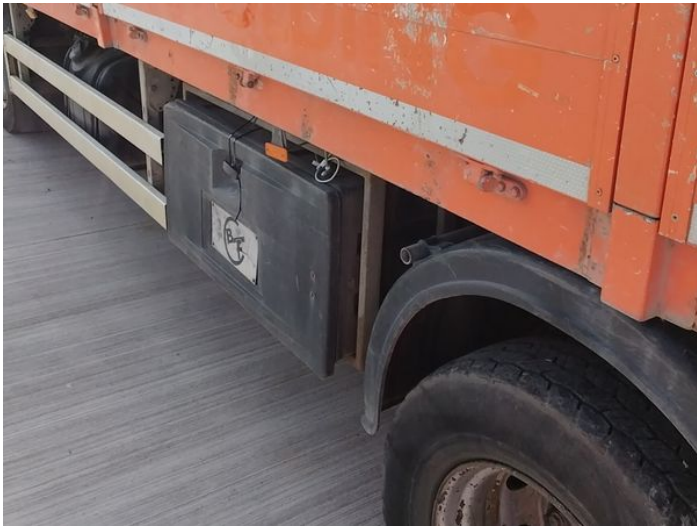
12: Qtr Panel nsr  
Dented  
Over 30mm

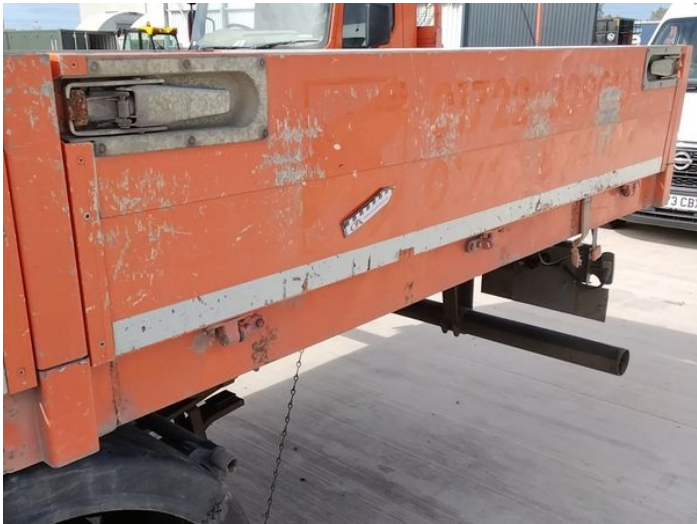
13: Qtr Panel nsr  
Chipped  
Over 5mm

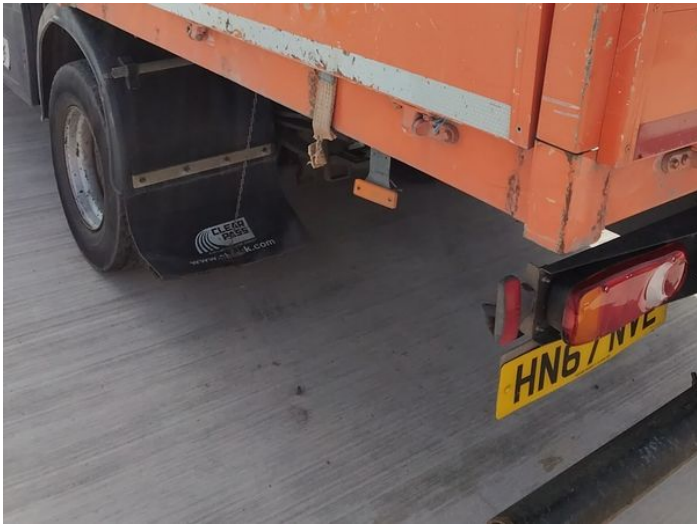
14: Qtr Panel nsr  
Dented  
Over 30mm

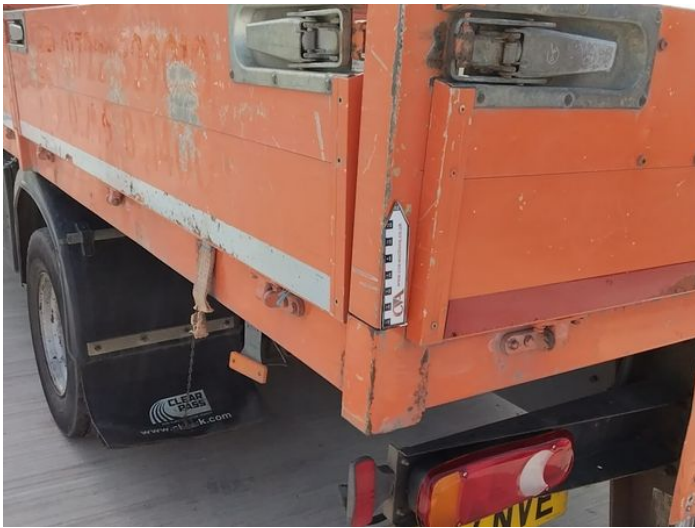
15: Qtr Panel nsr  
Chipped  
Over 5mm

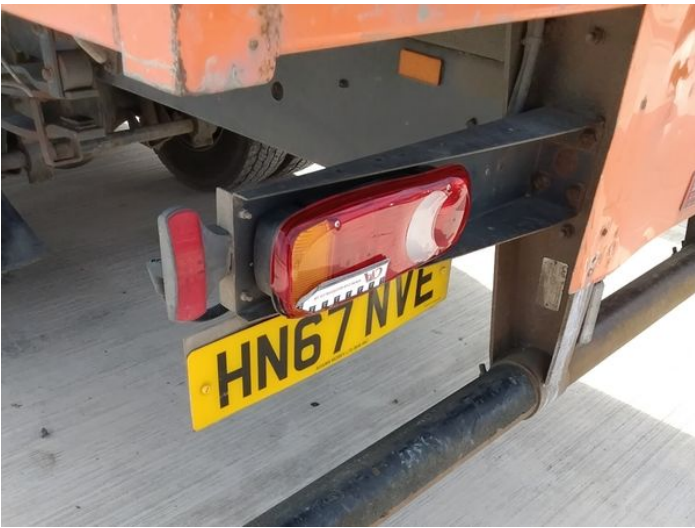
16: Lamp nsr  
Broken  
Replace

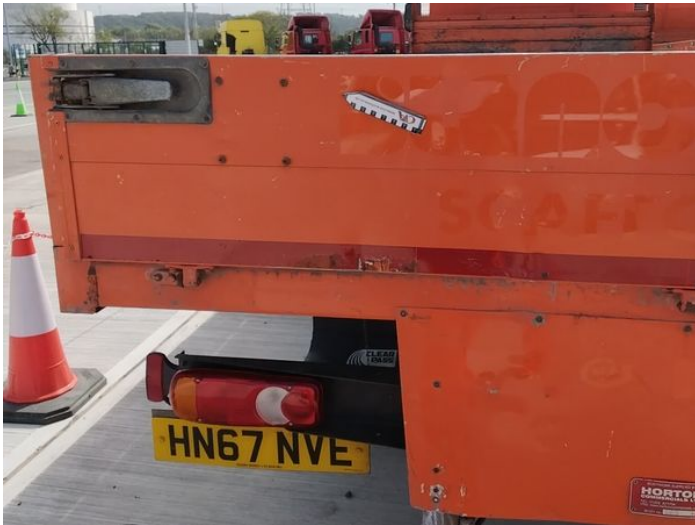
17: Tailgate  
Chipped  
Multiple Chips

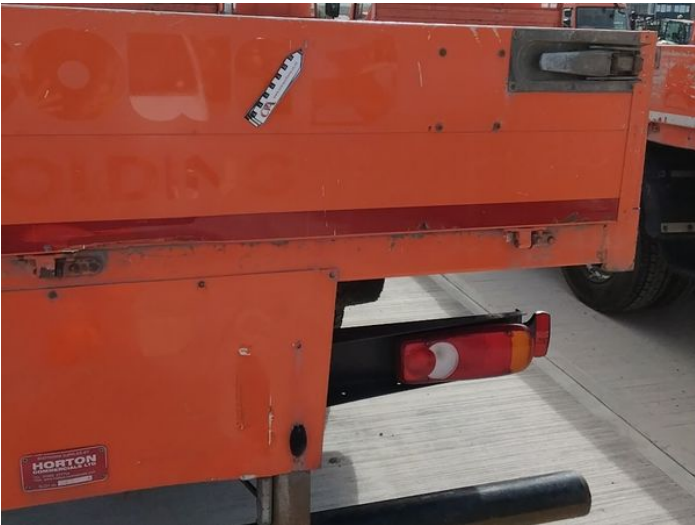
18: Tailgate  
Dented  
Over 30mm

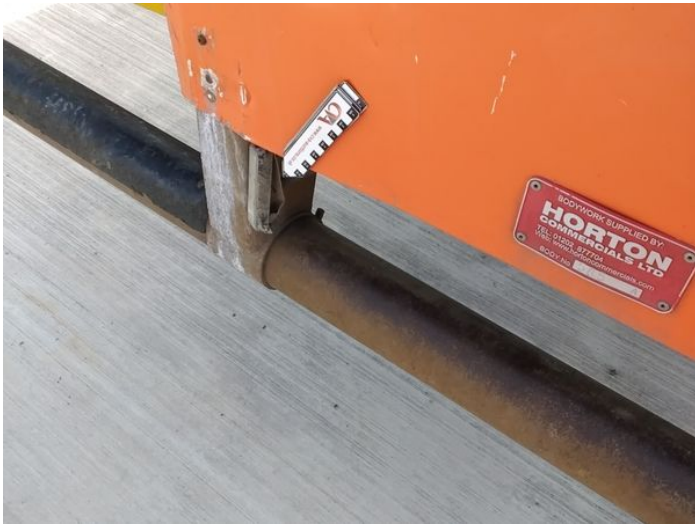
19: Reflector nsr  
Broken  
Replace

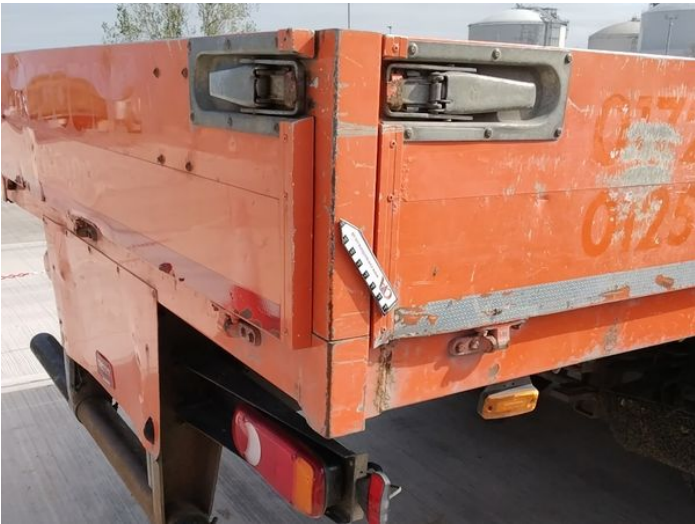
20: Qtr Panel osr  
Chipped  
Multiple Chips

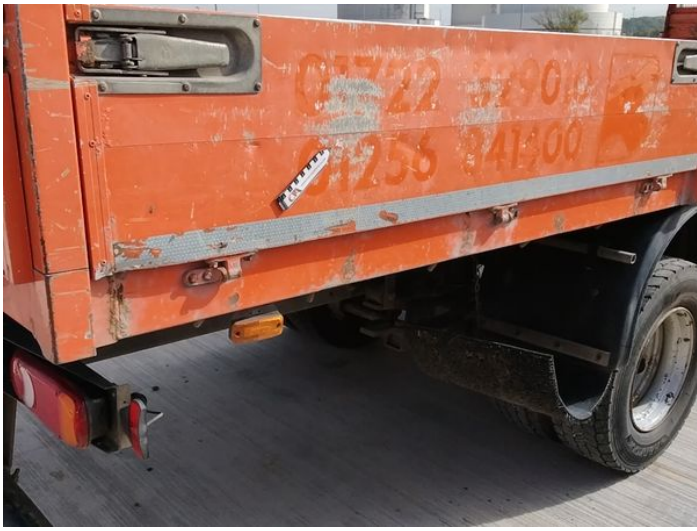
21: Qtr Panel osr  
Chipped  
Over 5mm

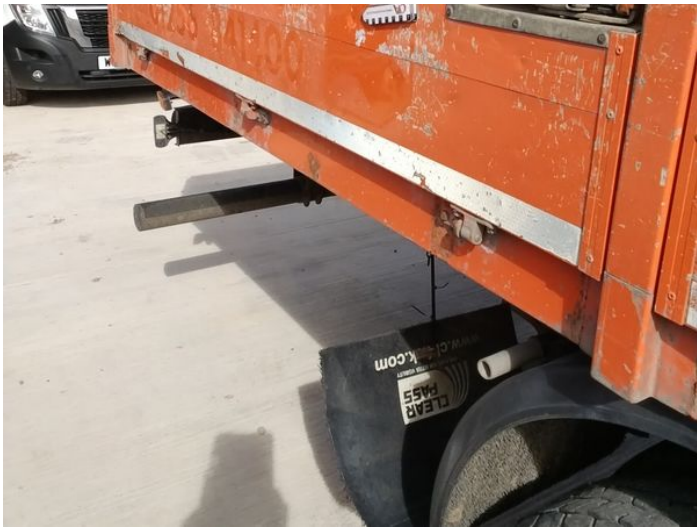
22: Qtr Panel osr  
Dented  
Over 30mm

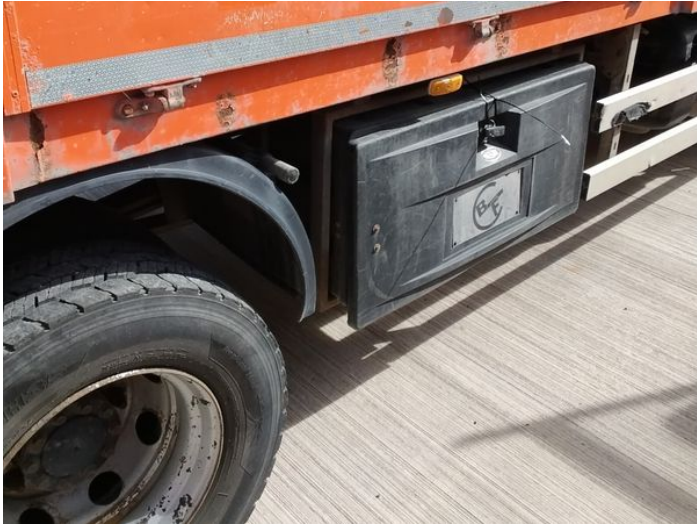
23: Qtr Panel osr  
Chipped  
Over 5mm

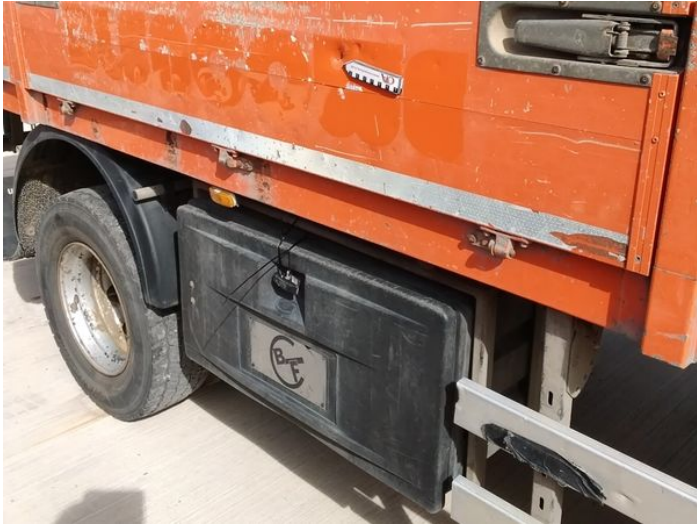
24: Qtr Panel osr  
Dented  
Over 30mm

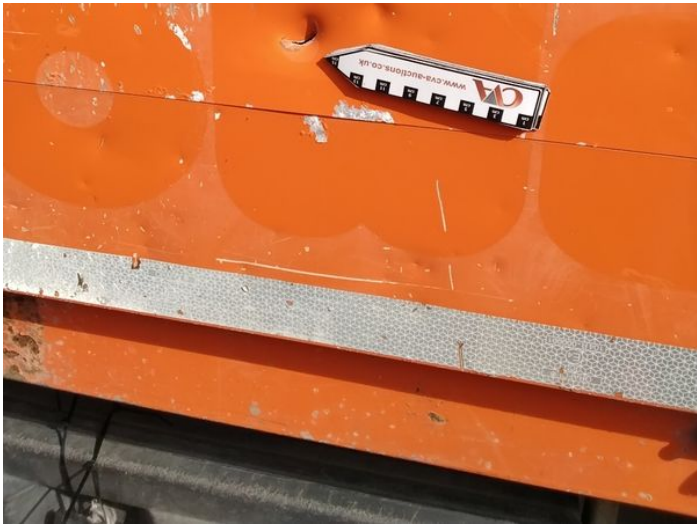
25: Qtr Panel osr  
Hole  
Over 10mm

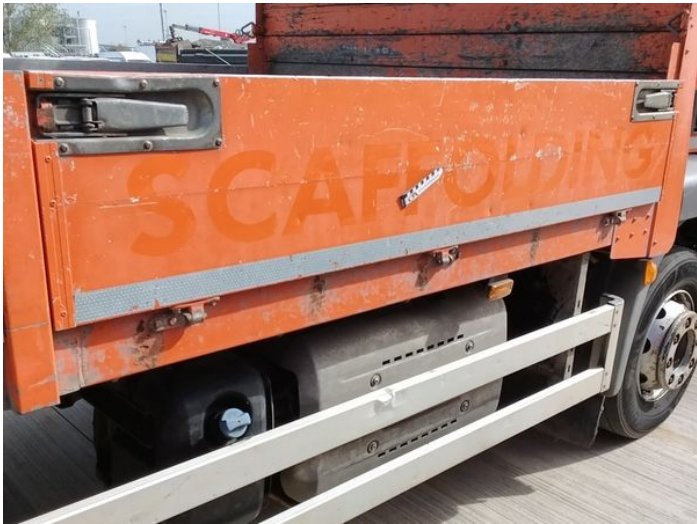
26: Qtr Panel osr  
Chipped  
Over 5mm

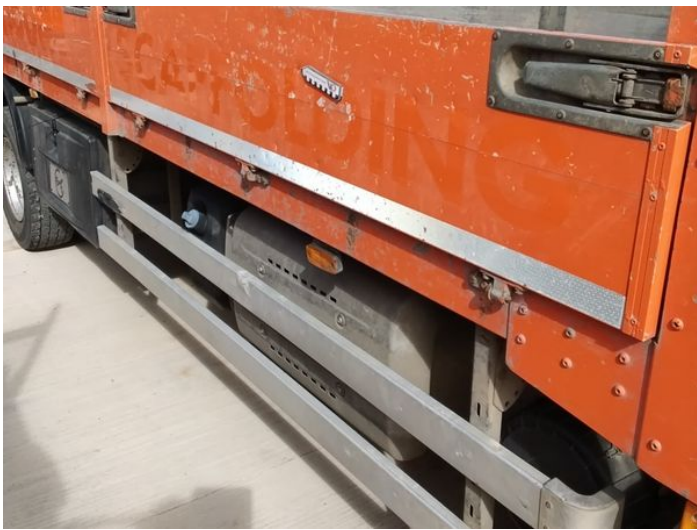
27: Qtr Panel osr  
Dented  
Over 30mm

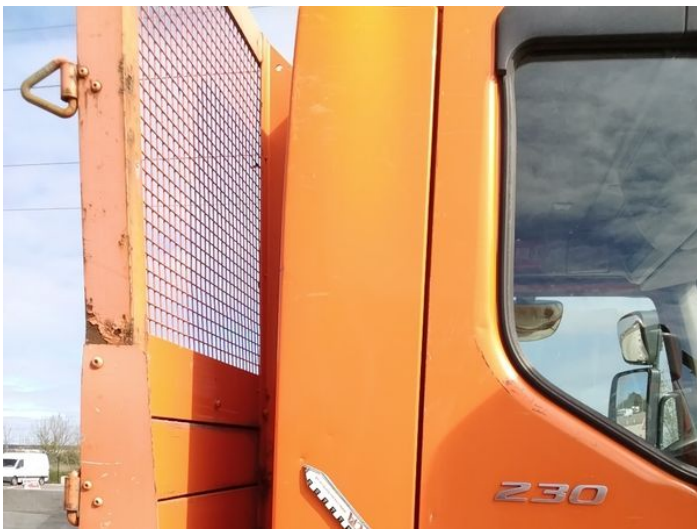
28: Panel Rear  
Dented  
Over 30mm

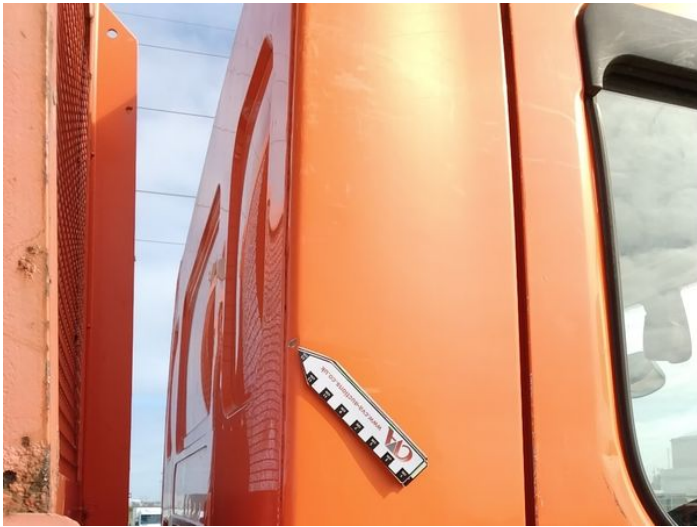
29: Panel Rear  
Chipped  
Over 5mm

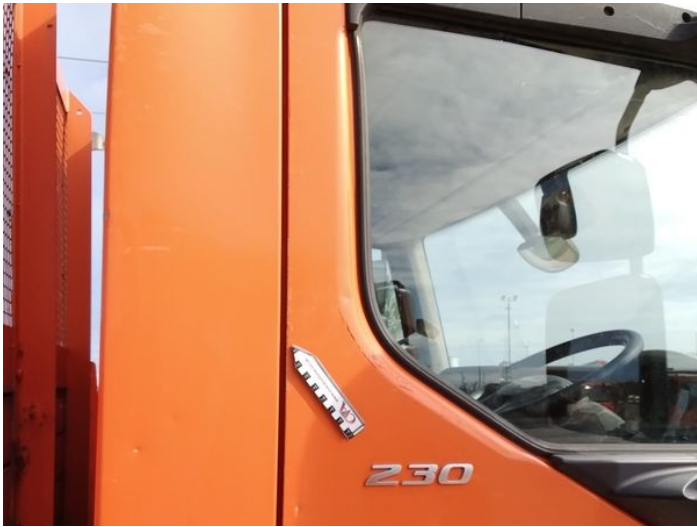
30: Door osf  
Chipped  
Multiple Chips

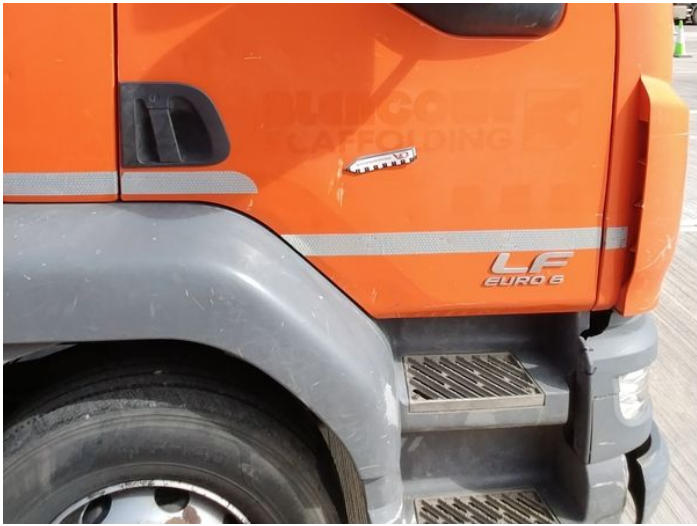
31: Door osf  
Scratched  
Over 25mm Thru Paint

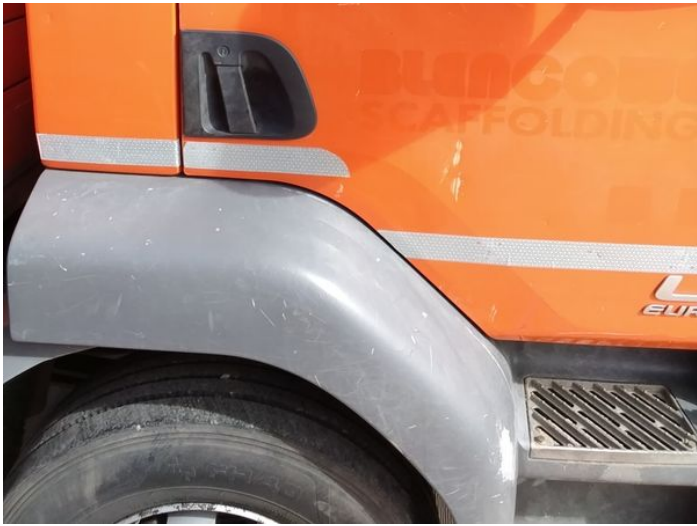
32: Door osf  
Chipped  
Multiple Chips

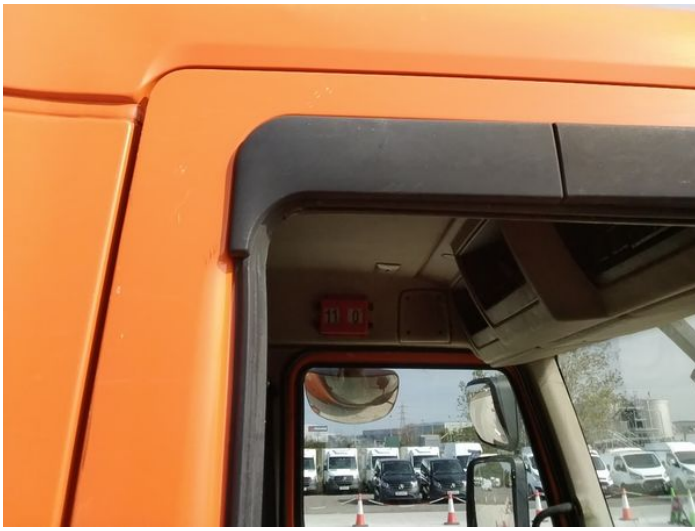
33: Roof  
Dented  
Over 30mm

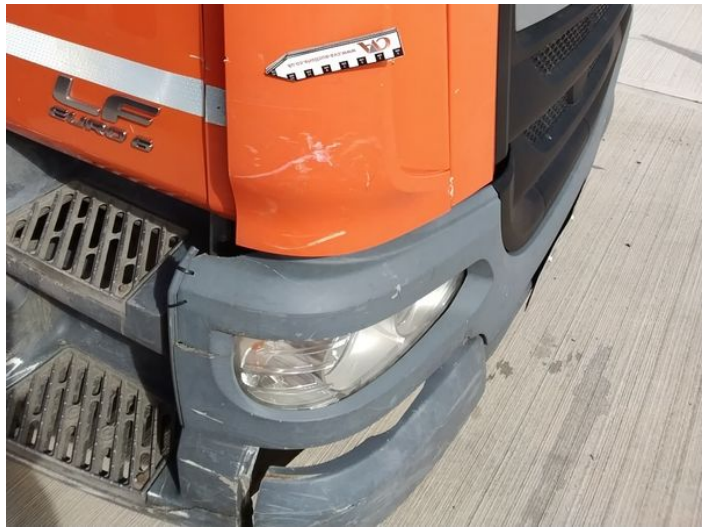
34: Moulding osf Wing  
Scratched (Painted)  
Over 25mm Thru Paint

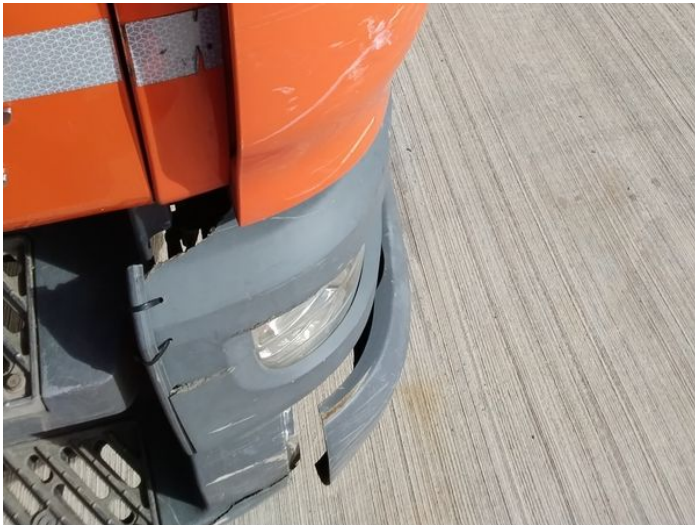
35: Moulding osf Wing  
Broken  
Replace

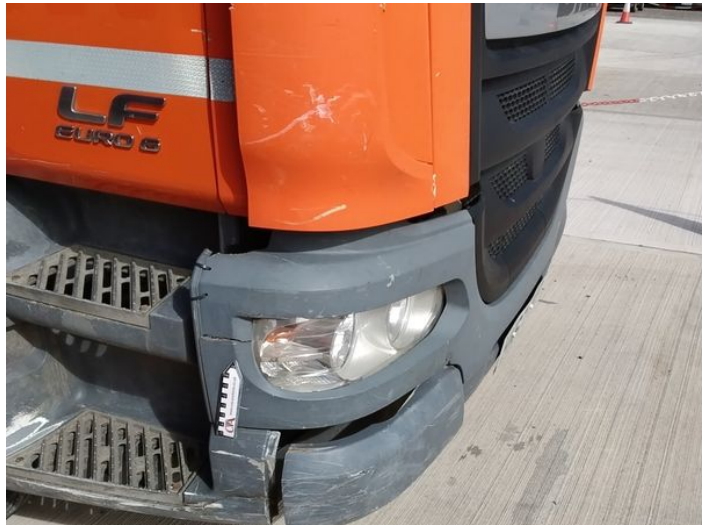
36: Bumper Front  
Insecure  
Action Required

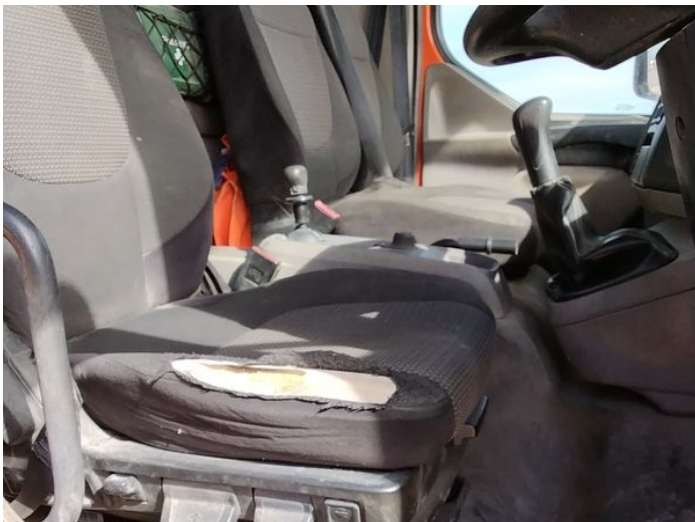
37: Seat Base Cover osf  
Torn  
Over 3mm

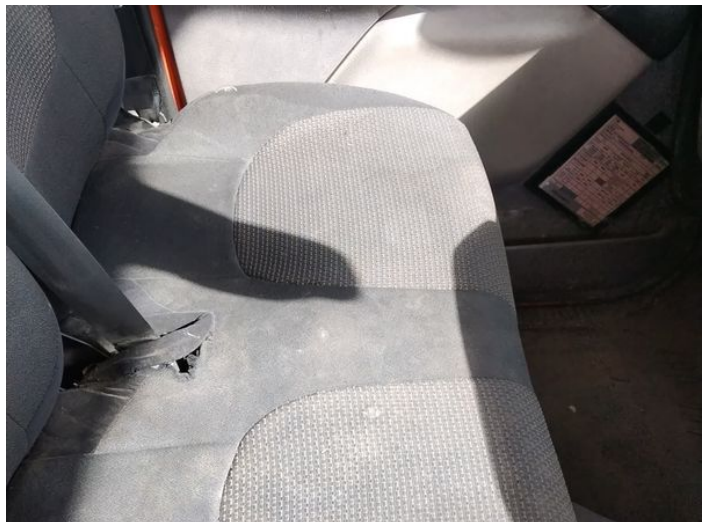
38: Seat Base Cover nsf  
Torn  
Over 3mm
