# VEHICLE INSPECTION REPORT

**HN67NVF**

## DAF LF 230

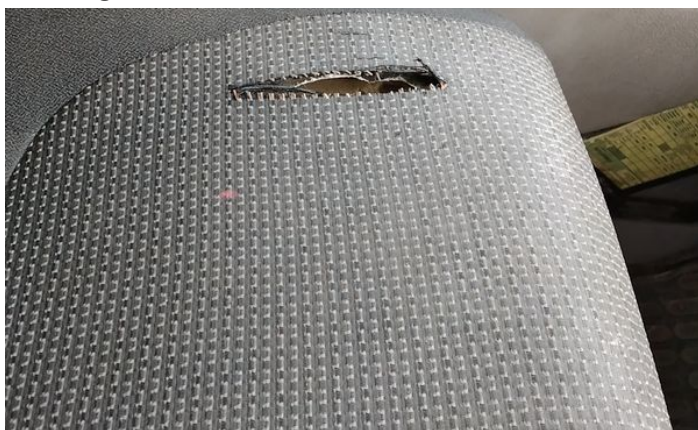
1: Seat Base Cover nsf  
Torn  
Over 3mm

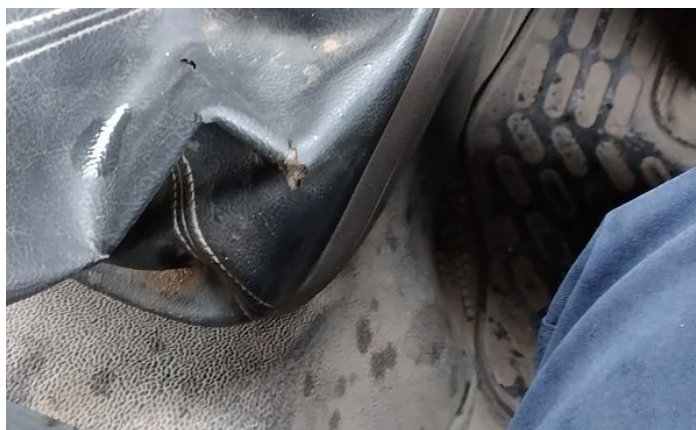
2: Fascia Trim  
Damaged  
Replace

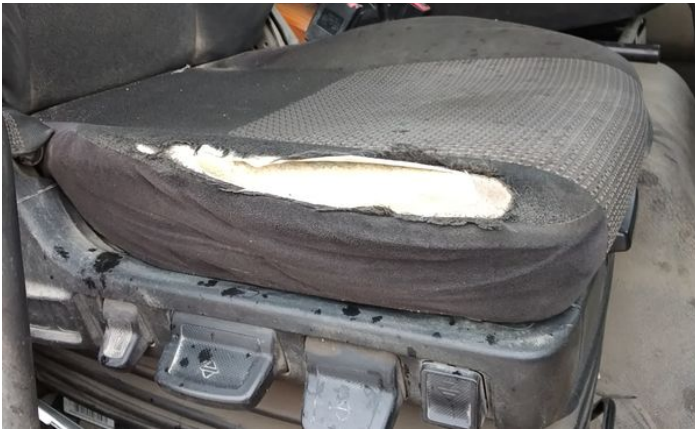
3: Seat Back Cover osf  
Torn  
Over 3mm

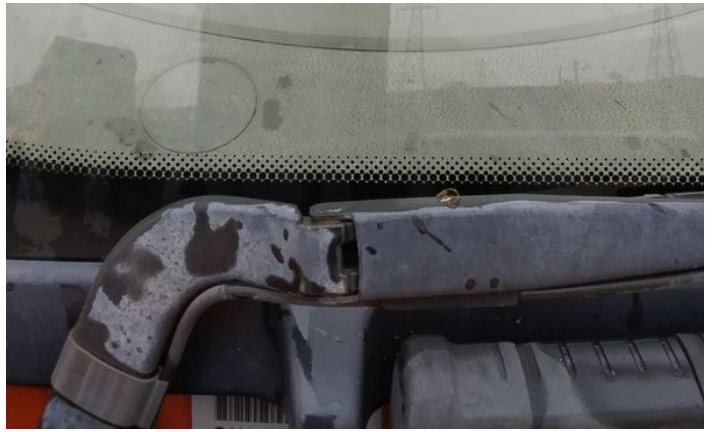
4: Screen Front  
Cracked  
Replace

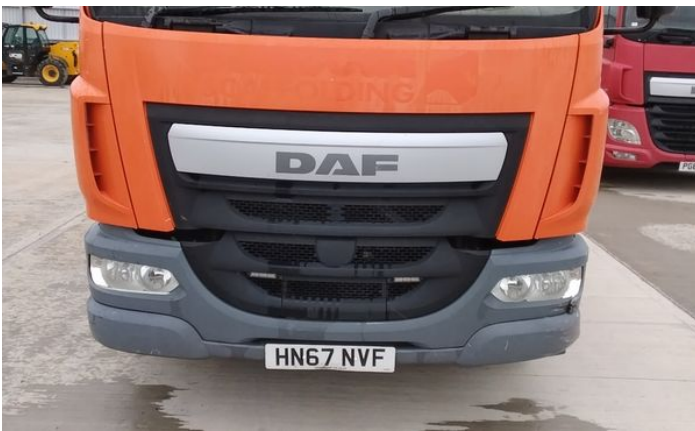
5: Bonnet  
Chipped  
Multiple Chips

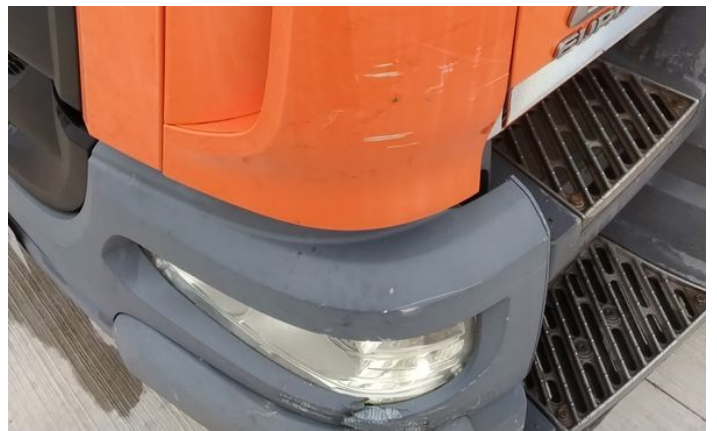
6: Moulding nsf Wing  
Scratched (Painted)  
Over 25mm Thru Paint

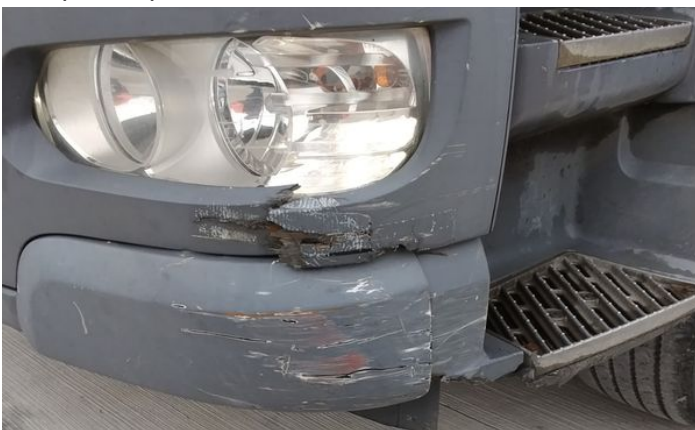
7: Bumper Front  
Cracked  
Over 25mm

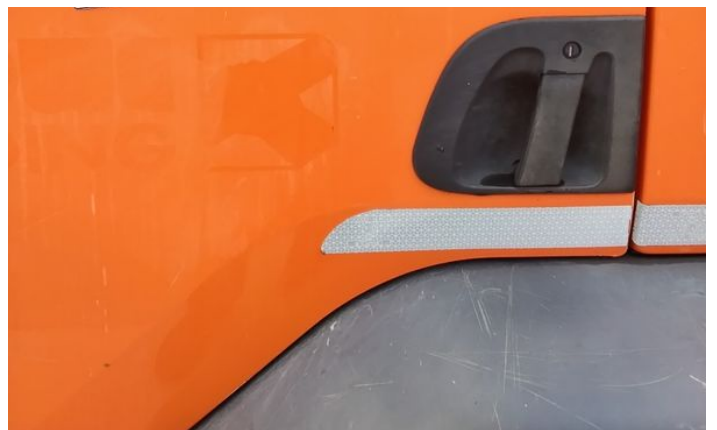
8: Door nsf  
Scratched  
Over 25mm Thru Paint

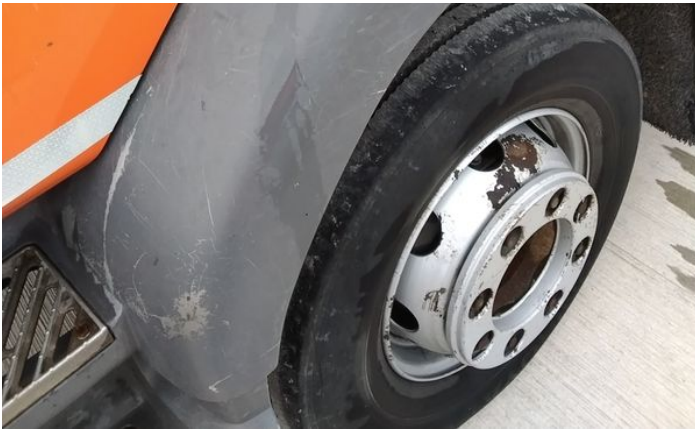
9: Wing Front Arch Extension ns  
Scratched (Painted)  
Over 25mm Thru Paint

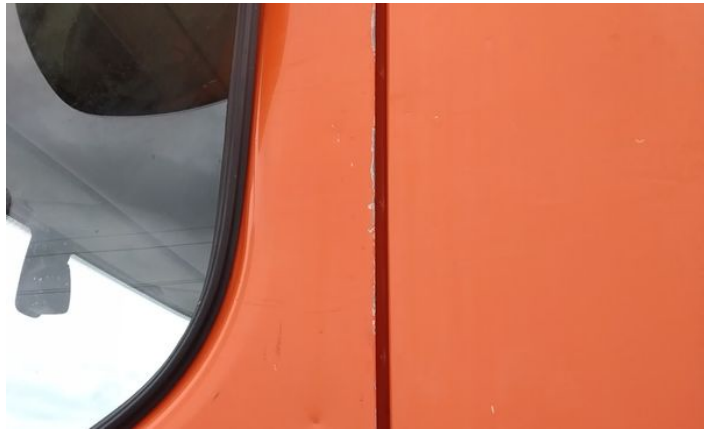
10: Door nsf  
Dented  
With Paint Damage

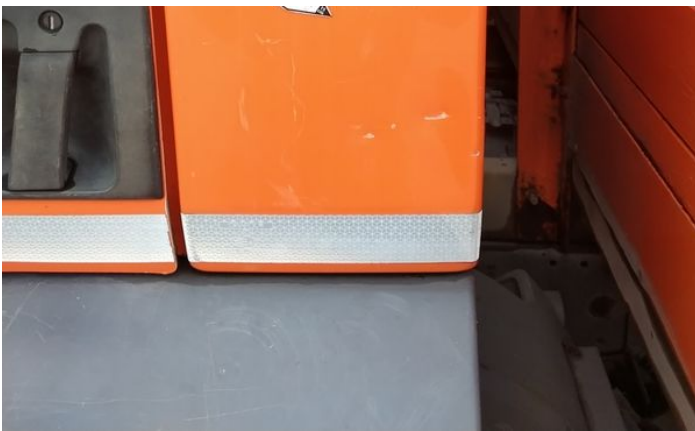
11: Qtr Panel nsr  
Dented  
With Paint Damage

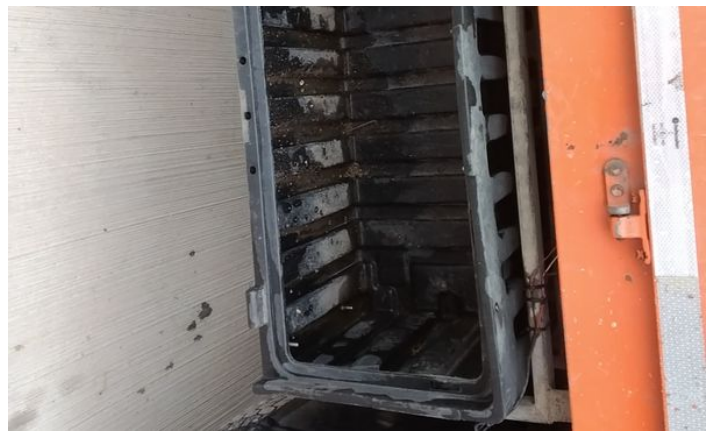
12: Qtr Panel Trim ns  
Missing  
Replace

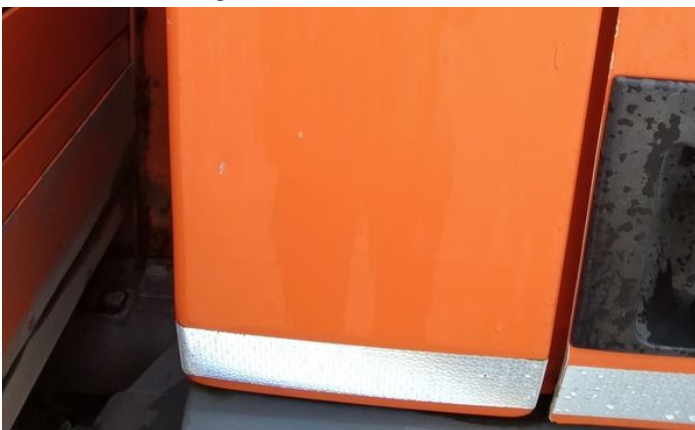
13: Qtr Panel osr  
Scratched  
Over 25mm Thru Paint

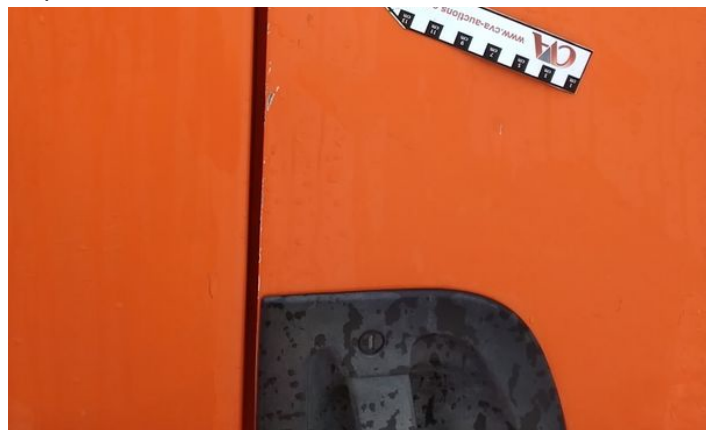
14: Door osf  
Dented  
With Paint Damage

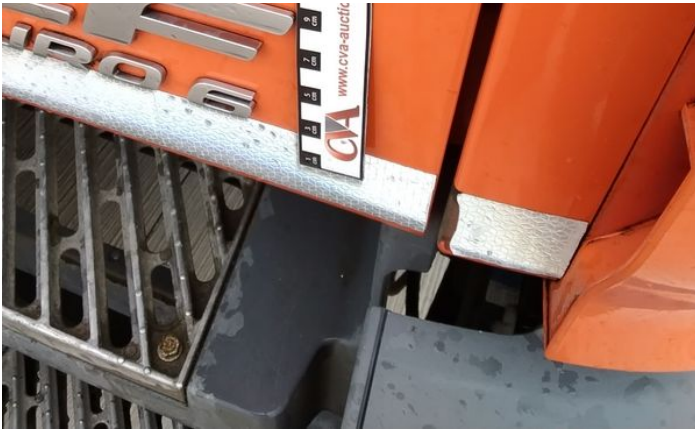
15: Moulding of Wing  
Scratched (Painted)  
Over 25mm Thru Paint

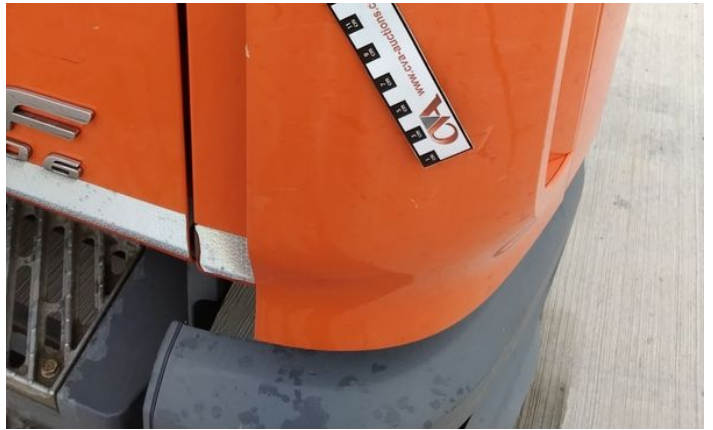
16: Moulding of Wing  
Scratched (Painted)  
Over 25mm Thru Paint

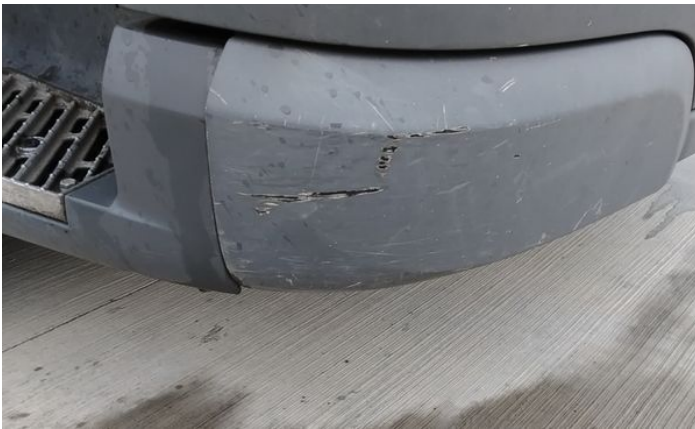
17: Bumper Front  
Scratched  
Over 100mm Thru Paint

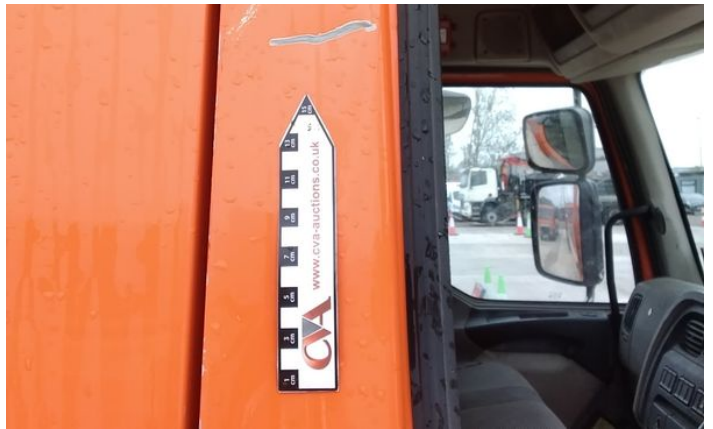
18: Door of  
Dented  
With Paint Damage
