# VEHICLE INSPECTION REPORT

**WX20KNJ**

## Fiat Ducato 140 35 2.3 MULTIJET I

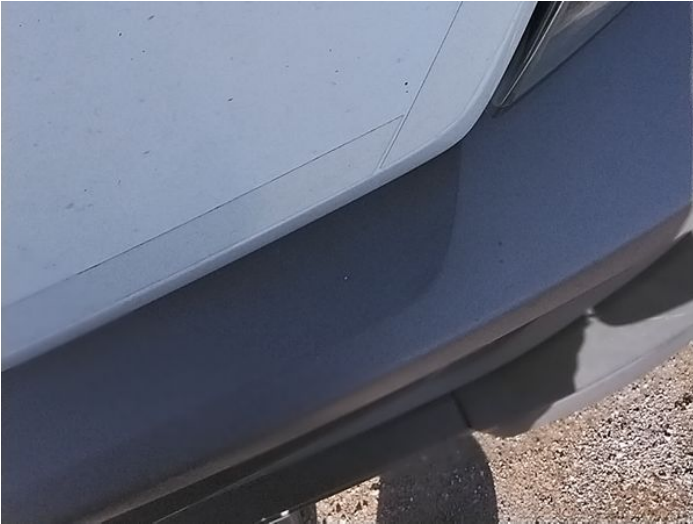
1: Bonnet  
Chipped  
Over 5mm

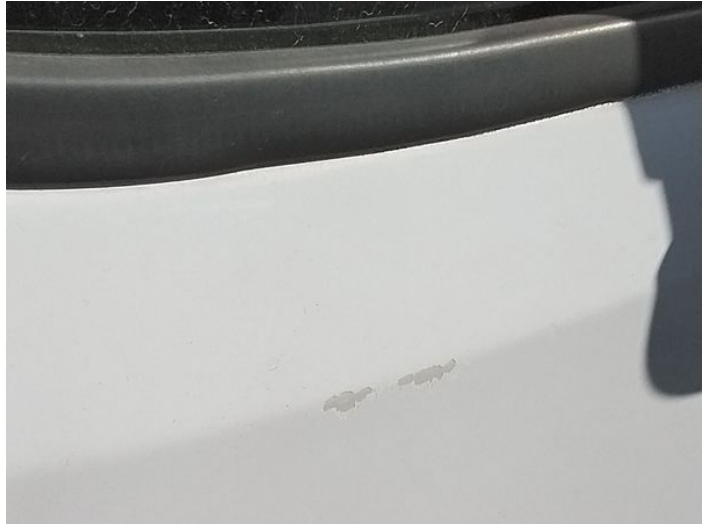
2: Door osf  
Chipped  
Over 5mm

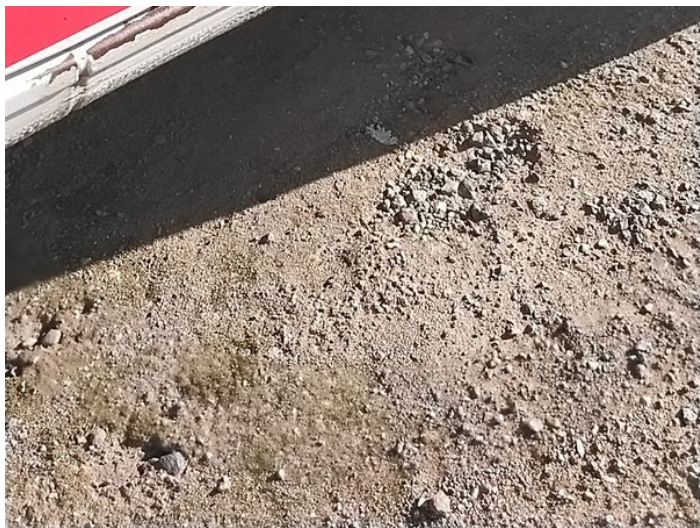
3: Sill os  
Chipped  
Edge Chip

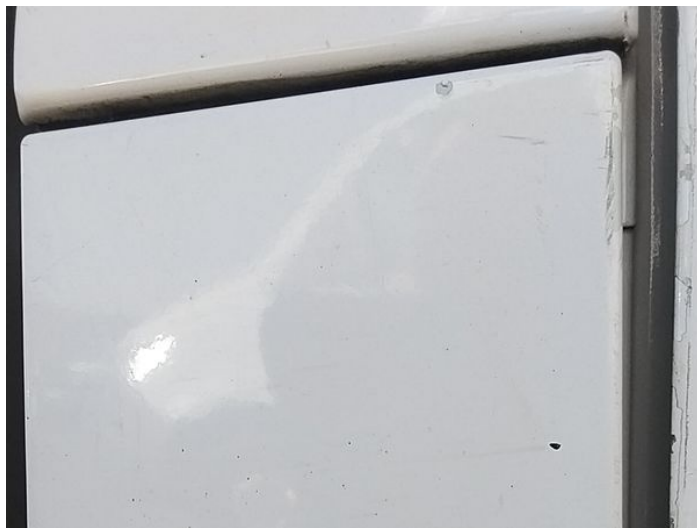
4: Fuel Flap  
Scratched  
Over 25mm Not Thru Paint

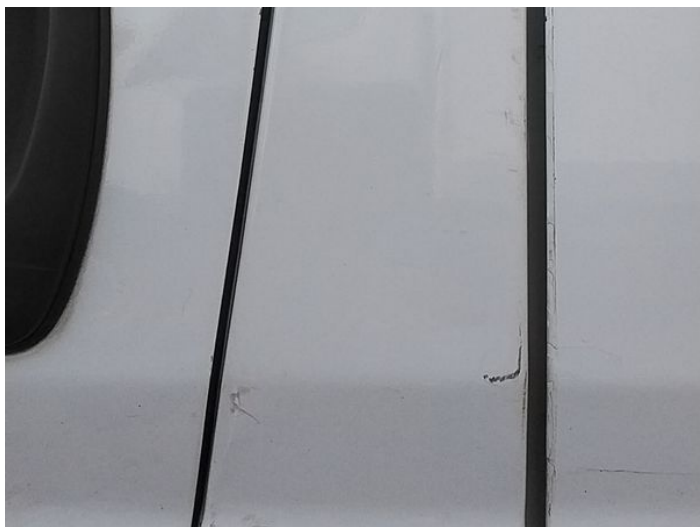
5: Panel Front  
Scratched  
Over 25mm Not Thru Paint

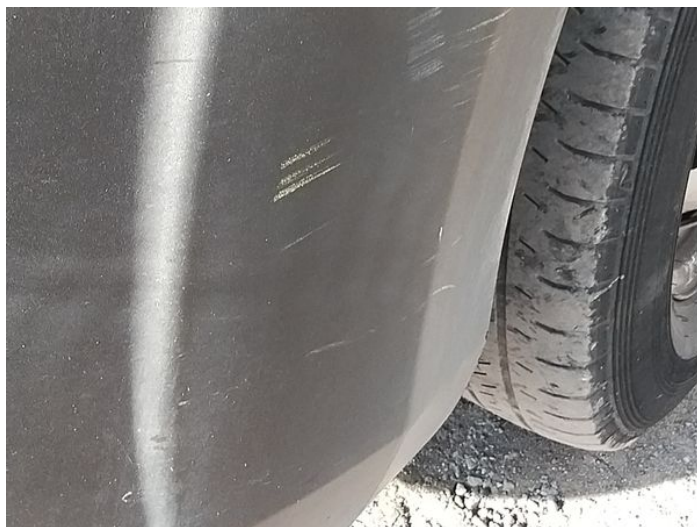
6: Bumper Front Moulding  
Scuffed (Unpainted)  
Over 100mm

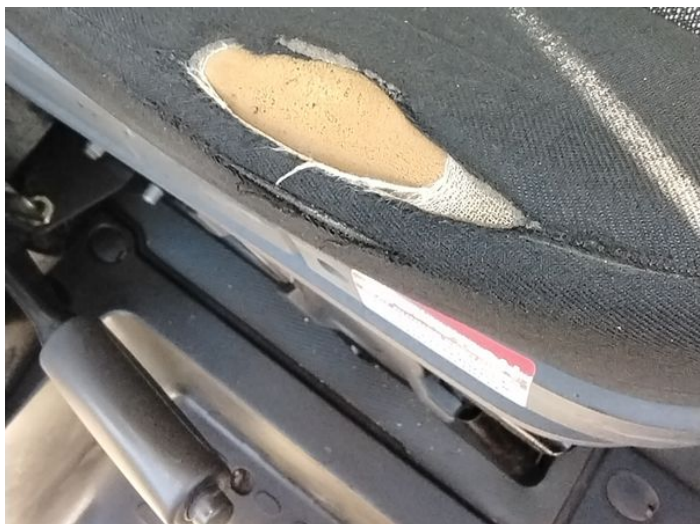
7: Seat Base Cover osf  
Torn  
Over 3mm

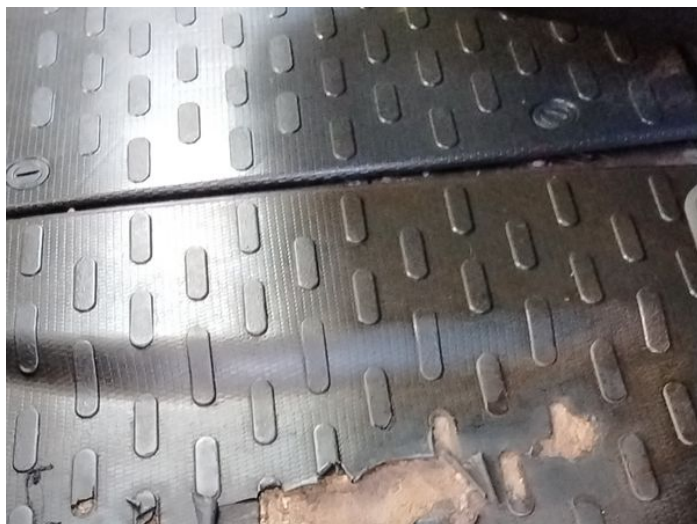
8: Carpets Front  
Torn  
Over 10mm
