# VEHICLE INSPECTION REPORT

**WV20HSA**

## FIAT DUCATO 35 2.3 Multijet 140

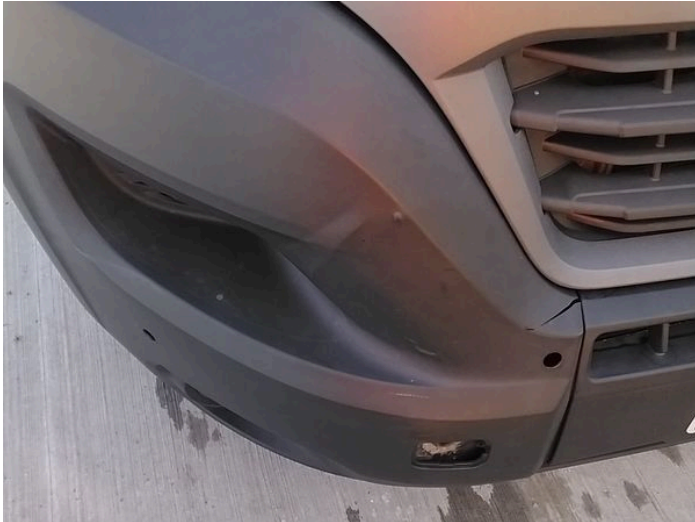
1: Bumper Front Moulding  
Broken  
Replace

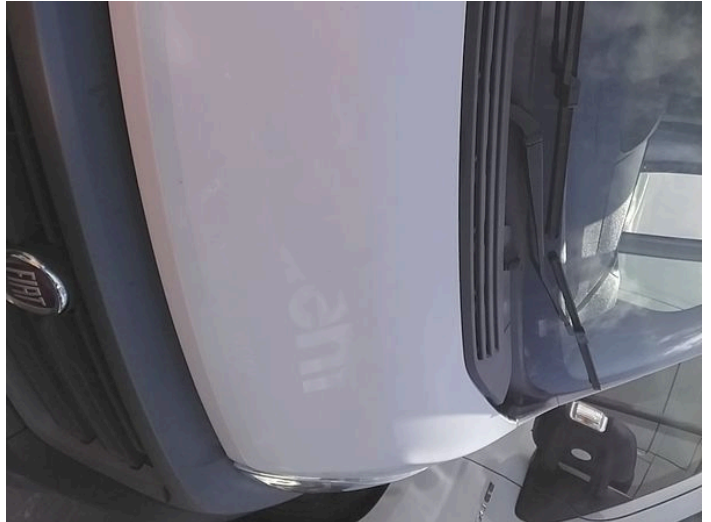
2: Bonnet  
Chipped  
Multiple Chips

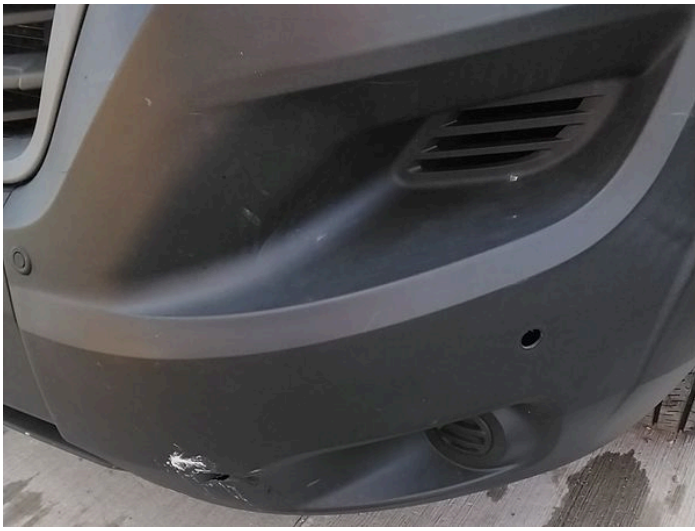
3: Bumper Front Moulding  
Broken  
Replace

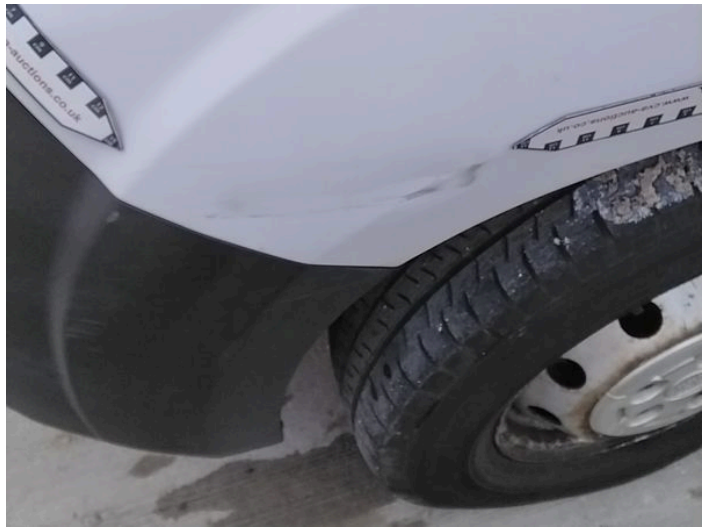
4: Wing nsf  
Dented  
With Paint Damage

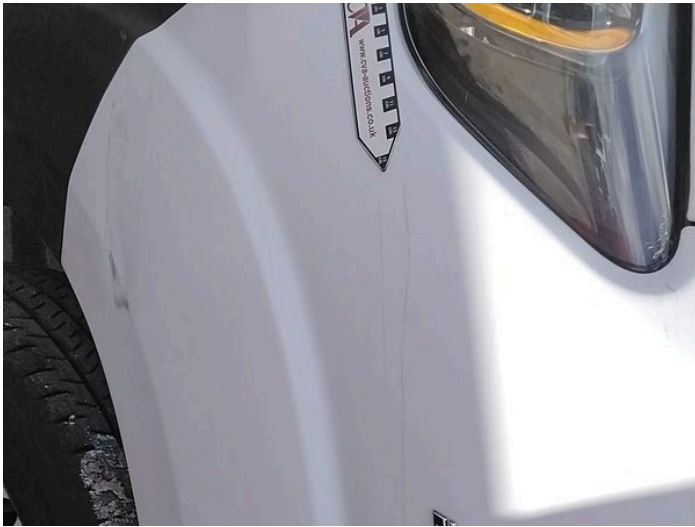
5: Wing nsf  
Scratched  
Over 25mm Thru Paint

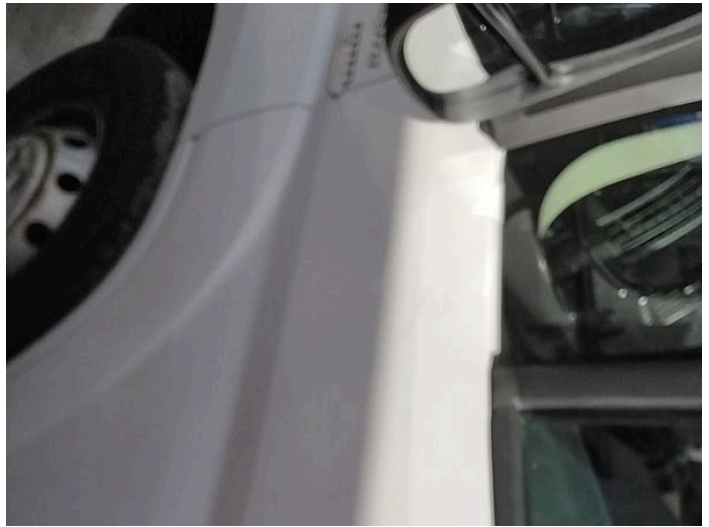
6: Door nsf  
Scratched  
Over 25mm Thru Paint

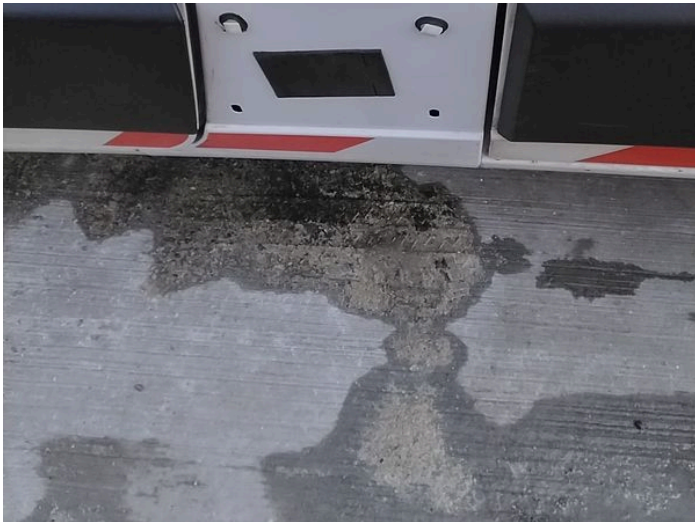
7: Door Moulding nsf  
Missing  
Replace

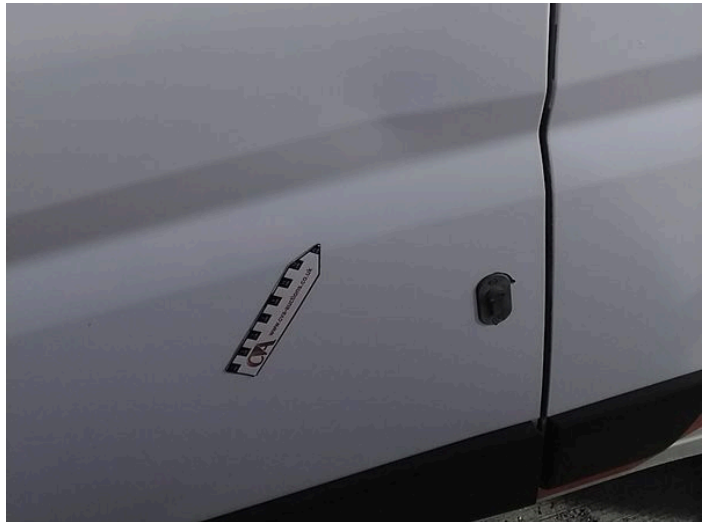
8: Qtr Panel nsr  
Dented  
Over 30mm

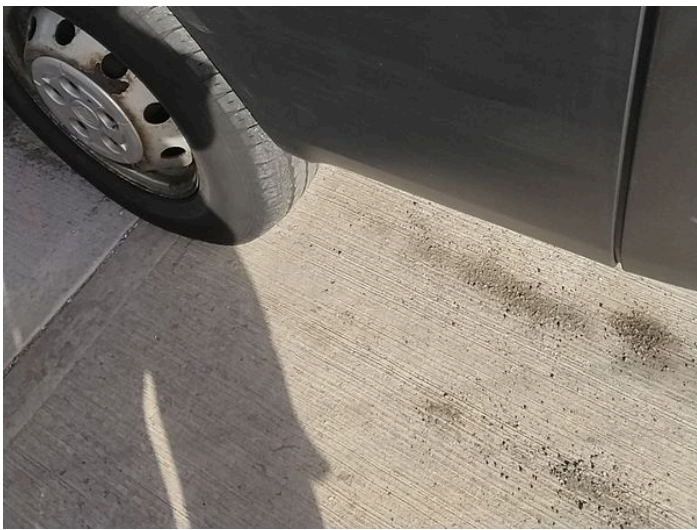
9: Qtr Panel Moulding ns  
Scuffed (Unpainted)  
Over 100mm

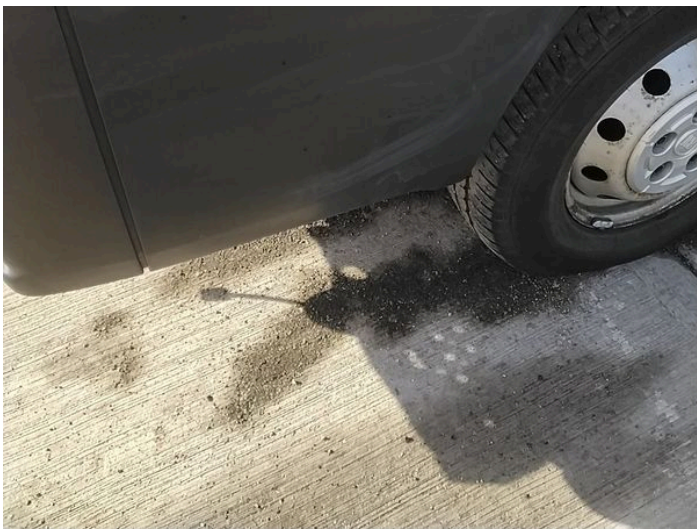
10: Qtr Panel Moulding os  
Scuffed (Unpainted)  
Over 100mm

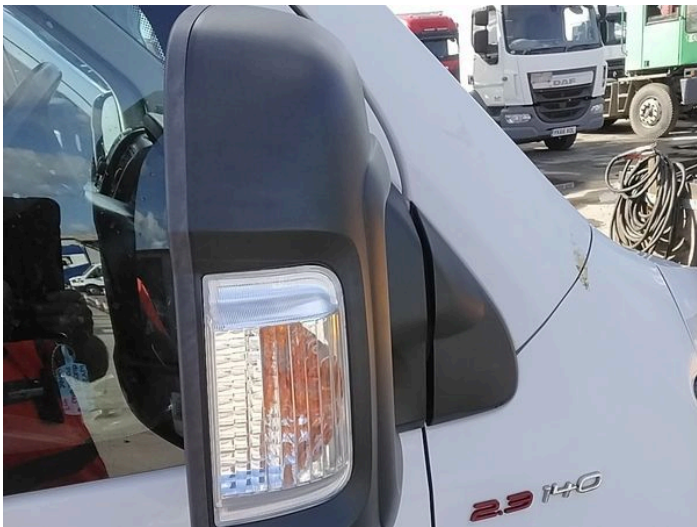
11: Door Mirror Assy osf  
Broken  
Replace

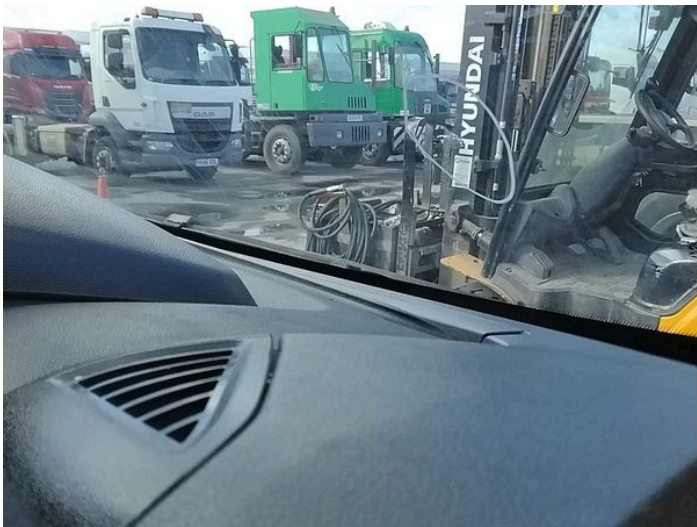
12: Screen Front  
Cracked  
Replace

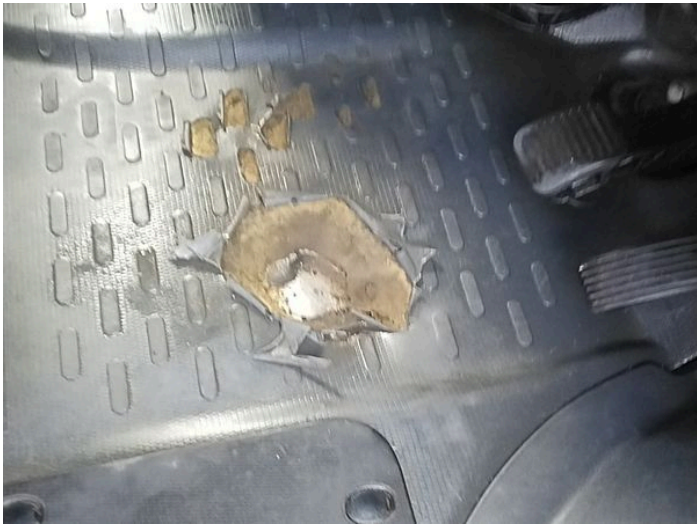
13: Carpets Front  
Holed  
Over 3mm

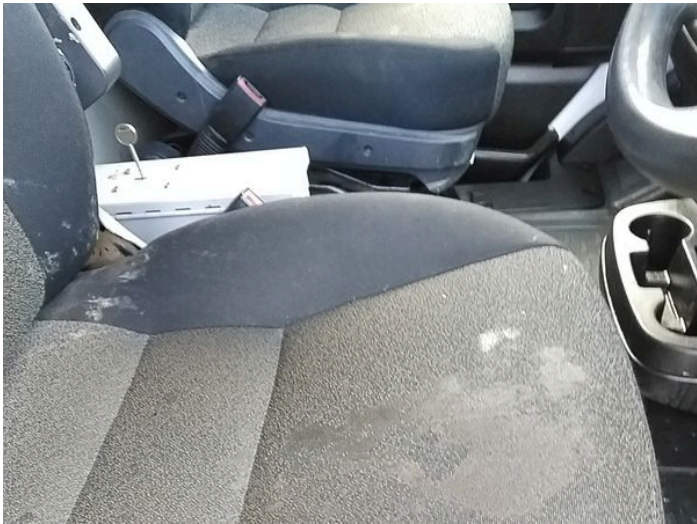
14: Seat Base Cover osf  
Soiled  
Heavy

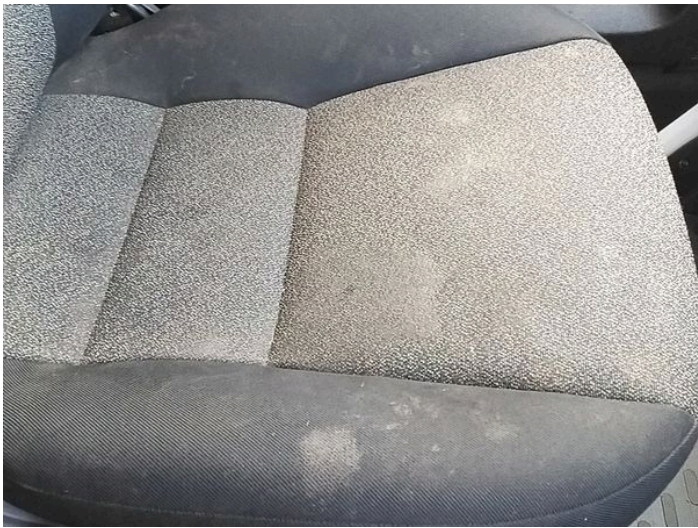
15: Seat Base Cover nsf  
Soiled  
Heavy
