# VEHICLE INSPECTION REPORT

**WS19ADU**

## Fiat Ducato 35 II 2.3 MULTIJET 130PS

### Inspection

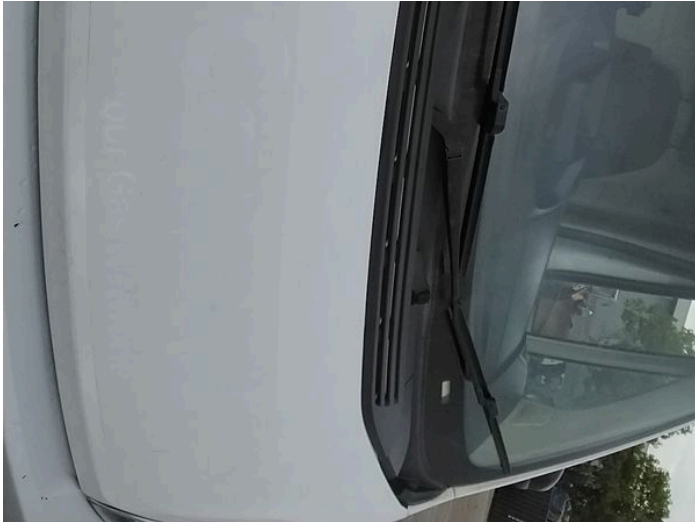
1: Bonnet  
Chipped  
Multiple Chips

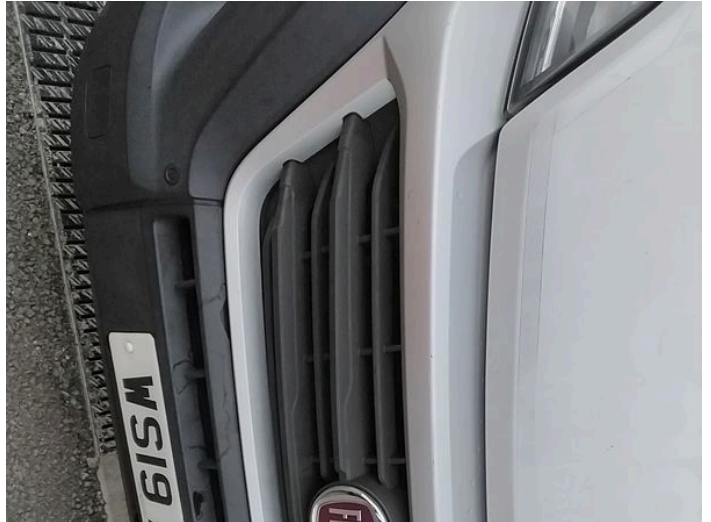
2: Panel Front  
Chipped  
Multiple Chips

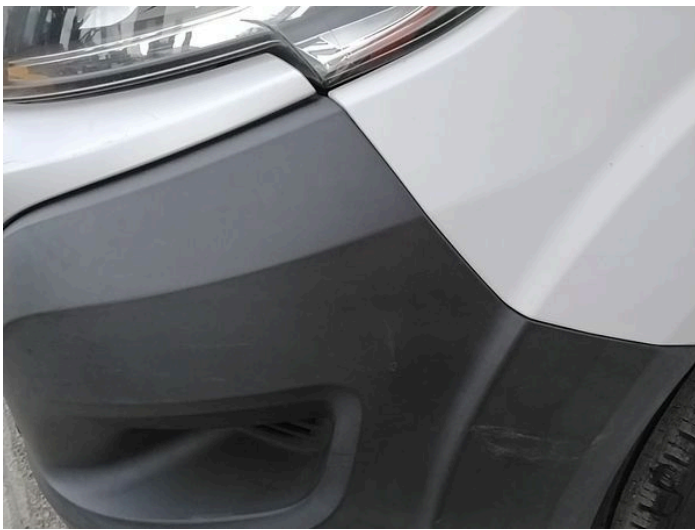
3: Bumper Front Moulding  
Scuffed (Unpainted)  
Over 100mm

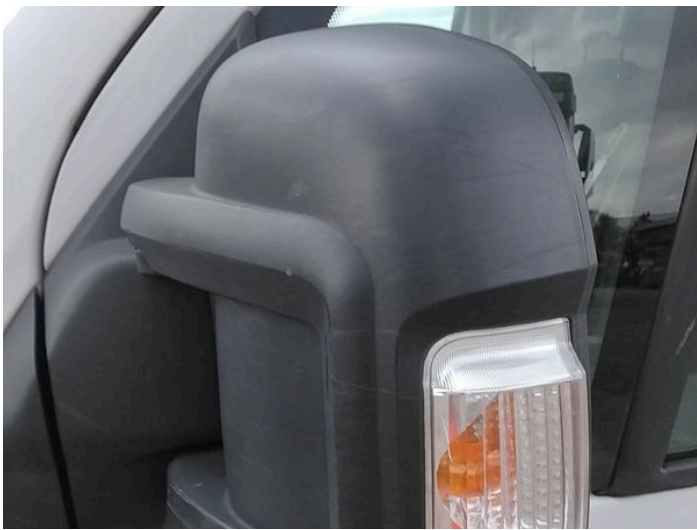
4: Door Mirror Assy nsf  
Broken  
Replace

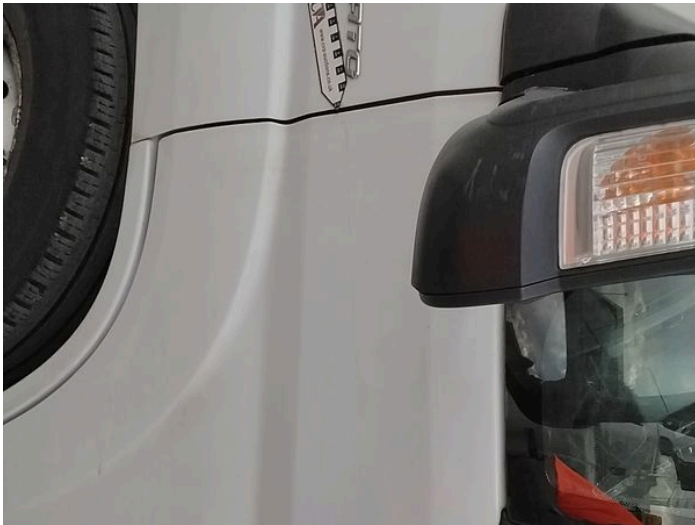
5: Door nsf  
Scratched  
Over 25mm Thru Paint

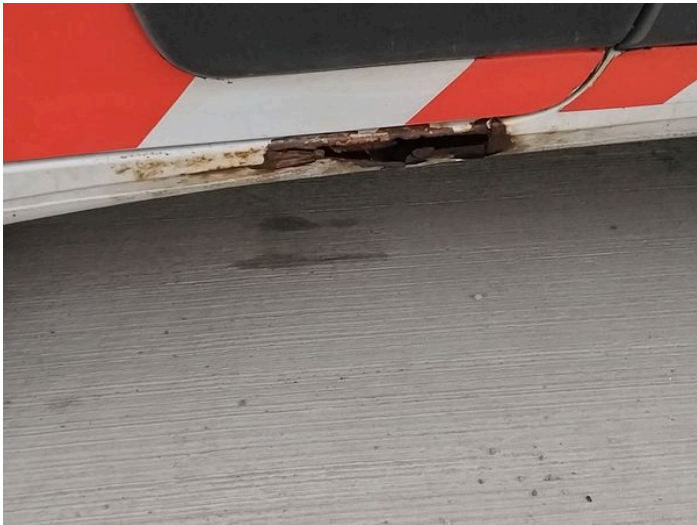
6: Sill ns  
Rusted  
Holed

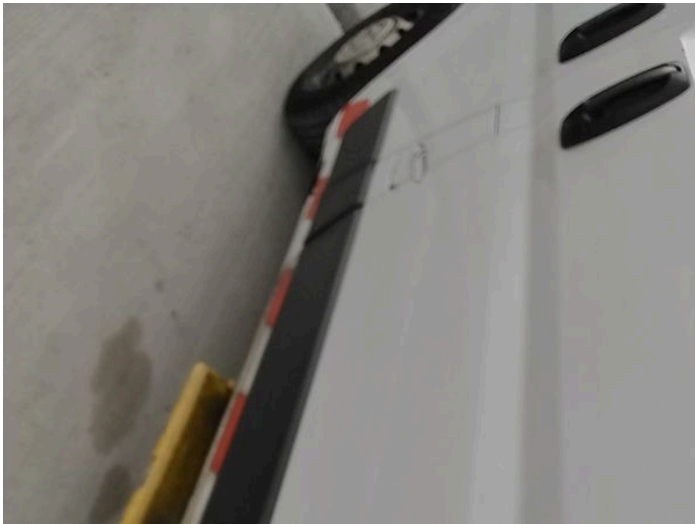
7: Qtr Panel nsr  
Scratched  
Over 25mm Thru Paint

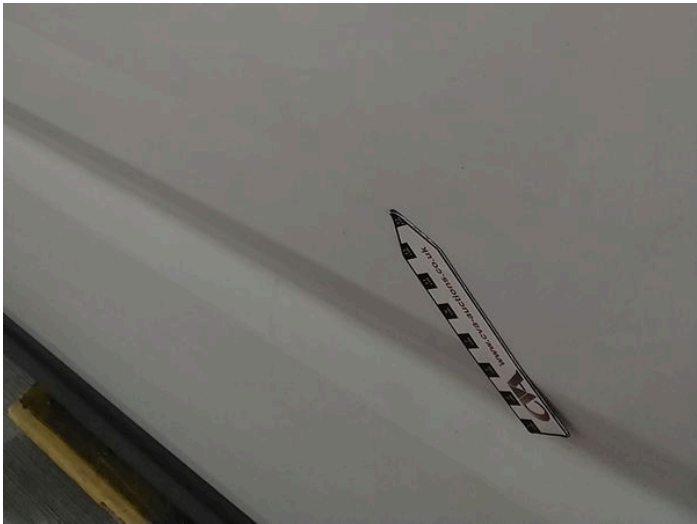
8: Qtr Panel nsr  
Dented  
Over 30mm

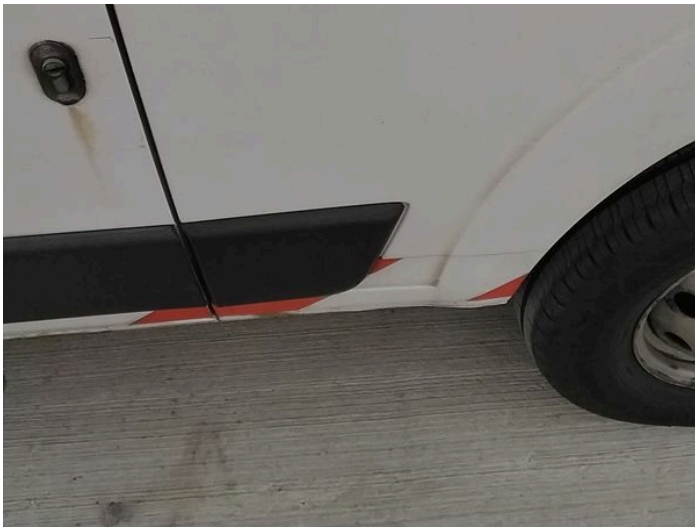
9: Qtr Panel nsr  
Chipped  
Multiple Chips

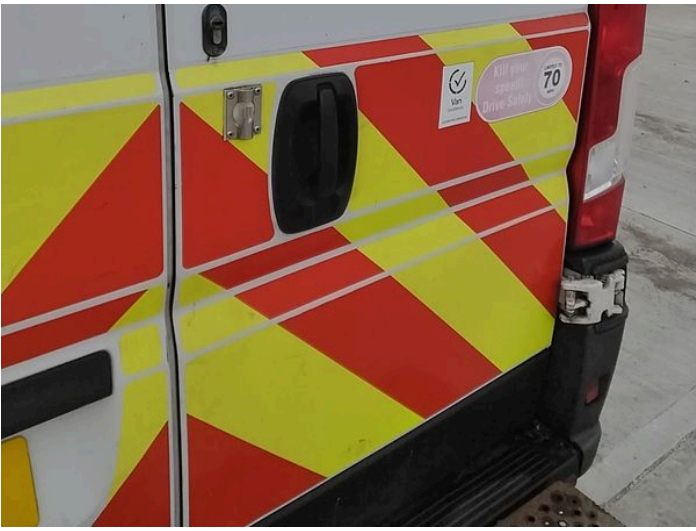
10: Door osr  
Chipped  
Multiple Chips

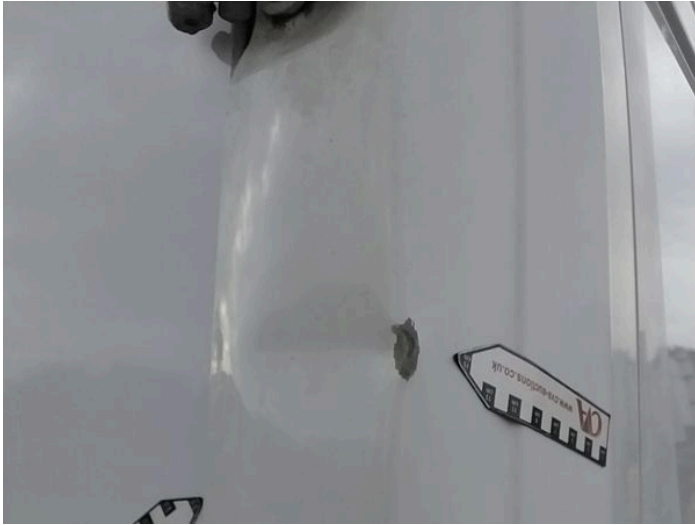
11: C Post os  
Dented  
With Paint Damage

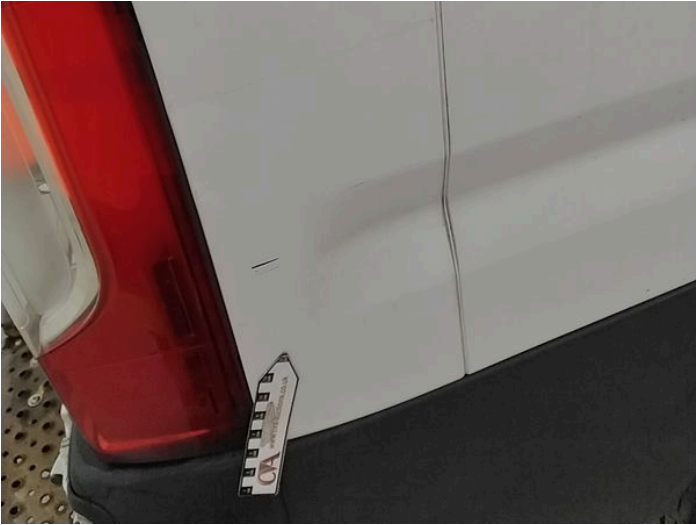
12: C Post os  
Dented  
With Paint Damage

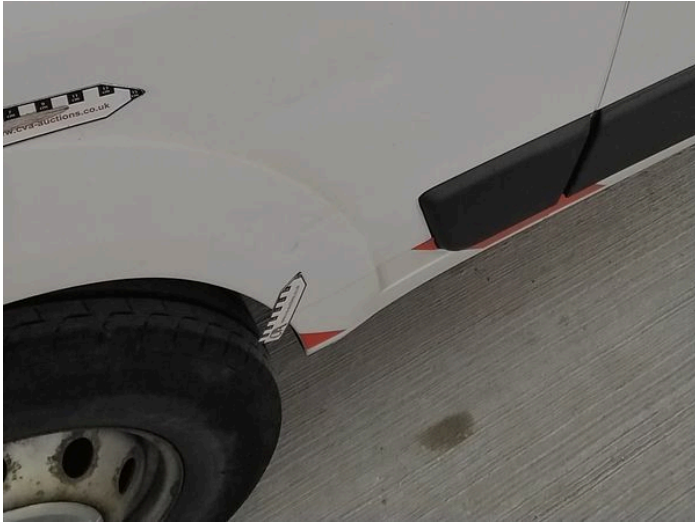
13: Qtr Panel osr  
Dented  
With Paint Damage

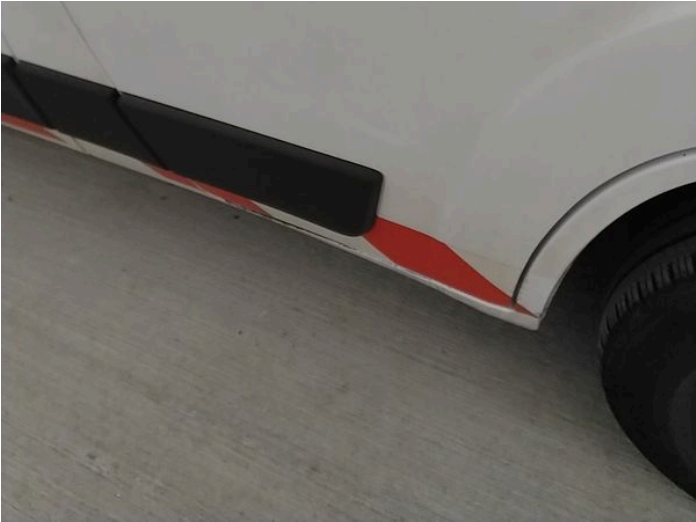
14: Door osf  
Chipped  
Multiple Chips

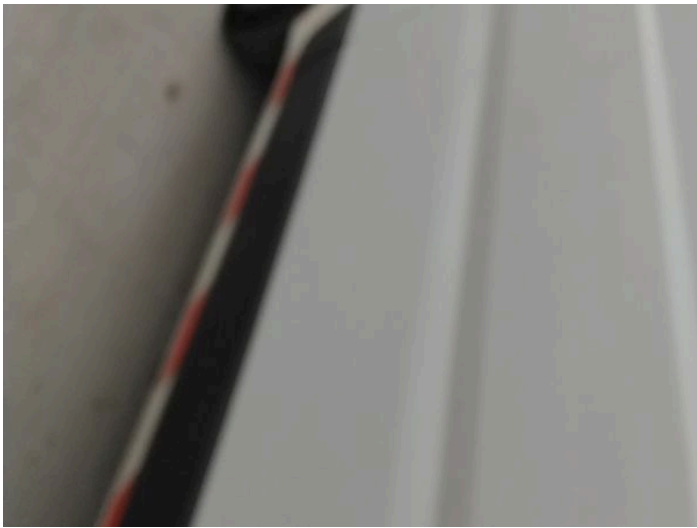
15: Qtr Panel osr  
Chipped  
Multiple Chips

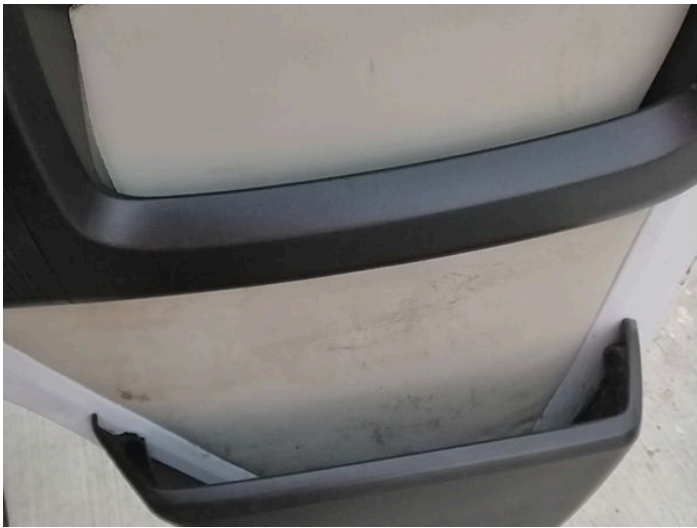
16: Door Pad osf  
Soiled  
Heavy

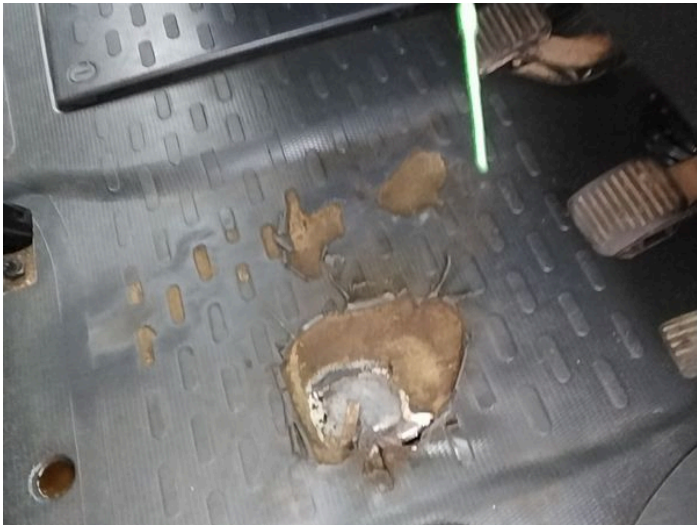
17: Carpets Front  
Holed  
Over 3mm

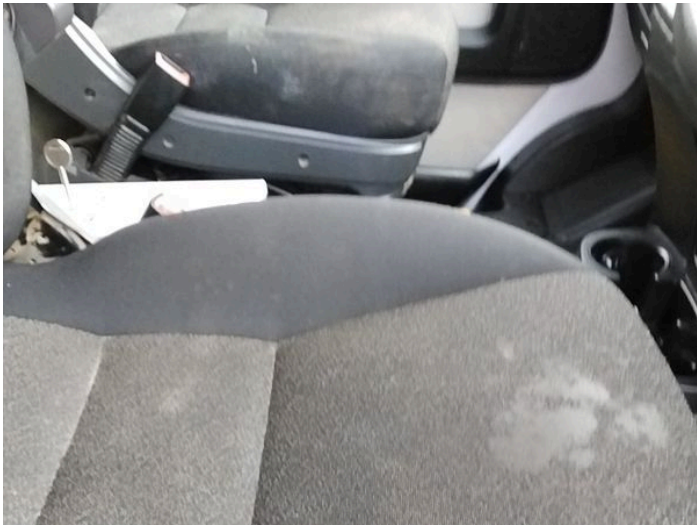
18: Seat Base Cover osf  
Torn  
Over 3mm

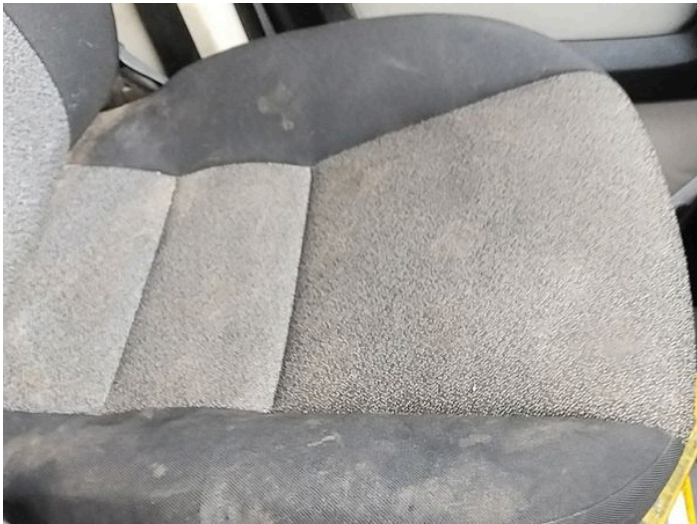
19: Seat Base Cover nsf  
Soiled  
Heavy
