# VEHICLE INSPECTION REPORT

**AL67LNZ**

## Mercedes-Benz Antos

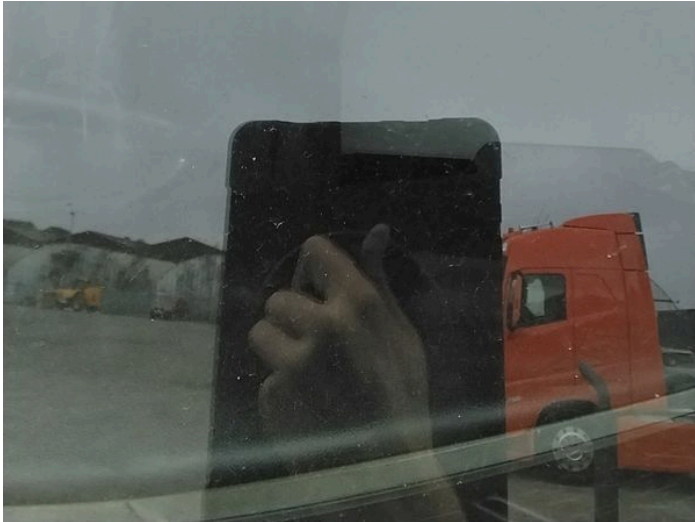
1: Screen Front  
Chipped  
UpTo 10mm

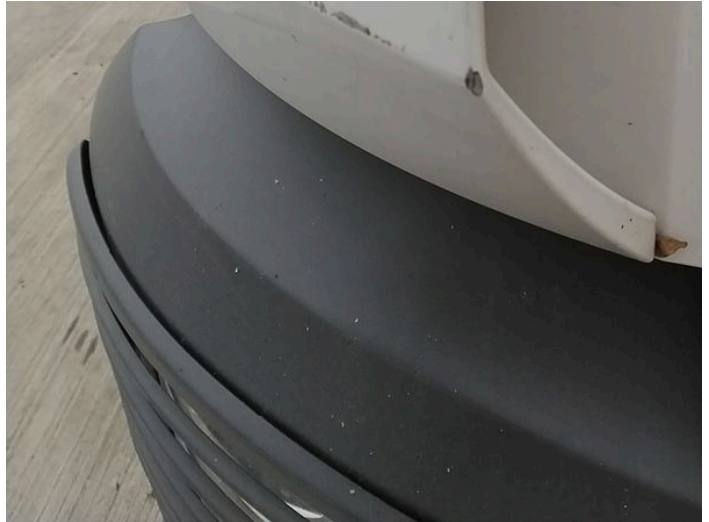
2: Panel Front  
Scratched  
Over 25mm Thru Paint

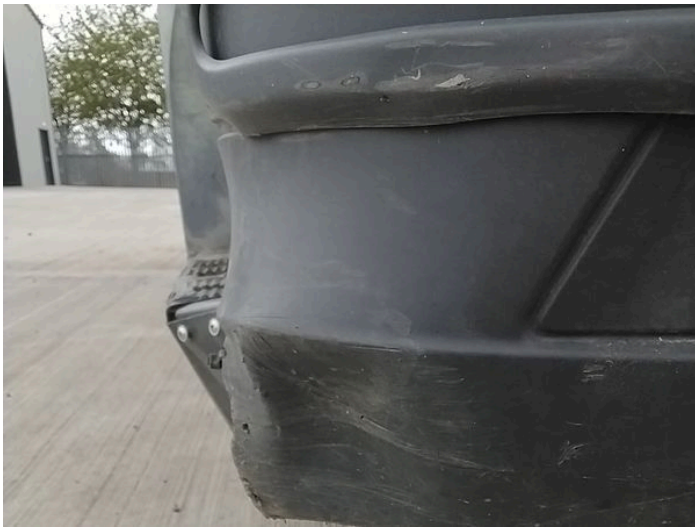
3: Bumper Front Moulding  
Scuffed (Unpainted)  
Over 100mm

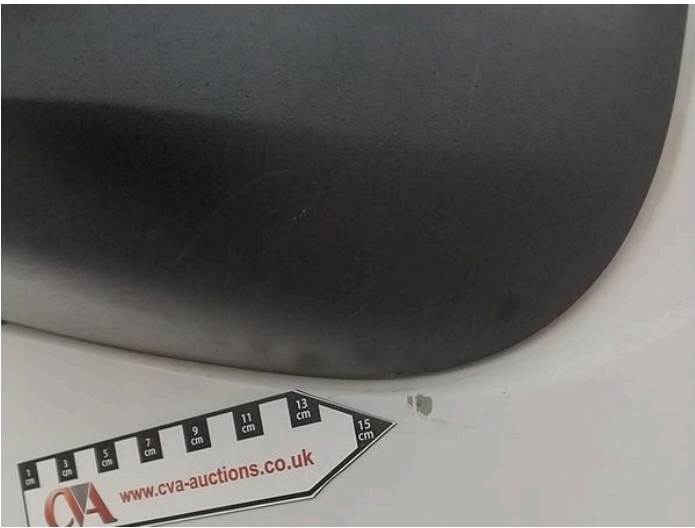
4: Door osf  
Chipped  
Over 5mm

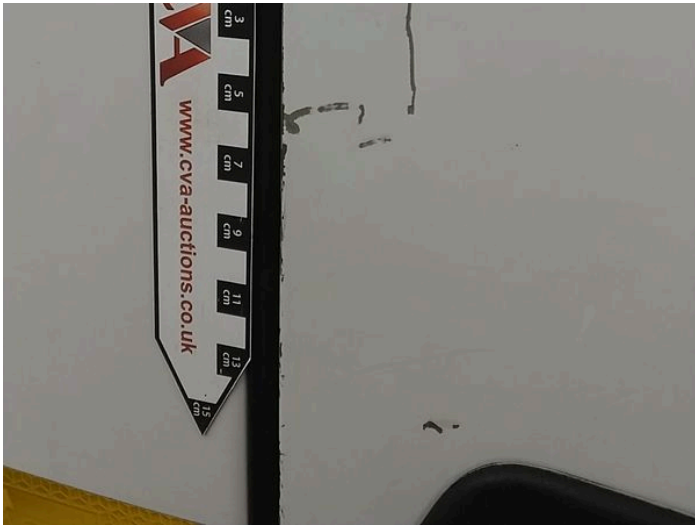
5: Door osf  
Scratched  
Over 25mm Thru Paint

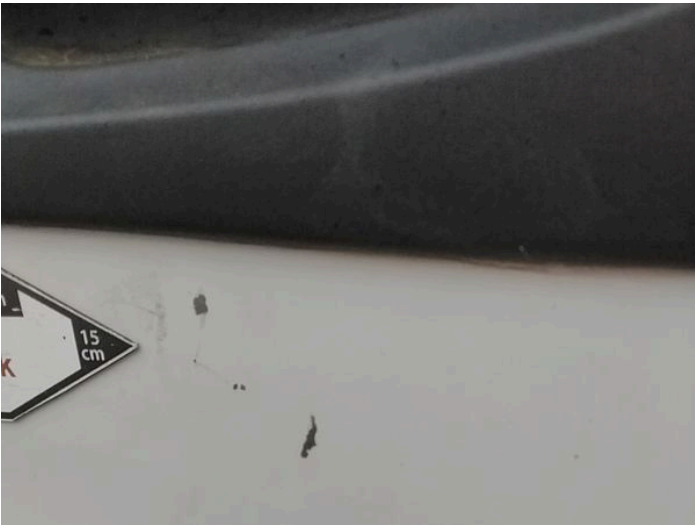
6: Door osf  
Scratched  
Over 25mm Thru Paint

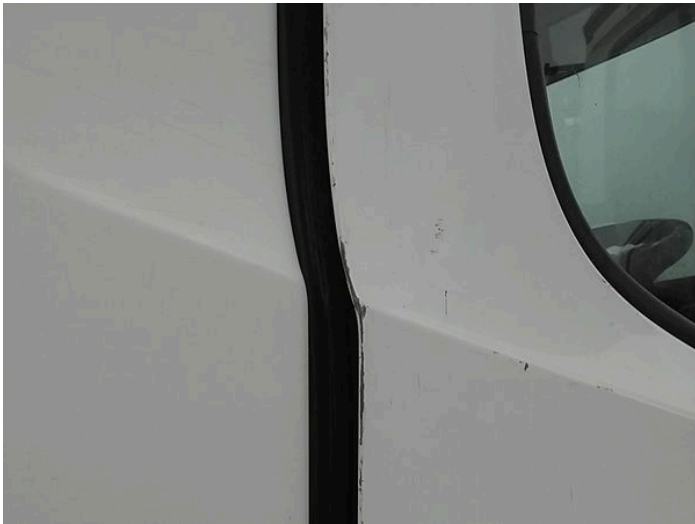
7: Door osf  
Chipped  
Edge Chip

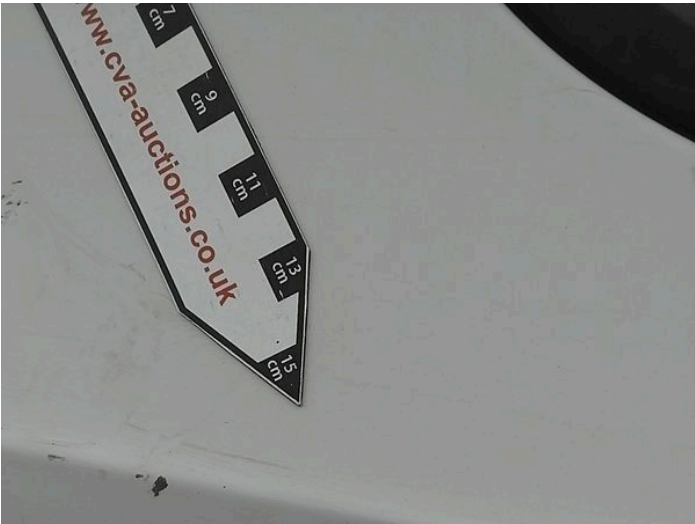
8: Door osf  
Scratched  
UpTo 25mm Thru Paint

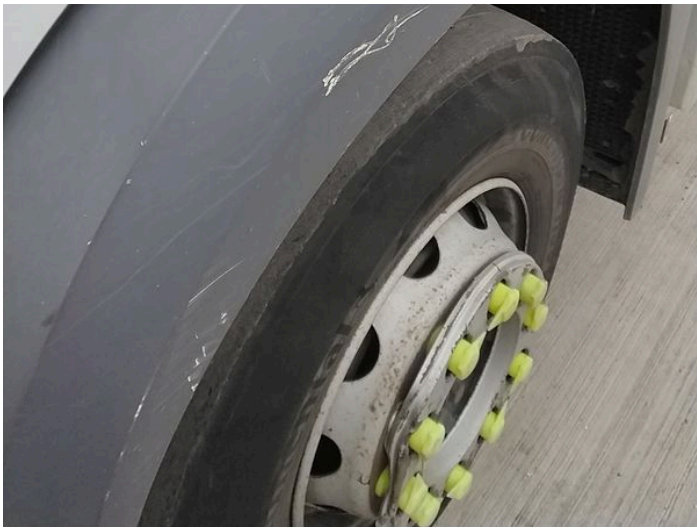
9: Moulding nsf Wing  
Scratched (Painted)  
Over 25mm Thru Paint

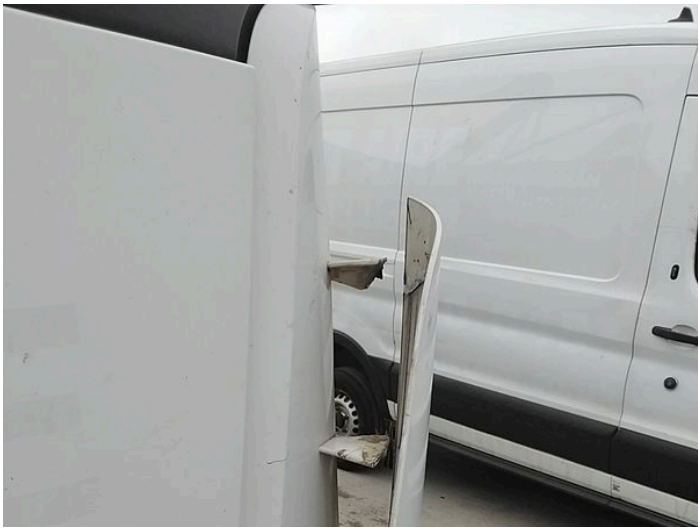
10: Grille Front  
Broken  
Replace

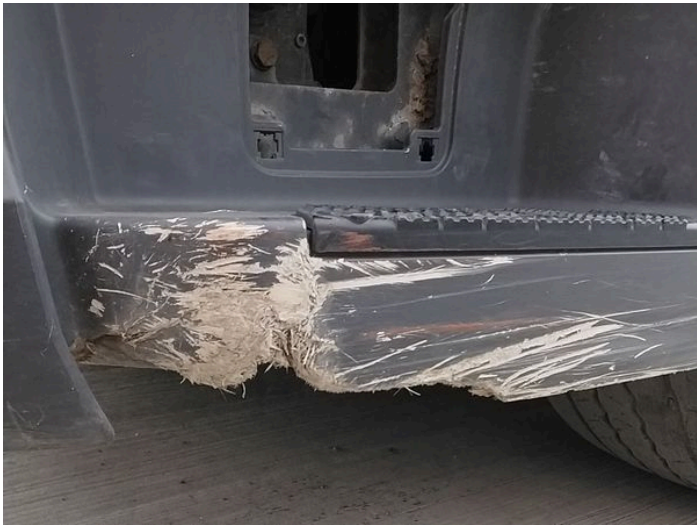
11: Moulding nsf Wing  
Broken  
Replace

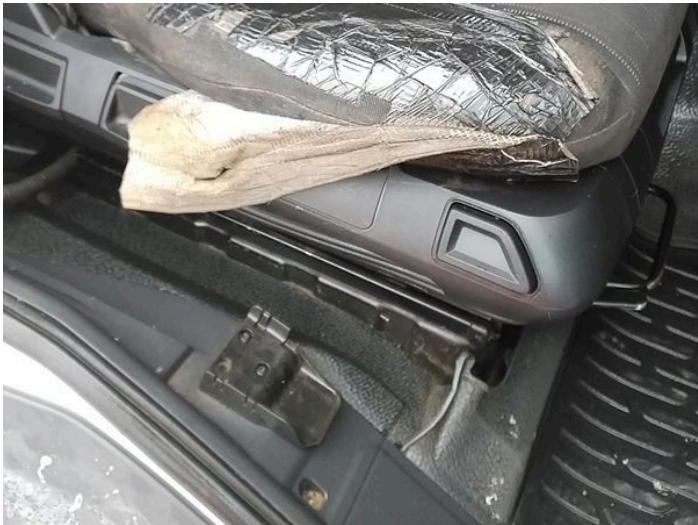
12: Seat Base Cover osf  
Torn  
Over 3mm
