VEHICLE INSPECTION REPORT

PJ16YSM

Daf LF 150

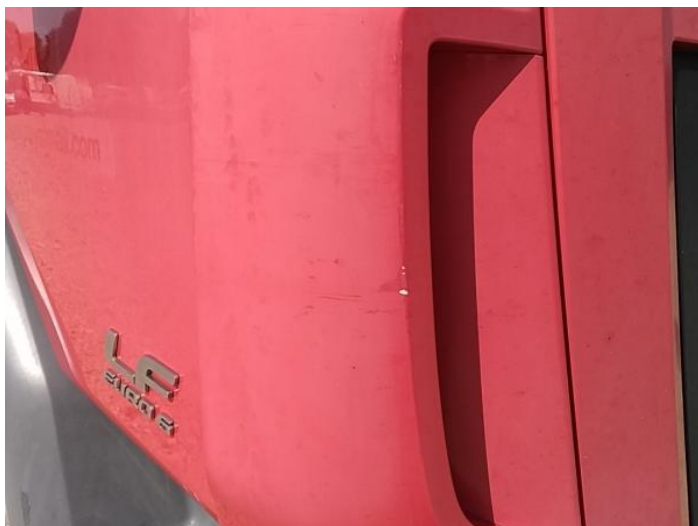
1: Moulding of Wing
Scratched (Painted)
Up To 25mm Thru Paint

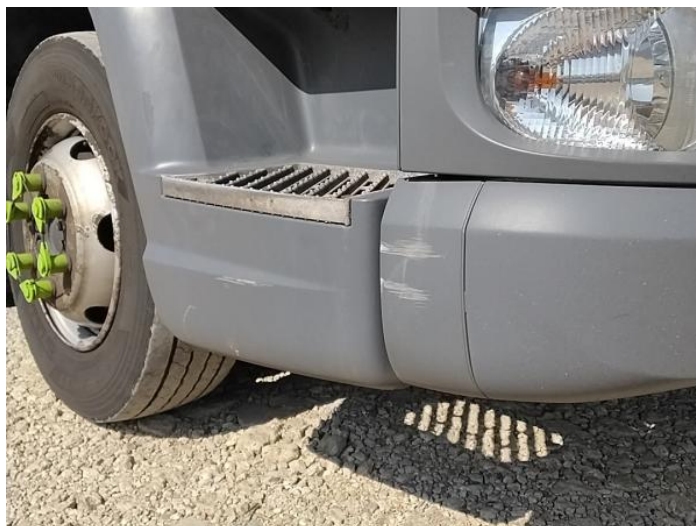
2: Bumper Front
Scratched
Over 100mm Thru Paint

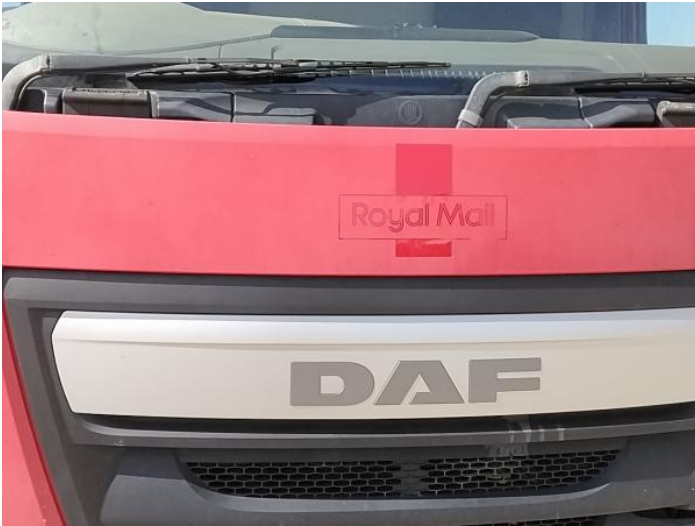
3: Bonnet
Chipped
Multiple Chips

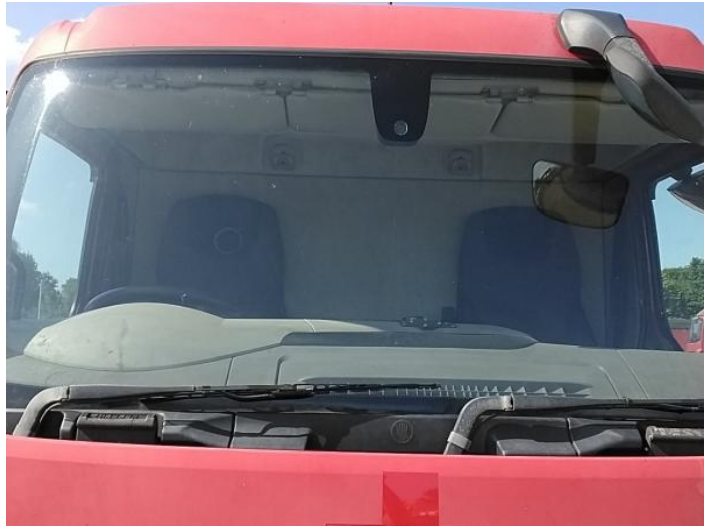
4: Screen Front
Chipped
Over 10mm

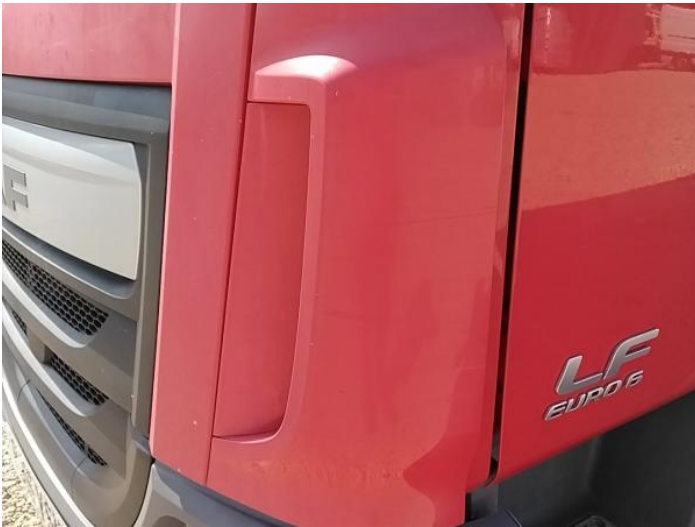
5: Moulding nsf Wing
Scratched (Painted)
Over 25mm Thru Paint

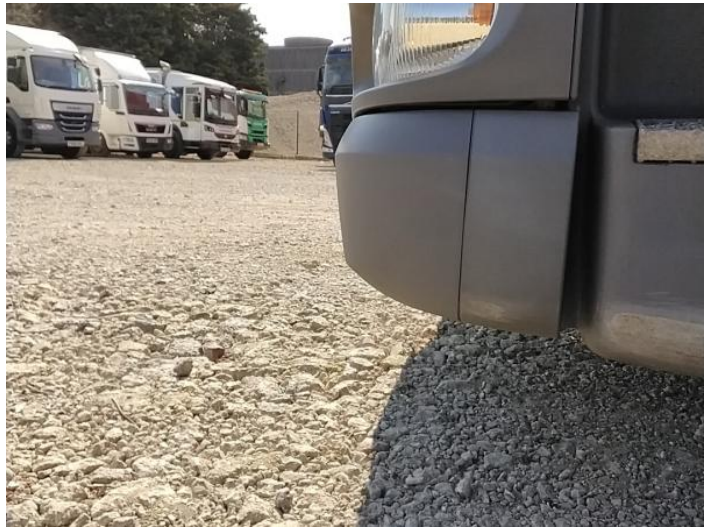
6: Bumper Front
Scratched
Over 100mm Thru Paint

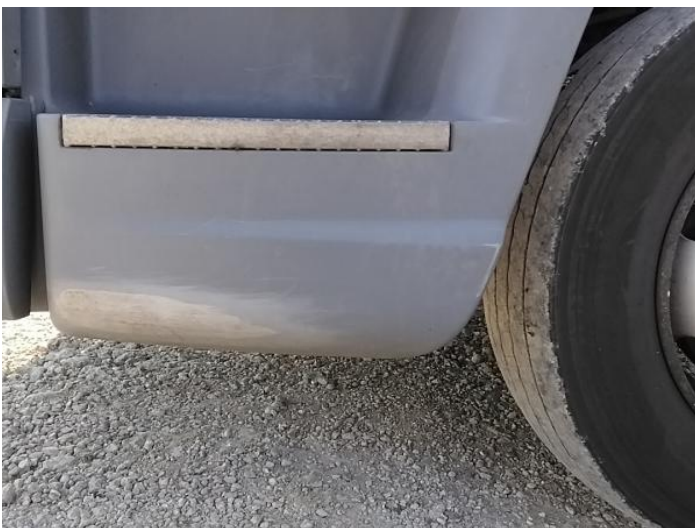
7: General Exterior
Soiled
Light

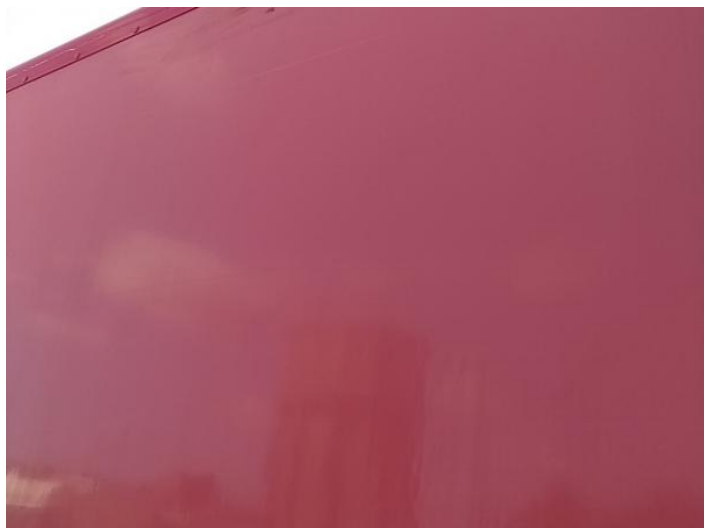
8: General Exterior
Soiled
Light

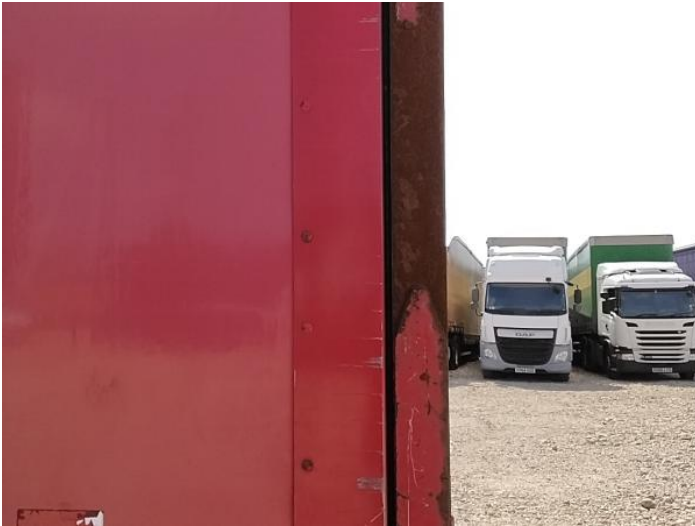
9: General Exterior
Soiled
Light

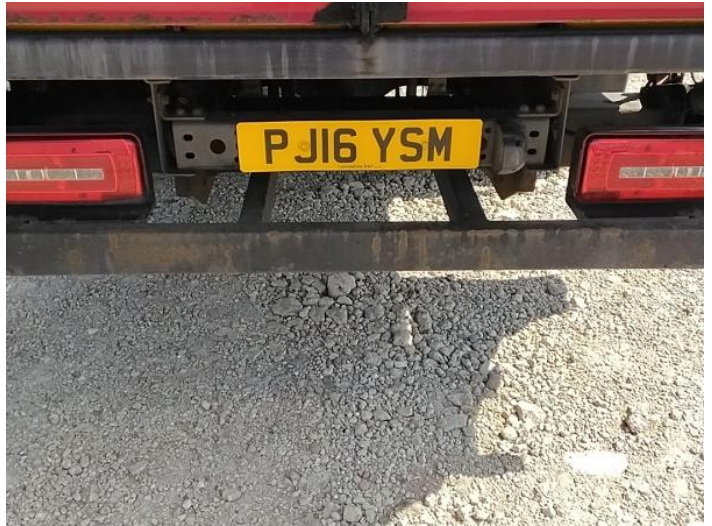
10: Bumper Rear
Rusted
Over 5mm

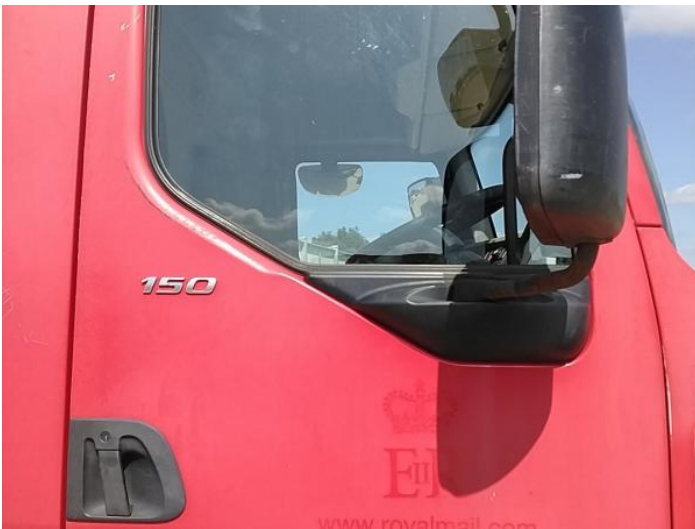
11: Door osf
Scratched
Over 25mm Thru Paint

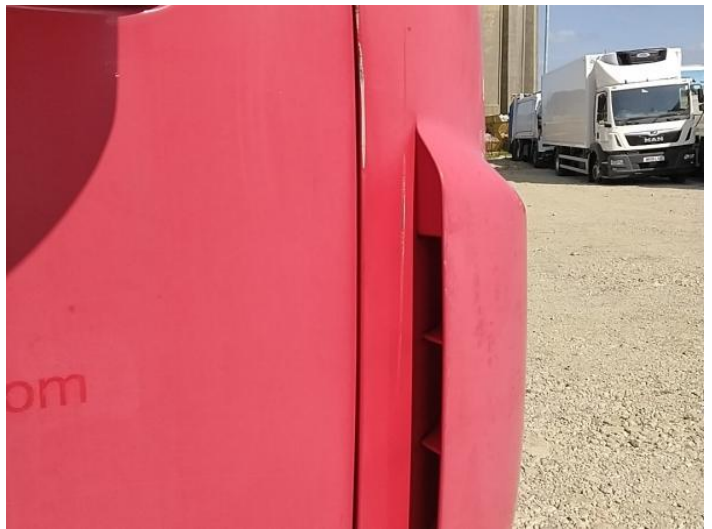
12: Moulding osf Wing
Scratched (Painted)
Over 25mm Thru Paint

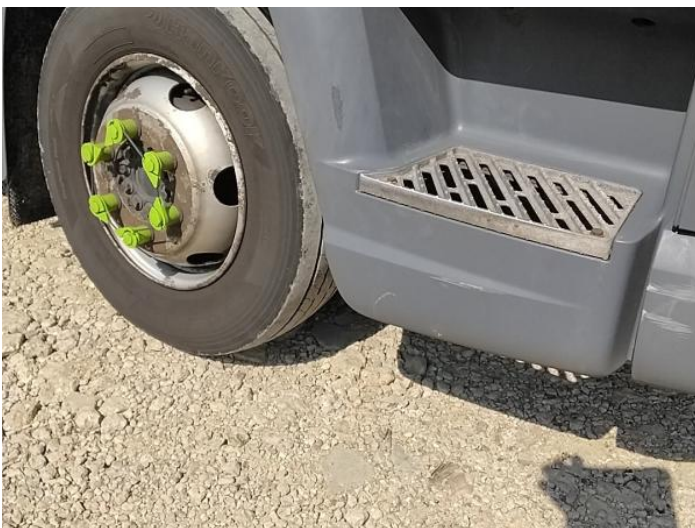
13: General Exterior
Soiled
Light

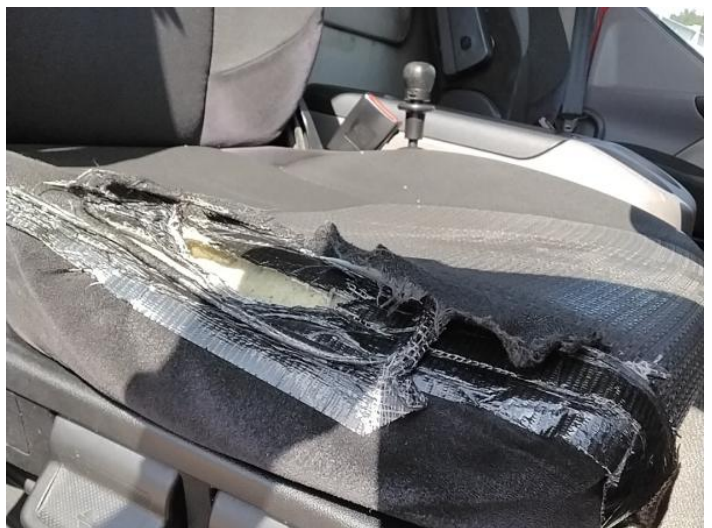
14: Seat Base Cover osf
Torn
Over 3mm

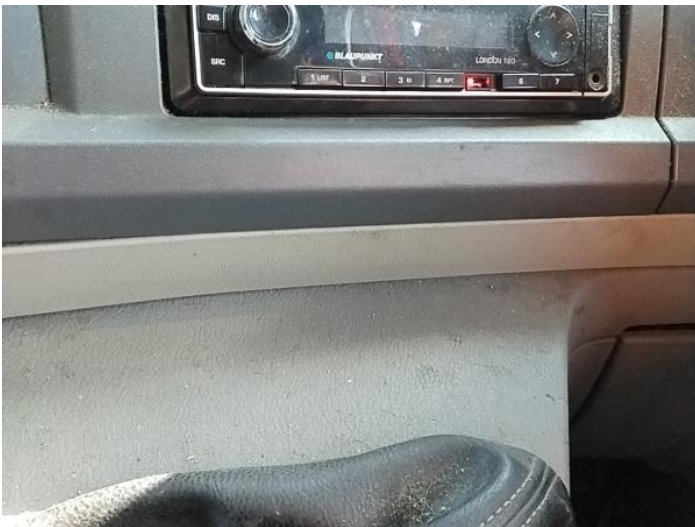
17: In Car Entertainment
Broken
Replace

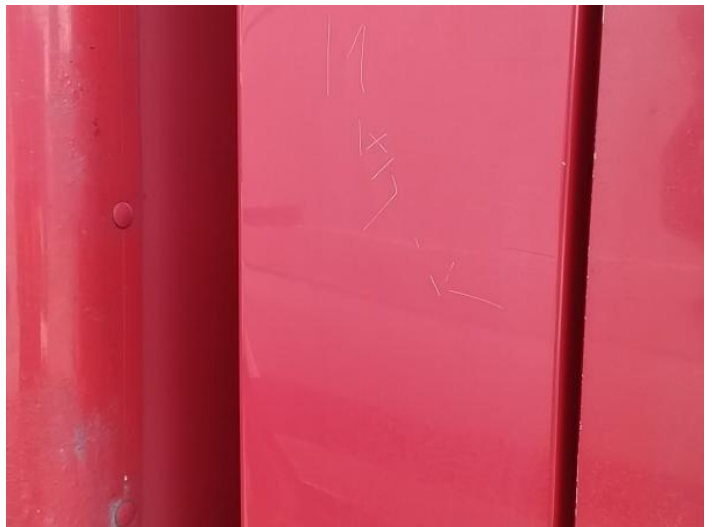
18: Door osf
Scratched
Over 25mm Thru Paint
