# VEHICLE INSPECTION REPORT

**BX09GBF**

## Daf LF 45.180

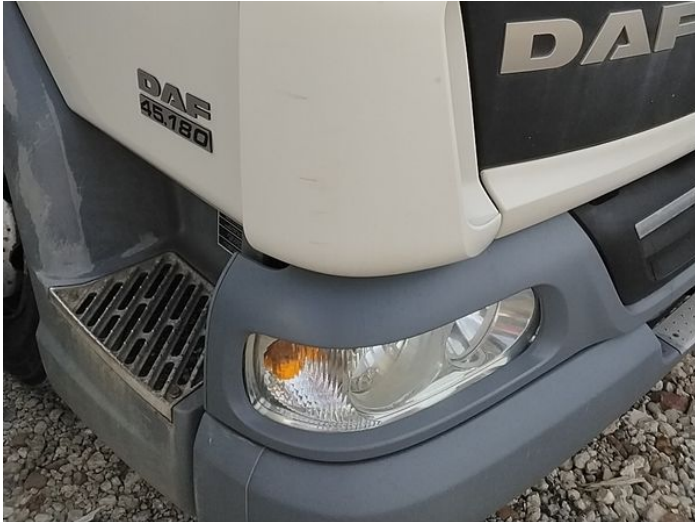
1: Wing osf  
Scratched  
Over 25mm Not Thru Paint

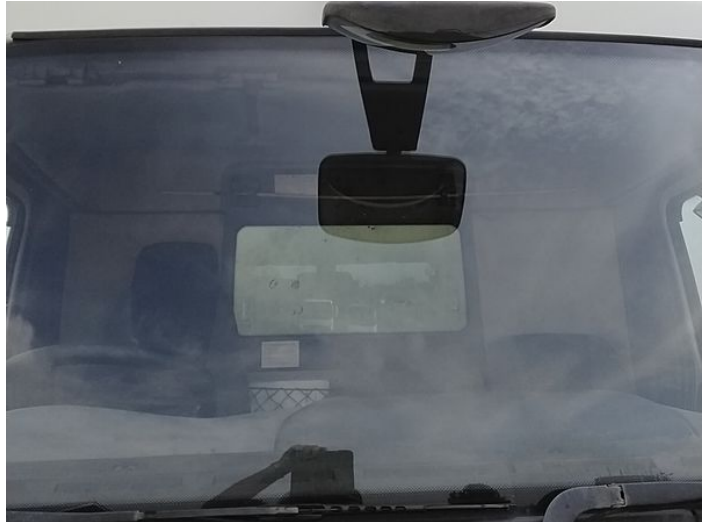
2: Screen Front  
Chipped  
UpTo 10mm

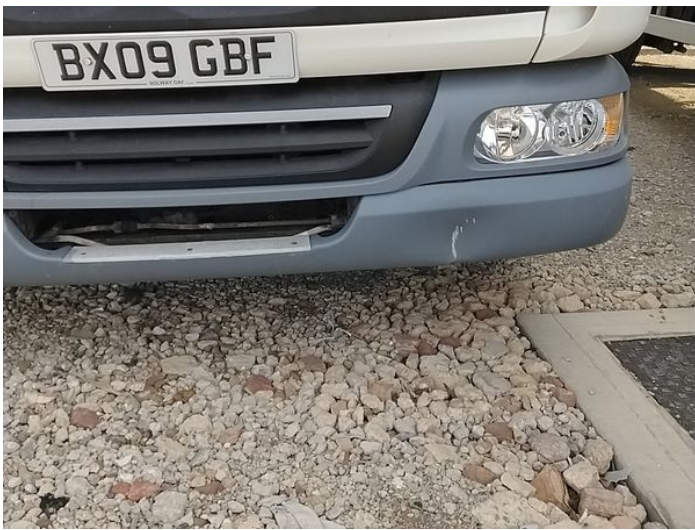
3: Bumper Front  
Dented  
With Paint Damage

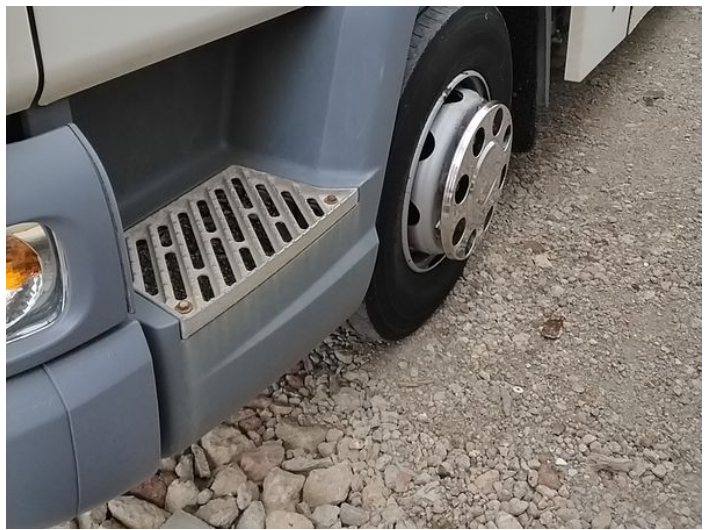
4: Wing Front Arch Extension ns  
Scuffed (Unpainted)  
Over 100mm

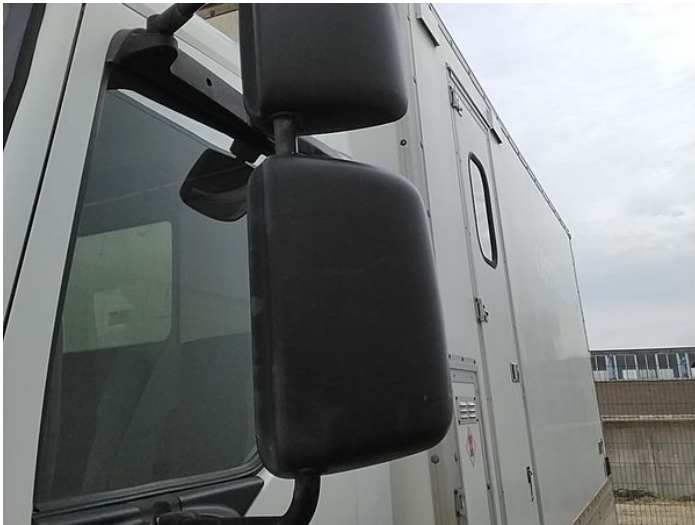
5: Door Mirror Assy nsf  
Scuffed (Unpainted)  
Over 100mm

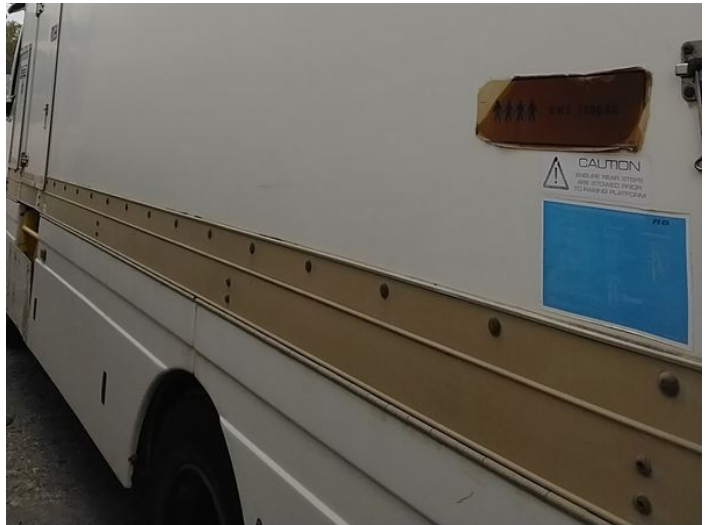
6: Qtr Panel nsr  
Scratched  
UpTo 25mm Not Thru Paint

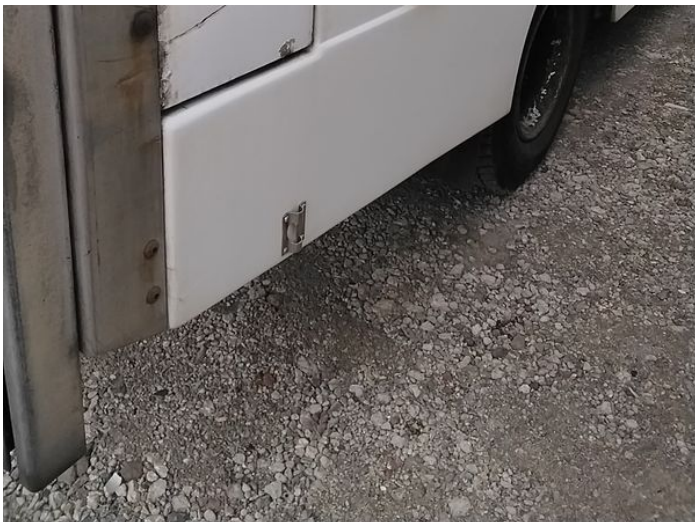
7: Qtr Panel osr  
Scratched  
Over 25mm Thru Paint

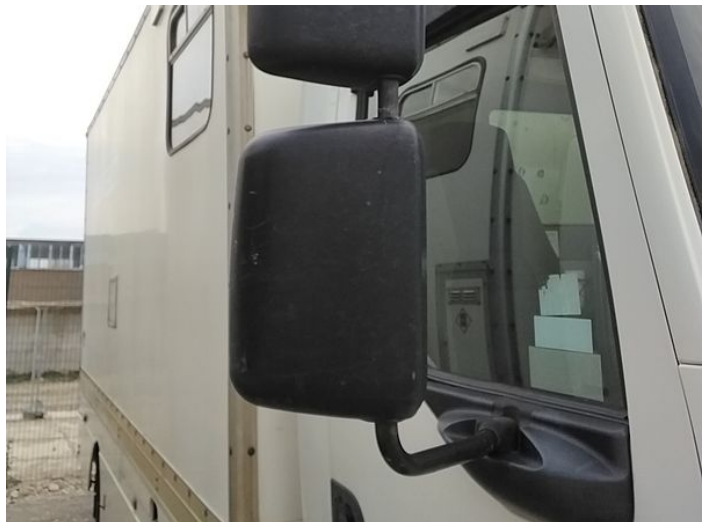
8: Door Mirror Assy osf  
Scuffed (Unpainted)  
Over 100mm

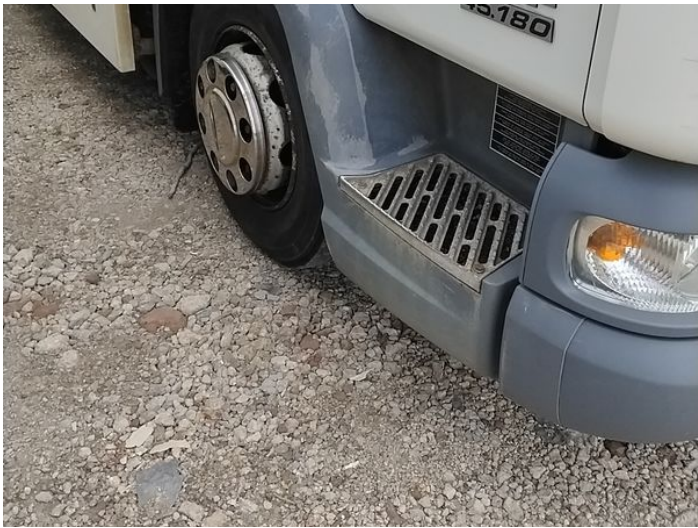
9: Wing Front Arch Extension os Scuffed (Unpainted) Over 100mm

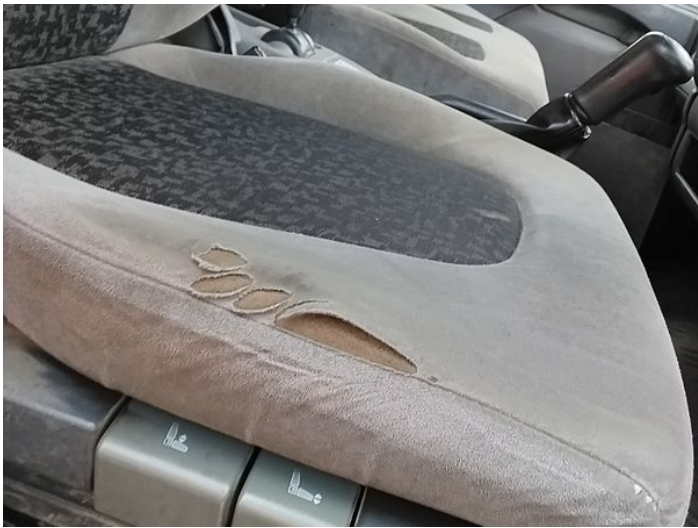
10: Seat Base Cover osf Holed Over 3mm
