# VEHICLE INSPECTION REPORT

**CP21KYV**

## Iveco Daily 72-180

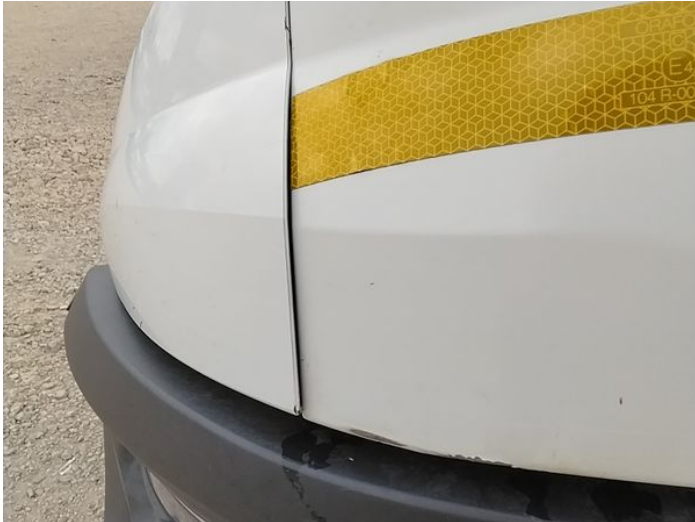
1: Panel Front  
Poor Previous Repair  
Poor Colour

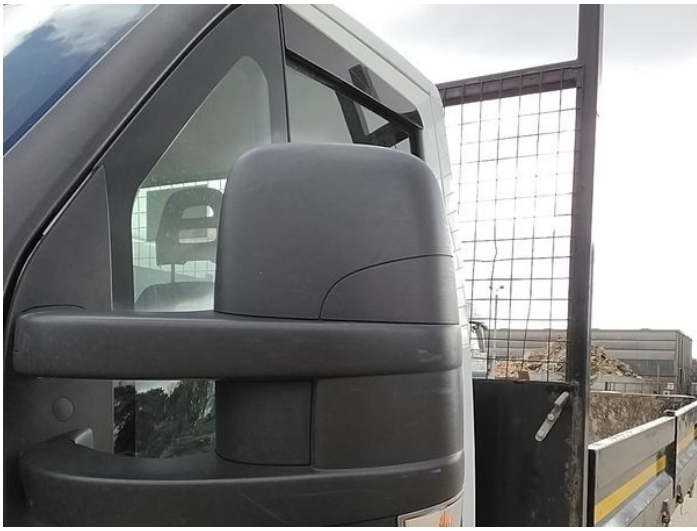
3: Door Mirror Assy nsf  
Scuffed (Unpainted)  
Over 100mm

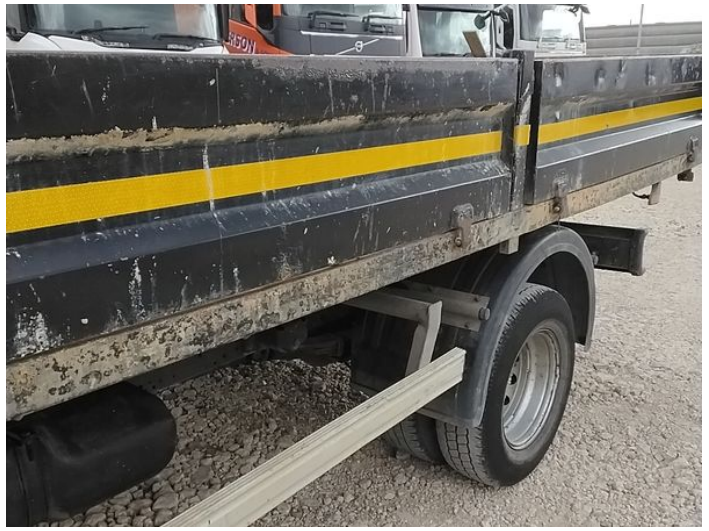
4: Qtr Panel nsr  
Scratched  
Over 25mm Thru Paint

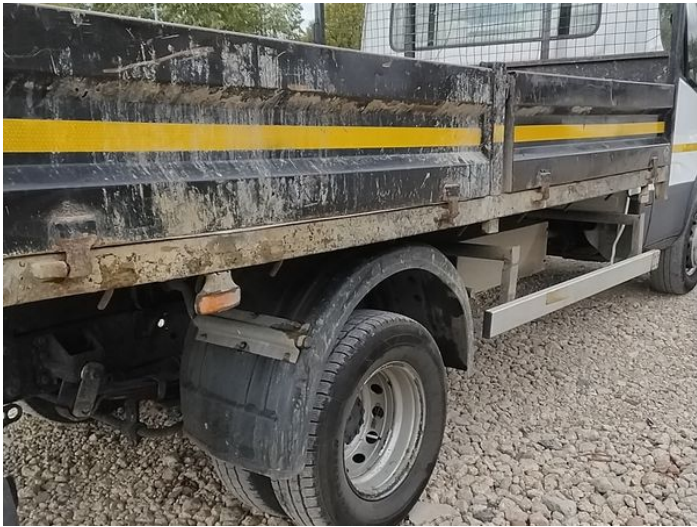
5: Qtr Panel osr  
Scratched  
Over 25mm Thru Paint

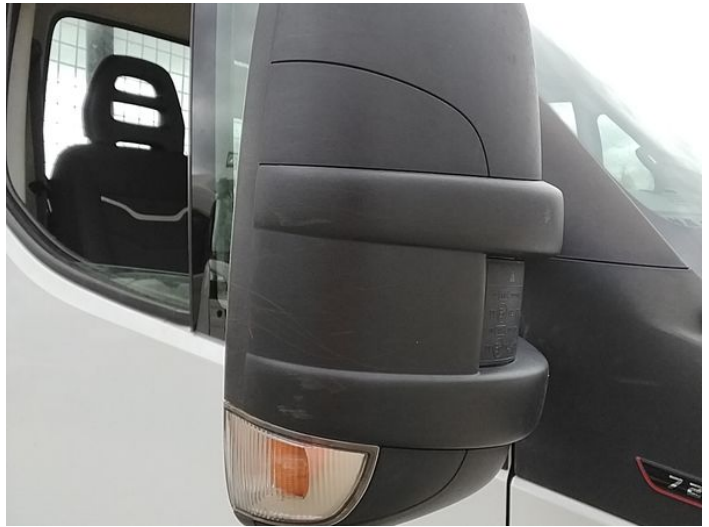
6: Door Mirror Assy osf  
Scuffed (Unpainted)  
UpTo 100mm

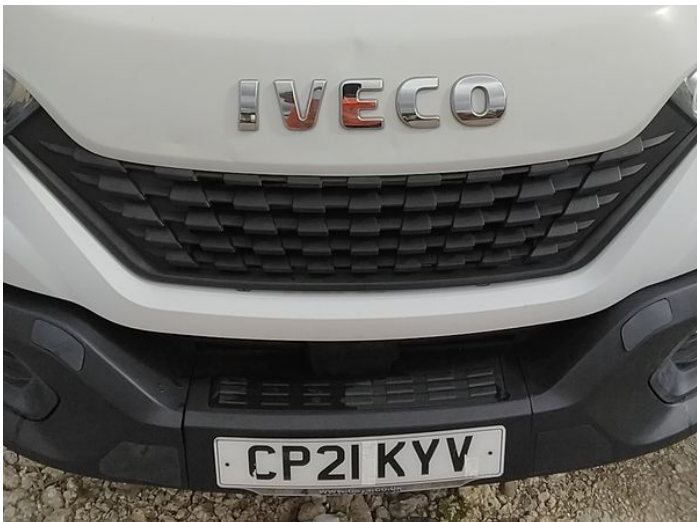
7: Bonnet  
Dented  
Over 30mm
