# VEHICLE INSPECTION REPORT

**HN63CVP**

## Iveco Eurocargo 120EL18

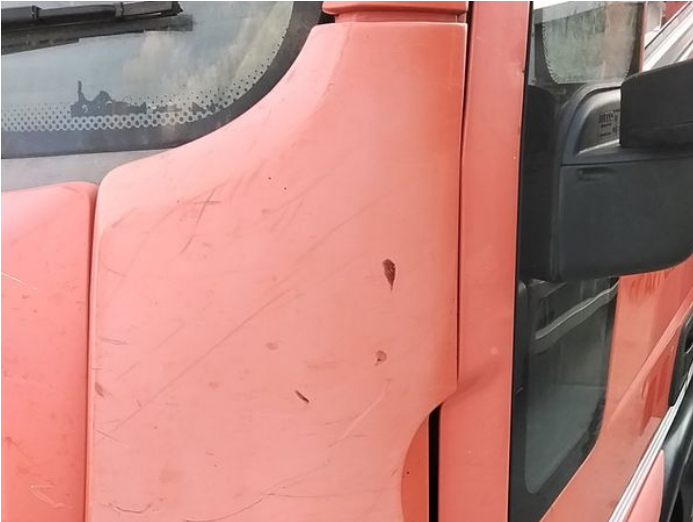
1: Panel Front  
Scratched  
Over 25mm Thru Paint

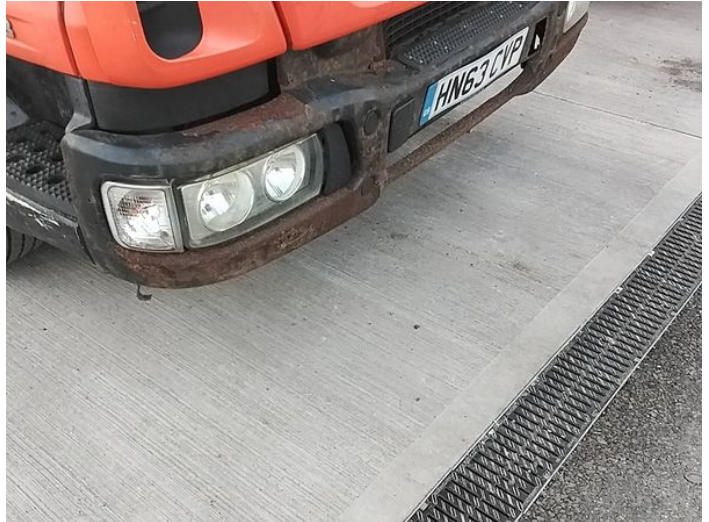
2: Bumper Front  
Rusted  
Over 5mm

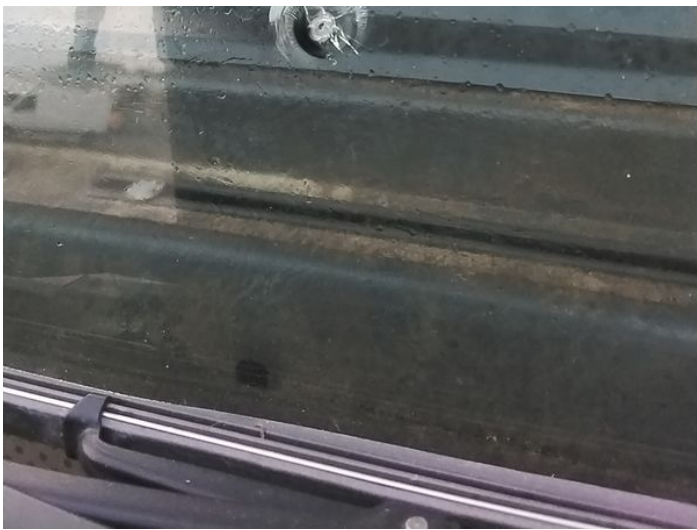
3: Screen Front  
Chipped  
UpTo 10mm

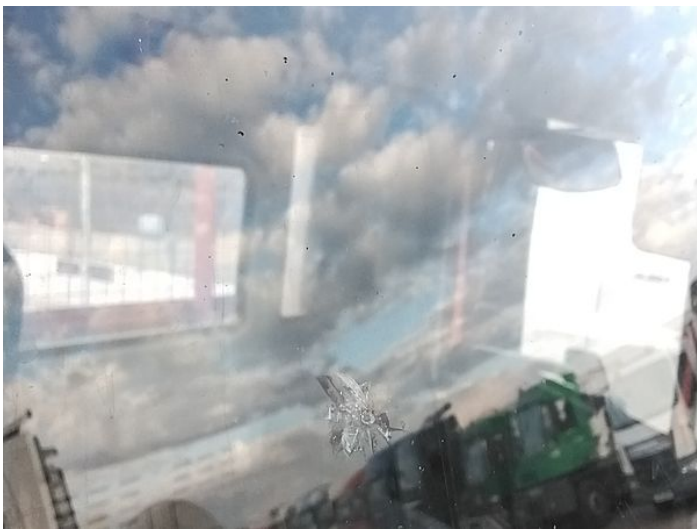
4: Screen Front  
Chipped  
UpTo 10mm

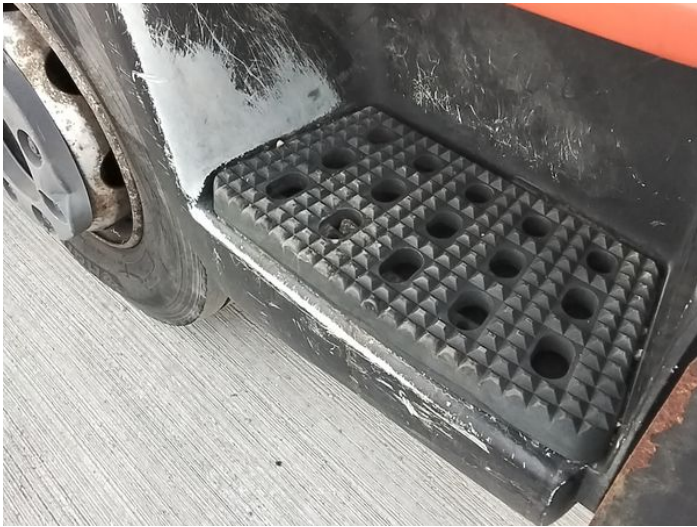
5: Moulding of Wing  
Scratched (Painted)  
Over 25mm Thru Paint

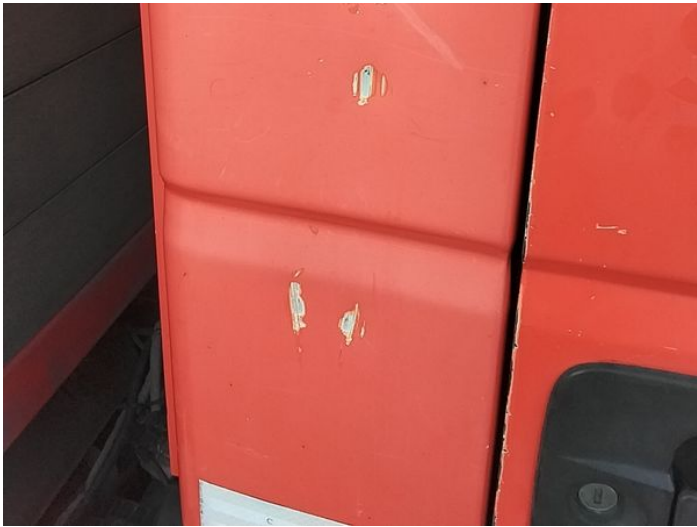
6: Panel Front  
Dented  
With Paint Damage

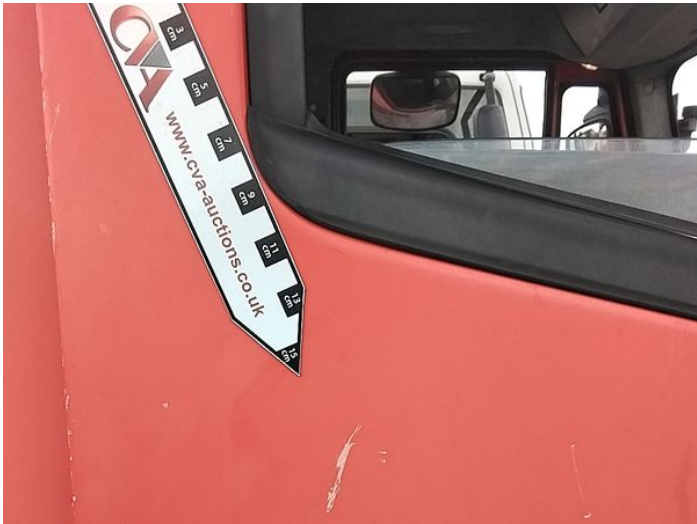
7: Door of  
Scratched  
Over 25mm Thru Paint

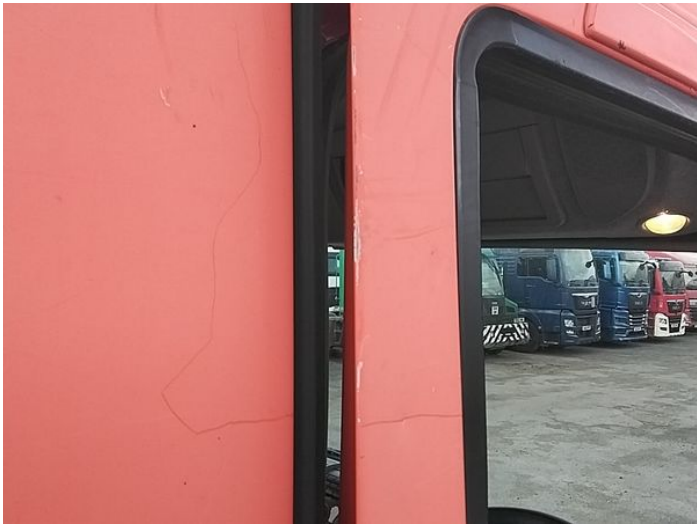
8: Door of  
Chipped  
Edge Chip

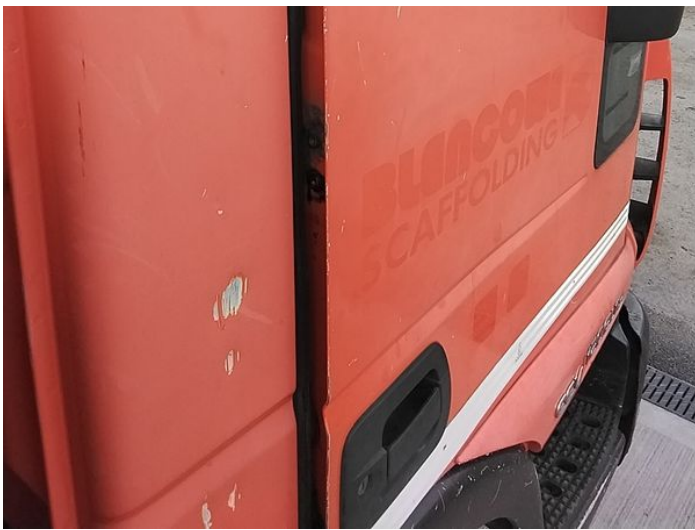
9: Door osf  
Chipped  
Edge Chip

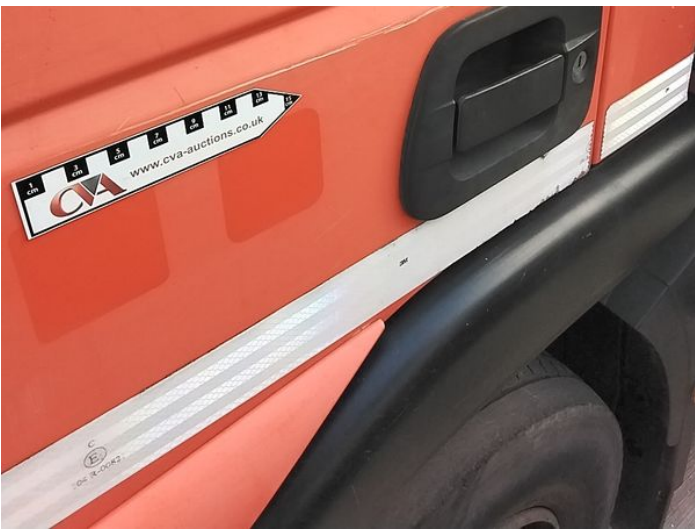
10: Door nsf  
Scratched  
Over 25mm Thru Paint

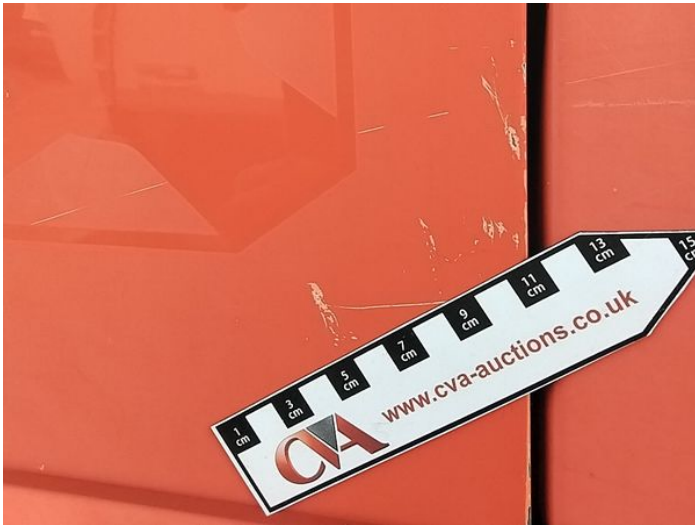
11: Door nsf  
Scratched  
Over 25mm Thru Paint

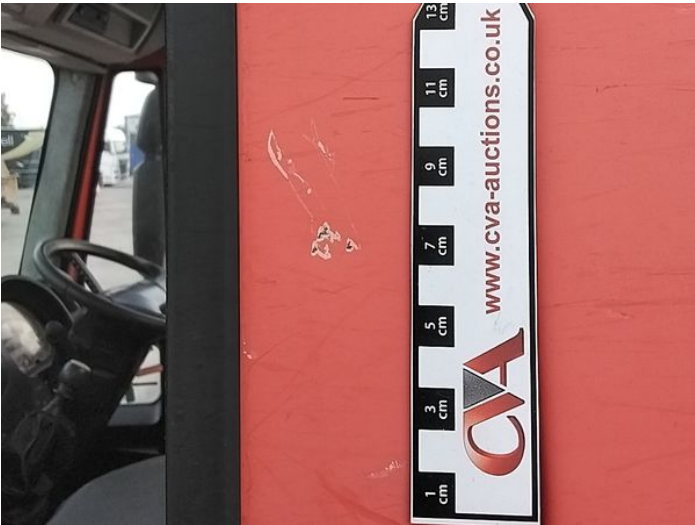
12: Door nsf  
Scratched  
Over 25mm Thru Paint

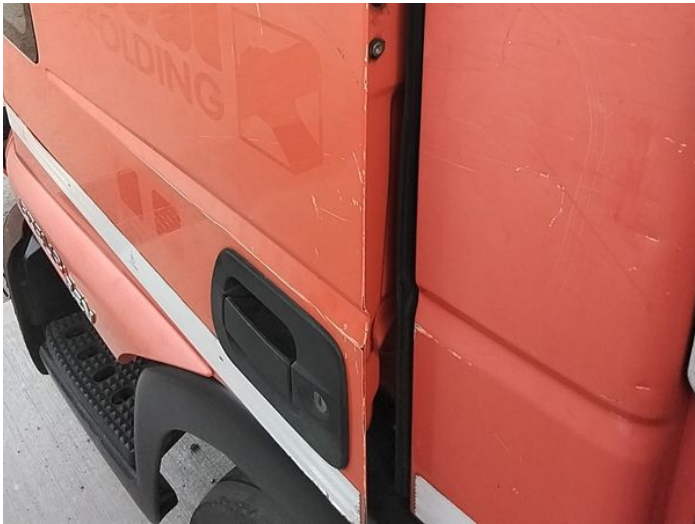
13: Door nsf  
Chipped  
Edge Chip

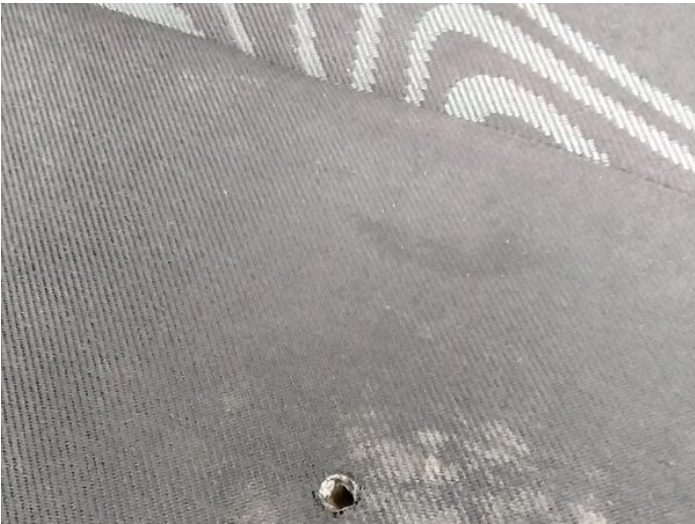
14: Seat Base Cover osf  
Holed  
UpTo 3mm
