# VEHICLE INSPECTION REPORT

**DK17LJE**

## Man TGS 26.360

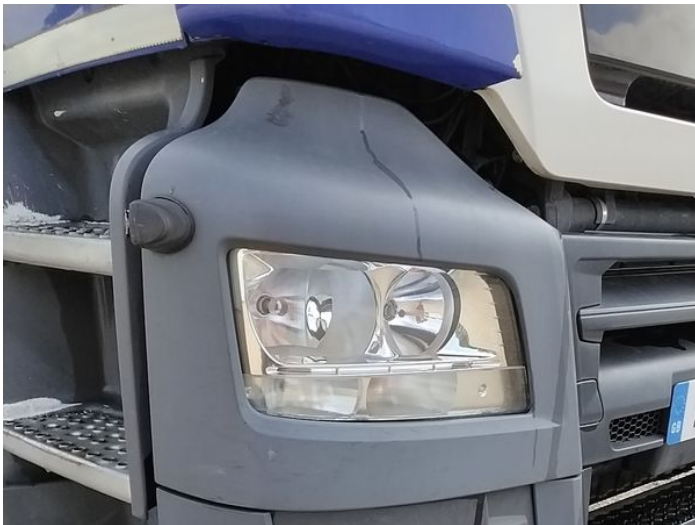
1: Bumper Front Moulding  
Scuffed (Unpainted)  
Over 100mm

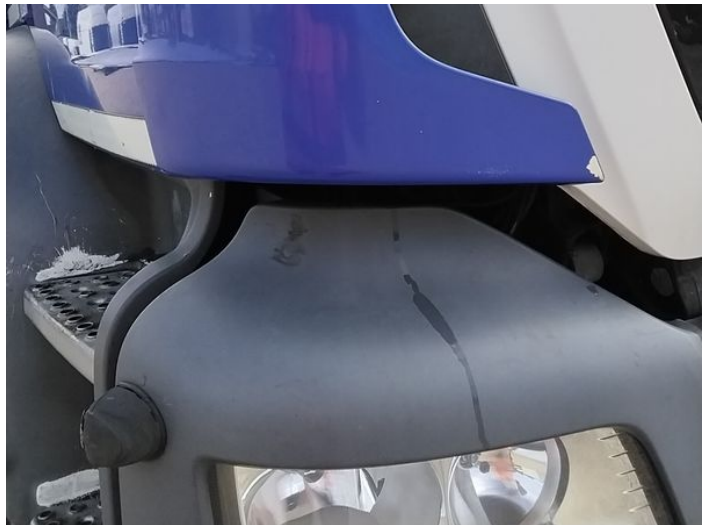
2: Wing of  
Scratched  
Up To 25mm Thru Paint

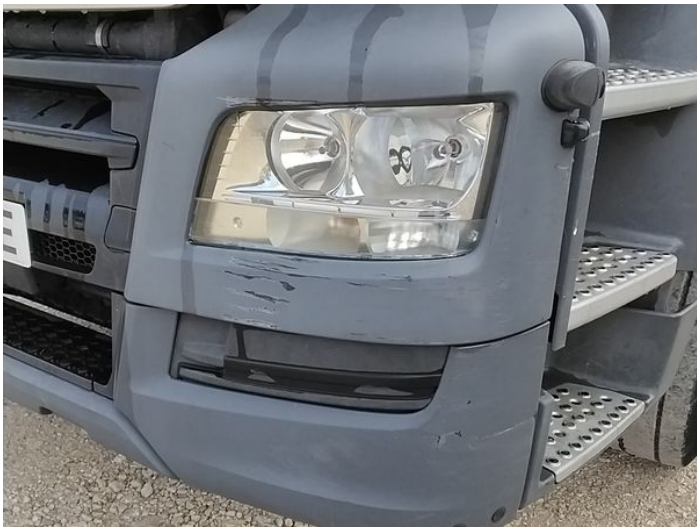
3: Bumper Front Moulding  
Scuffed (Unpainted)  
Over 100mm

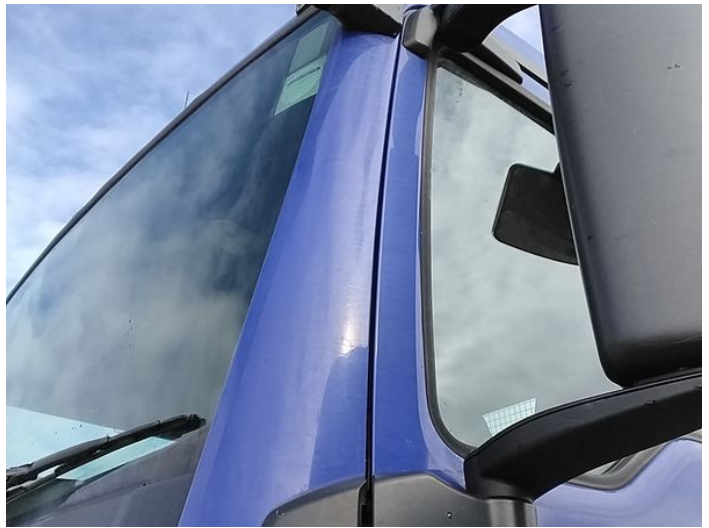
4: A Post ns  
Scratched  
Up To 25mm Not Thru Paint

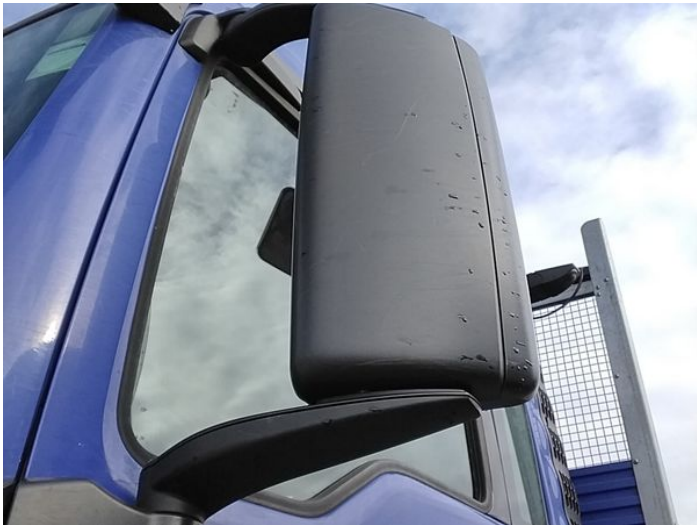
5: Door Mirror Assy nsf  
Scuffed (Unpainted)  
Over 100mm

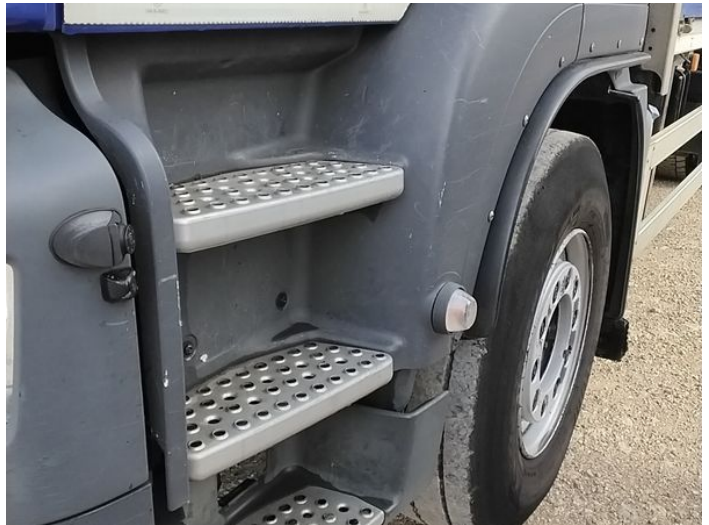
6: Wing Front Arch Extension ns  
Scuffed (Unpainted)  
Over 100mm

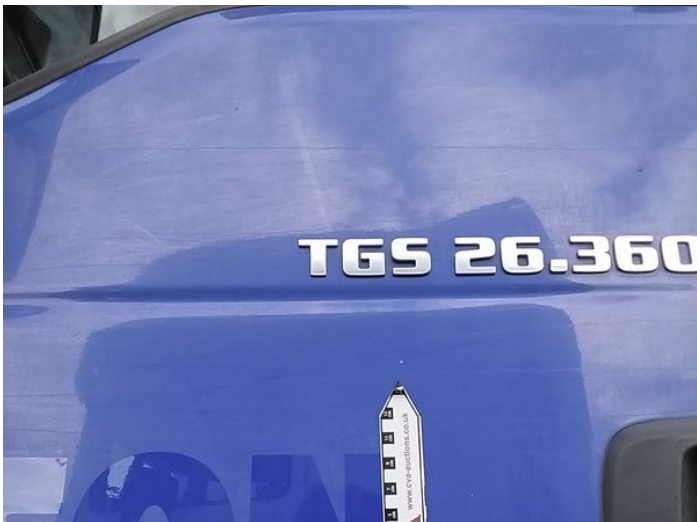
7: Door nsf  
Dented  
With Paint Damage

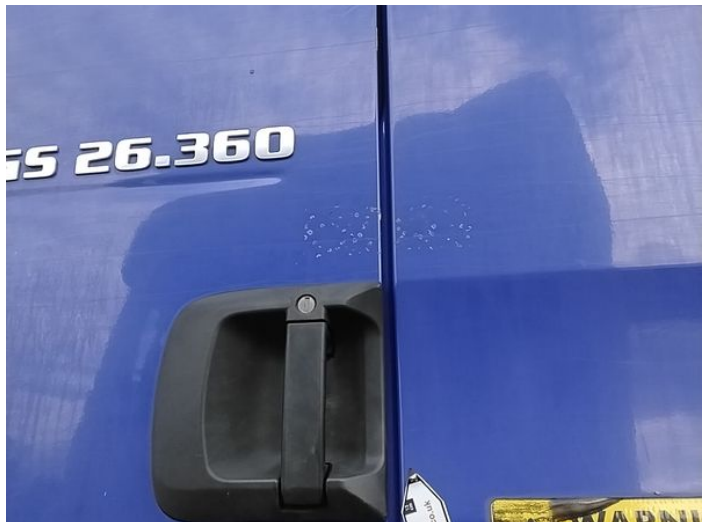
8: Door nsf  
Chipped  
Edge Chip

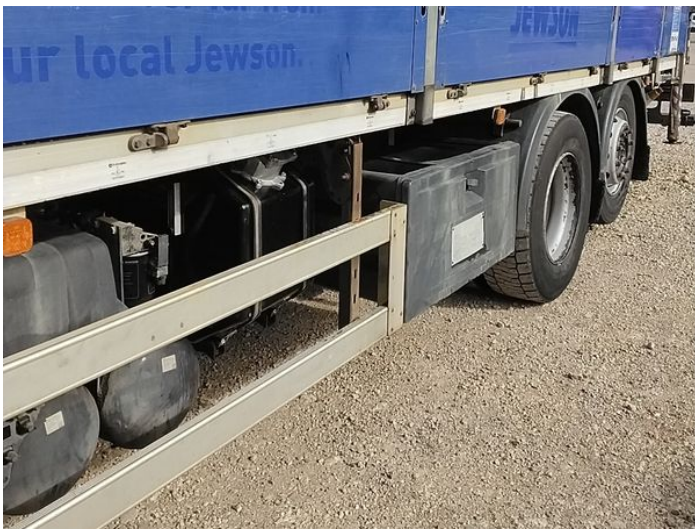
9: Qtr Panel nsr  
Scratched  
Over 25mm Thru Paint

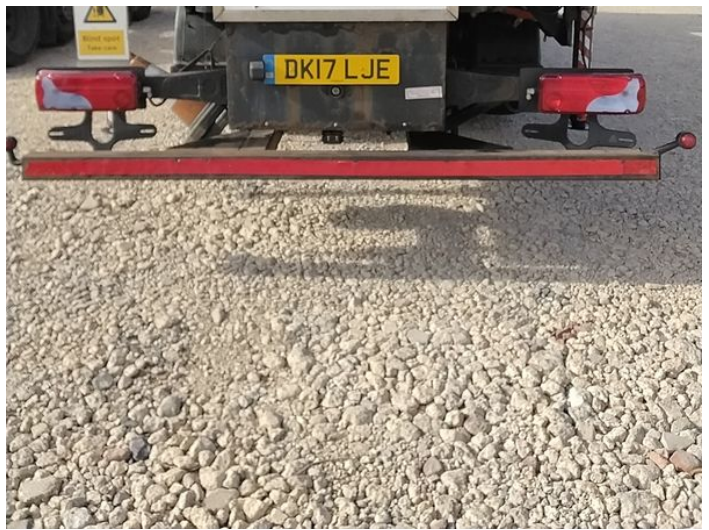
10: Bumper Rear  
Rusted  
Over 5mm

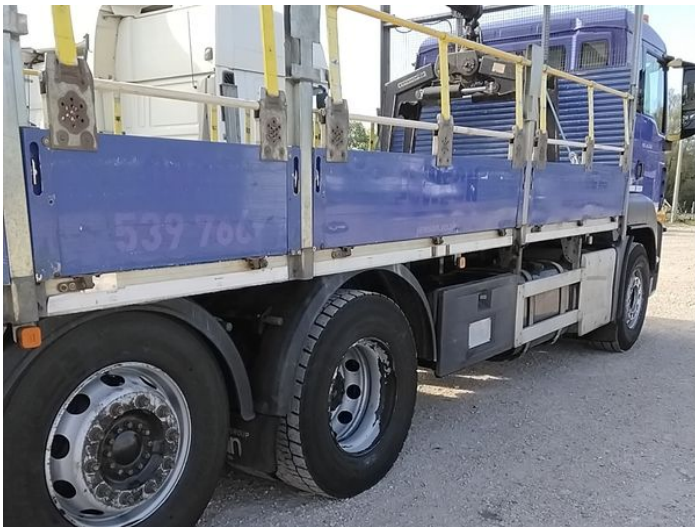
11: Qtr Panel osr  
Scratched  
Over 25mm Thru Paint

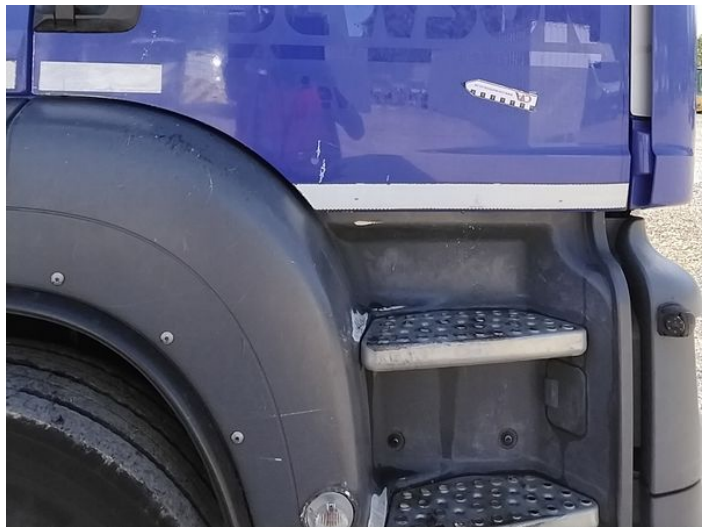
12: Door osf  
Scratched  
Over 25mm Thru Paint

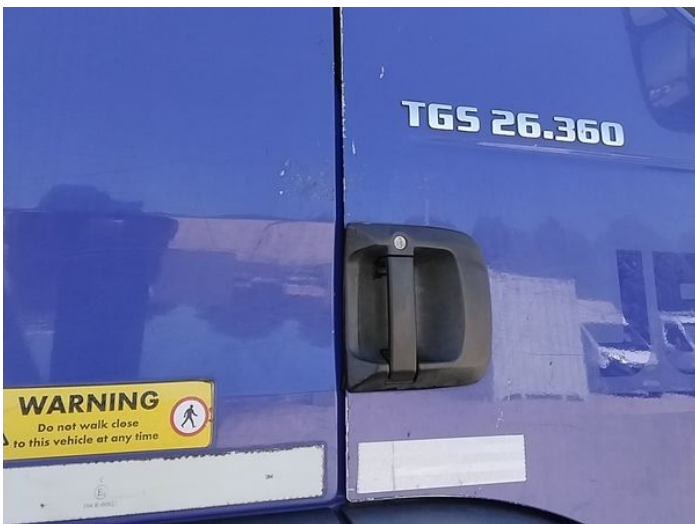
13: Door osf  
Chipped  
Edge Chip

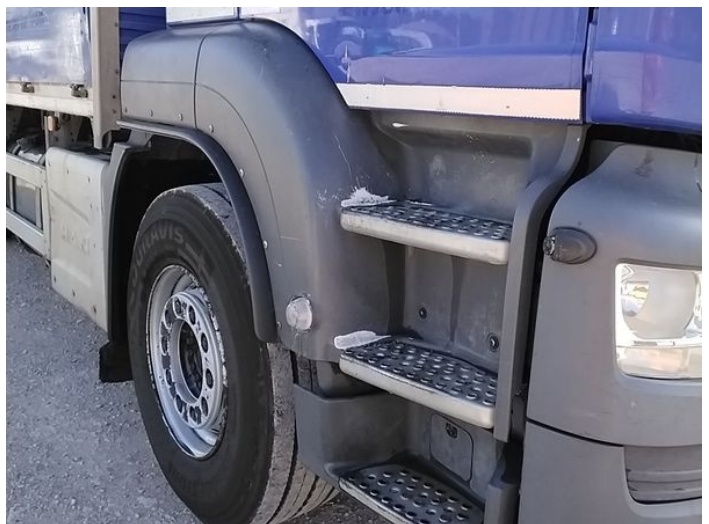
14: Wing Front Arch Extension os  
Scuffed (Unpainted)  
Over 100mm

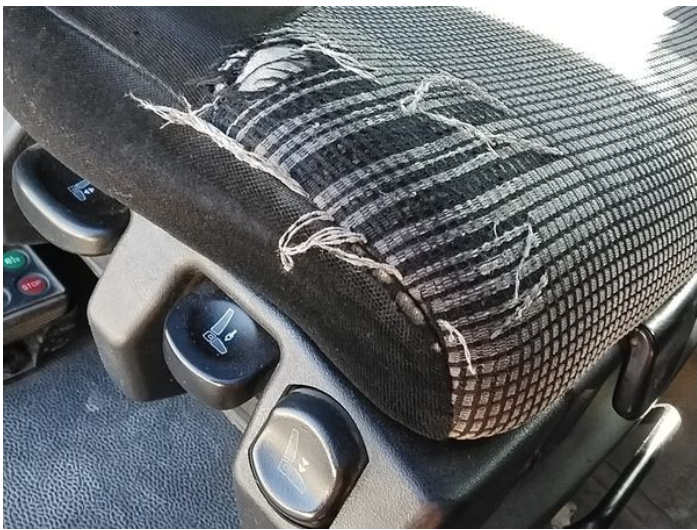
15: Seat Base Cover osf  
Holed  
Over 3mm

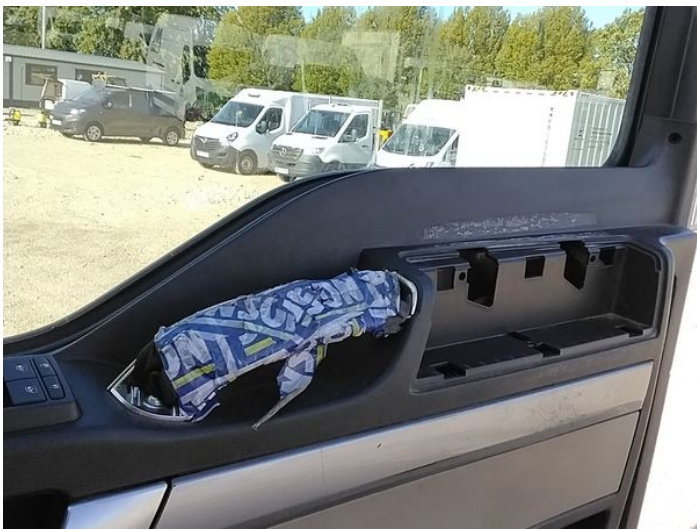
16: Handle Inner osf  
Damaged  
Replace

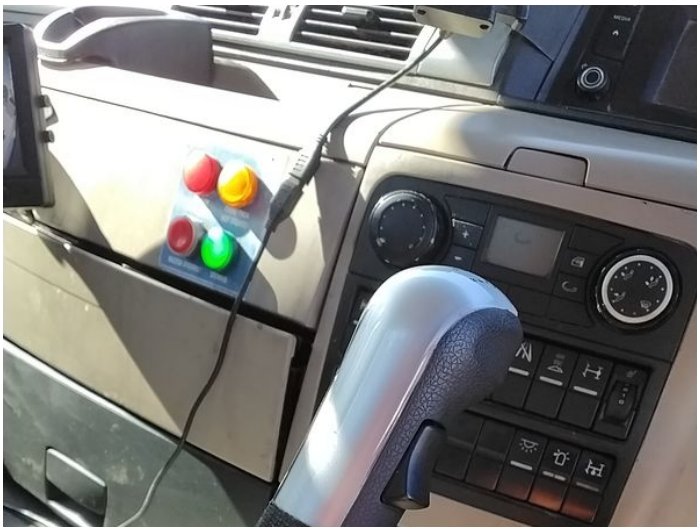
17: Switches And Controls  
Broken  
Replace
