# VEHICLE INSPECTION REPORT

**WR20DVJ**

## Fiat Ducato 35 2.3 Multijet 140

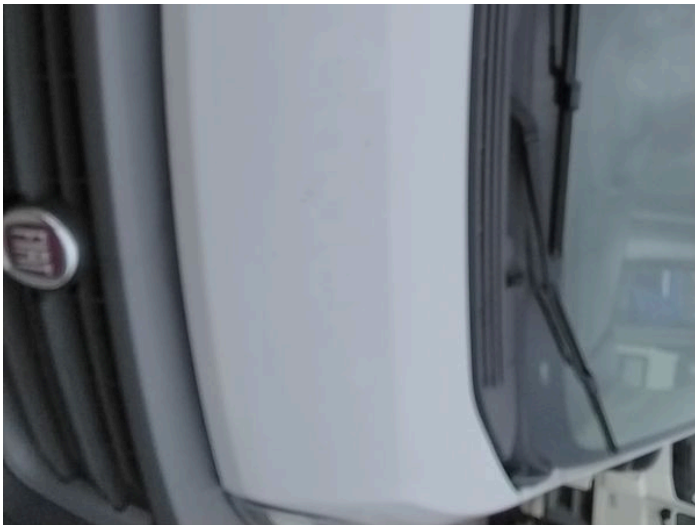
1: Bonnet  
Chipped  
Multiple Chips

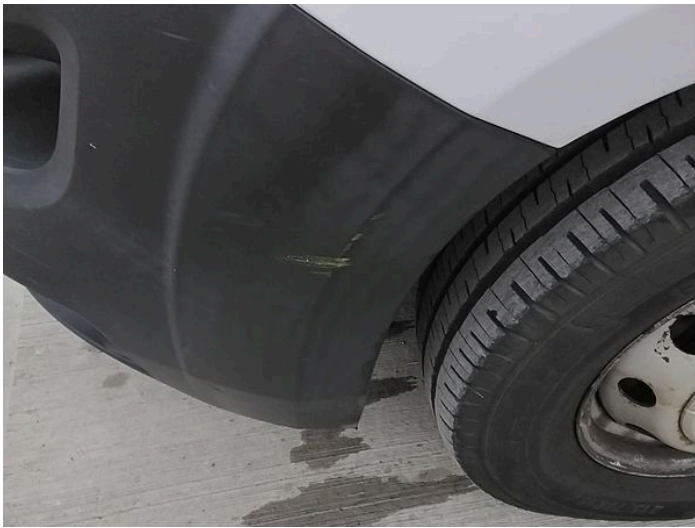
3: Bumper Front Moulding  
Scuffed (Unpainted)  
Over 100mm

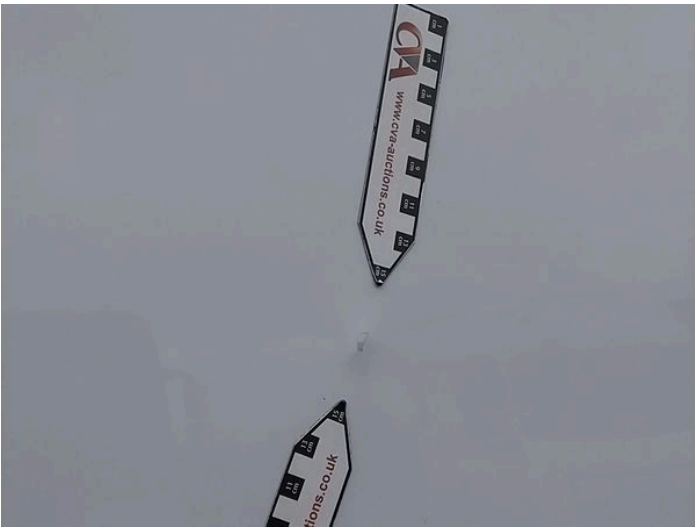
4: Qtr Panel nsr  
Dented  
With Paint Damage

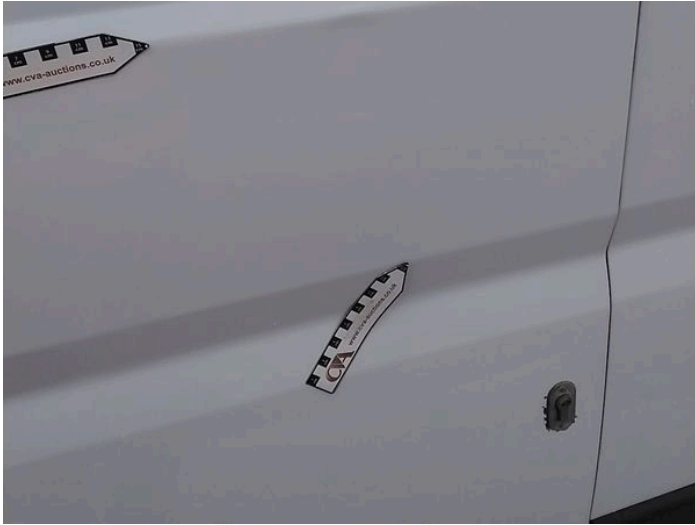
5: Qtr Panel nsr  
Dented  
Over 30mm

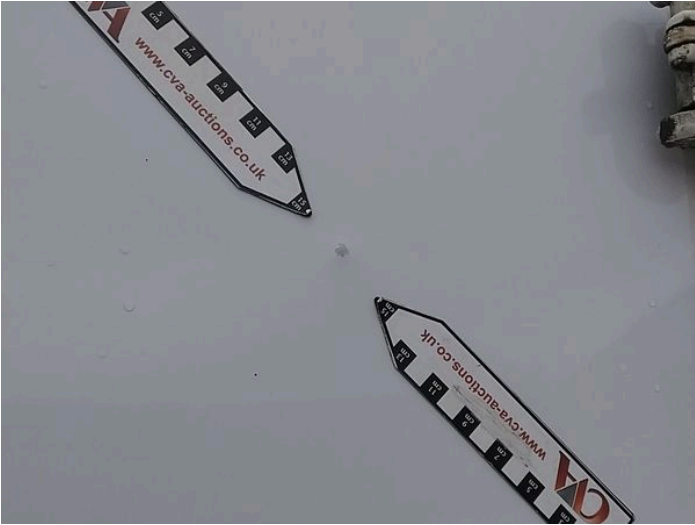
6: Door osr  
Dented  
With Paint Damage

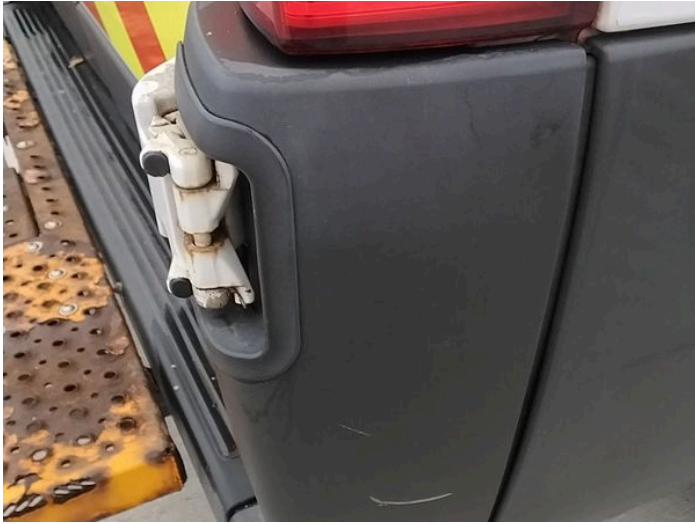
7: Bumper Rear Moulding  
Scuffed (Unpainted)  
UpTo 100mm

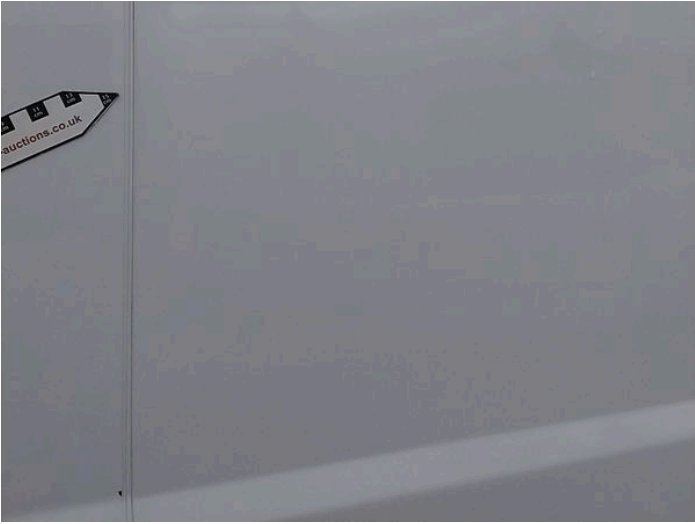
8: Qtr Panel osr  
Dented  
Over 30mm

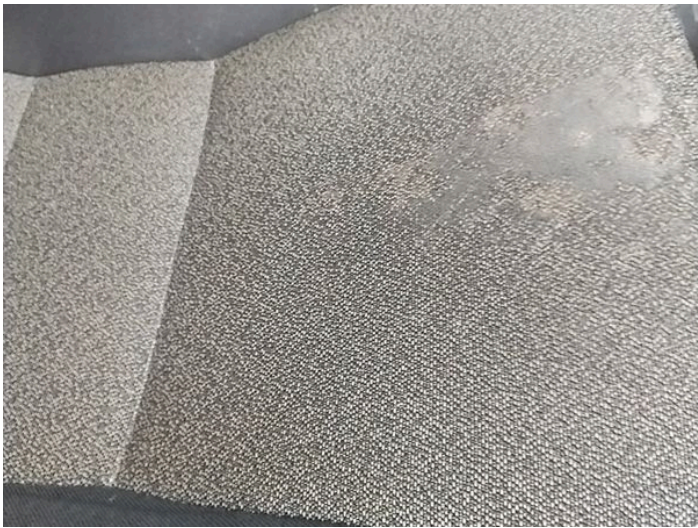
9: Seat Base Cover osf  
Soiled  
Heavy

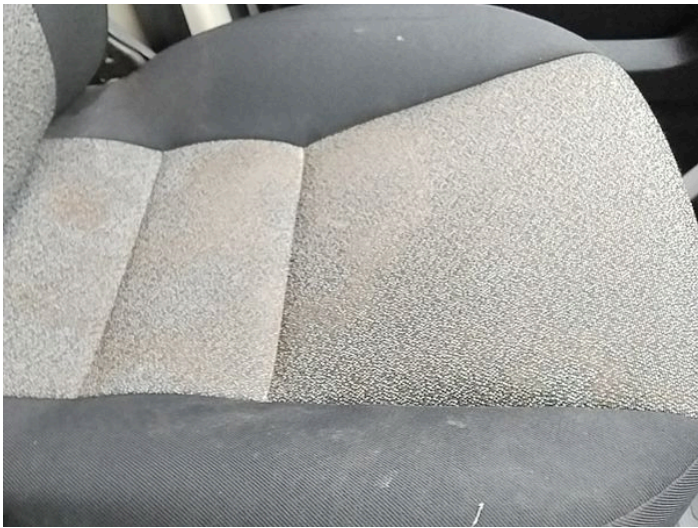
10: Seat Base Cover nsf  
Soiled  
Heavy
