# VEHICLE INSPECTION REPORT

**KY16SXZ**

## Isuzu D-Max A314 2.5TD

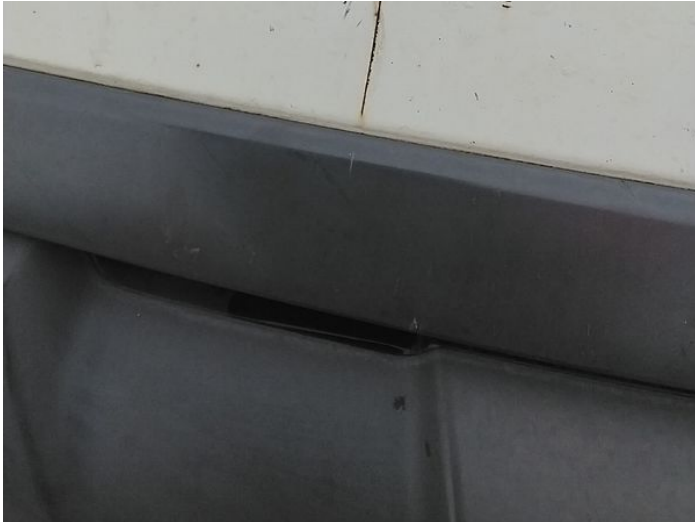
1: Bonnet  
Scratched  
Rusted

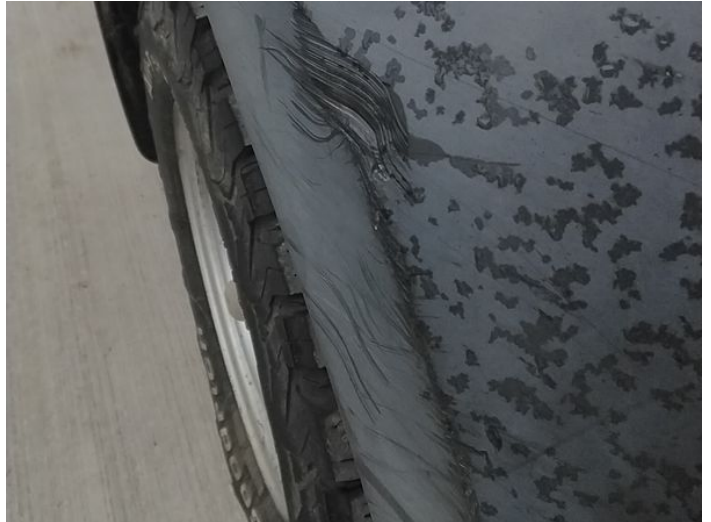
2: Bumper Front Moulding  
Scuffed (Unpainted)  
Over 100mm

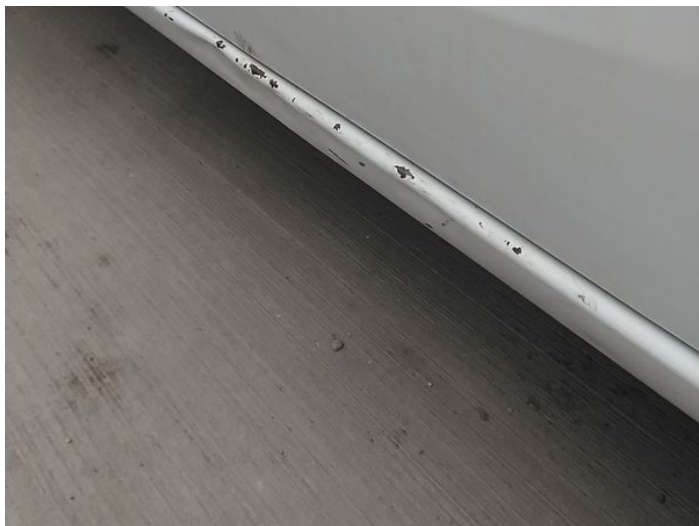
3: Sill os  
Chipped  
Multiple Chips

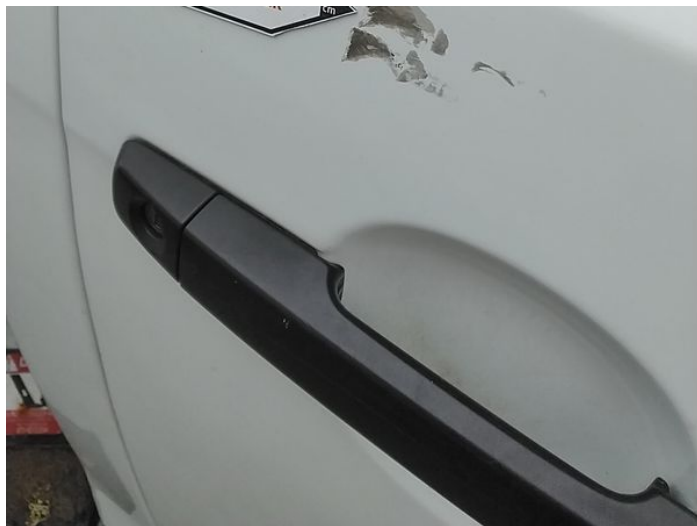
4: Door osf  
Scratched  
Over 25mm Thru Paint

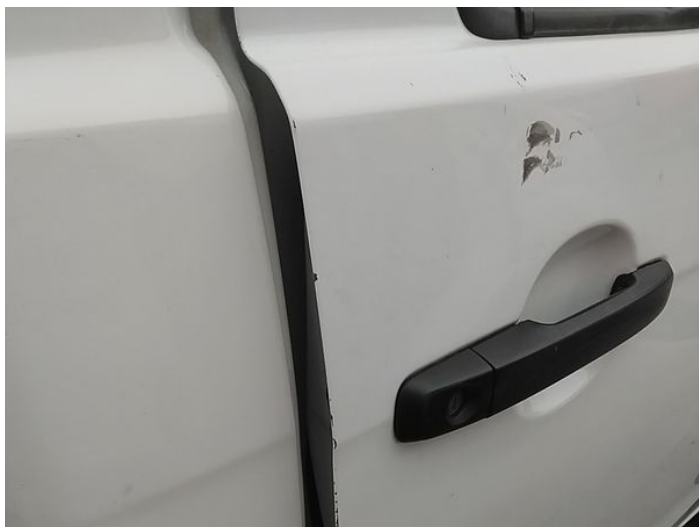
5: Door osf  
Chipped  
Edge Chip

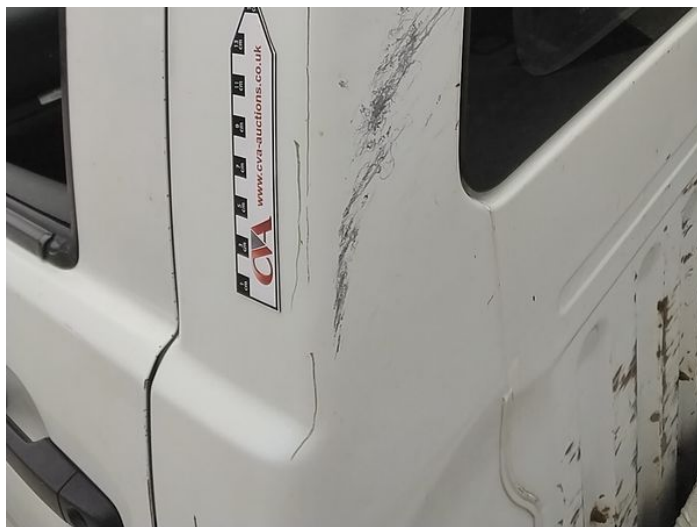
6: C Post ns  
Scratched  
Over 25mm Thru Paint

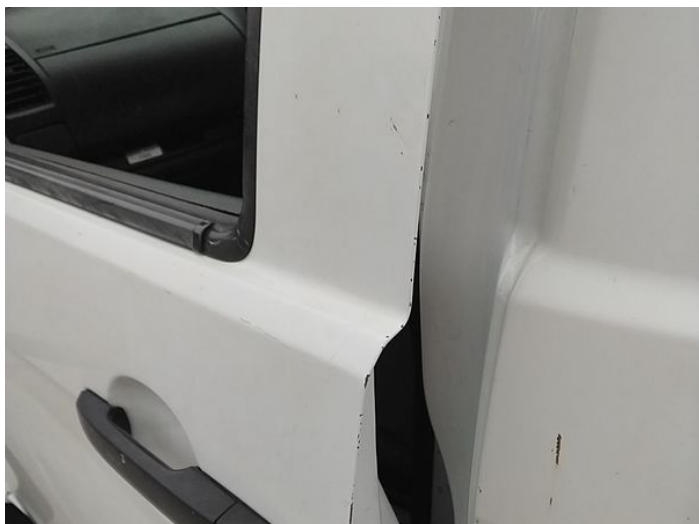
7: Door nsf  
Chipped  
Edge Chip

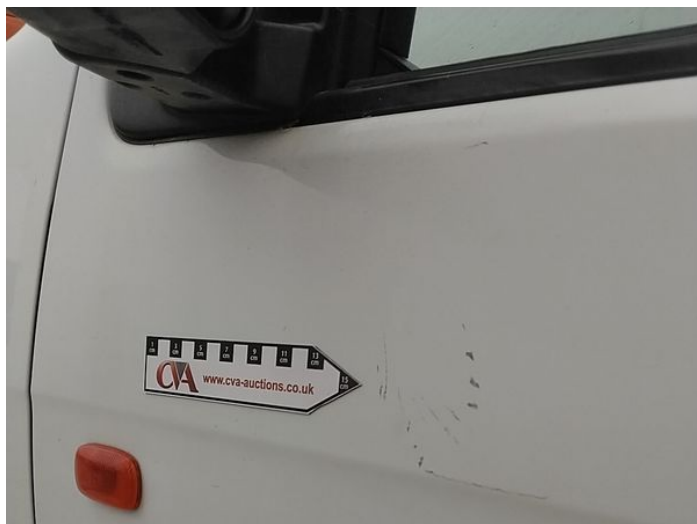
8: Door nsf  
Scratched  
Over 25mm Thru Paint

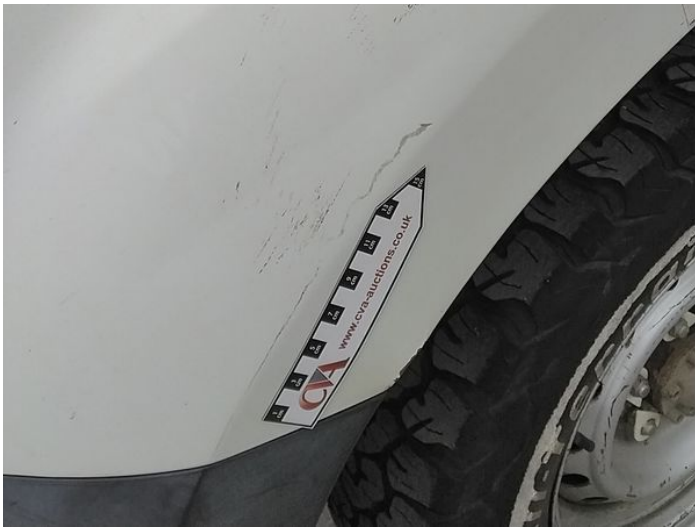
9: Wing nsf  
 Scratched  
 Over 25mm Not Thru Paint

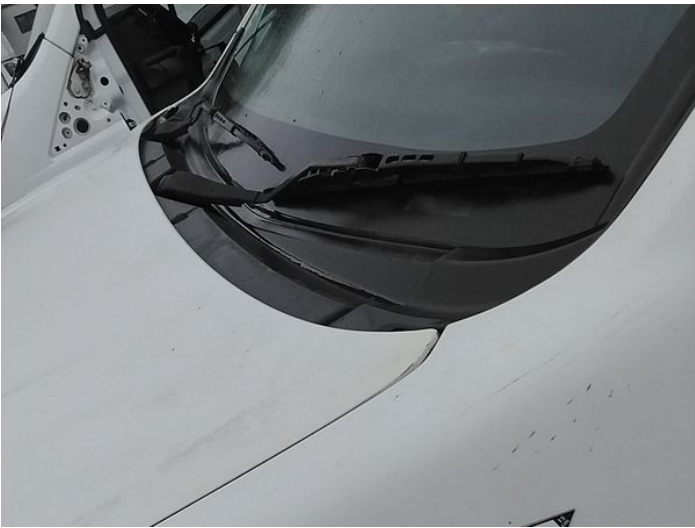
10: Wing nsf  
 Scratched  
 Over 25mm Not Thru Paint

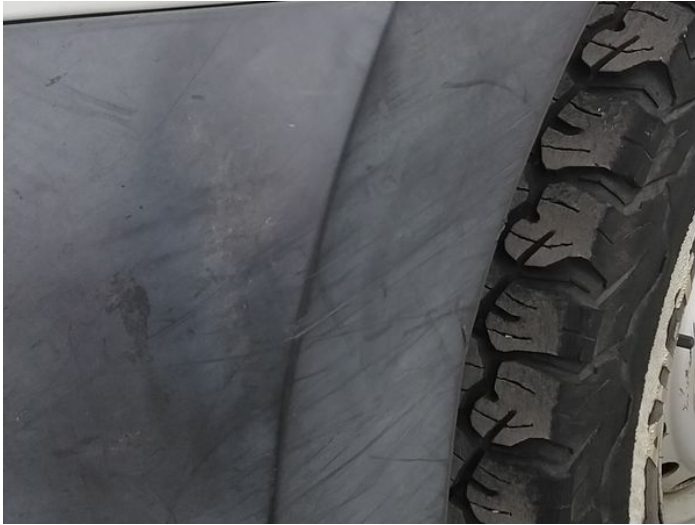
11: Bumper Front Moulding  
 Scuffed (Unpainted)  
 Over 100mm

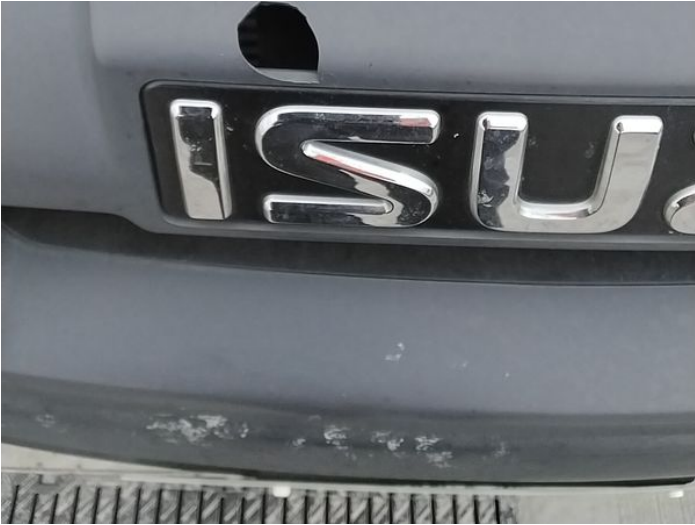
12: Bumper Front Grill  
 Broken  
 Replace

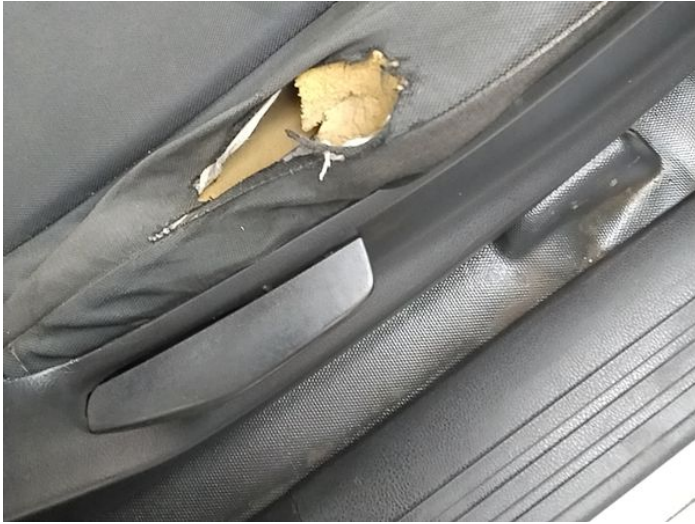
13: Seat Base Cover osf  
 Torn  
 Over 3mm
