# VEHICLE INSPECTION REPORT

**MK16HJN**

## VAUXHALL COMBO 2300 1.6 CDTI 16V 105ps H1

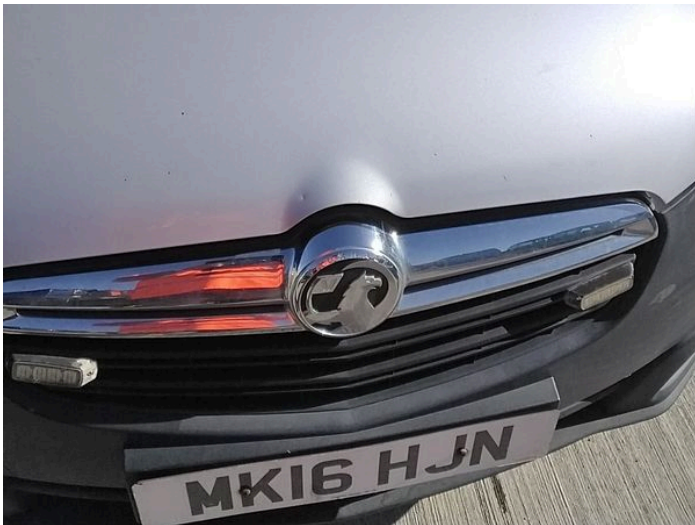
1: Bonnet  
Chipped  
Multiple Chips

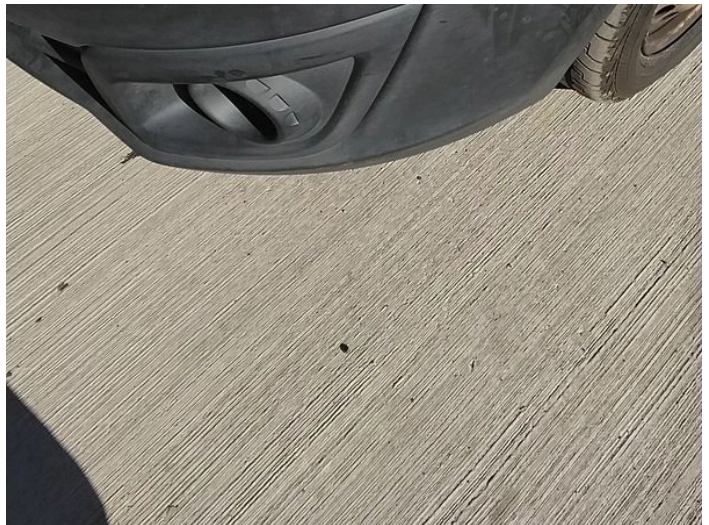
2: Bumper Front  
Scratched  
Over 100mm Thru Paint

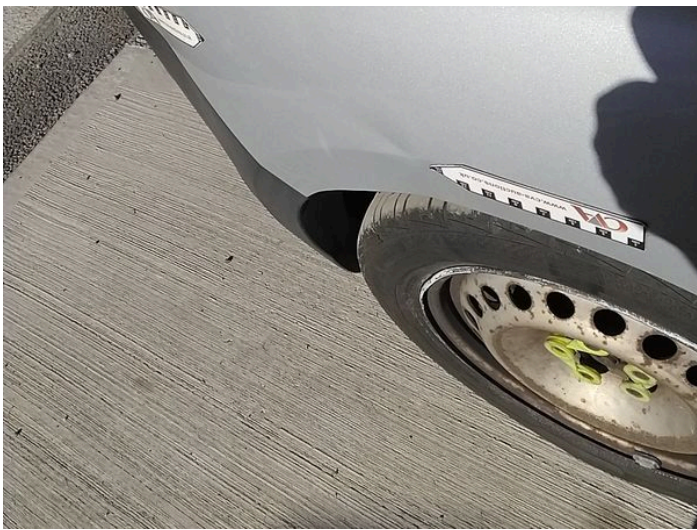
3: Wing nsf  
Dented  
Over 30mm

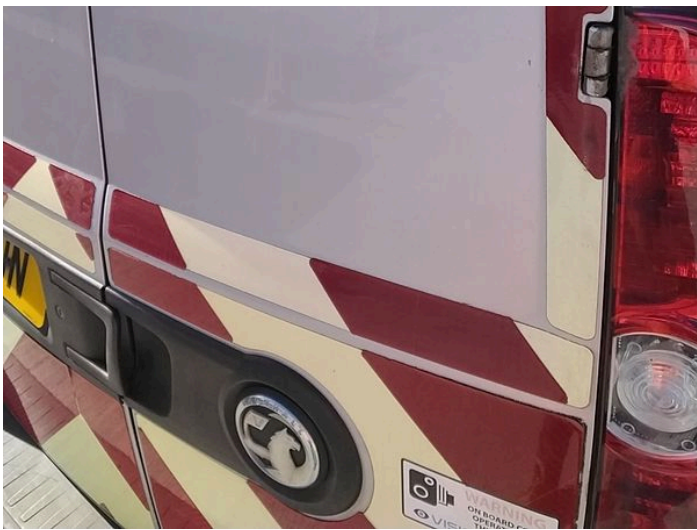
4: Door osr  
Chipped  
Multiple Chips

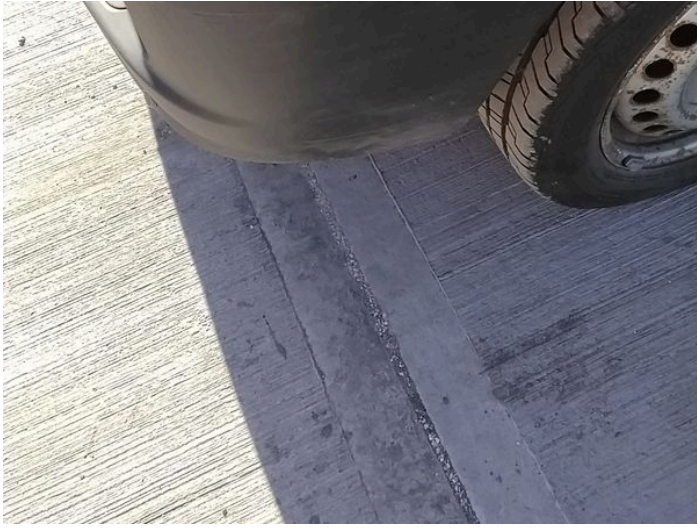
5: Bumper Rear  
Scratched  
Over 100mm Thru Paint

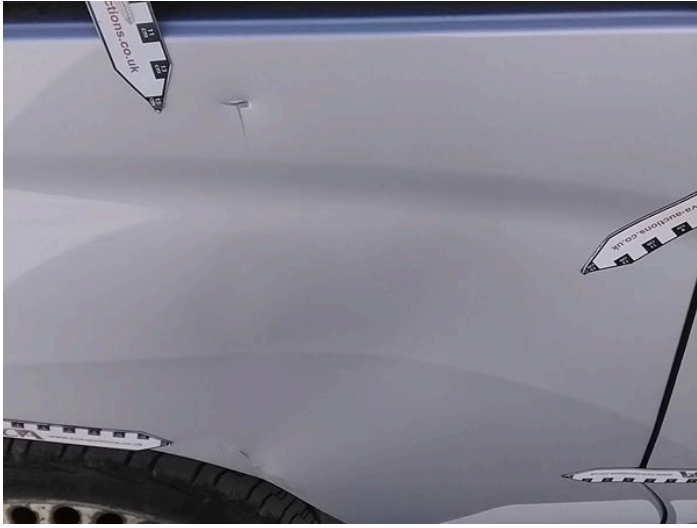
6: Qtr Panel osr  
Dented  
With Paint Damage

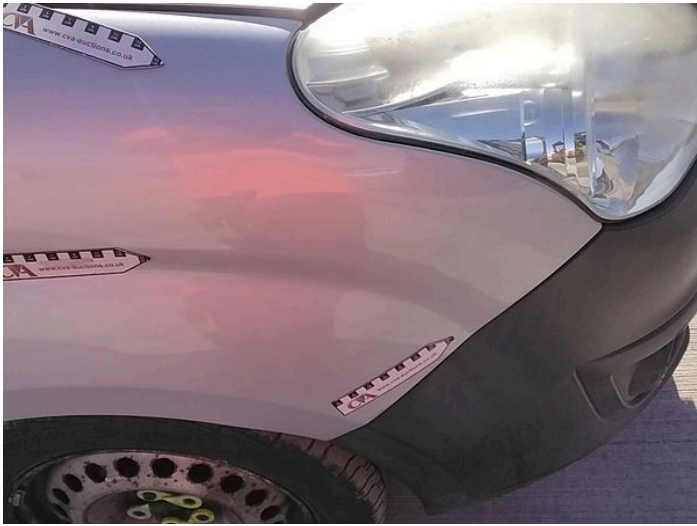
7: Wing osf  
Dented  
Over 30mm

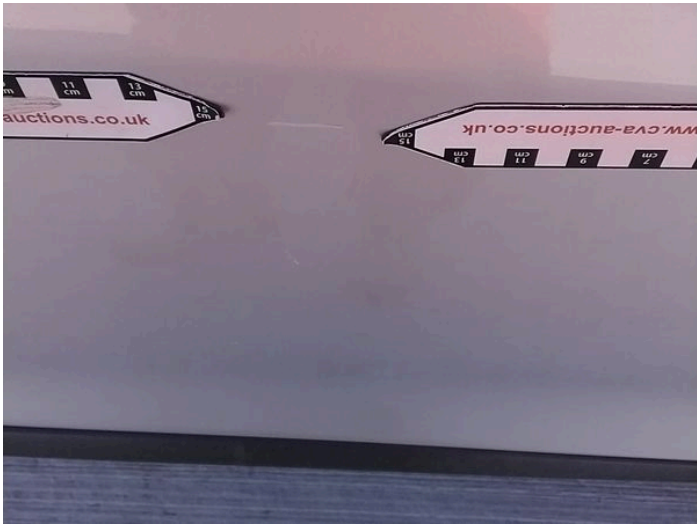
8: Door osf  
Scratched  
Over 25mm Thru Paint
