# VEHICLE INSPECTION REPORT

**LP68LCU**

## Mercedes-Benz Econic 2630

**Non Runner** **Serious Damage**

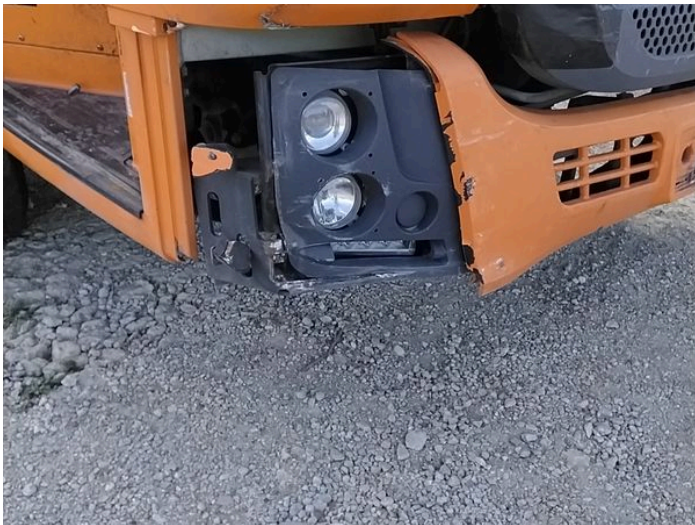
1: Bumper Front  
Missing  
Replace

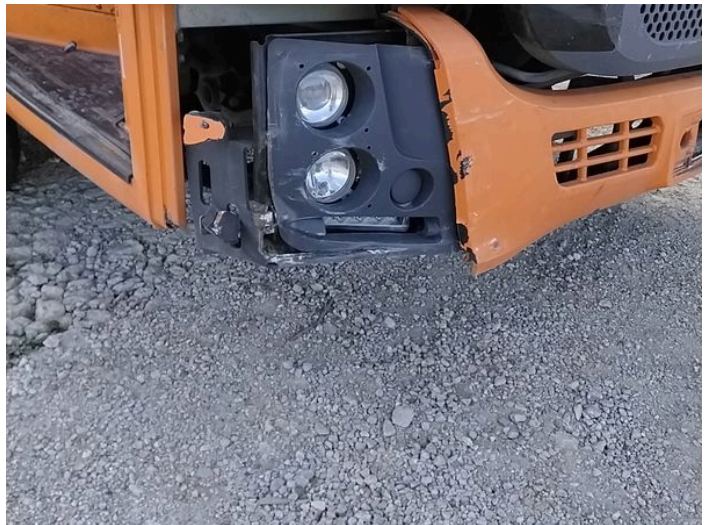
2: Fog Lamp Surround is  
Broken  
Replace

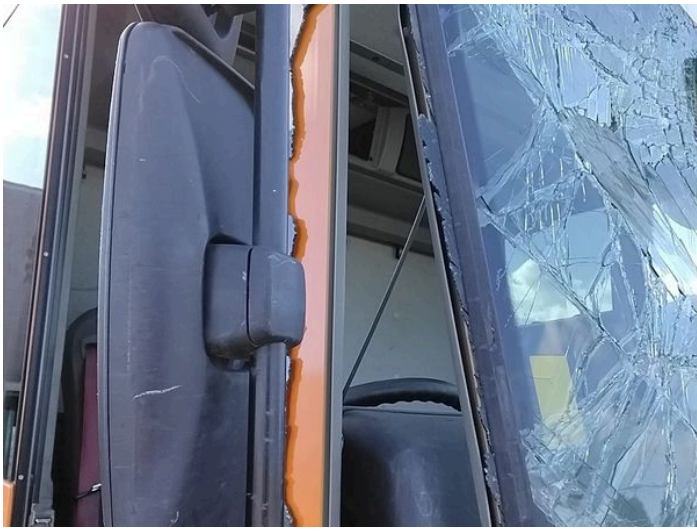
3: Door Qtr Light osf  
Missing  
Replace

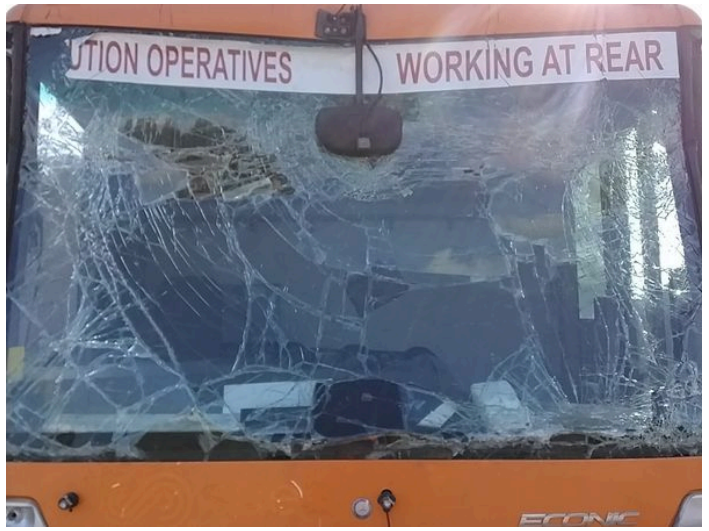
4: Screen Front  
Cracked  
Replace

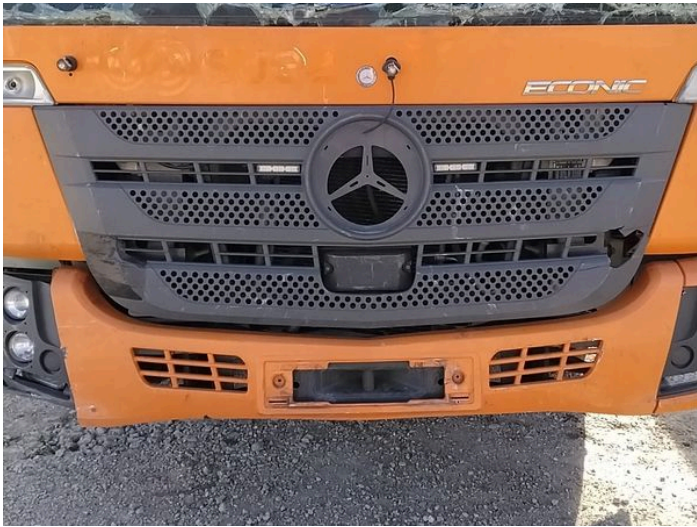
5: Grille Front  
Broken  
Replace

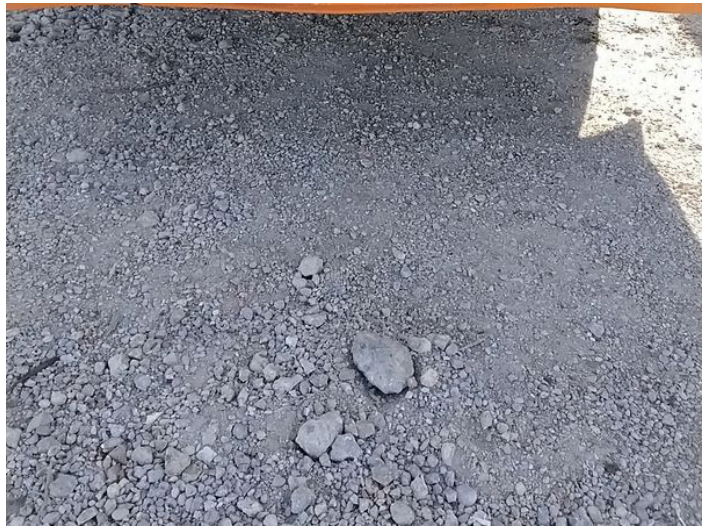
6: Number Plate Front  
Missing  
Replace

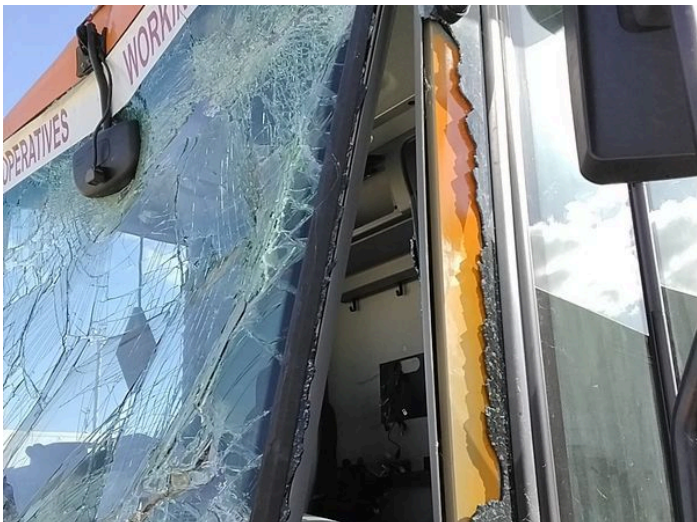
7: Door Qtr Light nsf  
Missing  
Replace

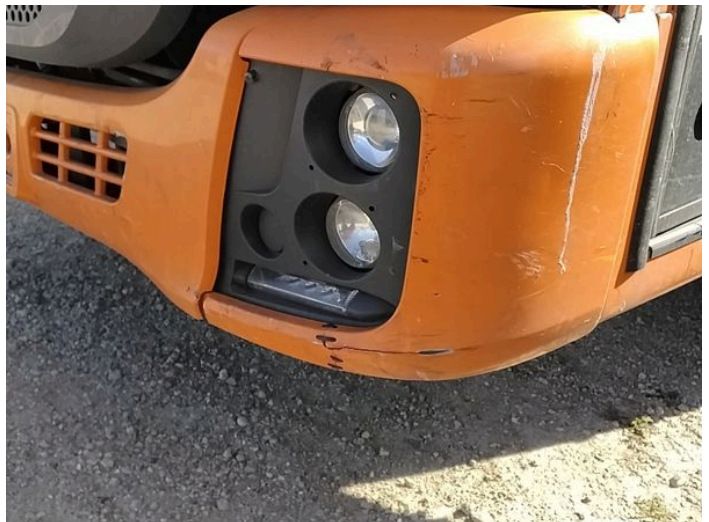
8: Bumper Front  
Cracked  
Over 25mm

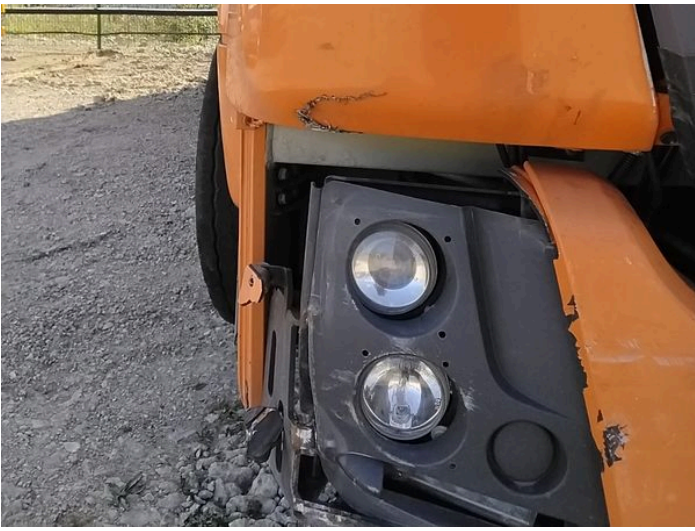
9: Wing nsf  
Cracked  
Replace

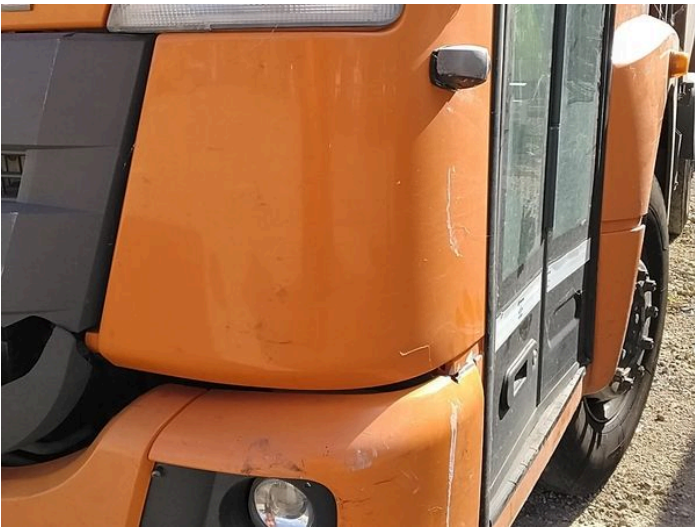
10: Wing nsf  
Scratched  
Over 25mm Not Thru Paint

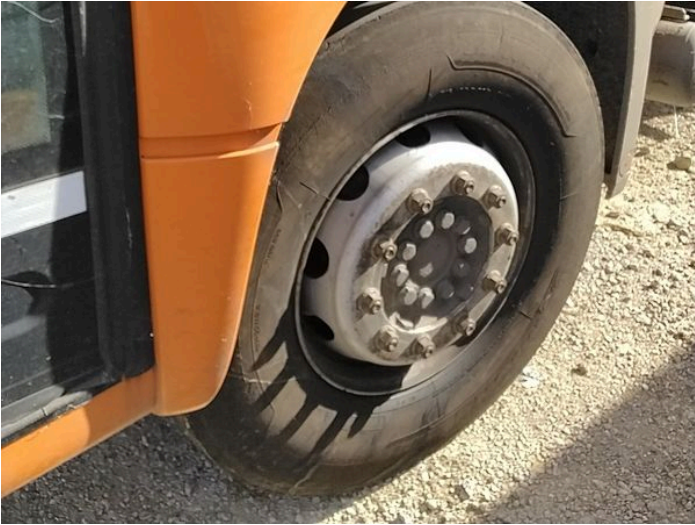
11: Wing Front Arch Extension ns  
Scratched (Painted)  
Over 25mm Not Thru Paint

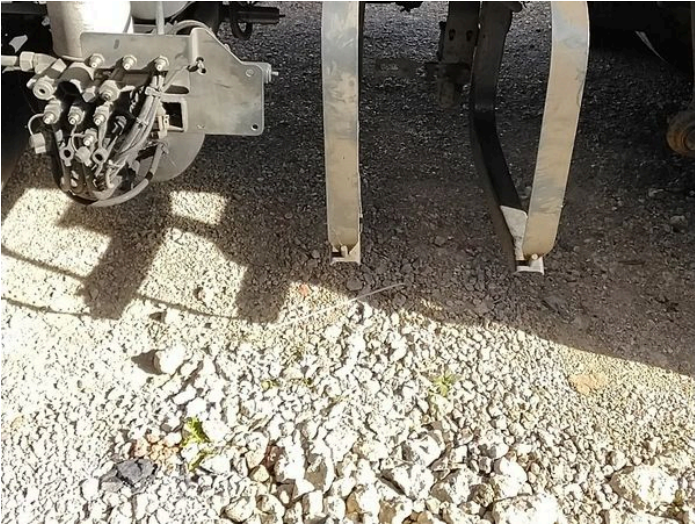
12: Fuel Flap  
Missing  
Replace

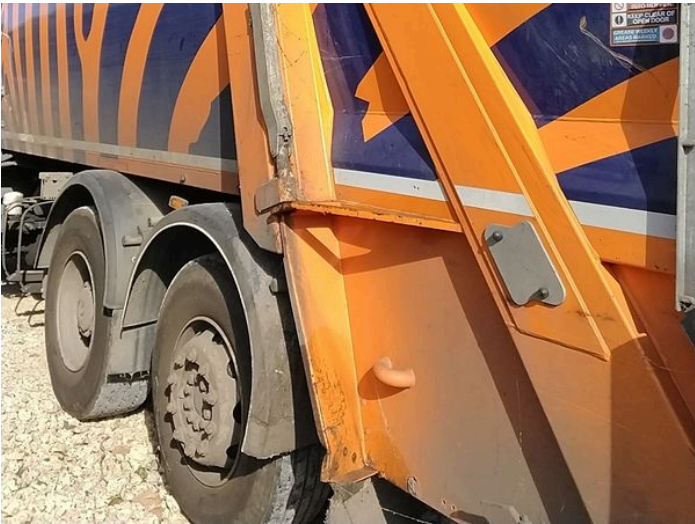
13: Qtr Panel nsr  
Scratched  
Over 25mm Thru Paint

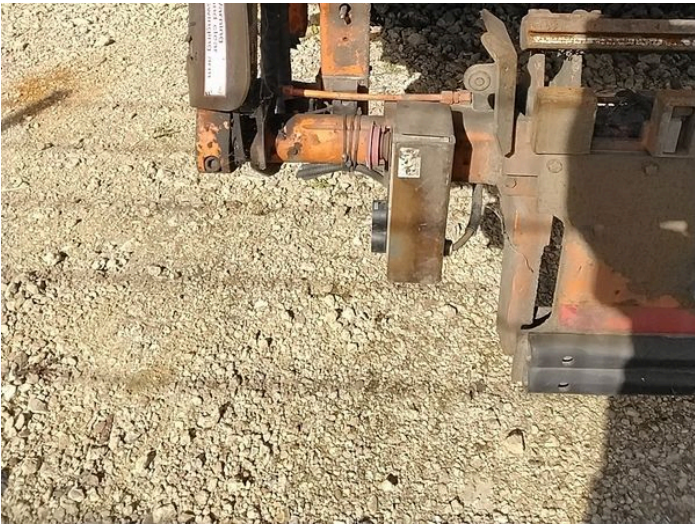
14: Lamp nsr  
Missing  
Replace

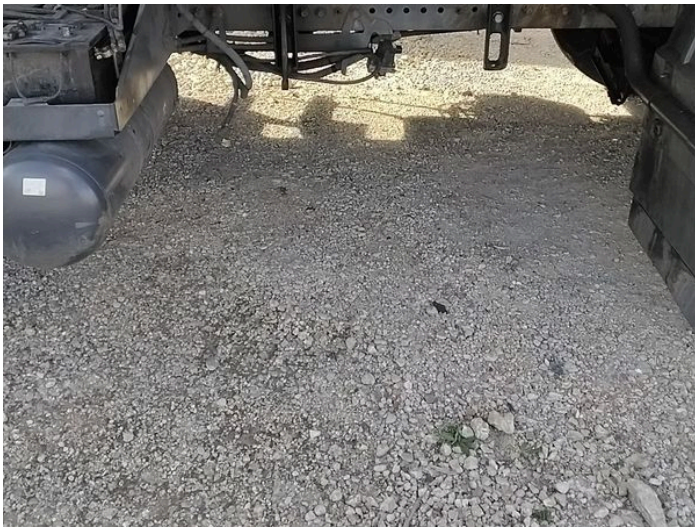
15: Fuel Flap  
Missing  
Replace

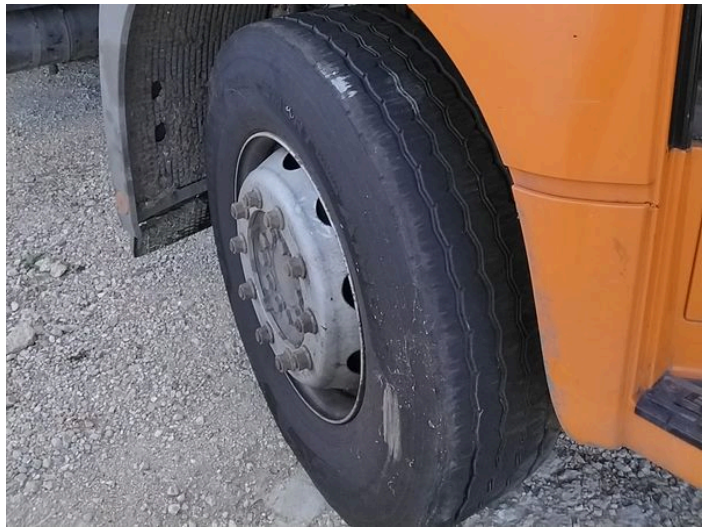
16: Wing Front Arch Extension os  
Scratched (Painted)  
Over 25mm Thru Paint

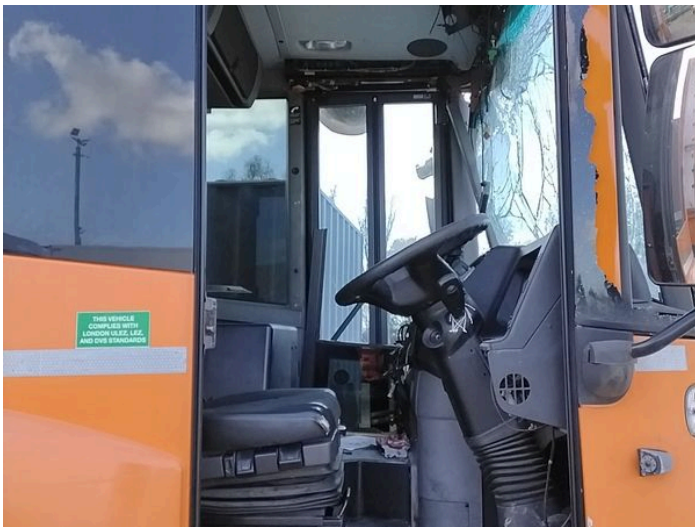
17: Door osf  
Missing  
Replace

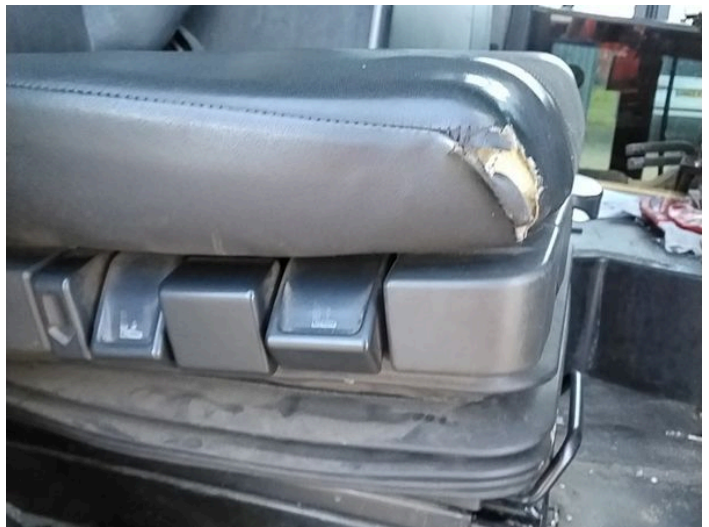
18: Seat Base Cover osf  
Holed  
Over 3mm

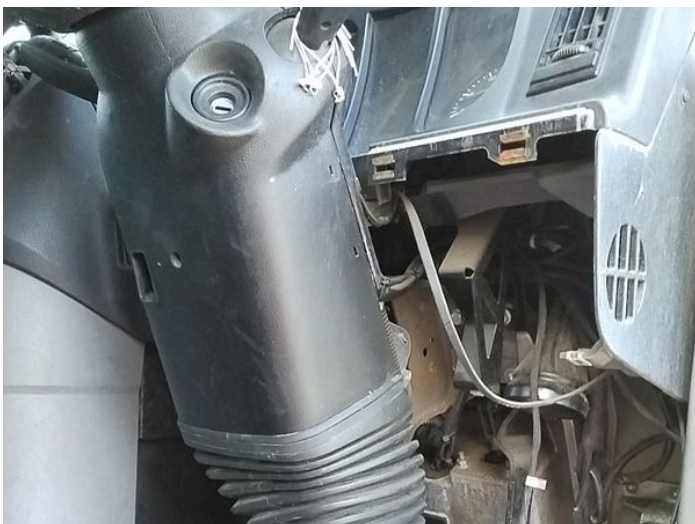
19: Switches And Controls  
Missing  
Replace

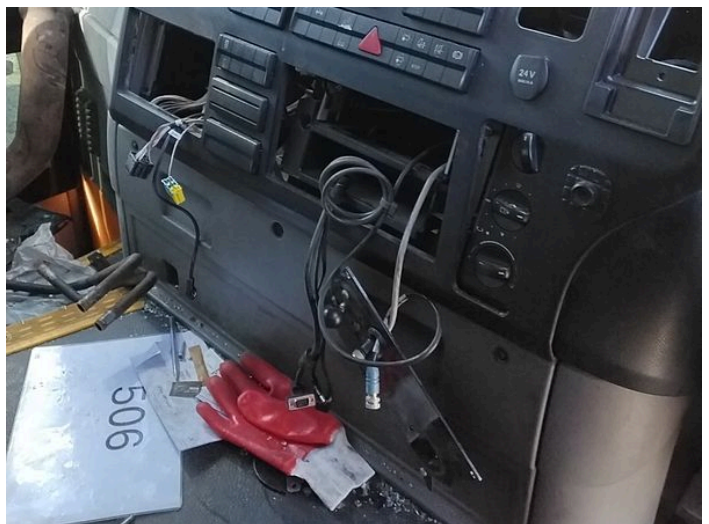
20: Switches And Controls  
Broken  
Replace

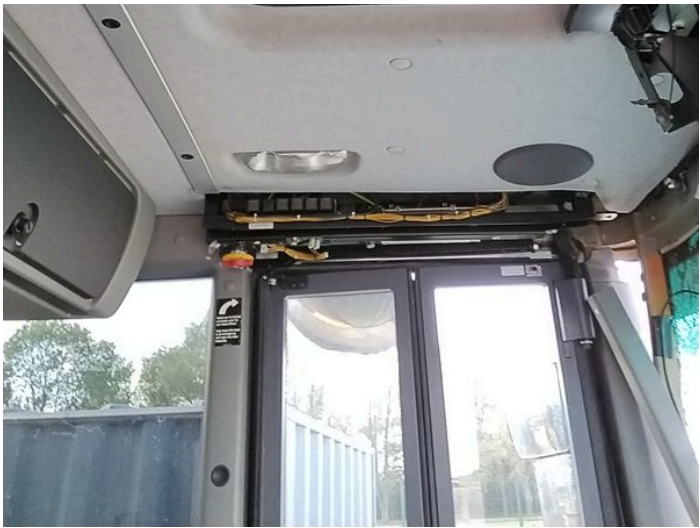
21: Switches And Controls  
Missing  
Replace

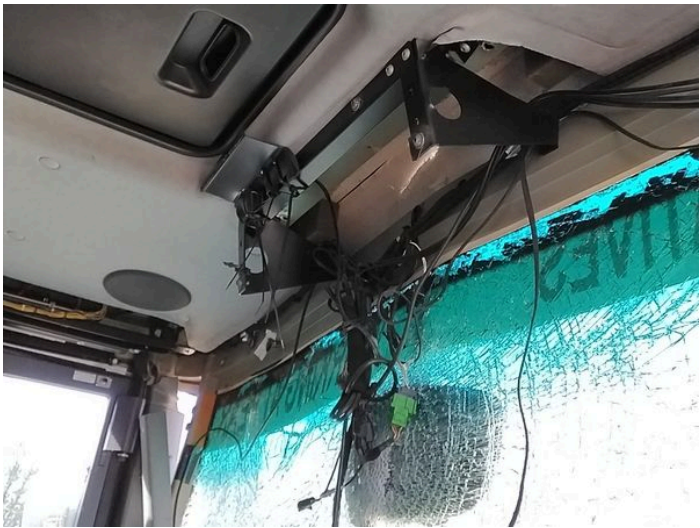
22: Switches And Controls  
Missing  
Replace

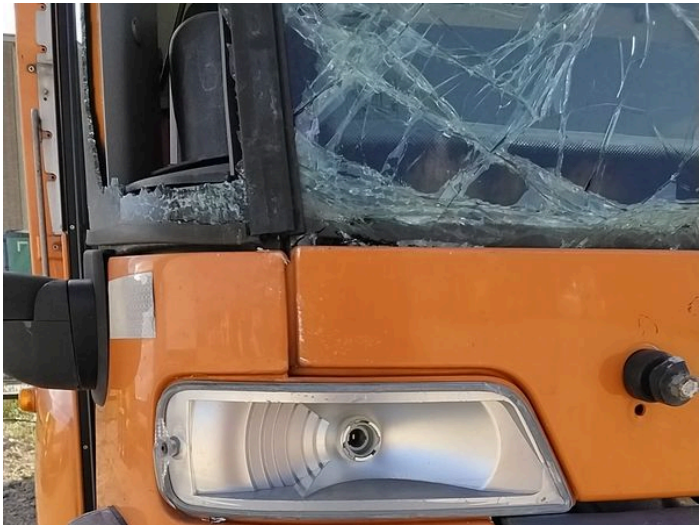
23: Flasher Side Repeater os  
Broken  
Replace
