VEHICLE INSPECTION REPORT

SG15EVW

Mercedes-Benz Antos 1827

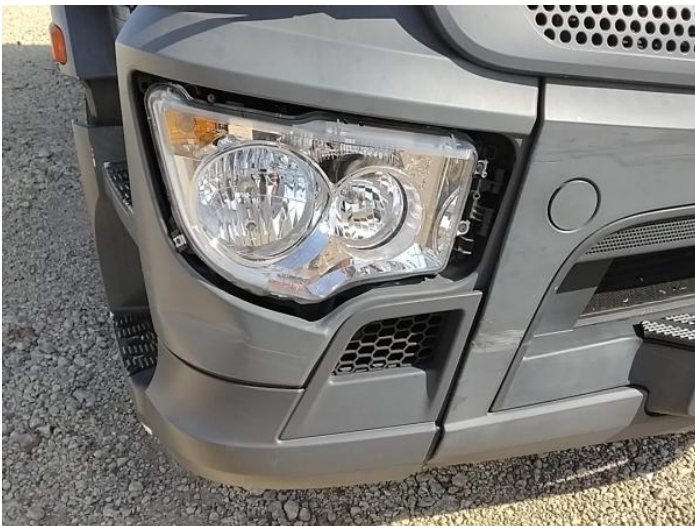
1: Fog Lamp Surrounds
Missing
Replace

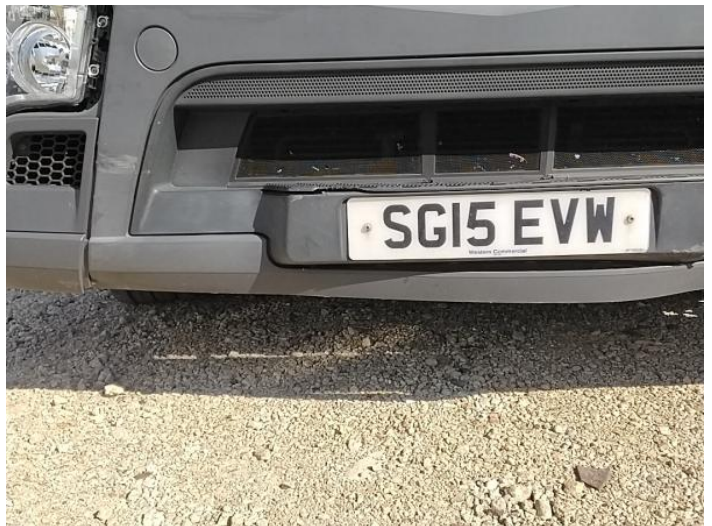
2: Bumper Front
Insecure
Action Required

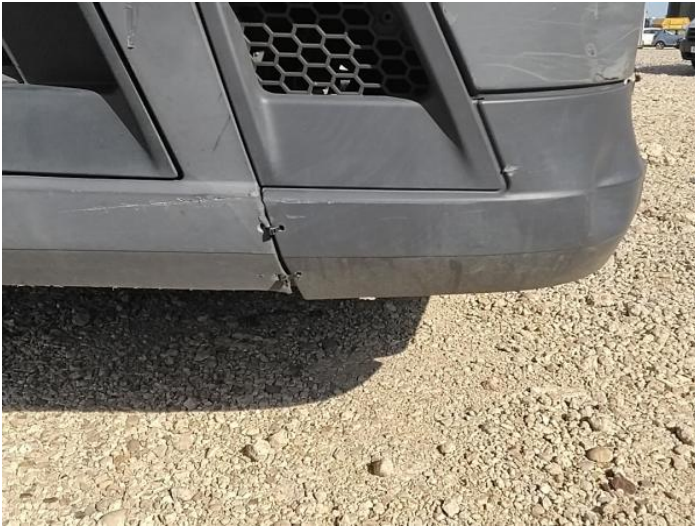
3: Bumper Front
Poor Previous Repair
Poor Paint

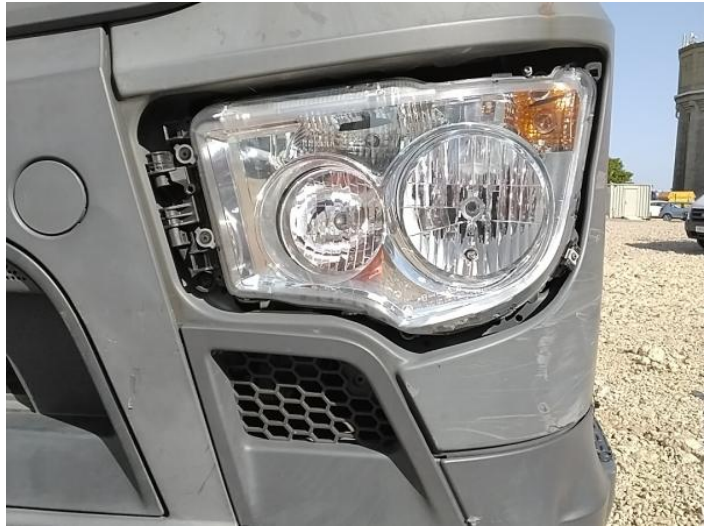
4: Fog Lamp Surrounds
Missing
Replace

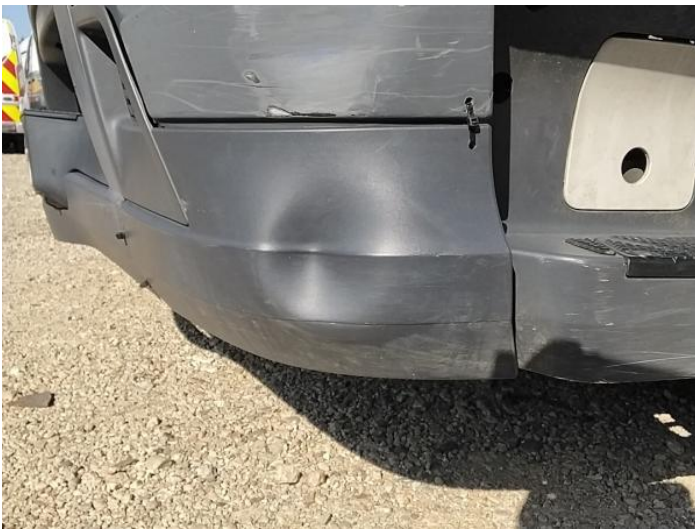
5: Bumper Front
Dented
Over 30mm

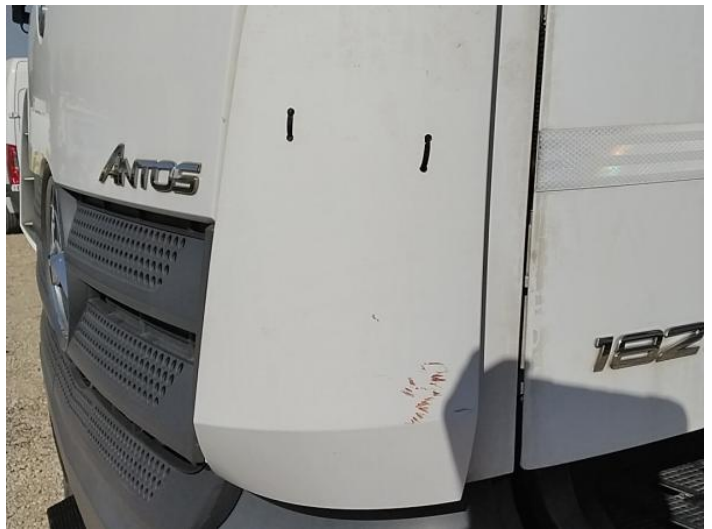
6: Moulding nsf Wing
Broken
Replace

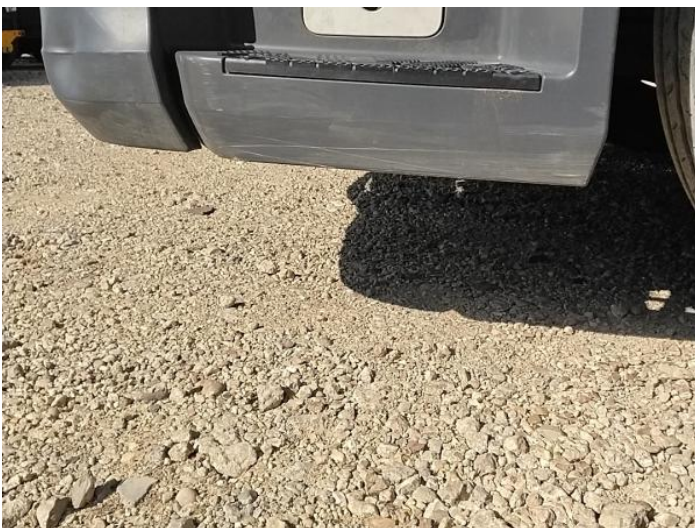
7: General Exterior
Soiled
Light

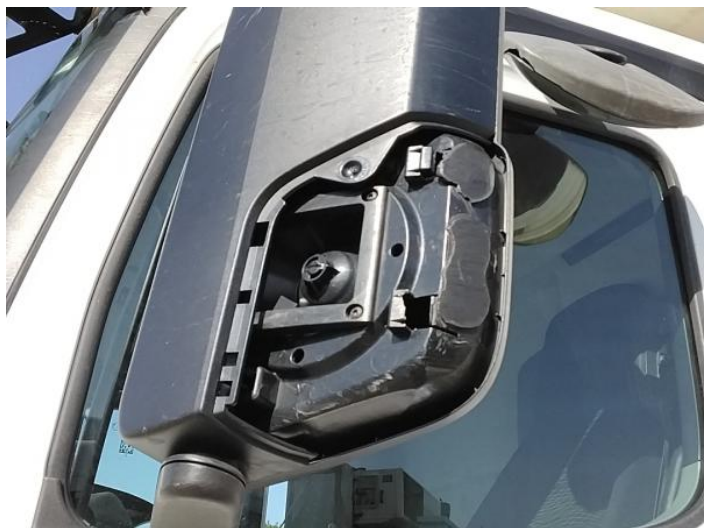
8: Door Mirror Assy nsf
Missing
Replace

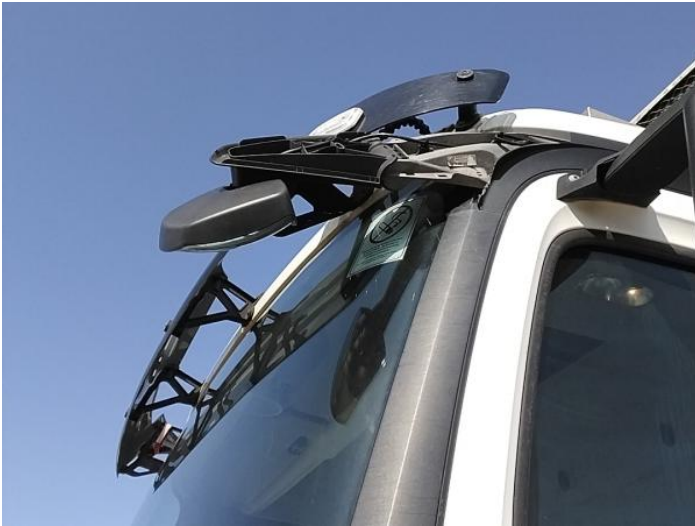
9: Door Mirror Assy nsf
Broken
Replace

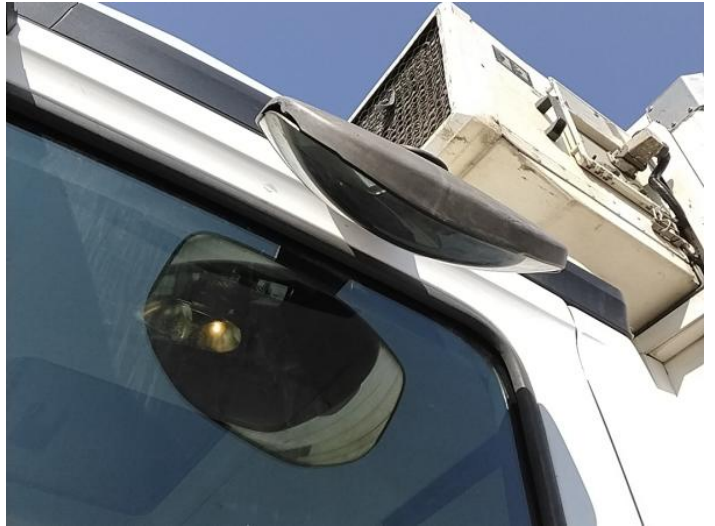
10: Door Mirror Assy nsf
Broken
Replace

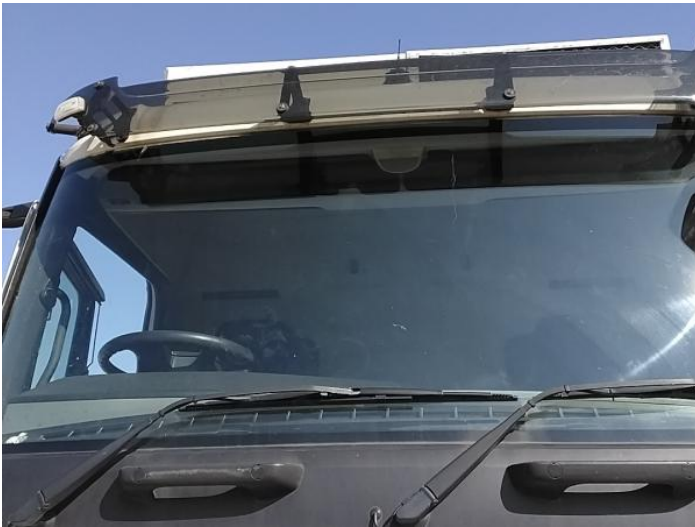
11: Screen Front
Chipped
UpTo 10mm

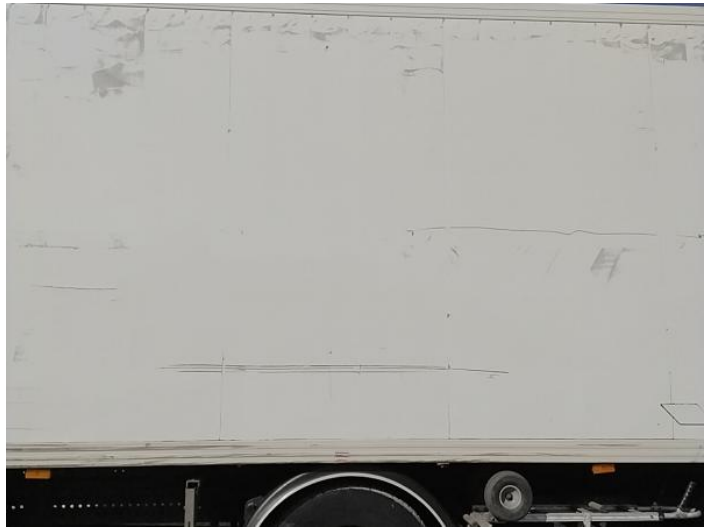
12: General Exterior
Soiled
Light

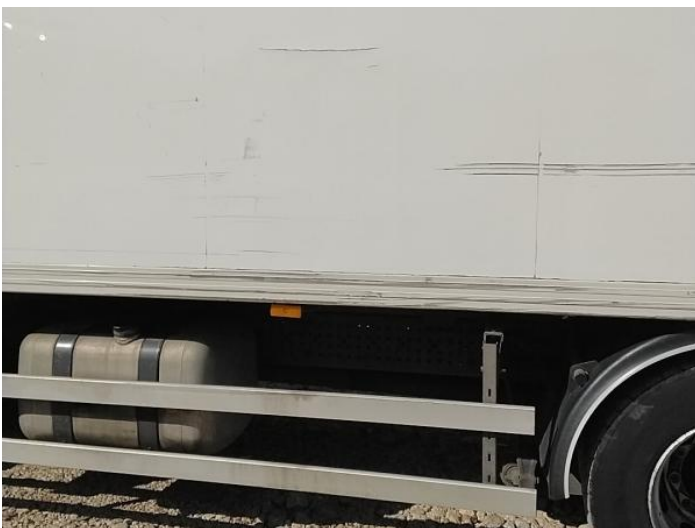
13: General Exterior
Soiled
Light

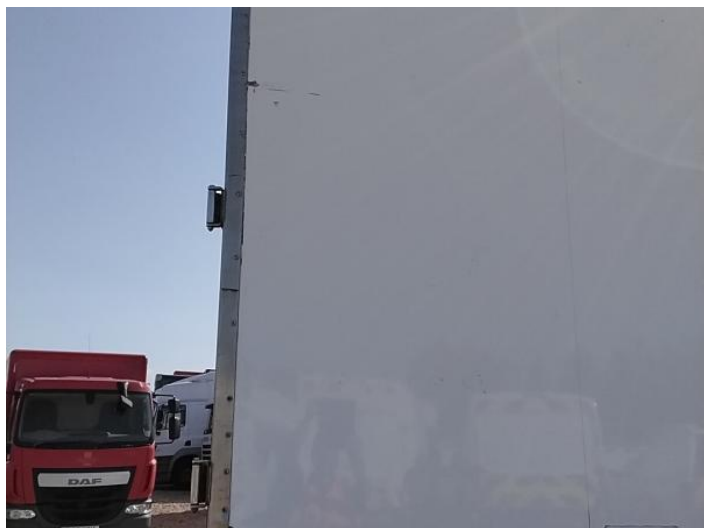
14: General Exterior
Soiled
Light

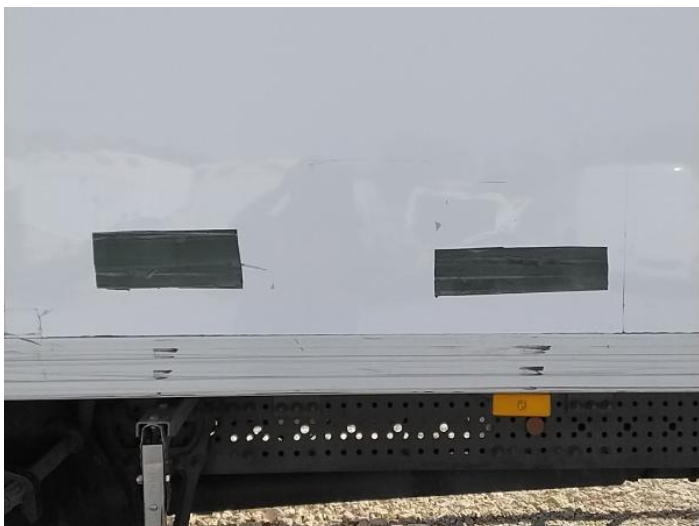
15: General Exterior
Soiled
Light

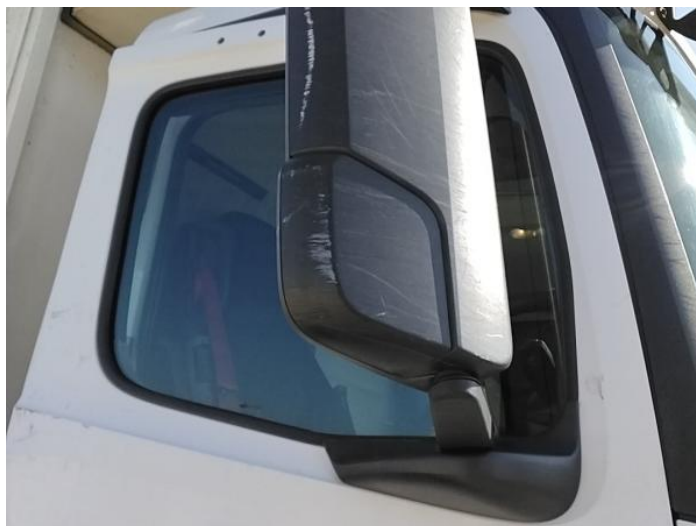
16: Door Mirror Assy osf
Scuffed (Unpainted)
Over 100mm

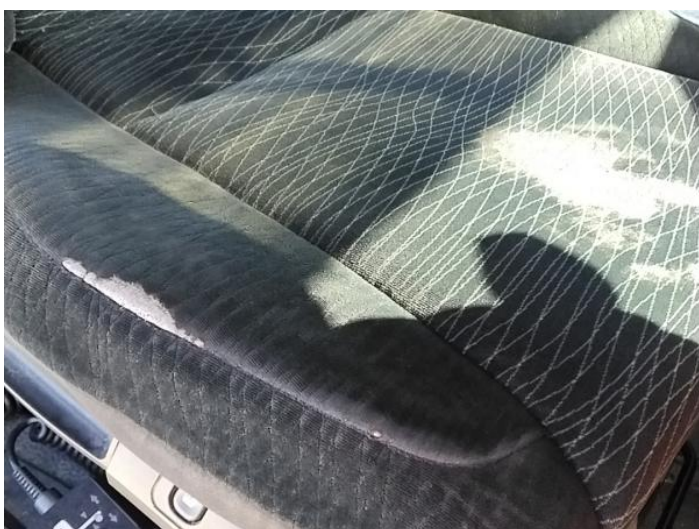
17: Seat Base Cover osf
Torn
Over 3mm
