VEHICLE INSPECTION REPORT

SJ65GJE

Mercedes-Benz Antos 1827

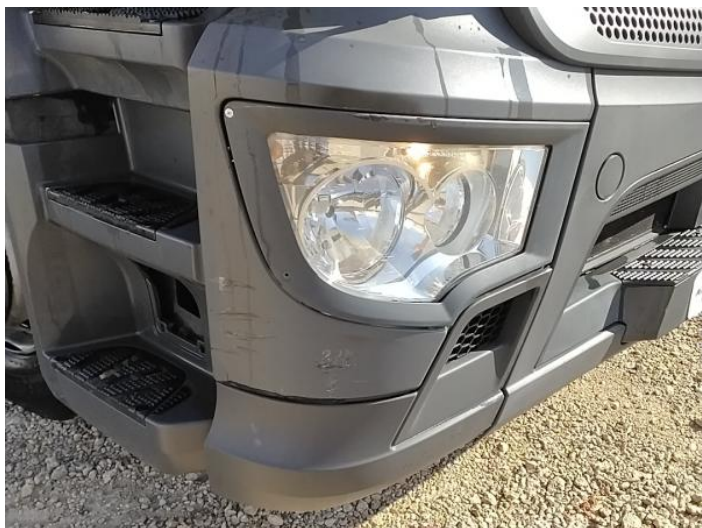
1: Fog Lamp Surround is
Broken
Replace

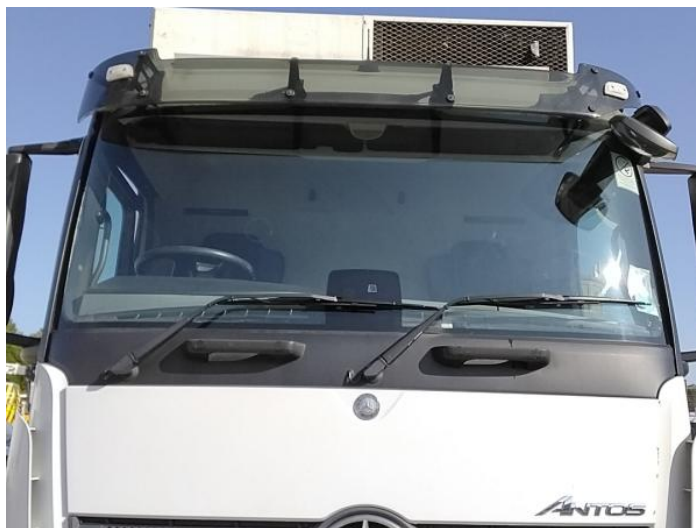
2: Screen Front
Chipped
Up To 10mm

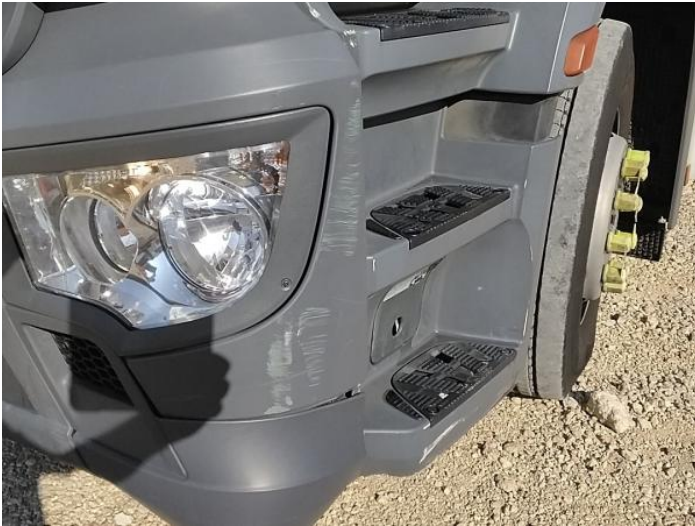
3: Fog Lamp Surrounds
Scuffed (Unpainted)
Over 100mm

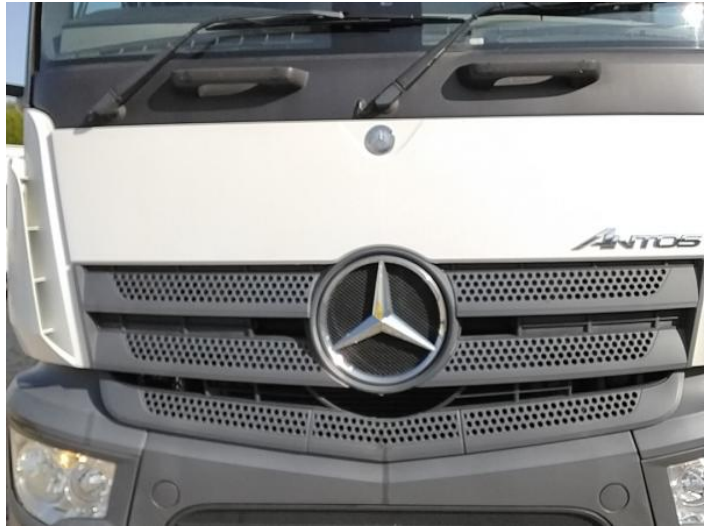
4: Bonnet
Chipped
Multiple Chips

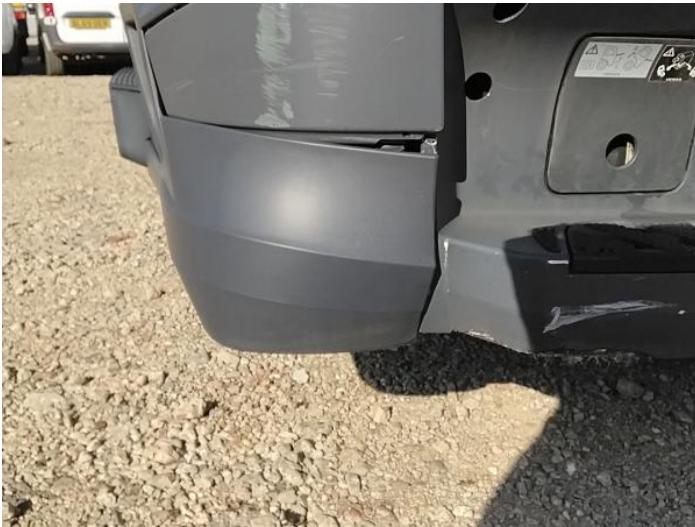
5: Bumper Front
Dented
Over 30mm

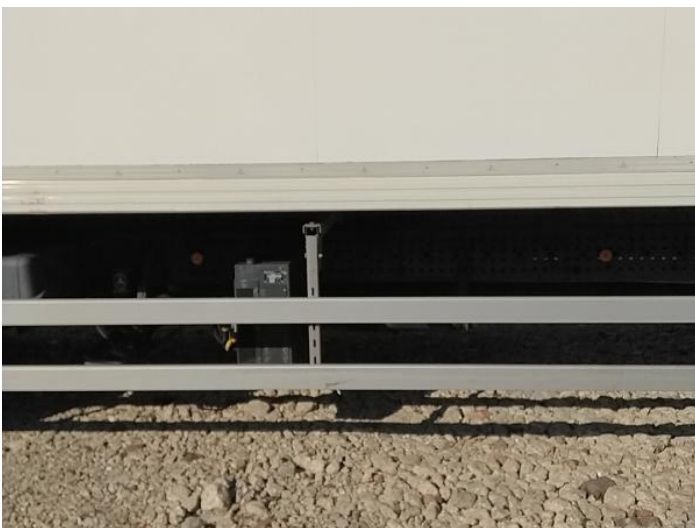
7: General Exterior
Soiled
Light

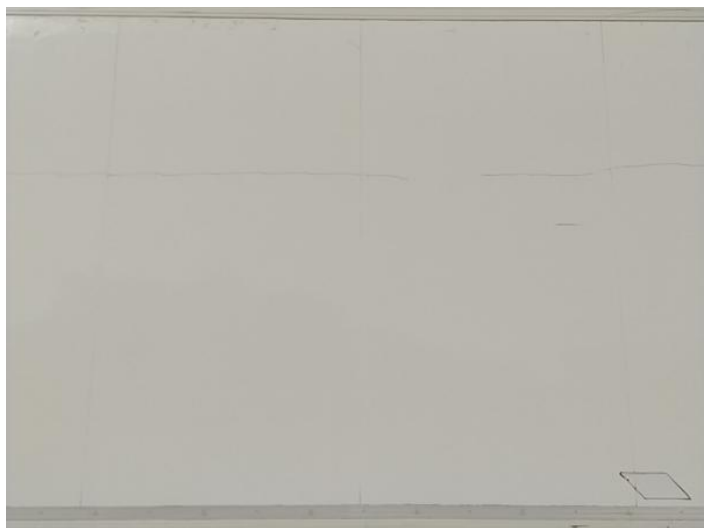
8: Qtr Panel nsr
Scratched
Over 25mm Thru Paint

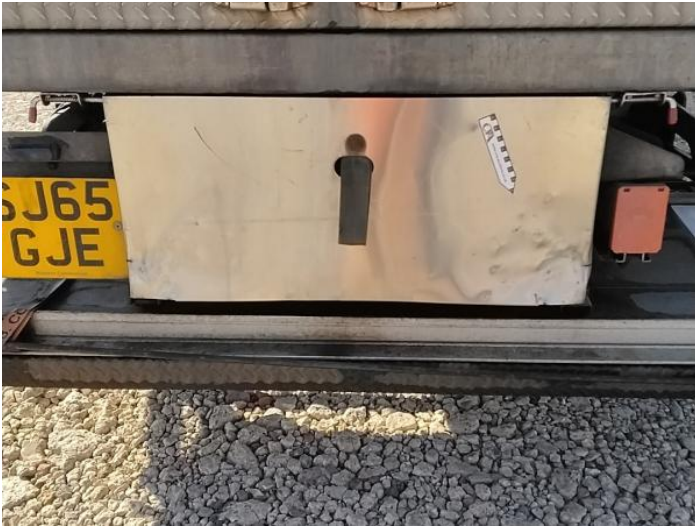
9: General Exterior
Soiled
Light

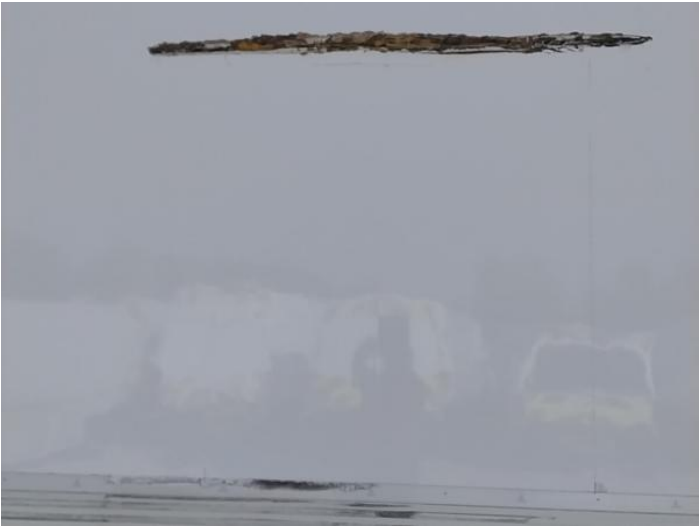
10: General Exterior
Soiled
Light

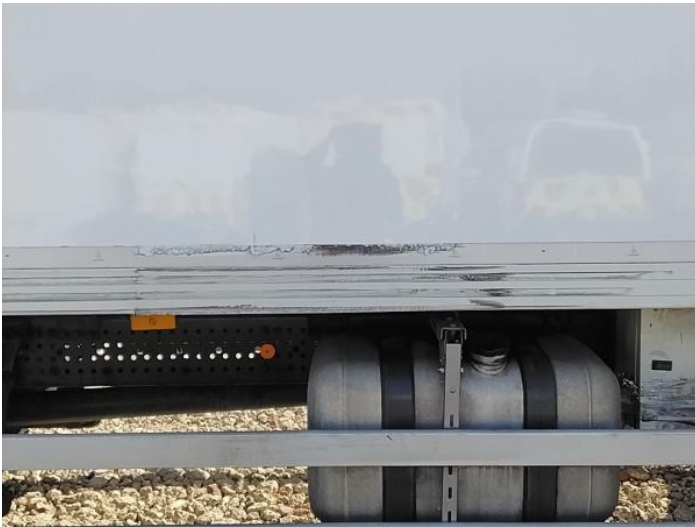
11: General Exterior
Soiled
Light

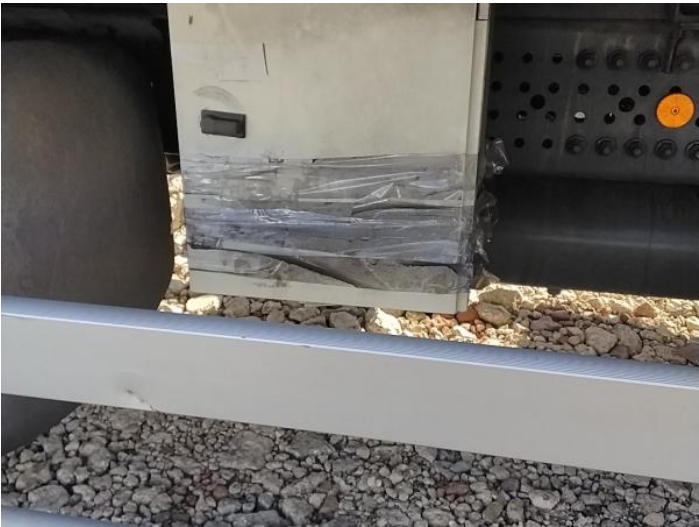
12: General Exterior
Soiled
Light

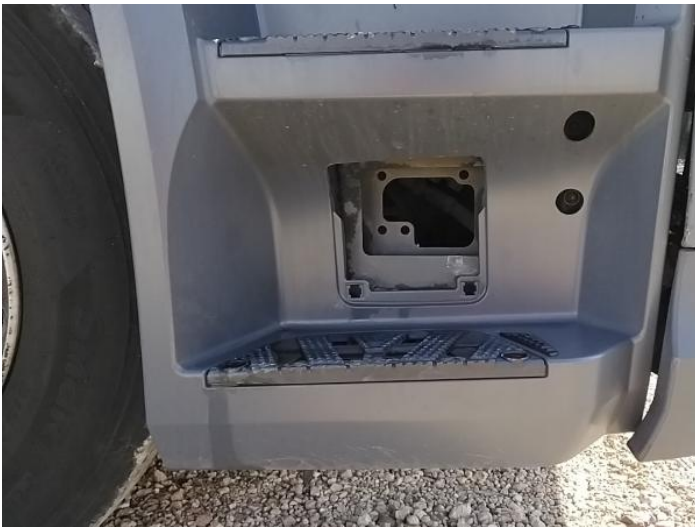
13: General Exterior
Soiled
Light
