# VEHICLE INSPECTION REPORT

**CP62UTL**

## Ford Ranger XL 2.2 TDCI 150PS

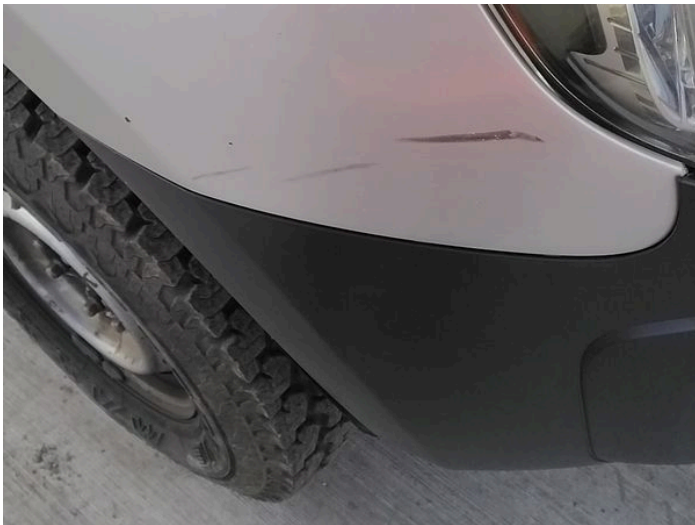
1: Wing of  
Scratched  
Over 25mm Thru Paint

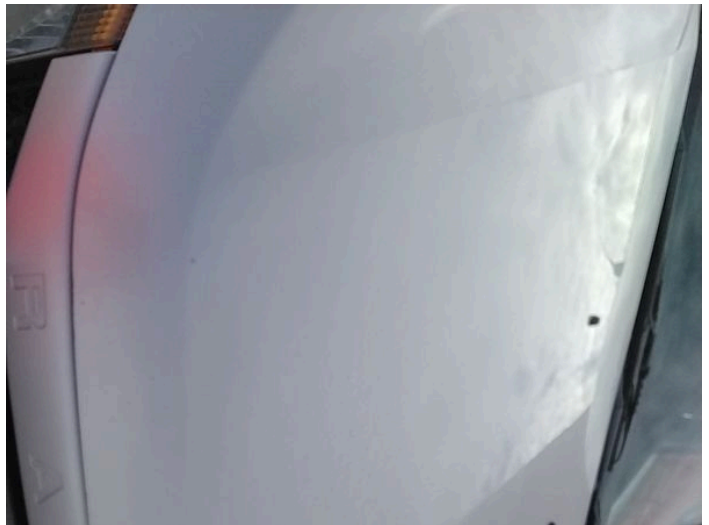
2: Bonnet  
Chipped  
Multiple Chips

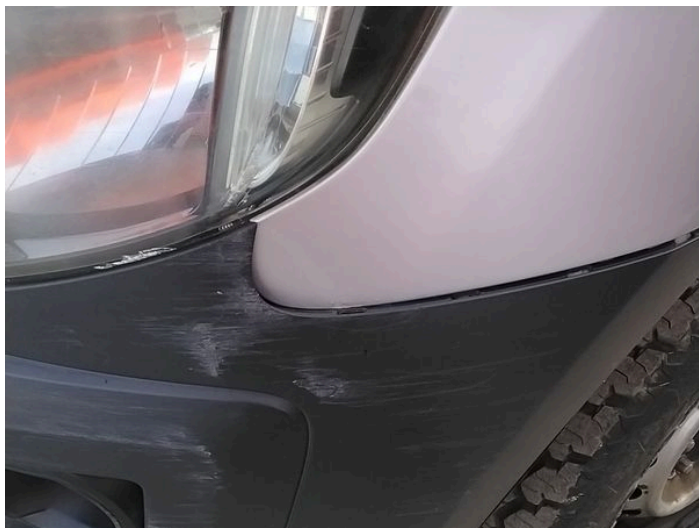
3: Bumper Front  
Scratched  
Over 100mm Thru Paint

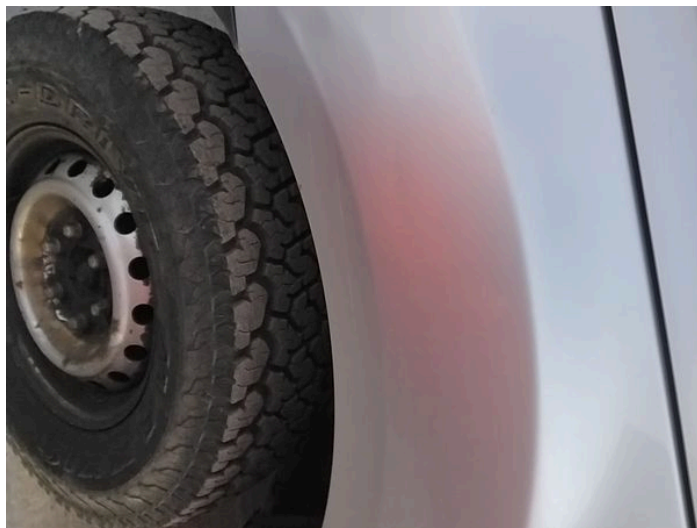
4: Wing nsf  
Dented  
With Paint Damage

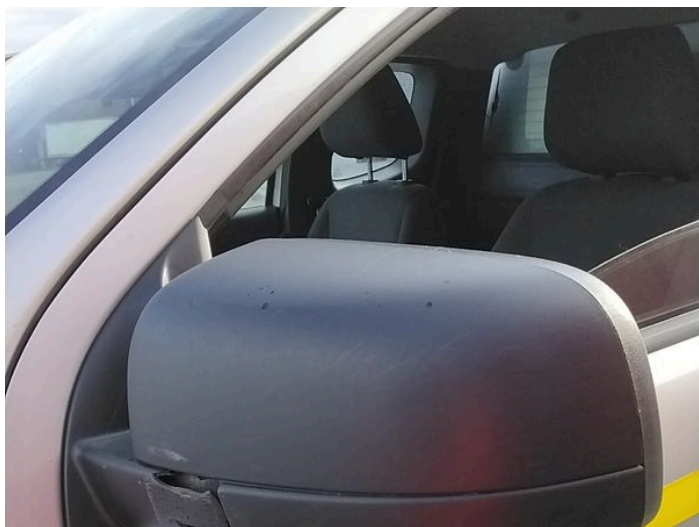
5: Door Mirror Assy nsf  
Broken  
Replace

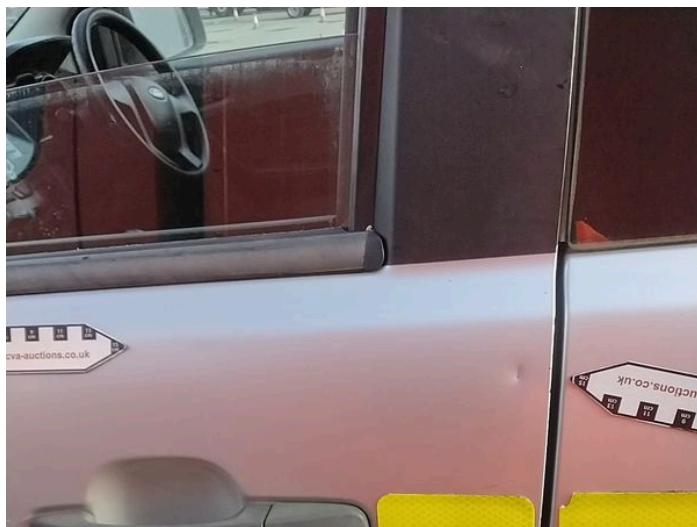
6: Door nsf  
Dented  
With Paint Damage

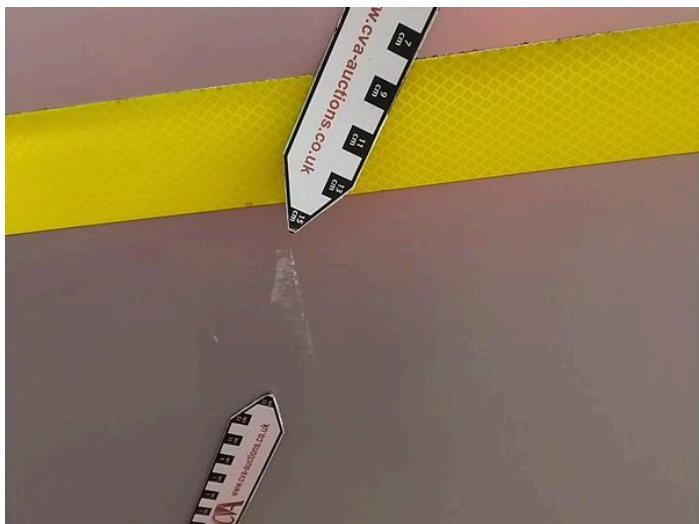
7: Qtr Panel nsr  
Scratched  
Over 25mm Thru Paint

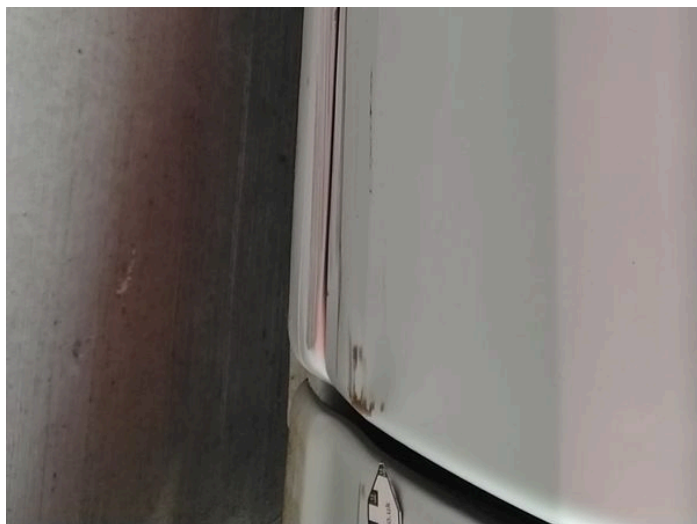
8: Qtr Panel nsr  
Dented  
With Paint Damage

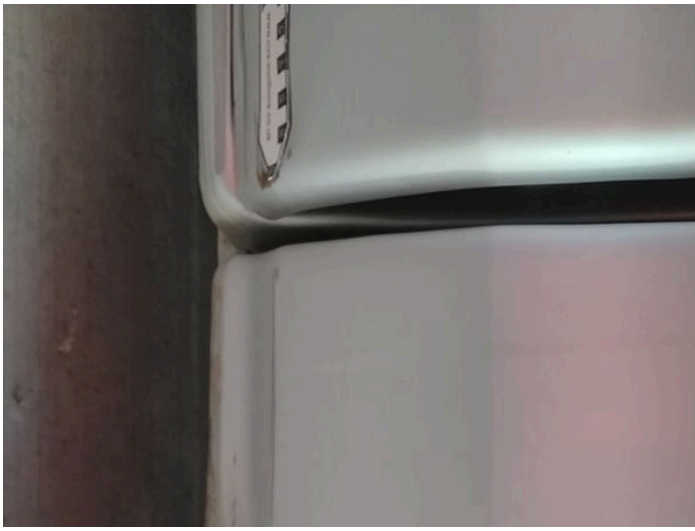
9: Qtr Panel nsr  
Dented  
With Paint Damage

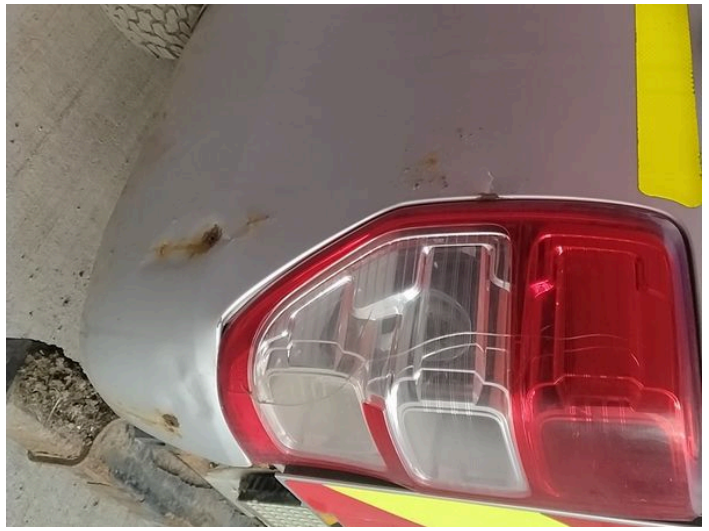
10: Qtr Panel nsr  
Rusted  
Holed

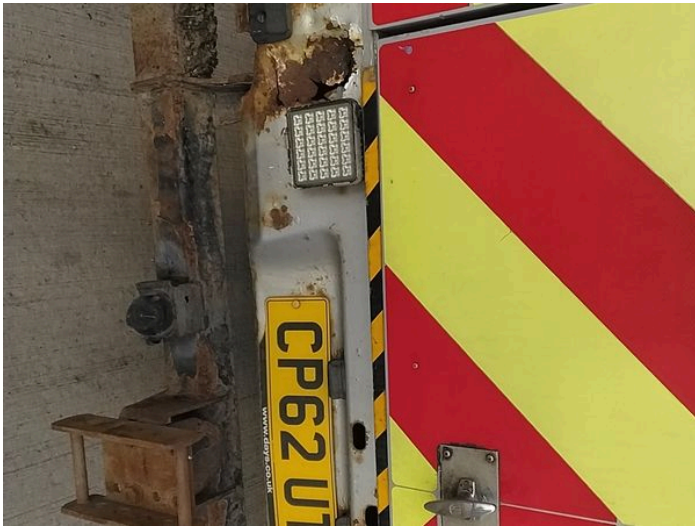
11: Panel Rear  
Rusted  
Holed

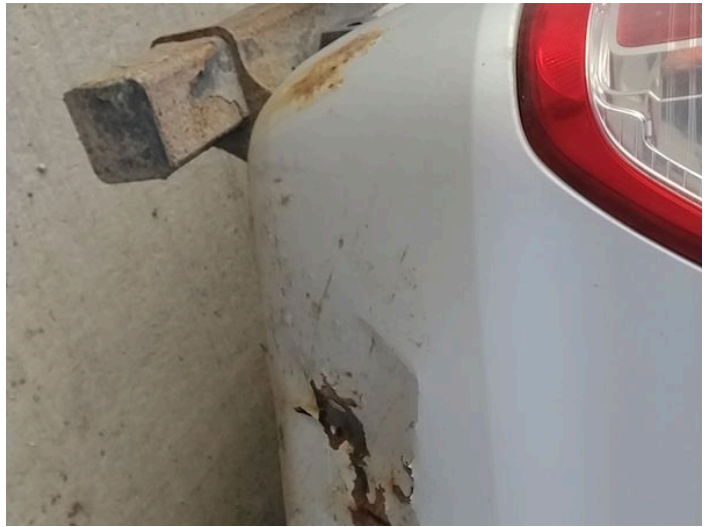
12: Qtr Panel osr  
Rusted  
Holed

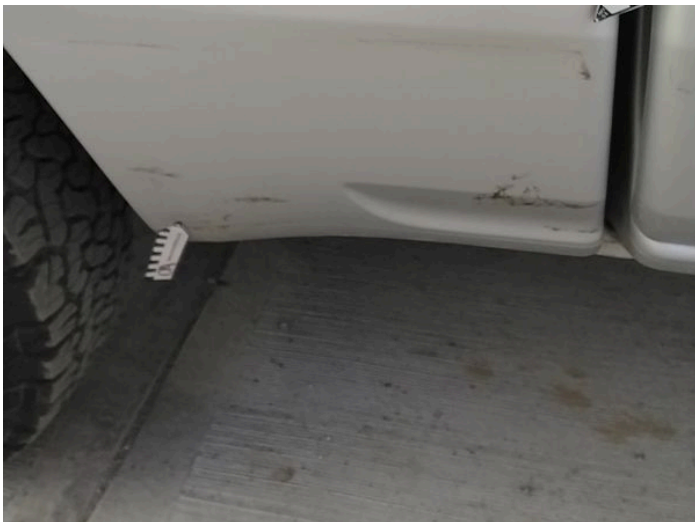
13: Qtr Panel osr  
Scratched  
Over 25mm Thru Paint

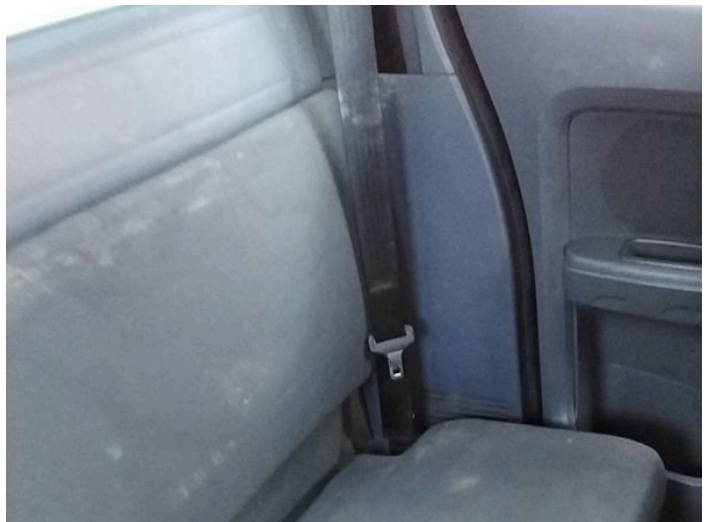
14: Seat Base Cover nsr  
Soiled  
Heavy

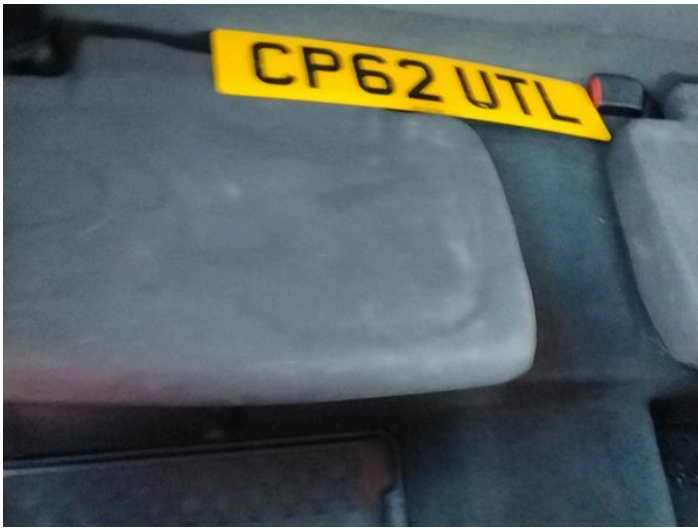
15: Seat Base Cover osr  
Soiled  
Heavy

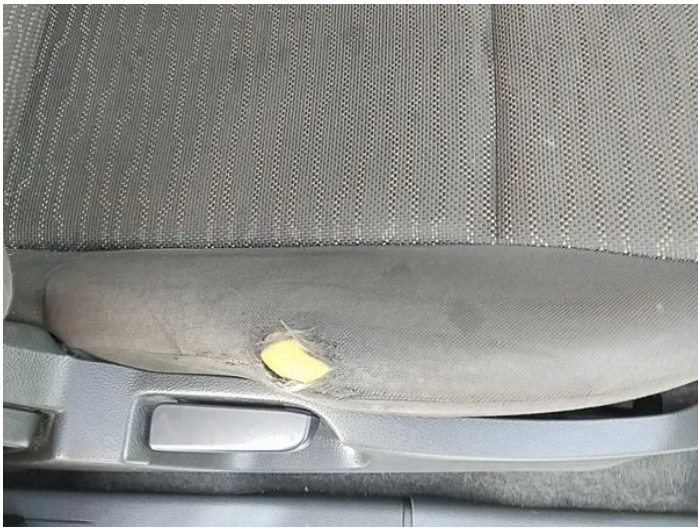
16: Seat Base Cover osf  
Holed  
Over 3mm

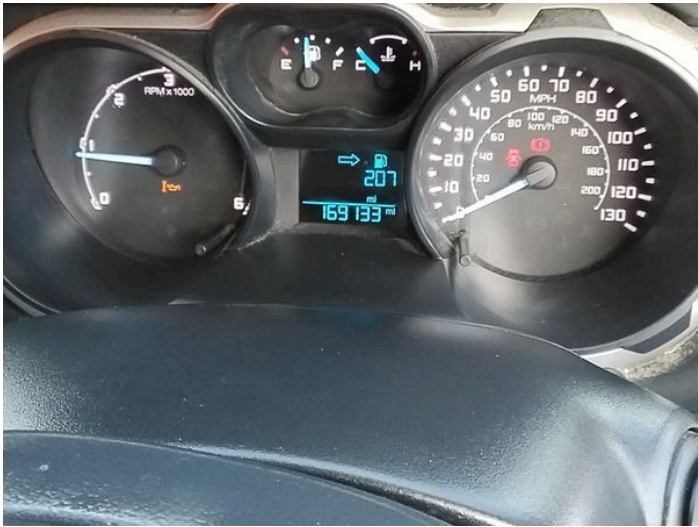
\*COLLECTED AS NON-RUNNER - UNKNOWN FAULTS RECOMMENDED NOT TO DRIVE, WARNING LIGHTS ON DASH\* E/ MIRRORS

17: Dash Warning Lights  
Displayed  
No Action

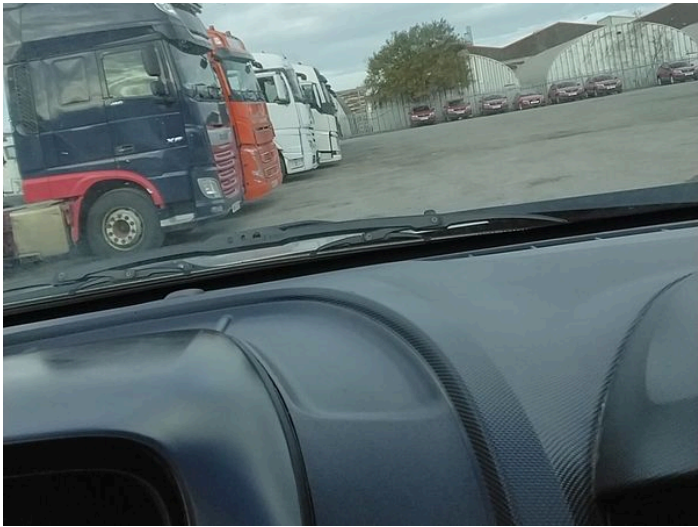
18: Screen Front  
Chipped  
Over 10mm
