# VEHICLE INSPECTION REPORT

**WX20KJN**

## Fiat Ducato 35 2.3 MULTIJET 140PS

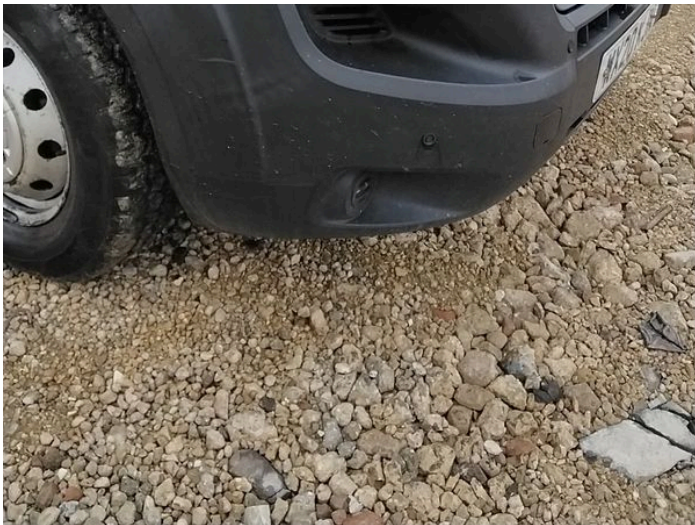
1: Bumper Front Moulding  
Scuffed (Unpainted)  
UpTo 100mm

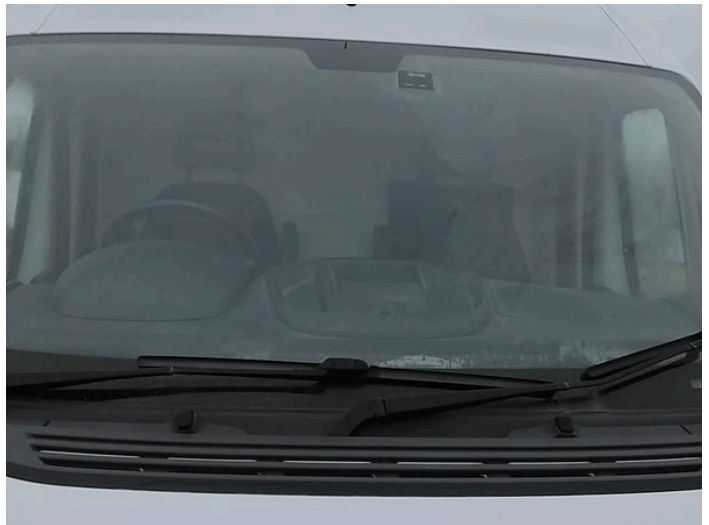
2: Screen Front  
Chipped  
Over 10mm

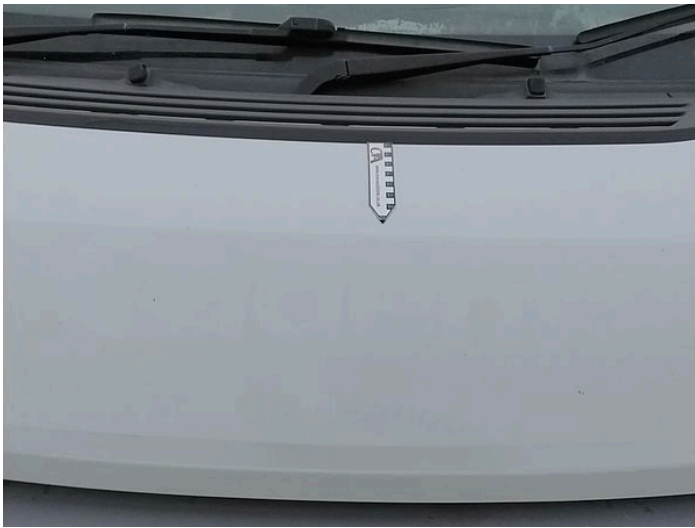
3: Bonnet  
Chipped  
Multiple Chips

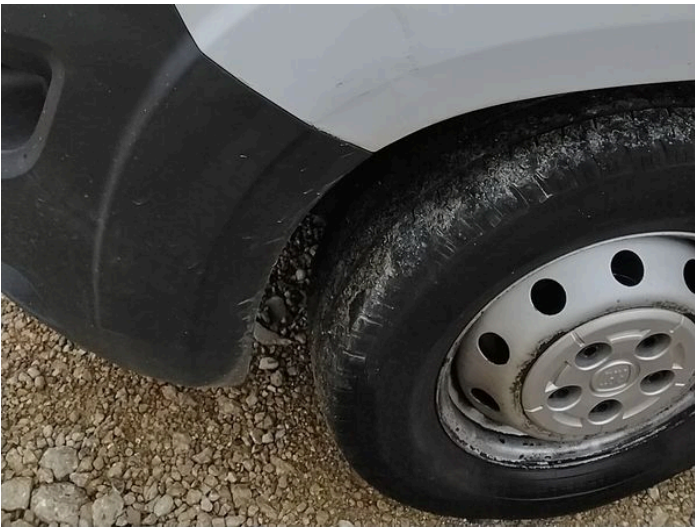
4: Wing nsf  
Dented  
With Paint Damage

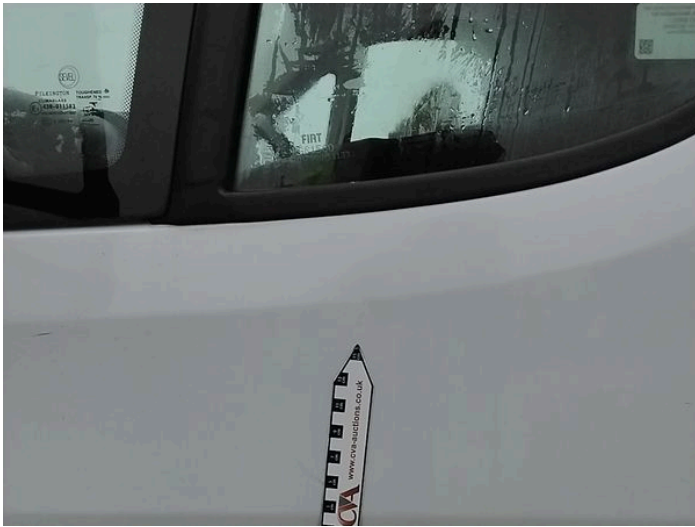
5: Door nsf  
Dented  
Over 2 UpTo 10mm

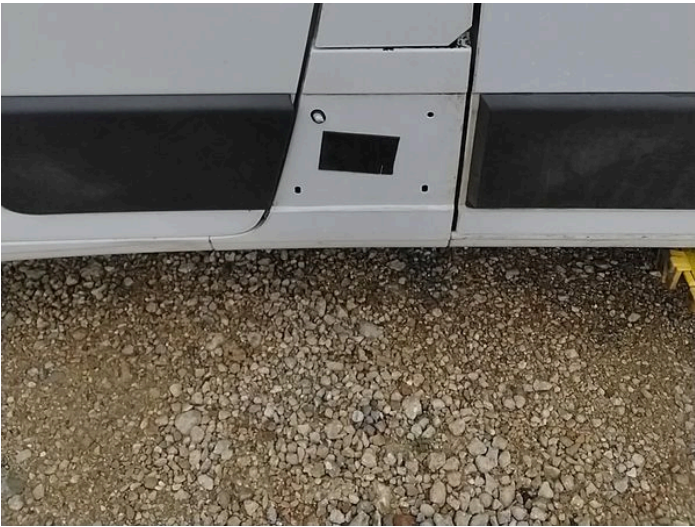
6: Qtr Panel Trim ns  
Missing  
Replace

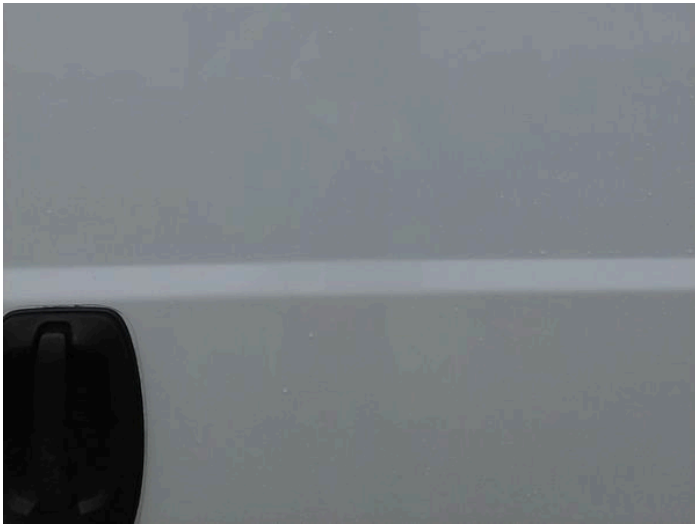
7: Door nsr  
Dented  
Over 2 UpTo 10mm

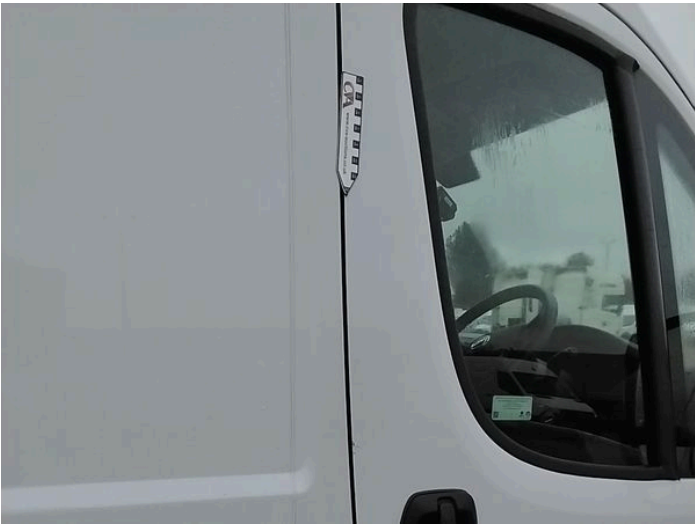
8: Door osf  
Chipped  
Edge Chip

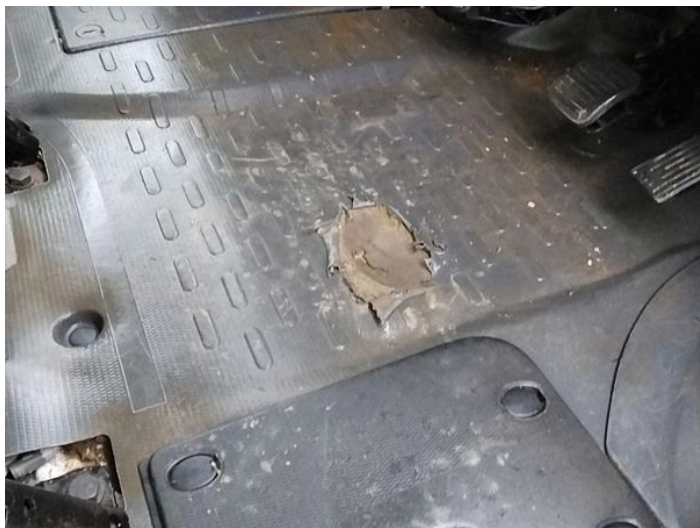
9: Carpets Front  
 Holed  
 Over 3mm
