VEHICLE INSPECTION REPORT

YA66VCJ

Daf LF 150

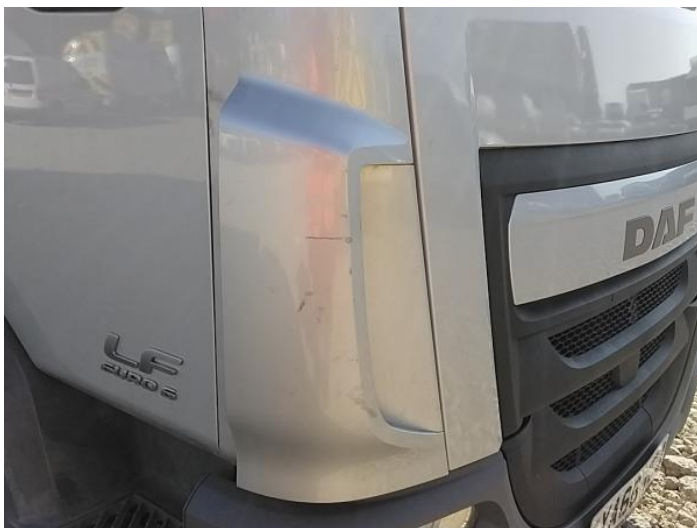
1: Moulding on Wing
Scratched (Painted)
Over 25mm Thru Paint

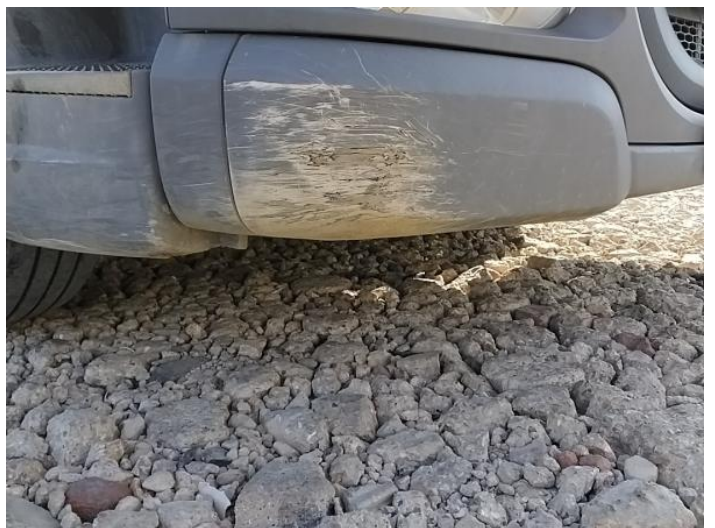
2: Bumper Front
Dented
Over 30mm

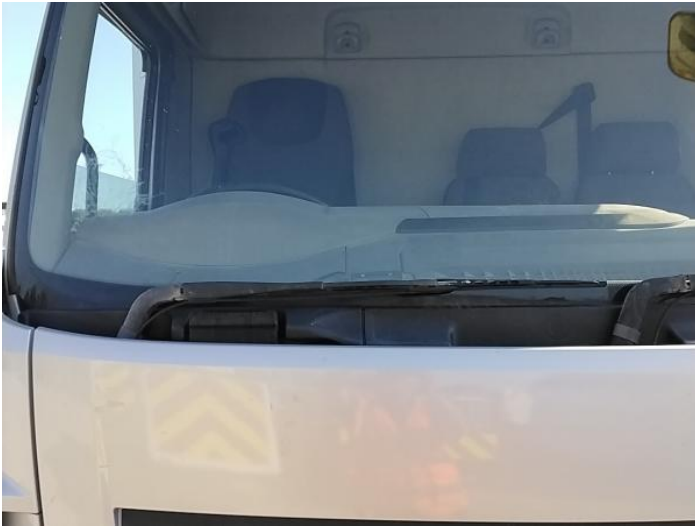
3: Screen Front
Chipped
Over 10mm

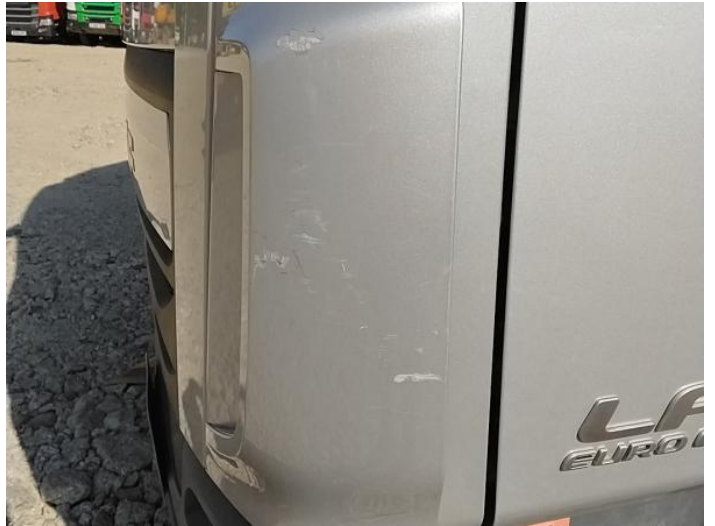
4: Moulding nsf Wing
Scratched (Painted)
Over 25mm Thru Paint

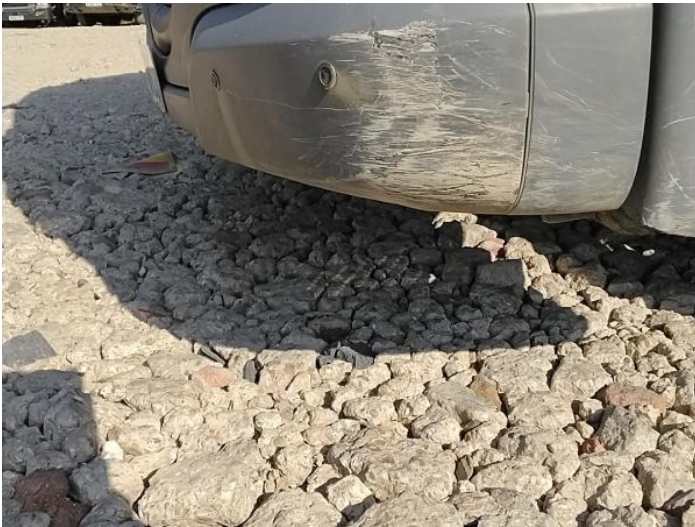
5: Bumper Front
Scratched
Over 25mm Not Thru Paint

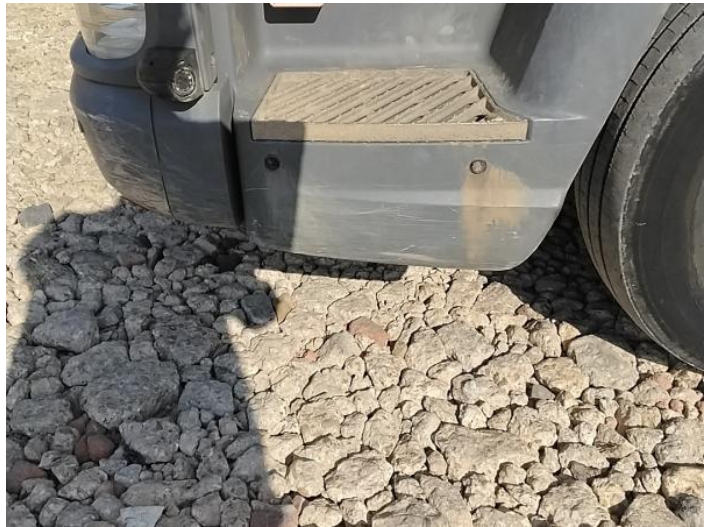
6: General Exterior
Soiled
Light

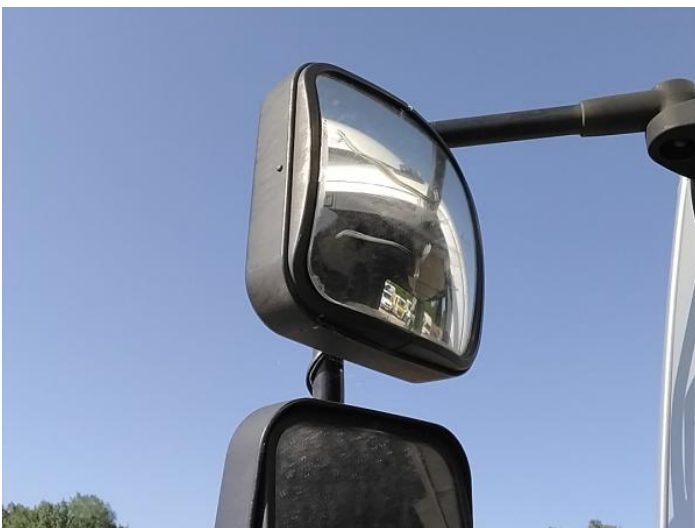
7: Door Mirror Glass ns
Broken
Replace

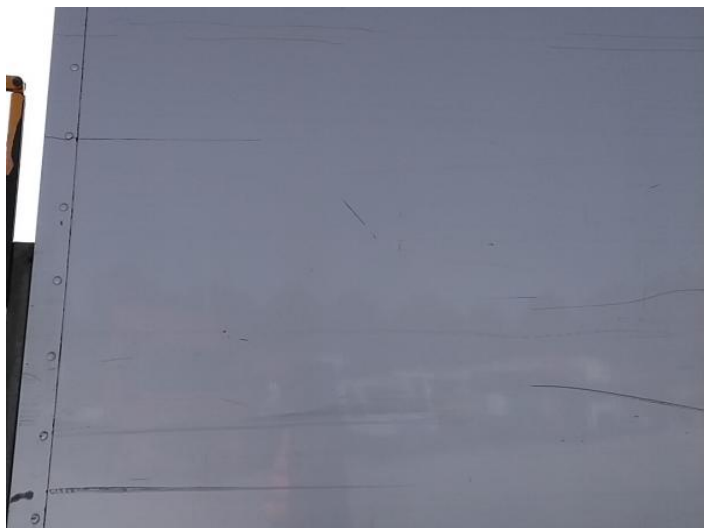
8: Qtr Panel osr
Scratched
Over 25mm Thru Paint

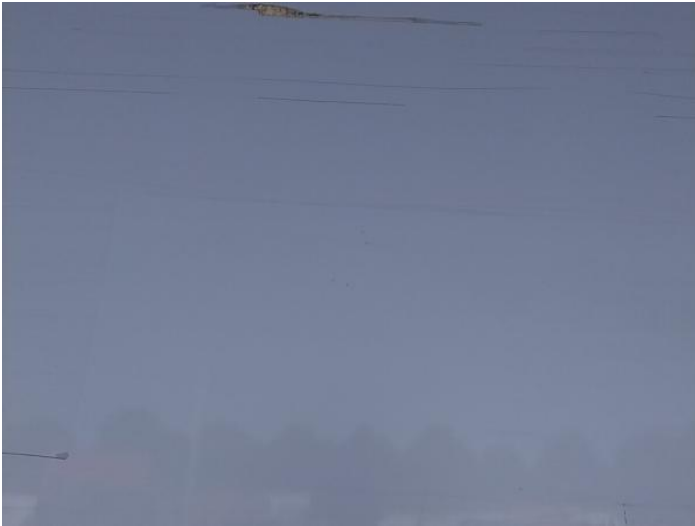
9: Qtr Panel osr
Scratched
Over 25mm Thru Paint

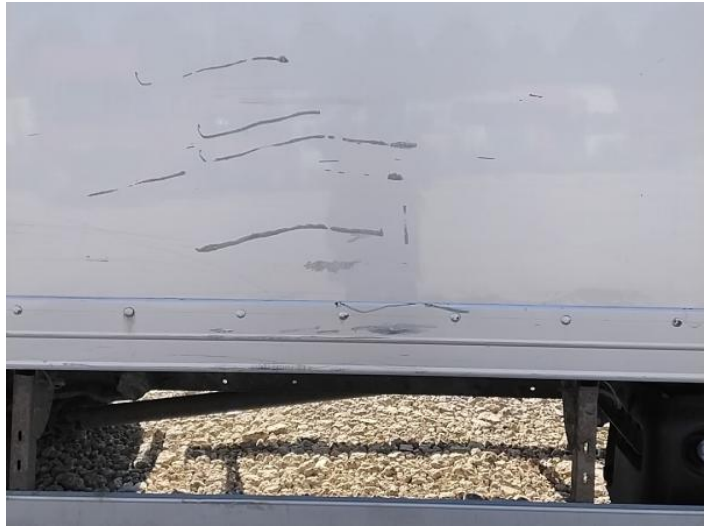
10: General Exterior
Soiled
Light

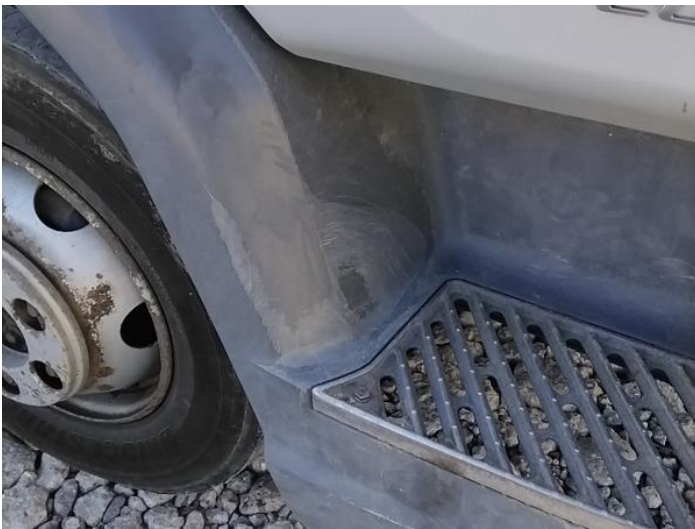
11: General Exterior
Soiled
Light

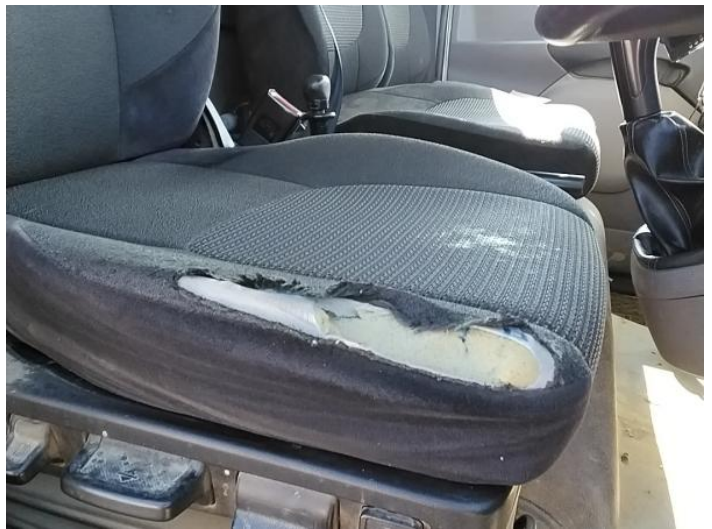
12: Seat Base Cover osf
Torn
Over 3mm
