# VEHICLE INSPECTION REPORT

**KX70BAV**

## Isuzu D-Max

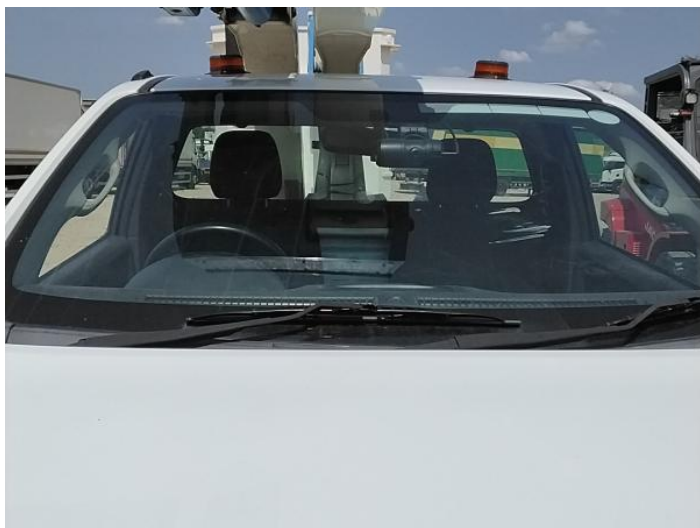
1: Screen Front  
Chipped  
UpTo 10mm

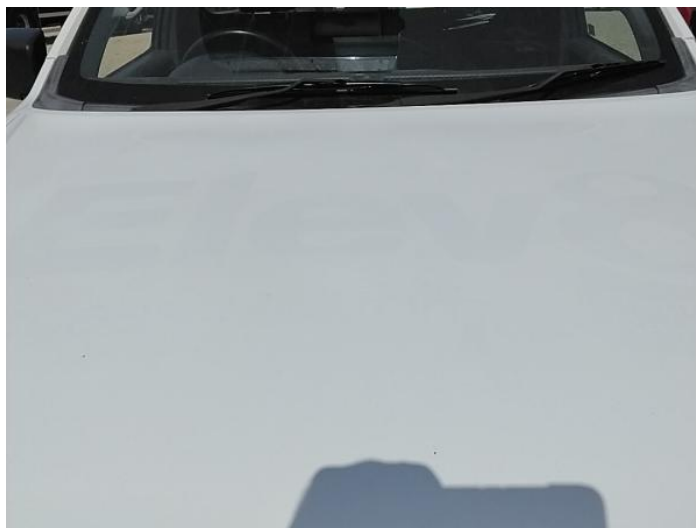
2: Bonnet  
Chipped  
Multiple Chips

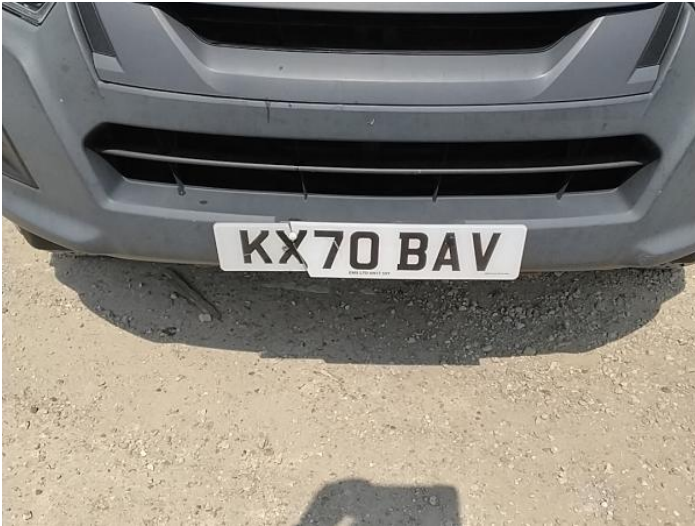
3: General Exterior  
Soiled  
Light

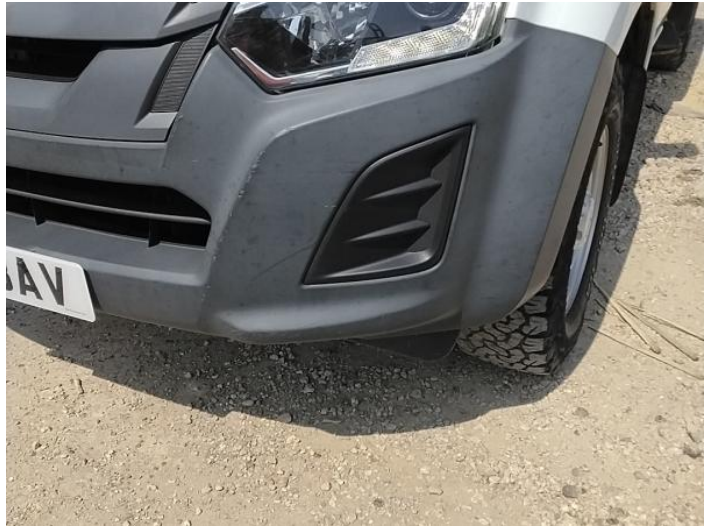
4: Bumper Front  
Scratched  
Over 25mm Not Thru Paint

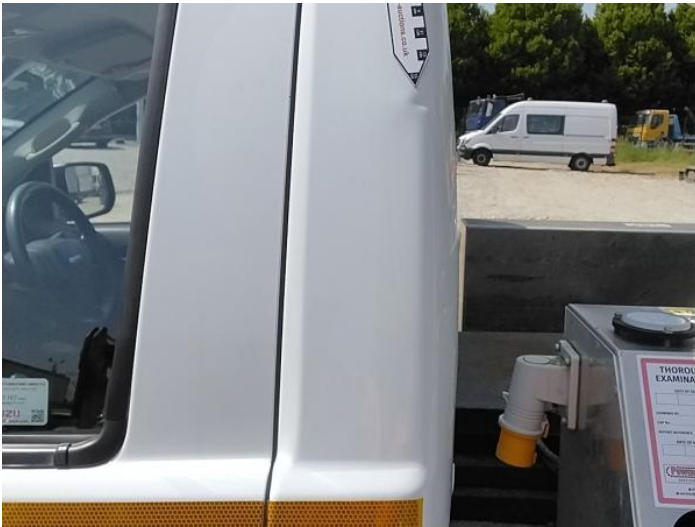
5: B Post ns  
Dented  
Over 2 UpTo 10mm

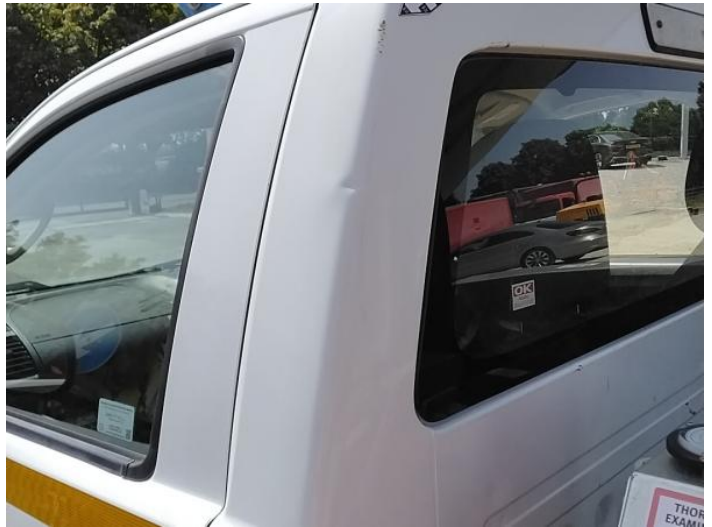
6: B Post ns  
Rusted  
Over 5mm

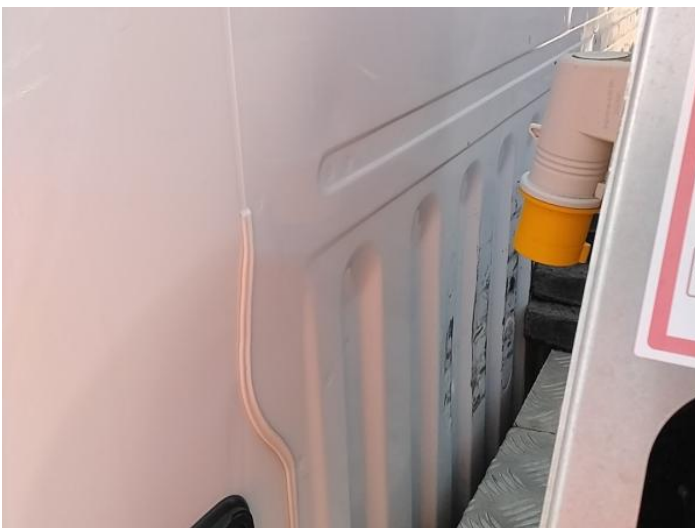
7: General Exterior  
Soiled  
Light

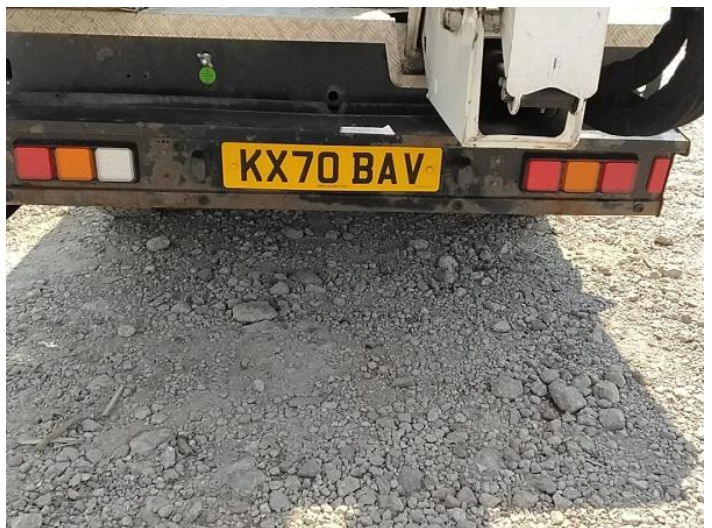
8: Bumper Rear  
Rusted  
Over 5mm

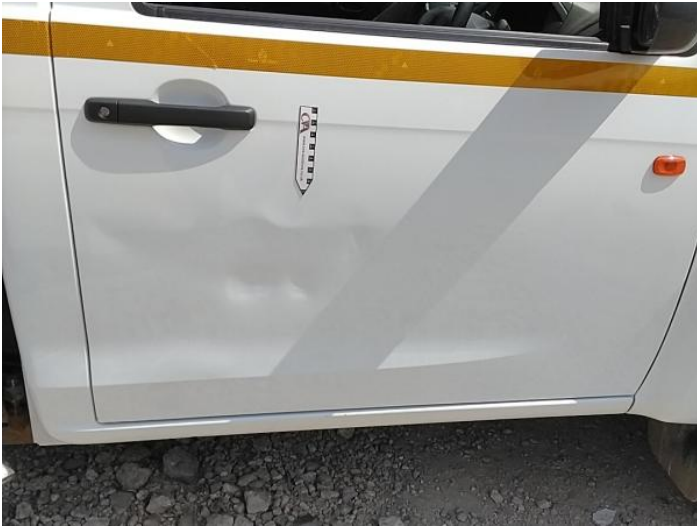
9: Door osf  
Dented  
Over 30% Of Panel

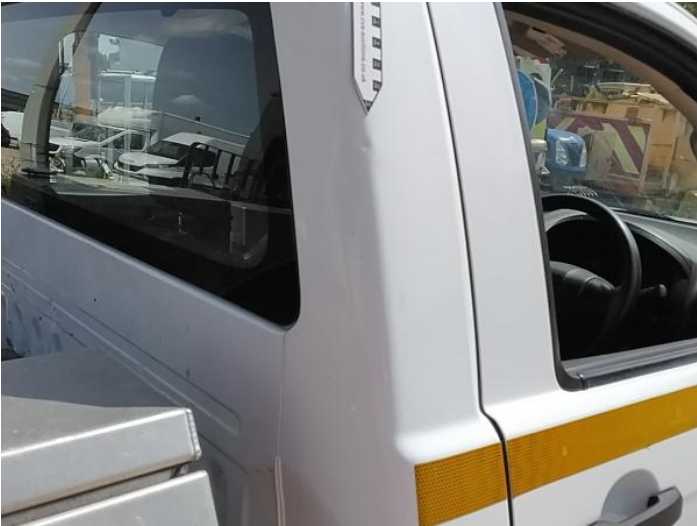
10: B Post os  
Dented  
Over 2 UpTo 10mm

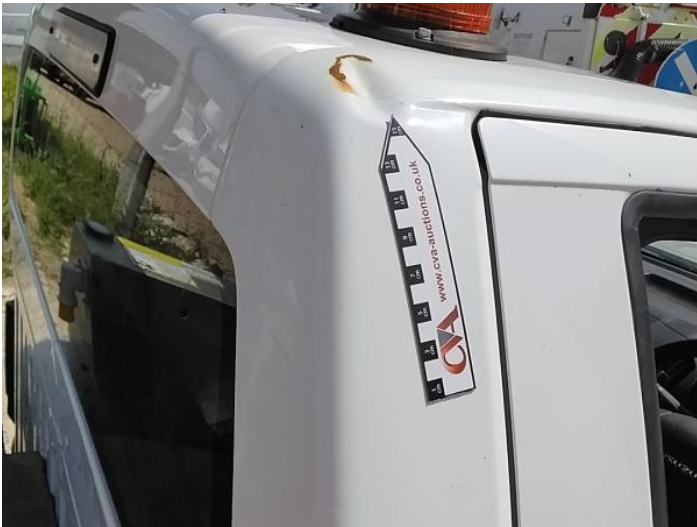
11: B Post os  
Dented  
With Paint Damage
