## VEHICLE INSPECTION REPORT

**DN73HVL**

### Vauxhall Vivaro 2900 1.5d 100PS Prime

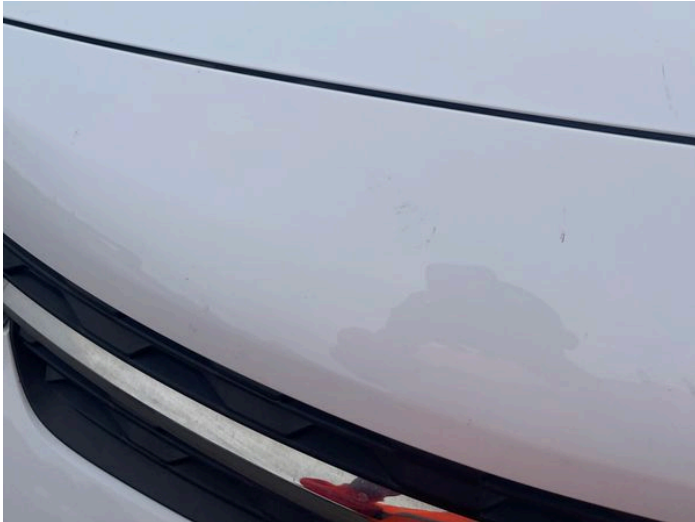
1: Bonnet  
Chipped  
Multiple Chips

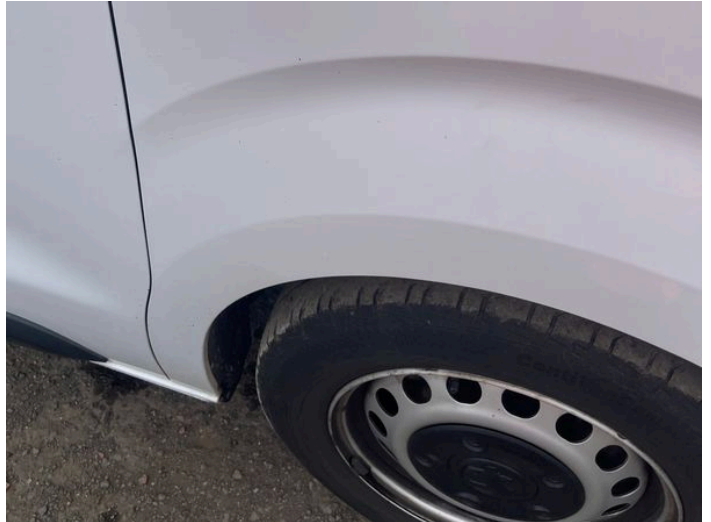
2: Panel Front  
Chipped  
Multiple Chips

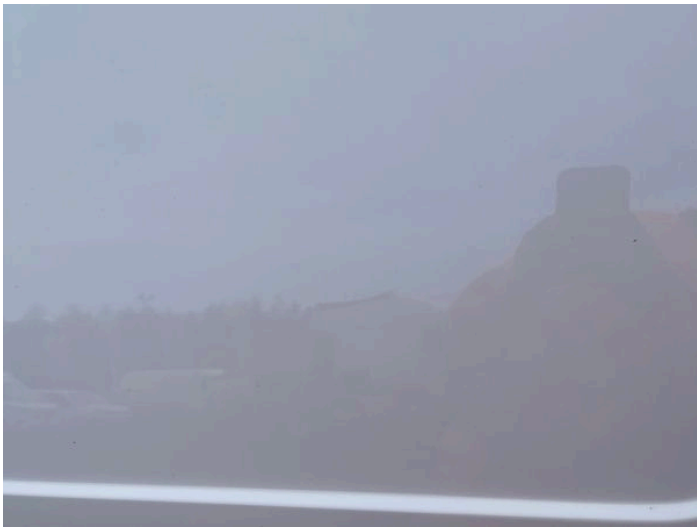
3: Qtr Panel osr  
Dented  
Over 30mm

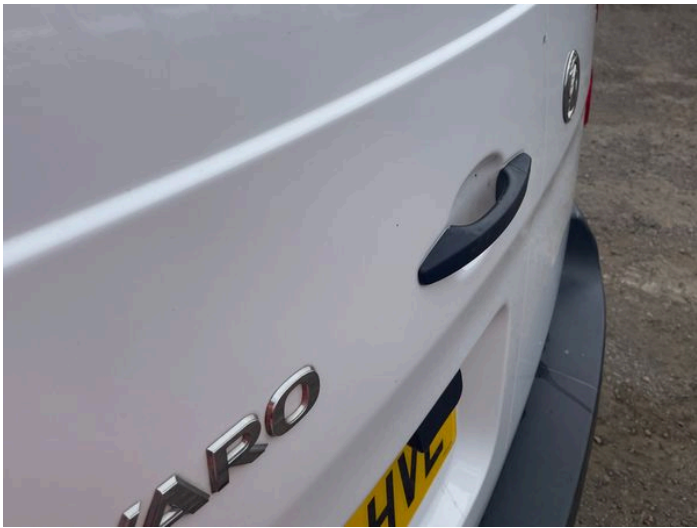
4: Tailgate  
Dented  
Over 30mm

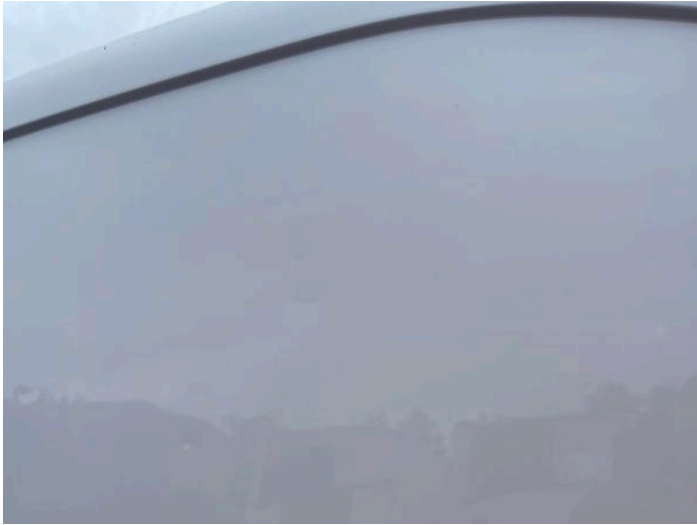
5: Qtr Panel nsr  
Dented  
Over 30mm

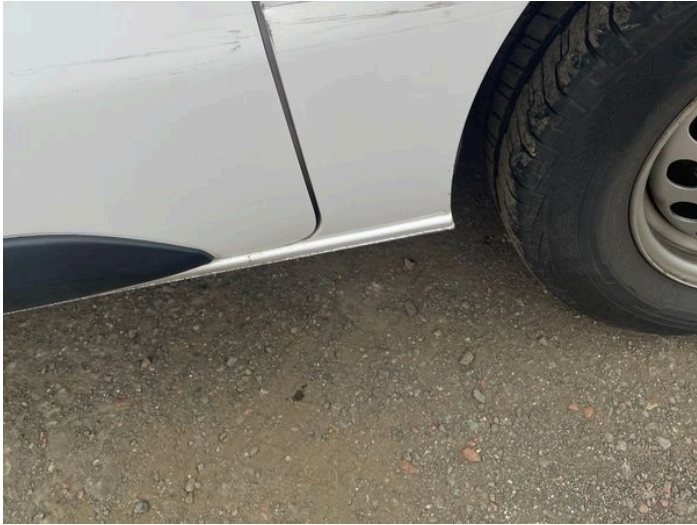
6: Panel Rear  
Scratched  
Over 25mm Thru Paint
