# VEHICLE INSPECTION REPORT

**AU20LTY**

## Renault Master

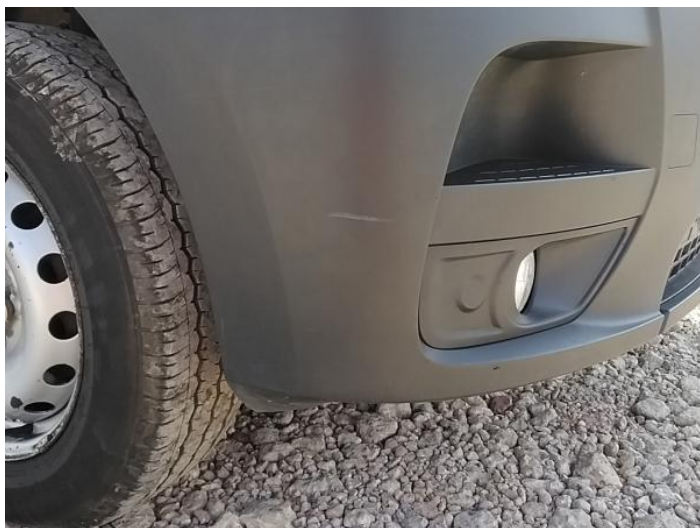
1: Bumper Front  
Scratched  
Over 25mm Not Thru Paint

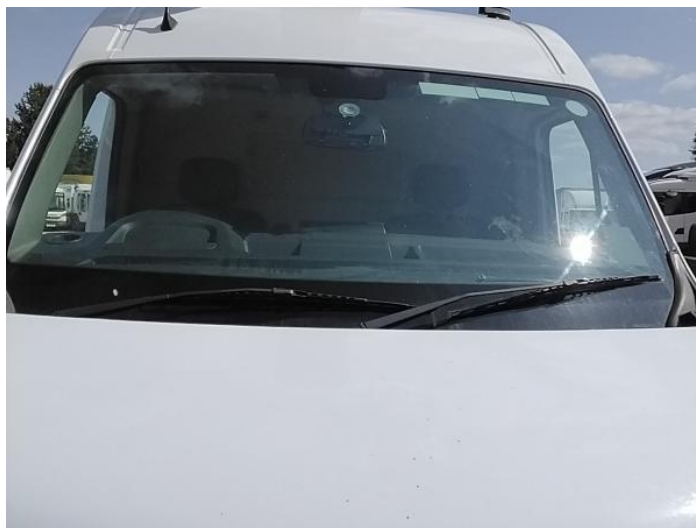
2: Screen Front  
Chipped  
UpTo 10mm

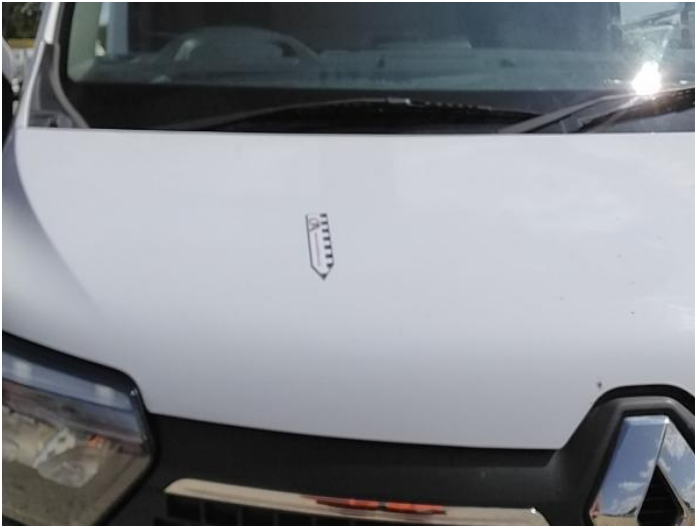
3: Bonnet  
Chipped  
Multiple Chips

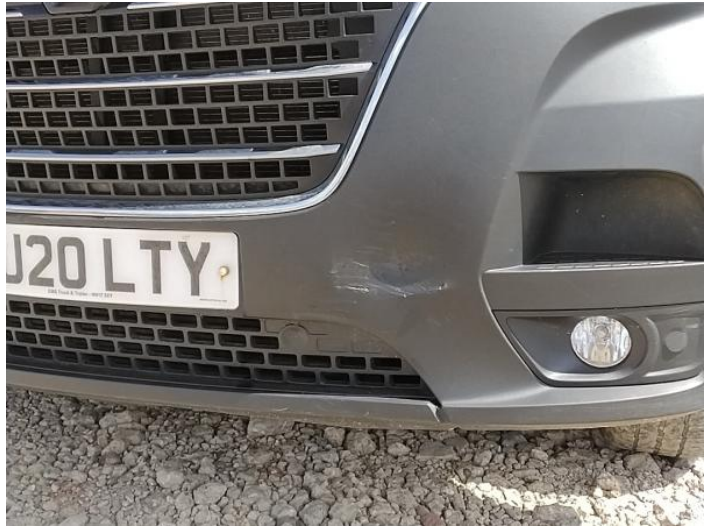
4: Bumper Front  
Dented  
Over 30mm

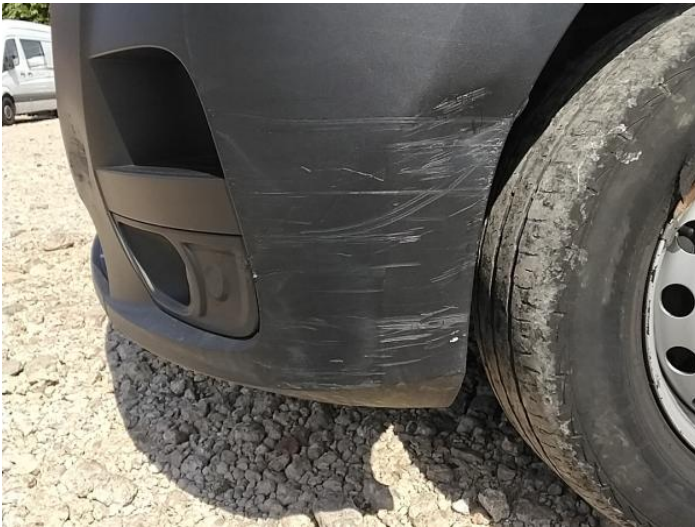
5: Bumper Front  
Scratched  
Over 25mm Not Thru Paint

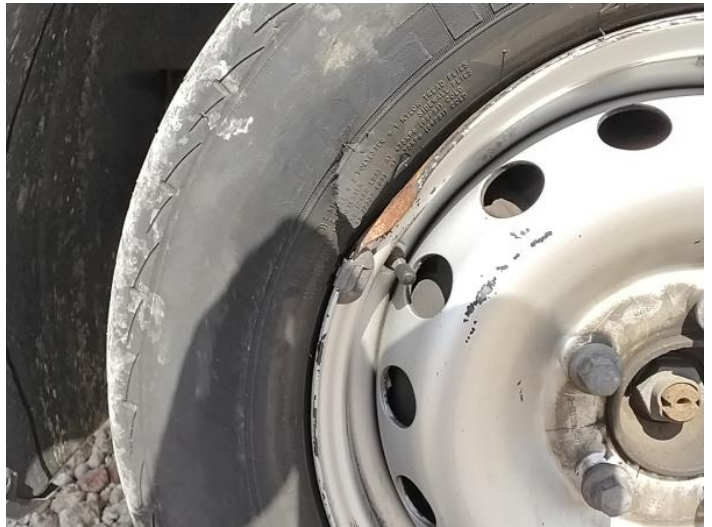
6: Wheel nsf  
Dented  
Over 30mm (Steel)

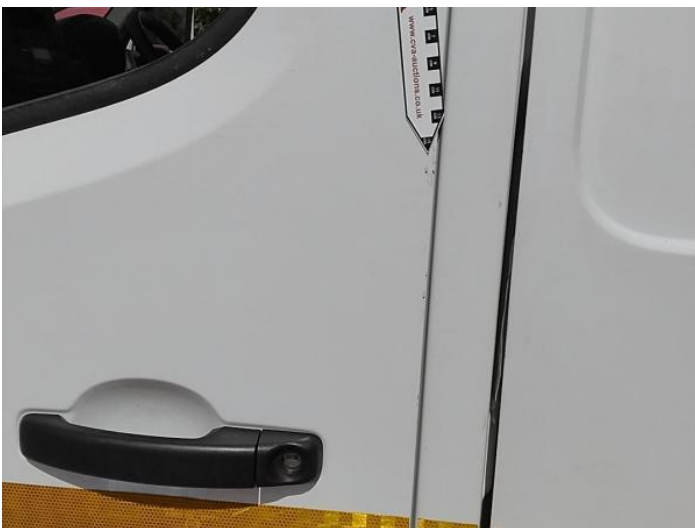
7: Door nsf  
Chipped  
Edge Chip

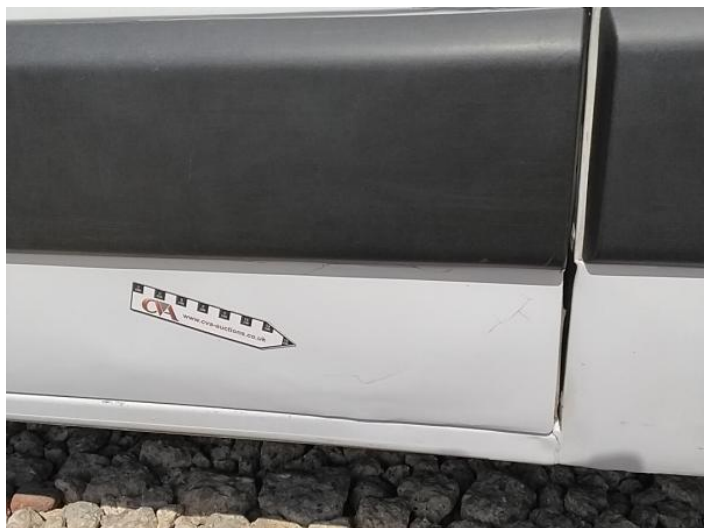
8: Door nsr  
Cracked  
Replace

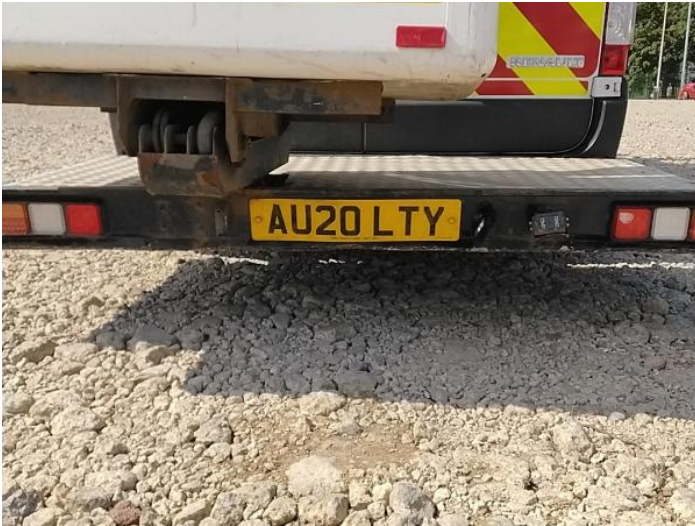
9: Bumper Rear  
Dented  
With Paint Damage

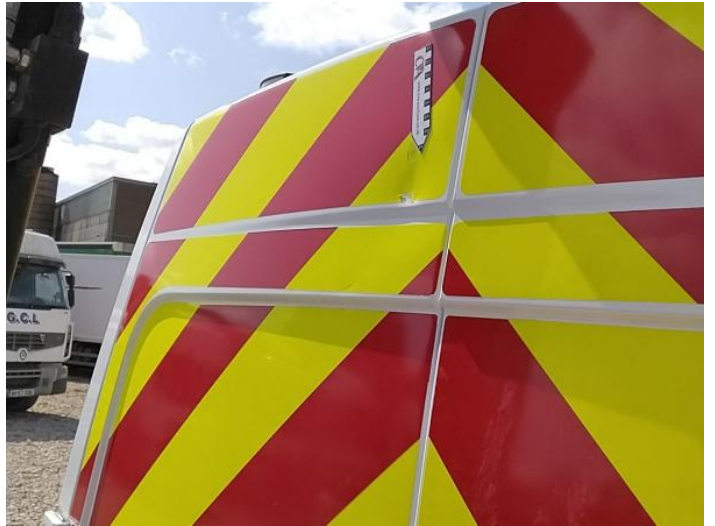
10: Door nsr  
Dented  
Over 30mm

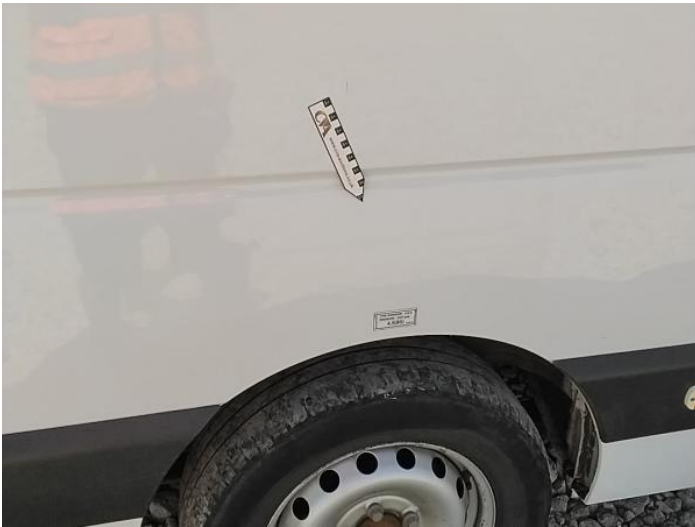
11: Qtr Panel osr  
Dented  
Over 30mm

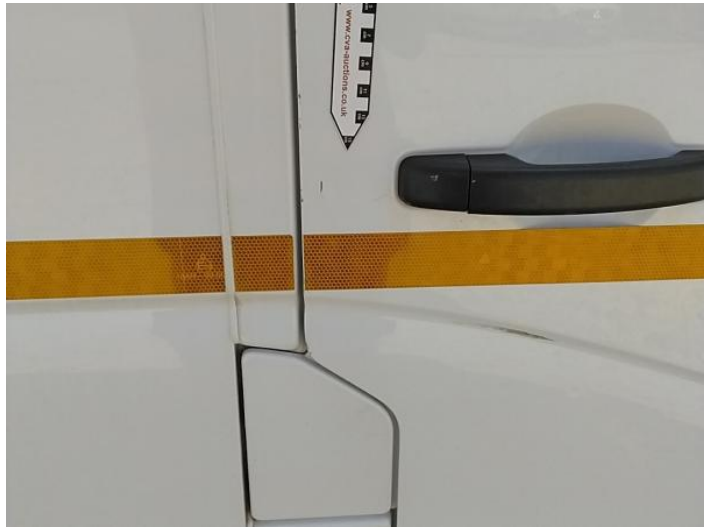
12: Door osf  
Dented  
Over 2 UpTo 10mm

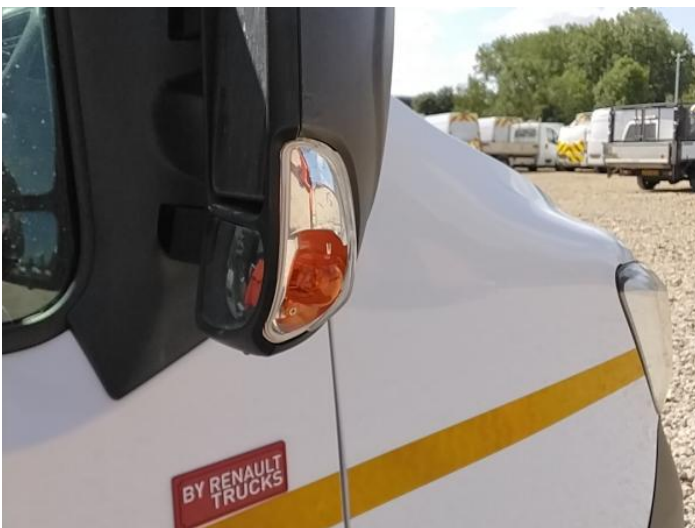
13: Door Mirror Assy osf  
Broken  
Replace

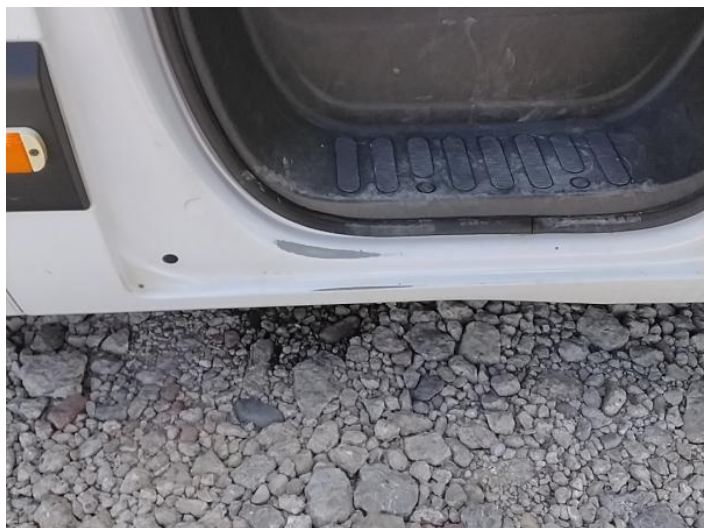
14: General Exterior  
Soiled  
Light
