# VEHICLE INSPECTION REPORT

**BG18UBK**

## Nissan Navara Tekna 2.3dCi 190PS

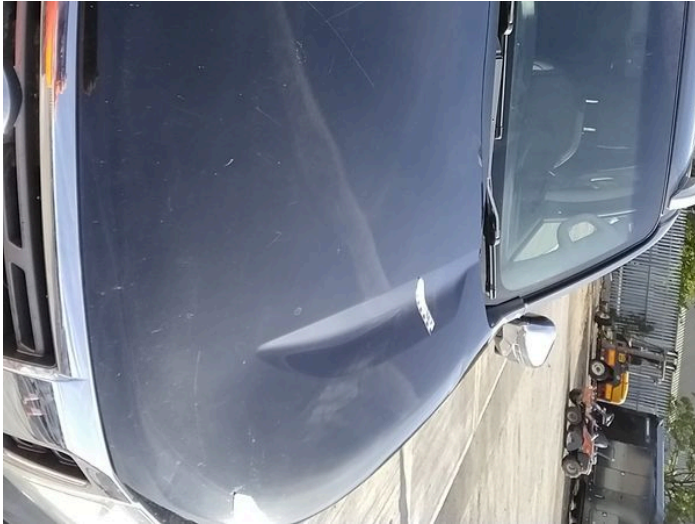
1: Bonnet  
Scratched  
Over 25mm Thru Paint

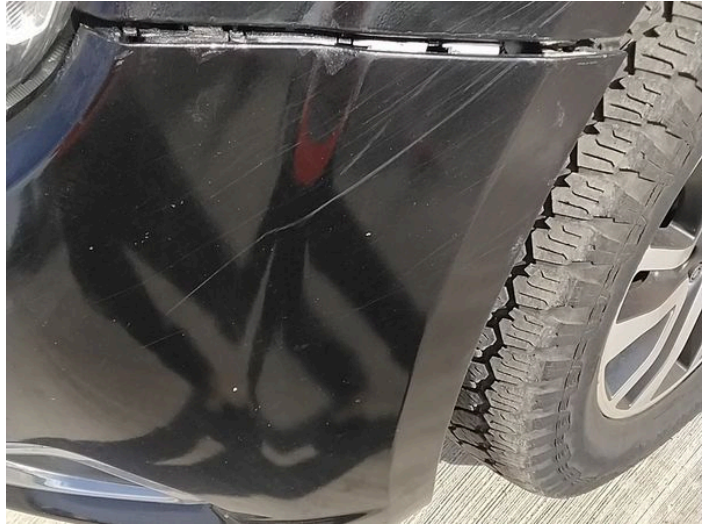
2: Bumper Front  
Insecure  
Action Required

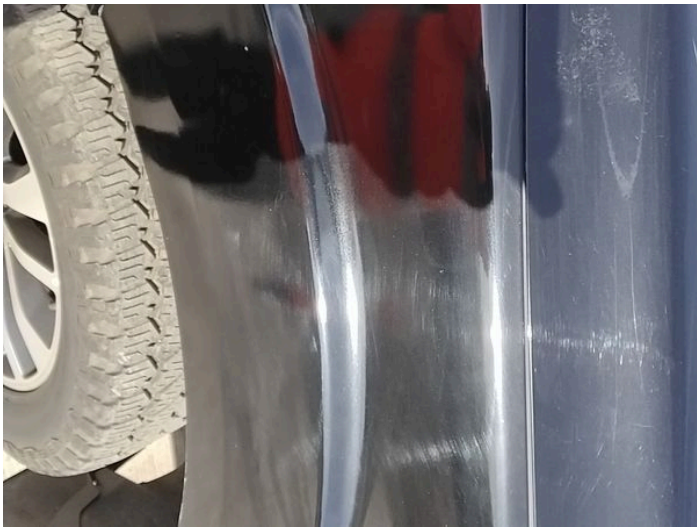
3: Wing nsf  
Poor Previous Repair  
Poor Paint

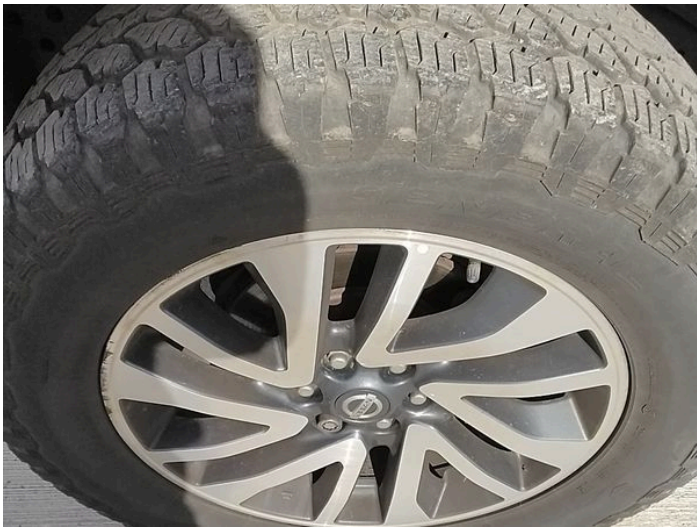
4: Wheel nsf  
Scratched  
Over 50mm

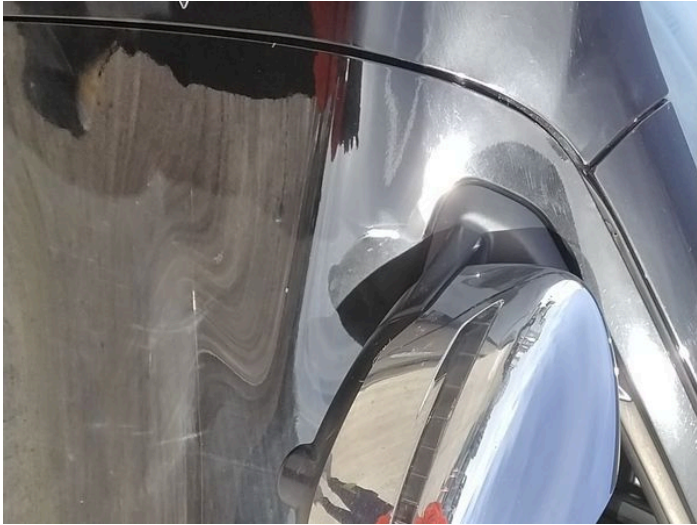
5: Door nsf  
Scratched  
Over 25mm Thru Paint

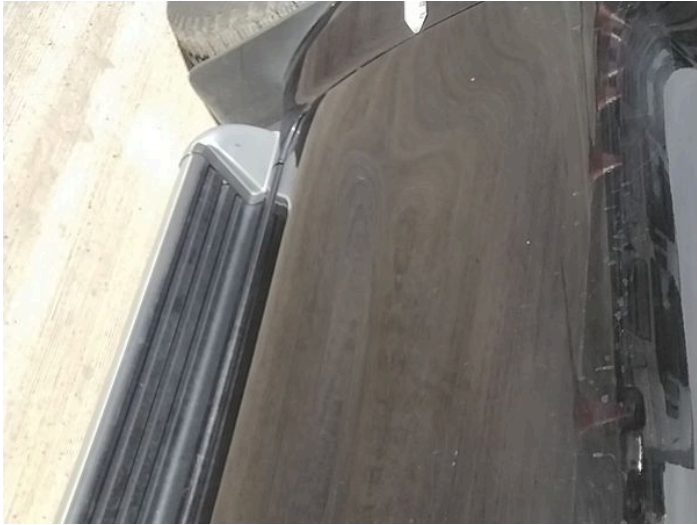
6: Door nsf  
Scratched  
Over 25mm Not Thru Paint

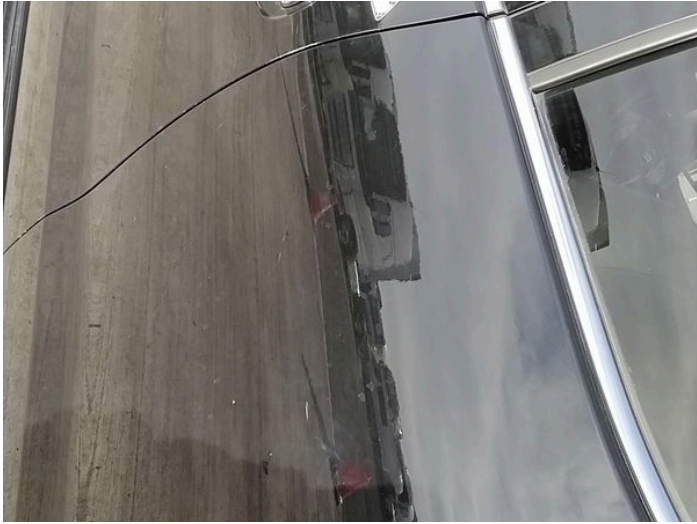
7: Door nsr  
Scratched  
Over 25mm Thru Paint

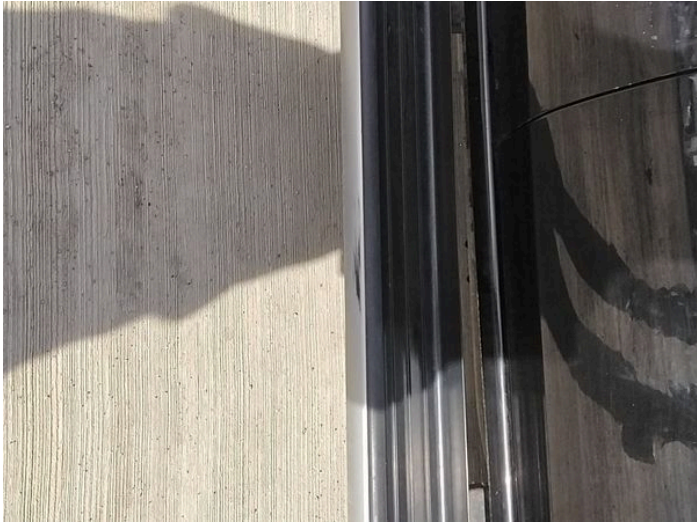
8: Qtr Panel Moulding ns  
Scuffed (Unpainted)  
Over 100mm

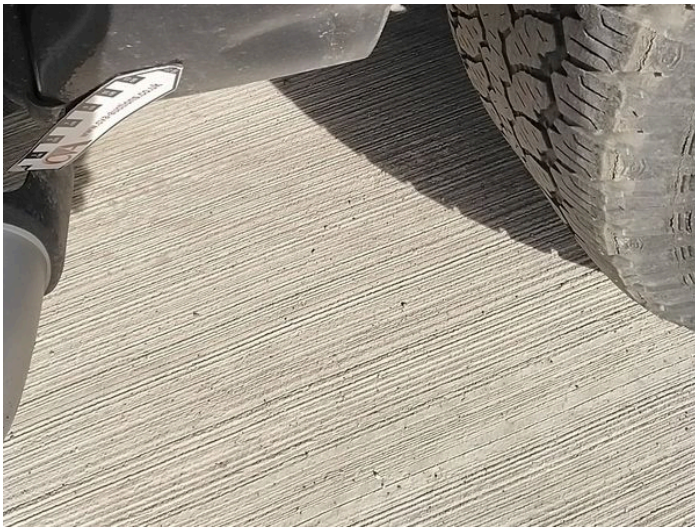
9: Qtr Panel nsr  
Dented  
Over 30mm

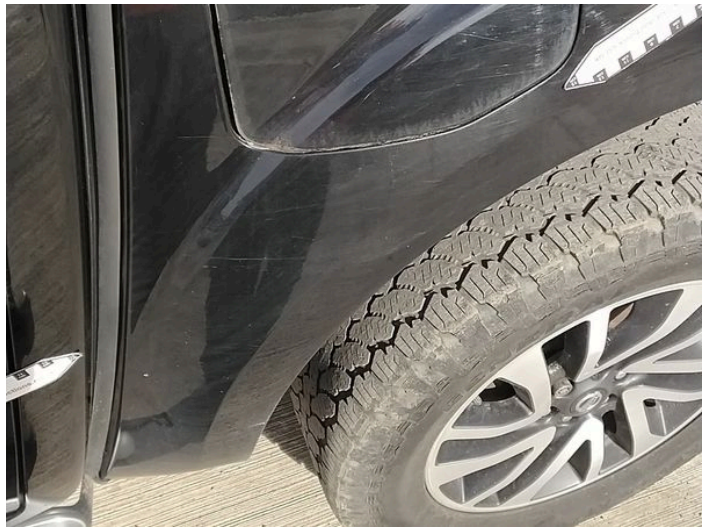
10: Qtr Panel nsr  
Scratched  
Over 25mm Thru Paint

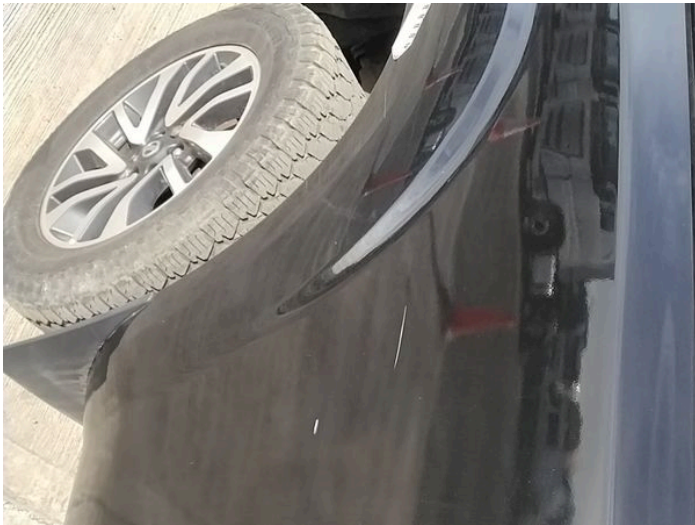
11: Qtr Panel nsr  
Scratched  
Over 25mm Thru Paint

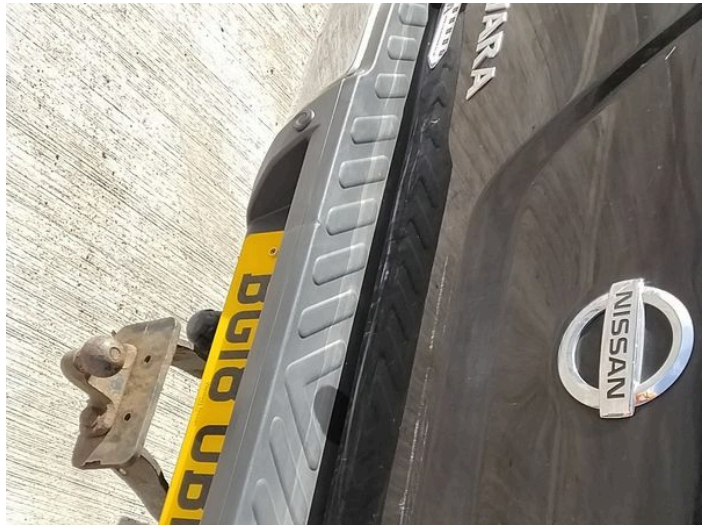
12: Tailgate  
Scratched  
Over 25mm Thru Paint

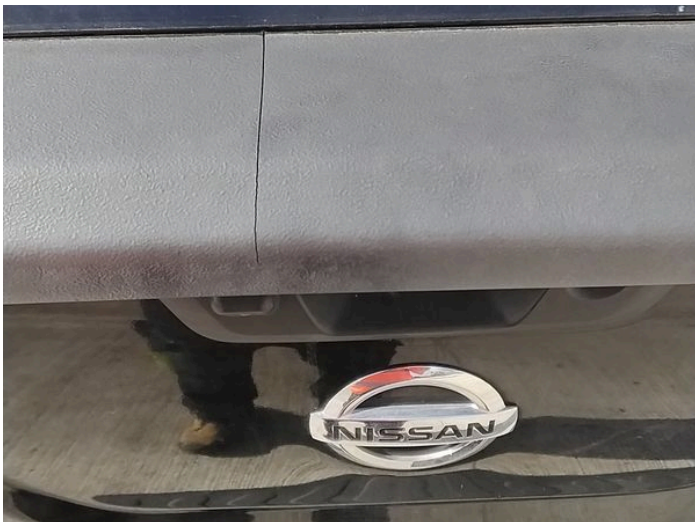
13: Tailgate Trim Panel  
Broken  
Replace

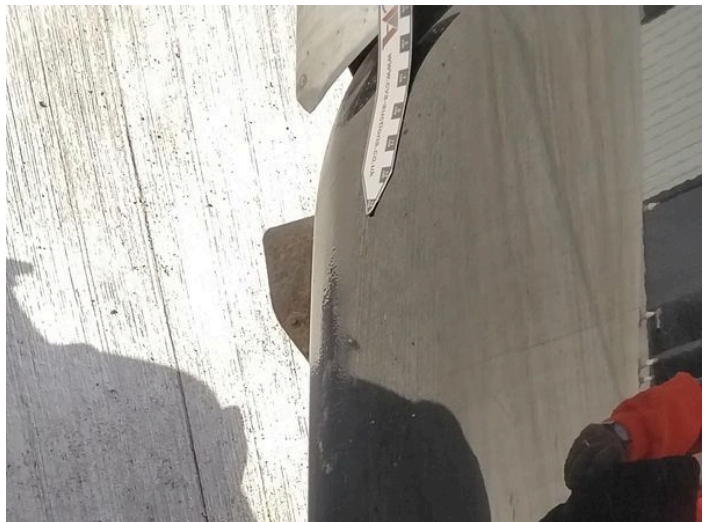
14: Qtr Panel osr  
Dented  
With Paint Damage

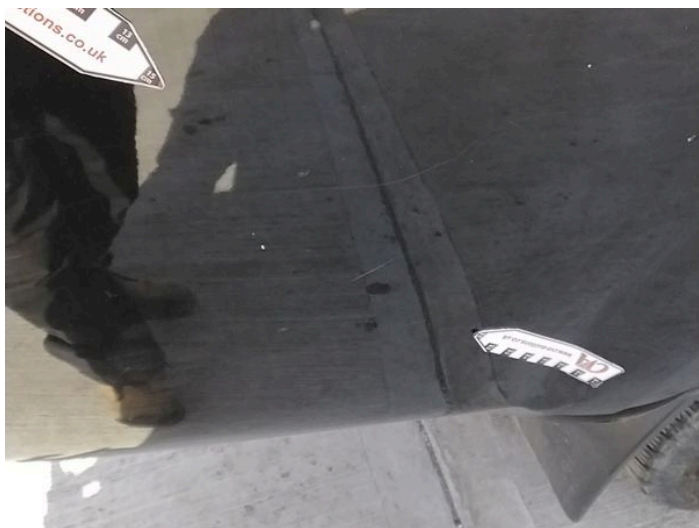
15: Qtr Panel osr  
Scratched  
Over 25mm Thru Paint

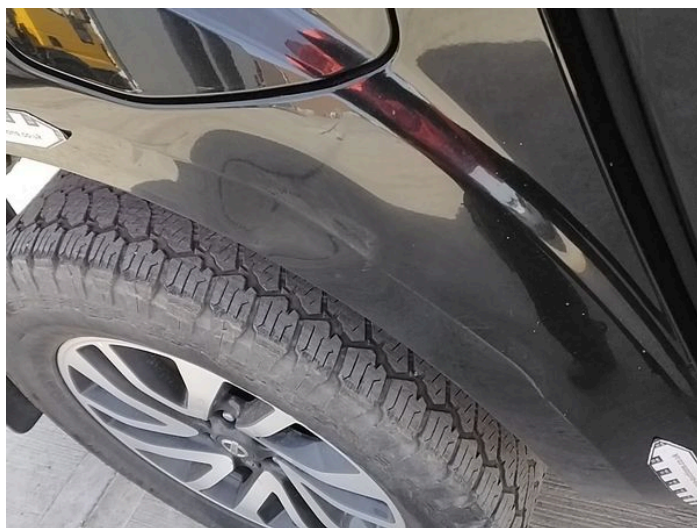
16: Qtr Panel osr  
Dented  
With Paint Damage

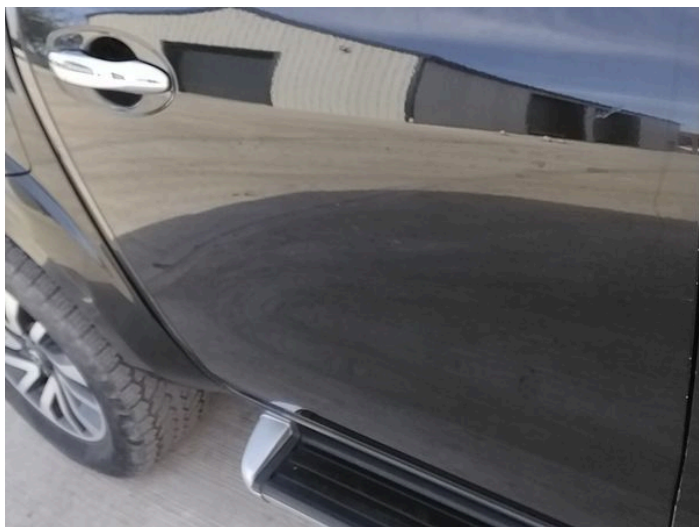
17: Door osr  
Chipped  
Multiple Chips

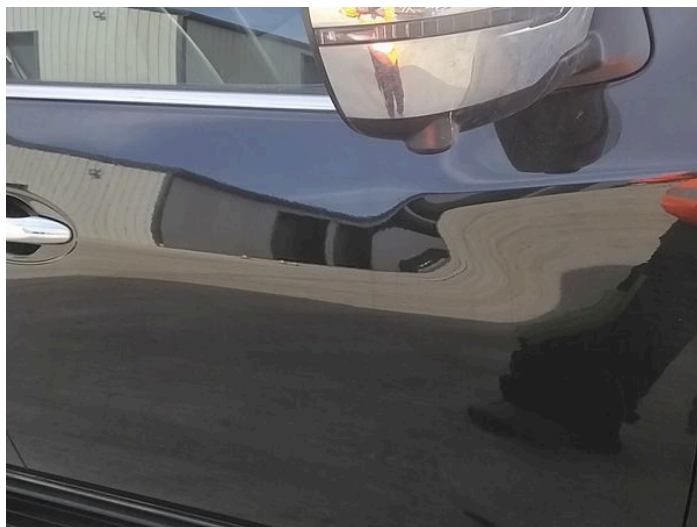
18: Door osf  
Chipped  
Multiple Chips

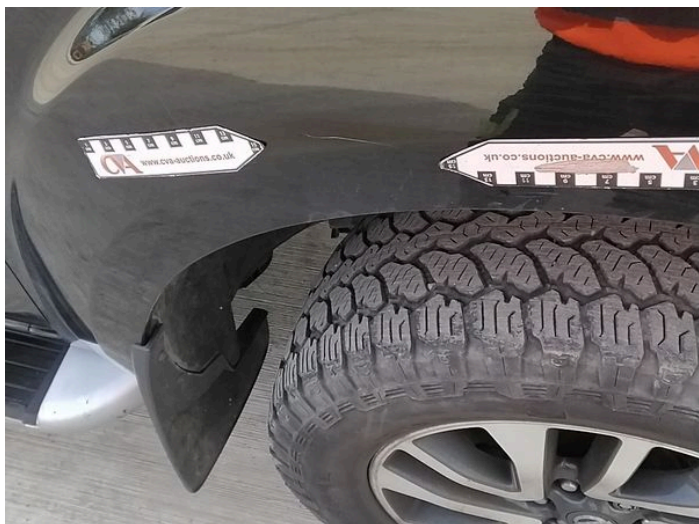
19: Wing osf  
Scratched  
Over 25mm Thru Paint

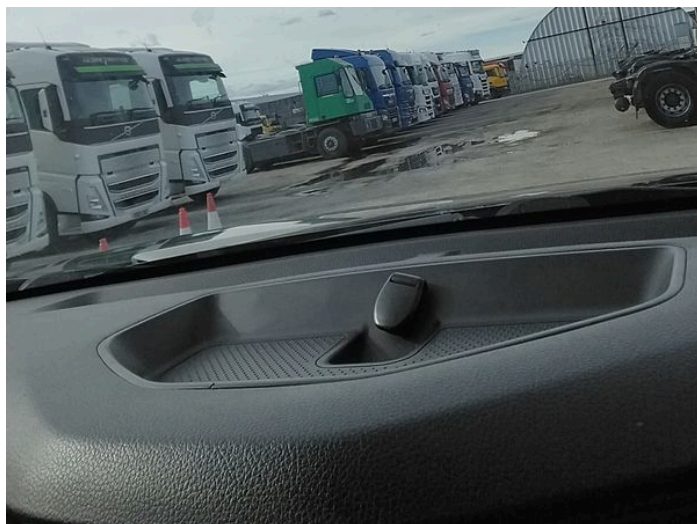
20: Screen Front  
Chipped  
Over 10mm

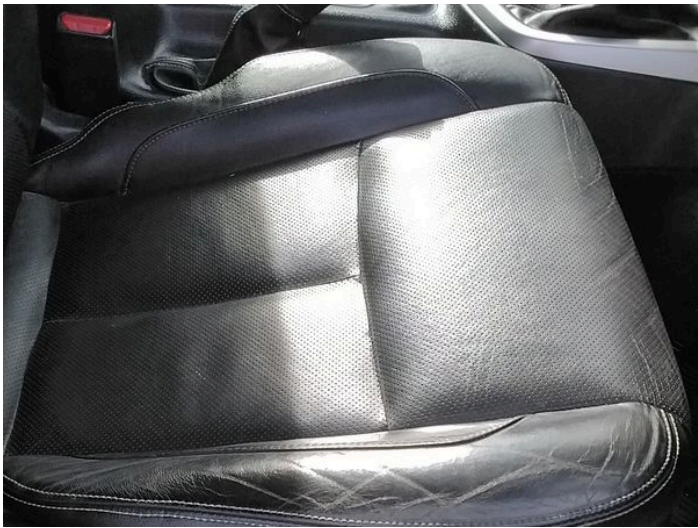
21: Seat Base Cover osf  
Torn  
Over 3mm

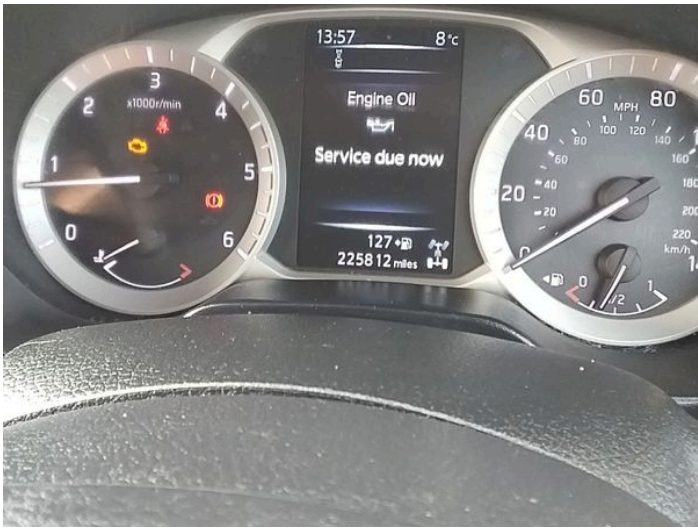
22: Dash Warning Lights  
Displayed  
No Action

| EML light illuminated | | Fault | DPF light illuminated | | OK |
| ABS light illuminated | | OK | Service indicator light illuminated | | Fault |
