# **VEHICLE INSPECTION REPORT**

PF19TZZ

# **Daf CF 410**

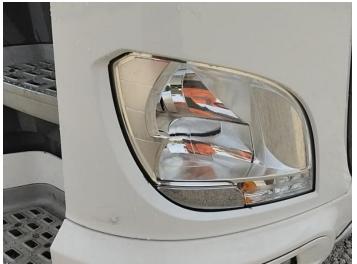
1: Fog Lamp Surround os Scratched (Painted) Over 25mm Thru Paint

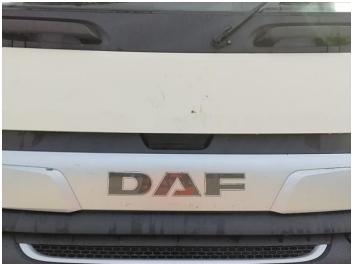
2: Bonnet Scratched Over 25mm Thru Paint

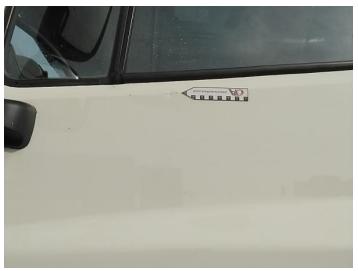
3: Door nsf Dented Over 2 UpTo 10mm

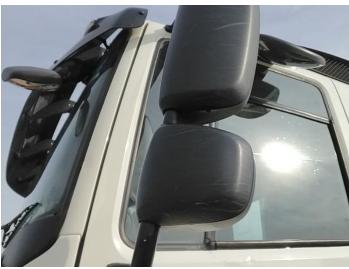
4: Door Mirror Assy nsf Scuffed (Unpainted) Over 100mm

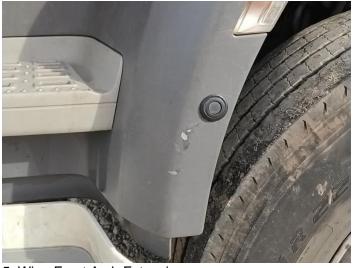
5: Wing Front Arch Extension ns Scuffed (Unpainted) Over 100mm

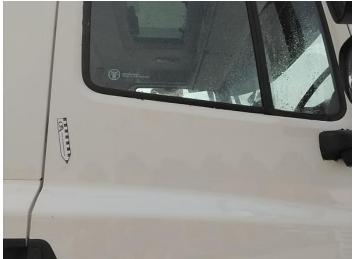
6: Door osf Dented Over 2 UpTo 10mm

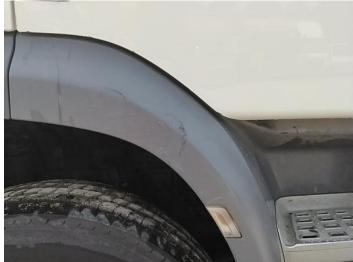
7: Wing Front Arch Extension os Scuffed (Unpainted) Over 100mm

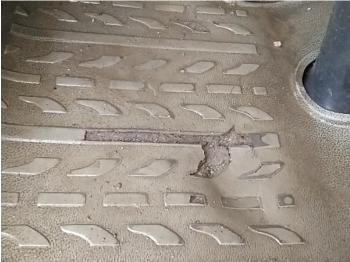
8: Carpets Front Holed Over 3mm

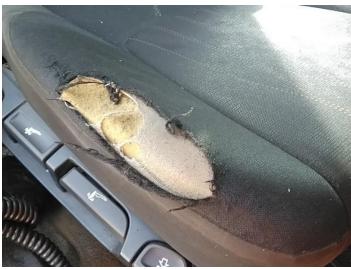
9: Seat Base Cover osf Torn Over 3mm
