VEHICLE INSPECTION REPORT

BD64DTK

Iveco Daily 50C15

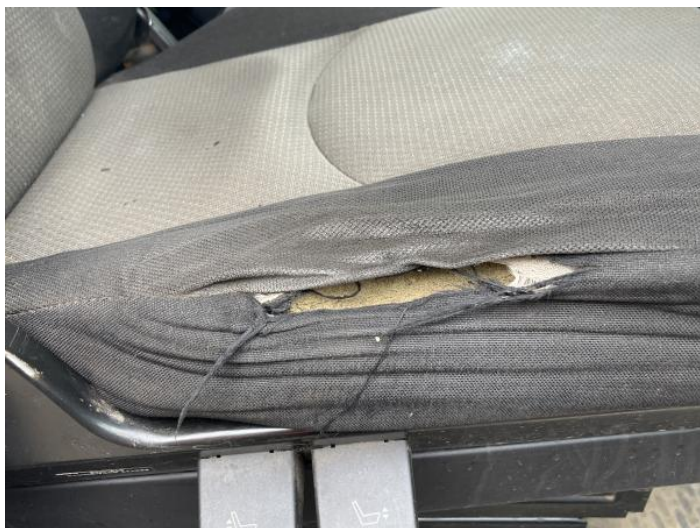
1: Seat Base Cover osf
Torn
Over 3mm

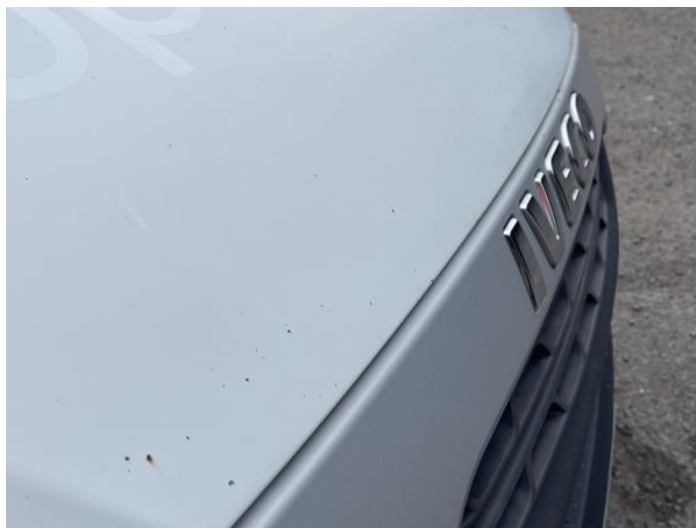
2: Bonnet
Dented
With Paint Damage

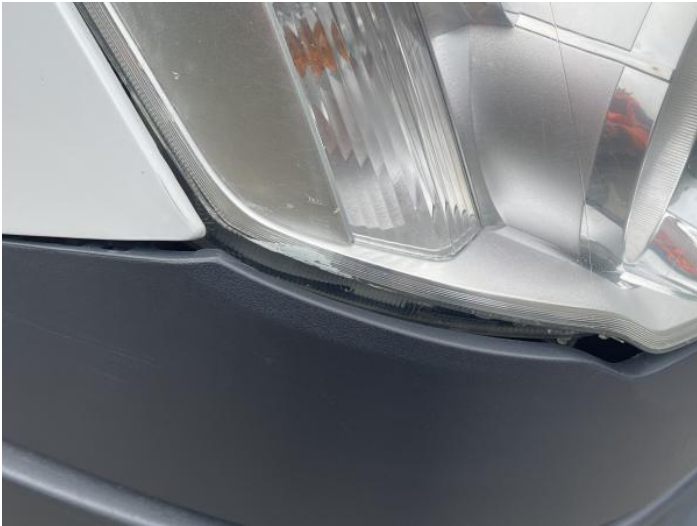
3: Bumper Front Moulding
Scuffed (Unpainted)
Over 100mm

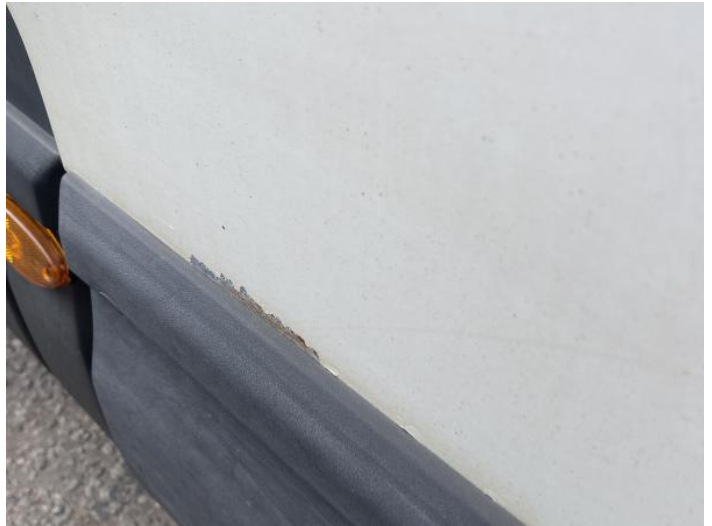
4: Door osf
Rusted
Over 5mm

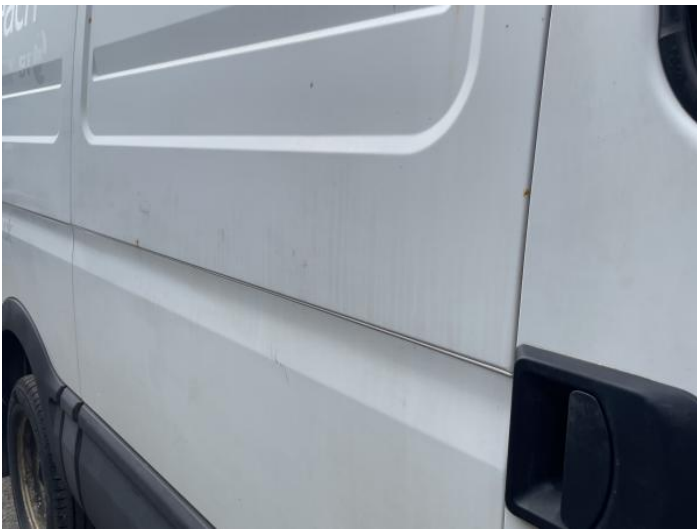
5: Qtr Panel osr
Rusted
Over 5mm

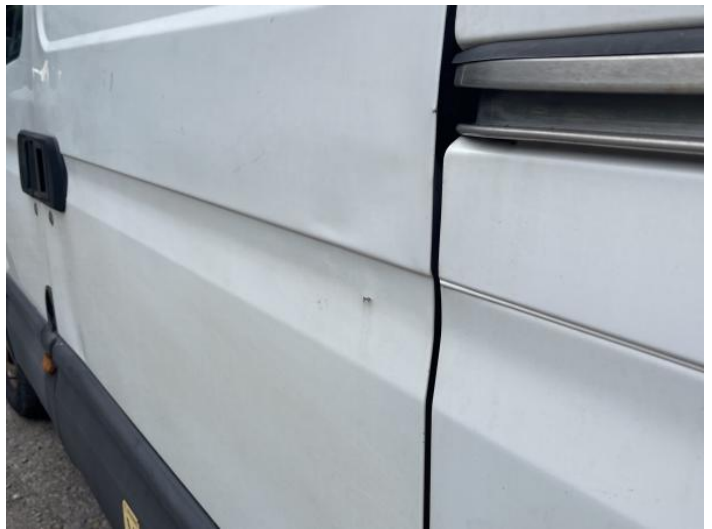
6: Door nsr
Dented
With Paint Damage

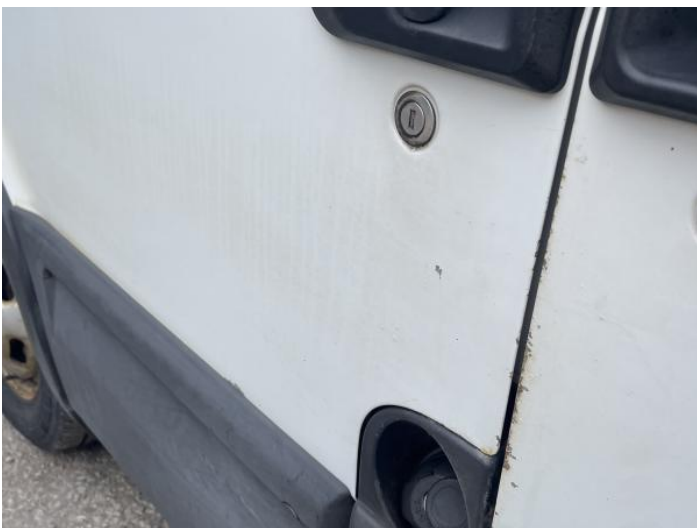
7: Door nsf
Rusted
Over 5mm

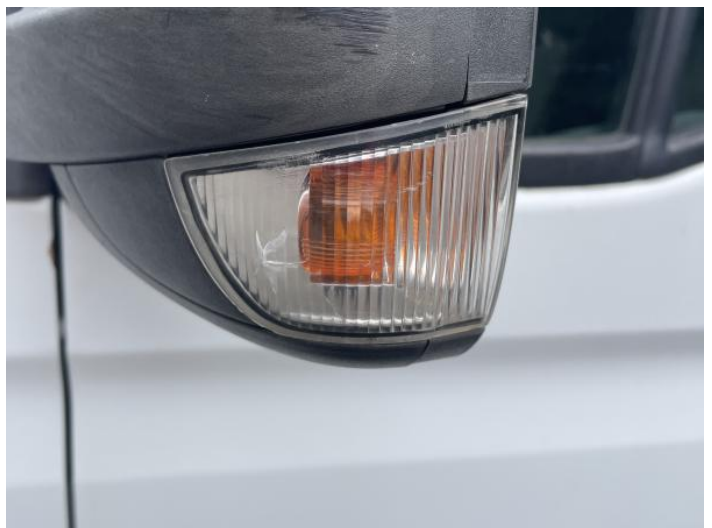
8: Flasher Side Repeater ns
Broken
Replace
