VEHICLE INSPECTION REPORT

Volvo B9R PLAXTON PANTHER

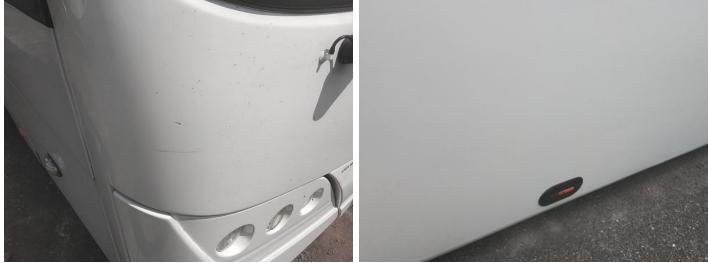
1: Bonnet Scratched Over 25mm Not Thru Paint

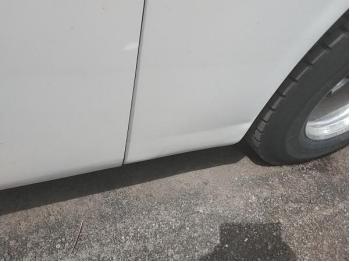
2: Qtr Panel nsr Dented Over 30mm

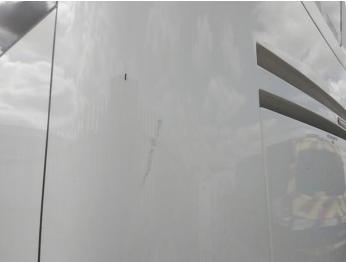
3: Qtr Panel nsr Dented Over 30mm

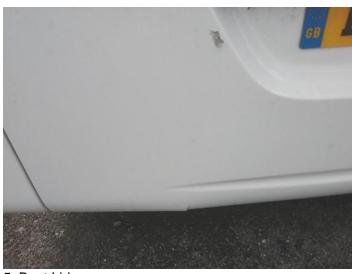
5: Boot Lid Cracked Replace

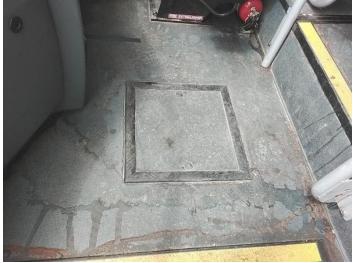
6: Carpets Front Soiled Heavy

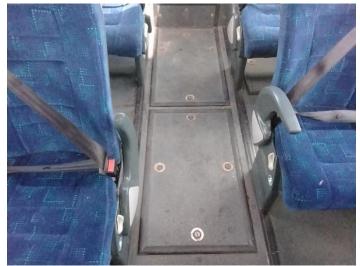
7: Carpets Rear Soiled Heavy

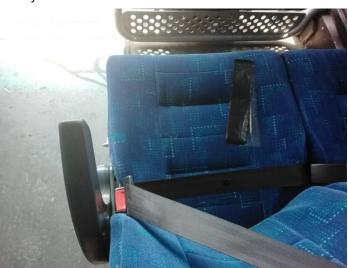
8: Seat Base Cover osr Torn Over 3mm
