VEHICLE INSPECTION REPORT

EF67KUK

Mercedes-Benz Sprinter 314 CDI

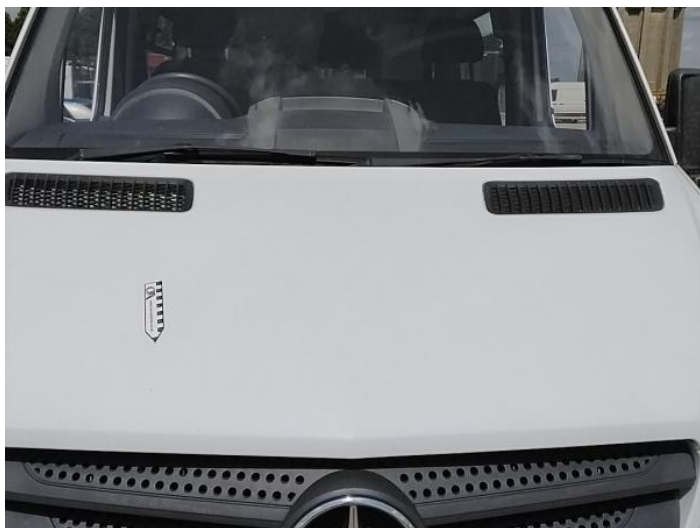
1: Bonnet
Chipped
Multiple Chips

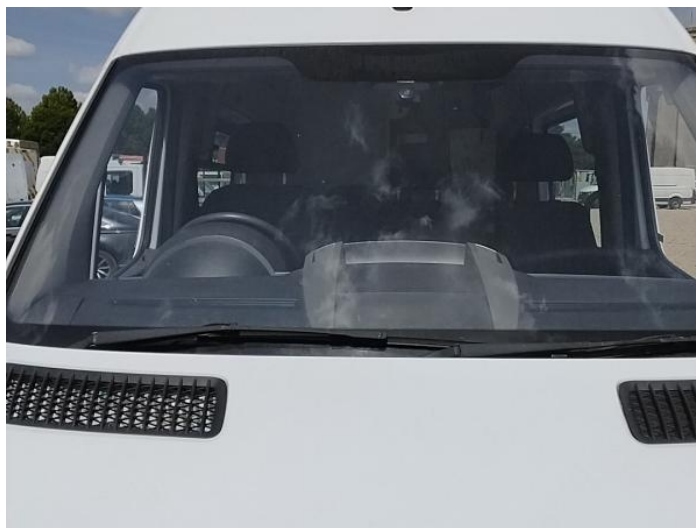
2: Screen Front
Chipped
Over 10mm

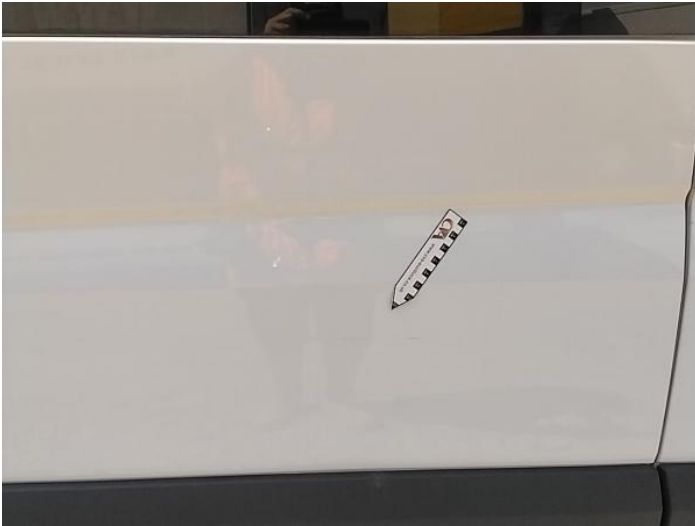
3: Door nsr
Scratched
Over 25mm Not Thru Paint

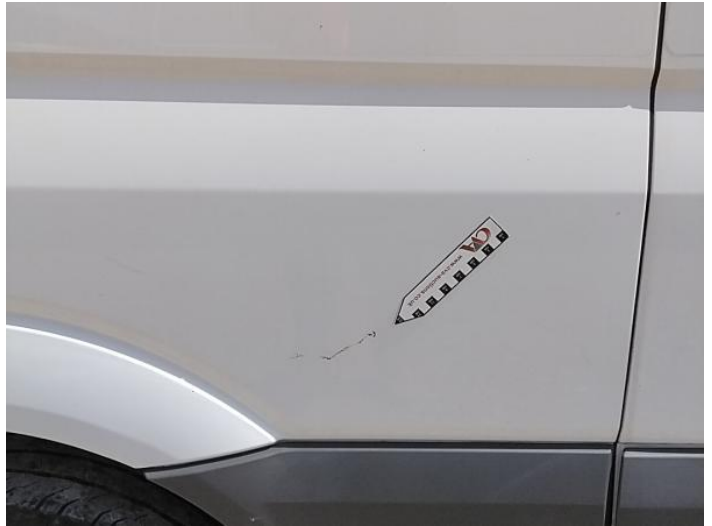
4: Qtr Panel osr
Scratched
Over 25mm Not Thru Paint

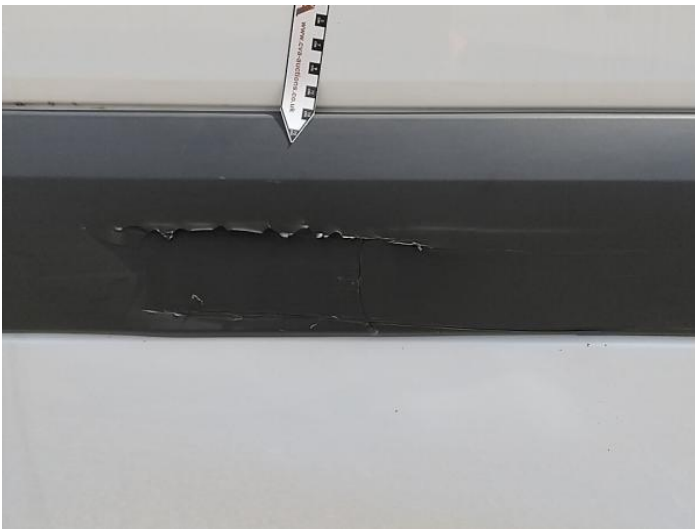
5: Qtr Panel osr
Cracked
Replace

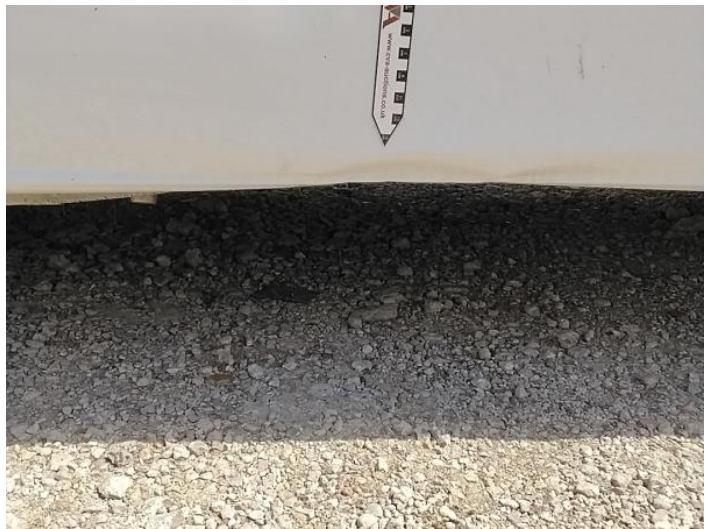
6: Sill os
Dented
Over 30mm

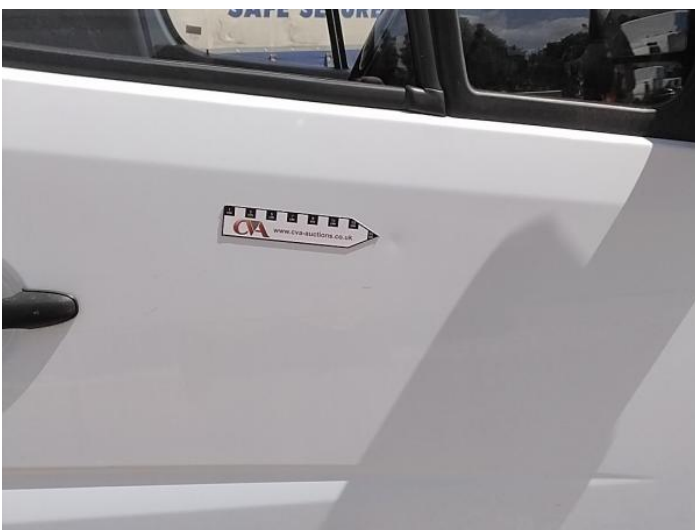
7: Door osf
Dented
Over 2 UpTo 10mm
