# VEHICLE INSPECTION REPORT

**PO18SCV**

## Daf CF 460

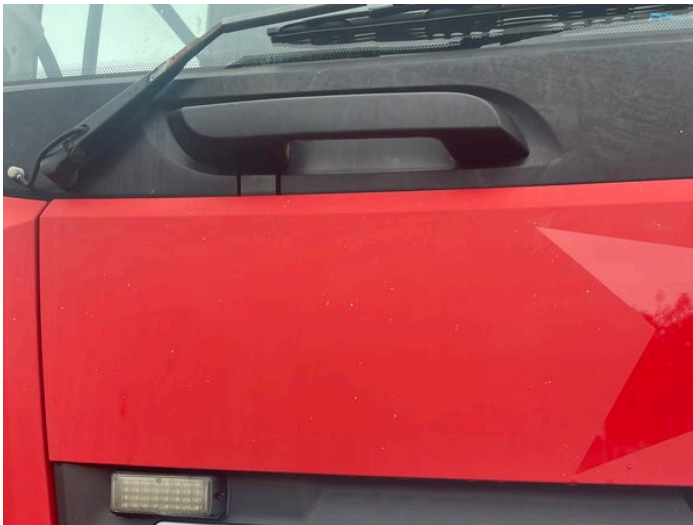
1: Bonnet  
Chipped  
Multiple Chips

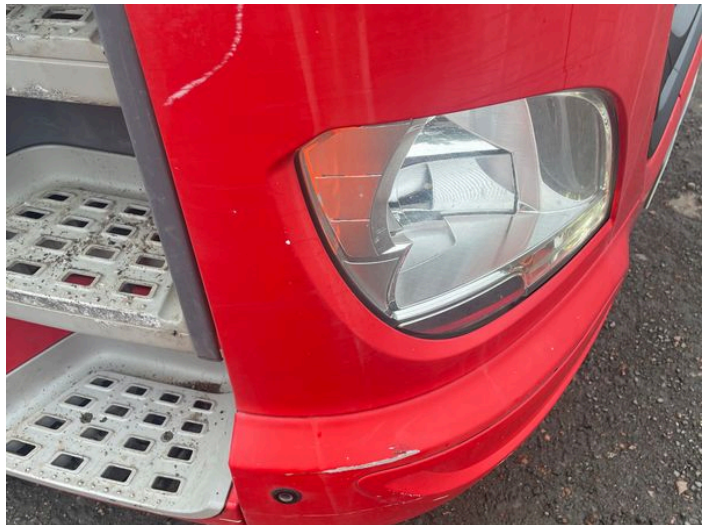
2: Qtr Panel Moulding os  
Scratched (Painted)  
Over 25mm Thru Paint

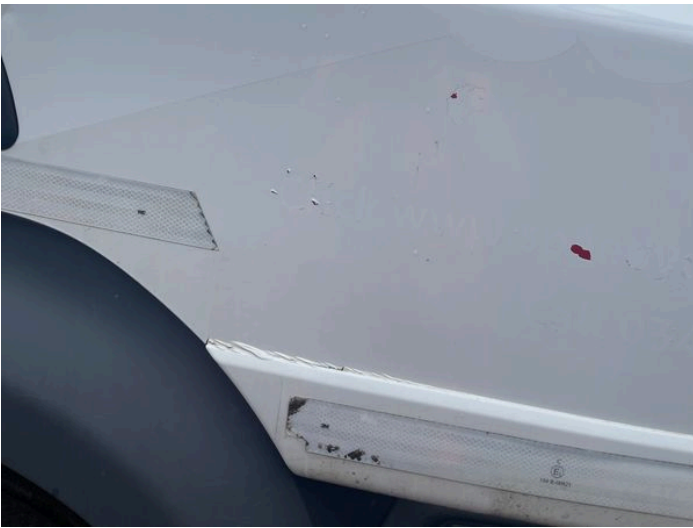
3: Door osf  
Chipped  
Multiple Chips

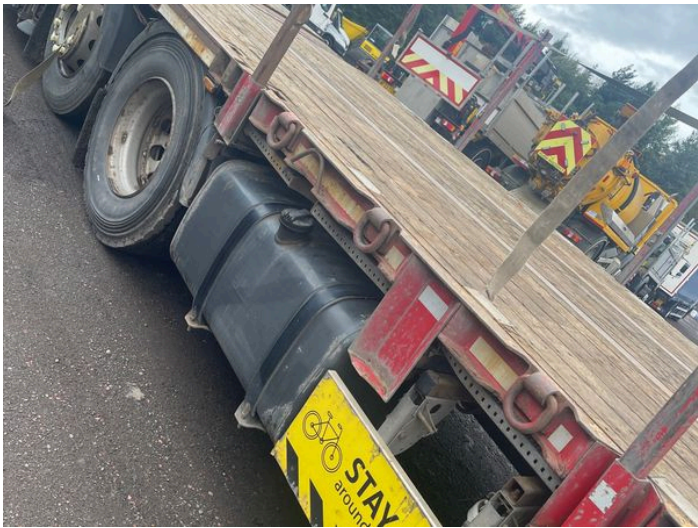
4: Qtr Panel osr  
Rusted  
Over 5mm

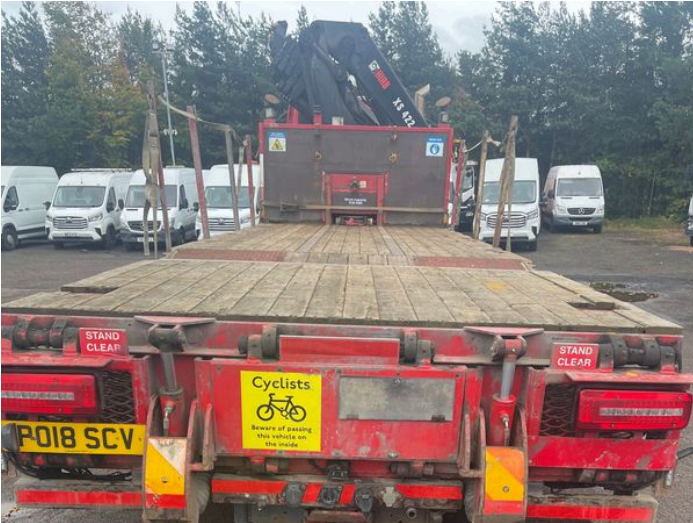
5: Tailgate  
Rusted  
Over 5mm

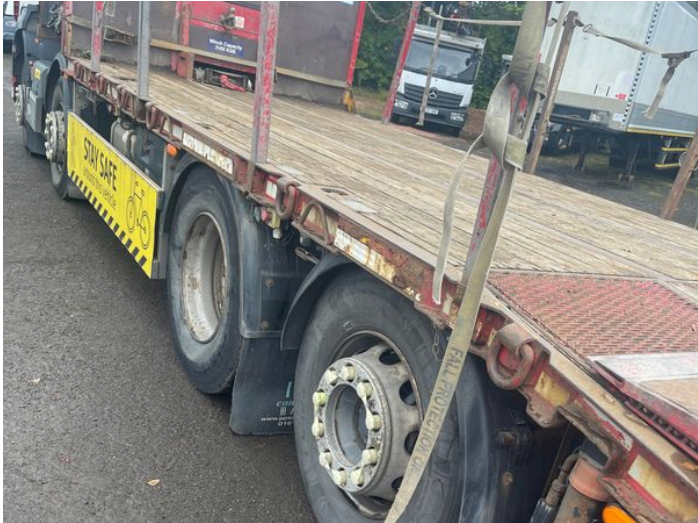
6: Qtr Panel nsr  
Rusted  
Over 5mm

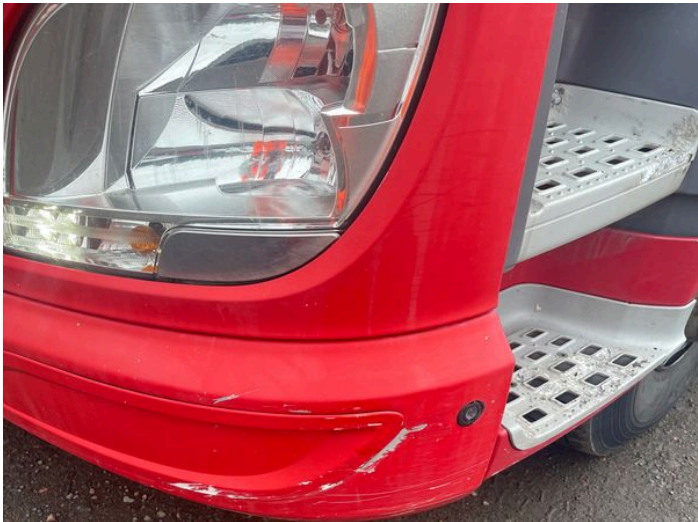
8: Qtr Panel Moulding ns  
Scratched (Painted)  
Over 25mm Thru Paint
