## VEHICLE INSPECTION REPORT

**EJ71AUP**

### Ford Transit Custom 300 2.0 ECOBLUE 130PS LEADER

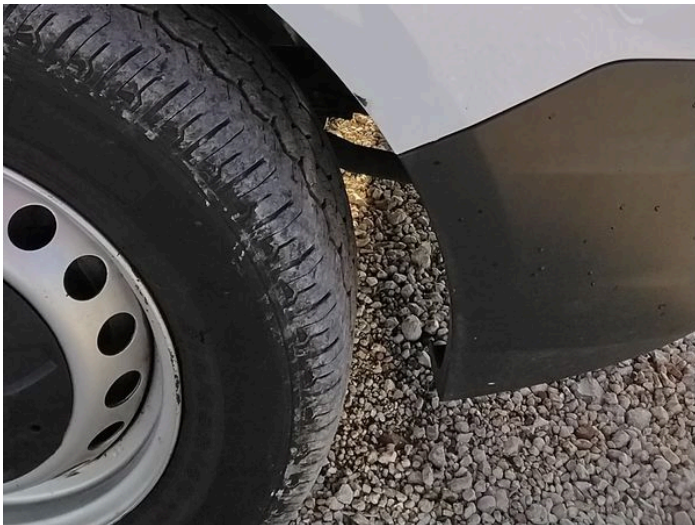
1: Bumper Front  
Scratched  
UpTo 25mm Thru Paint

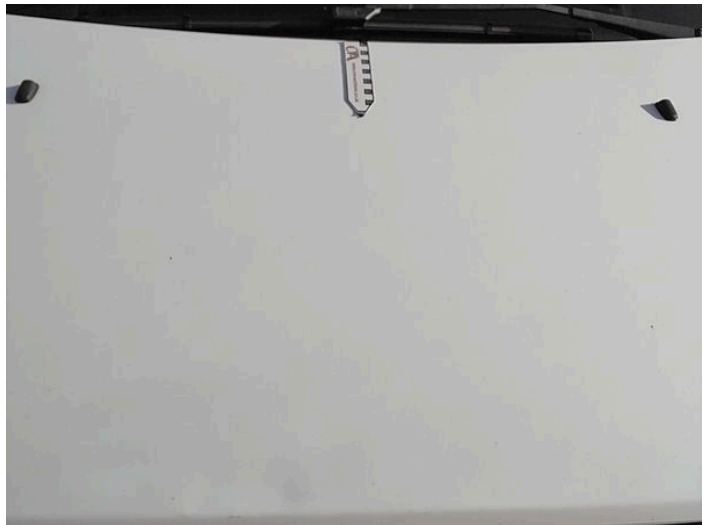
2: Bonnet  
Chipped  
Multiple Chips

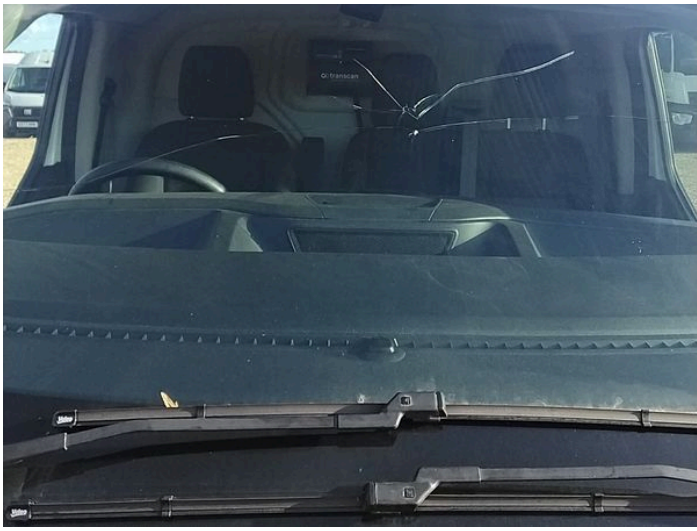
3: Screen Front  
Cracked  
Replace

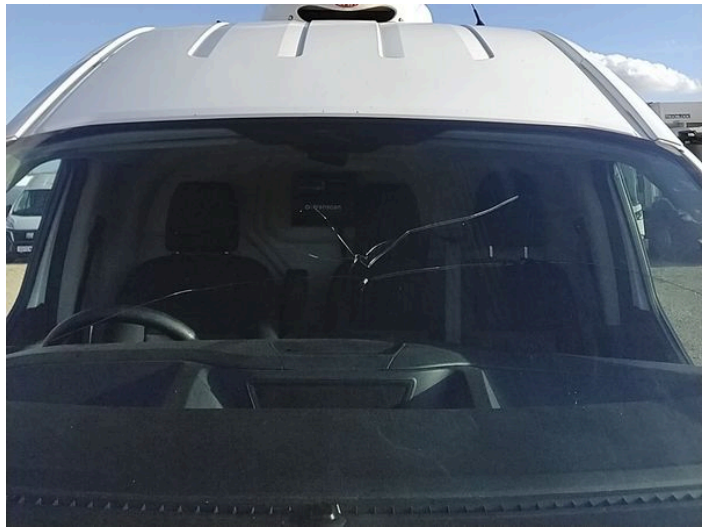
4: Roof  
Rusted  
Over 5mm

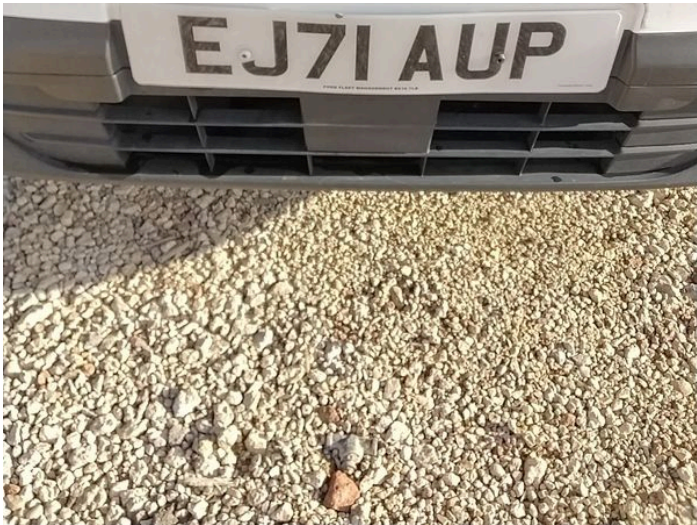
5: Bumper Front  
Scratched  
Over 25mm Not Thru Paint

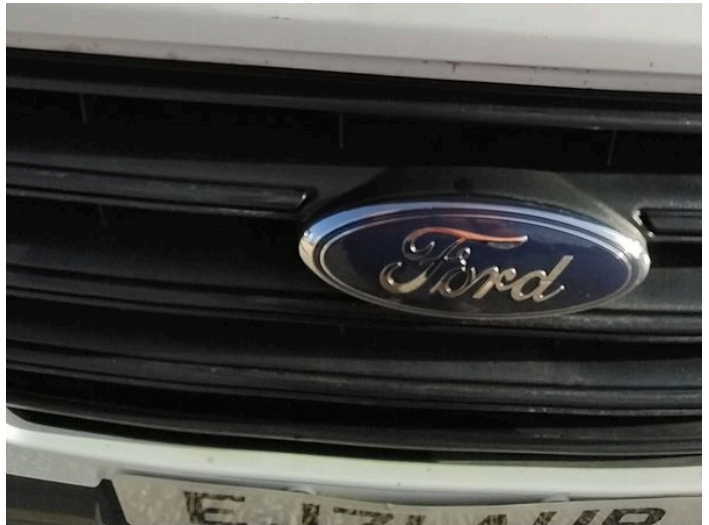
6: Bonnet  
Dented  
Between 10mm + 30mm

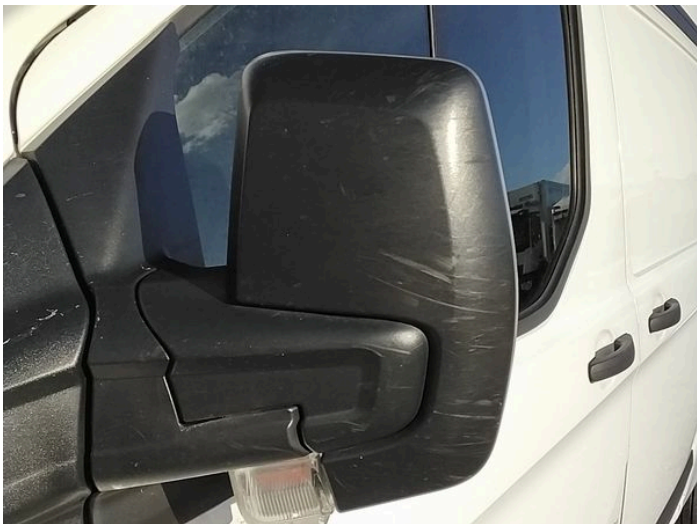
7: Door Mirror Assy nsf  
Scuffed (Unpainted)  
Over 100mm

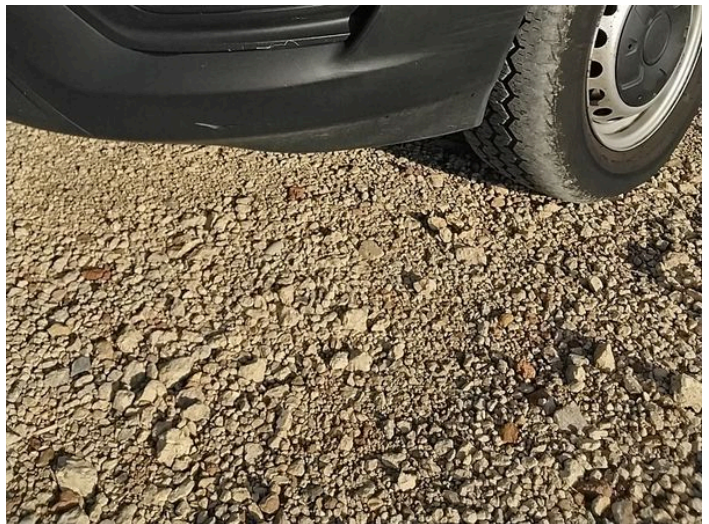
8: Bumper Front Moulding  
Scuffed (Unpainted)  
UpTo 100mm

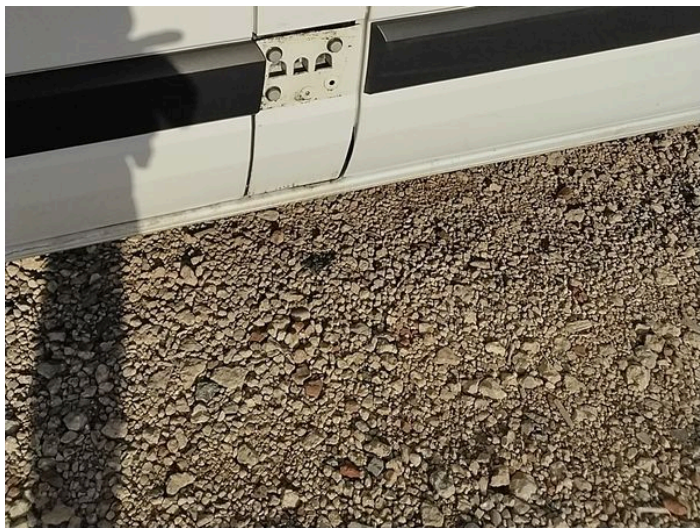
9: Qtr Panel Trim ns  
Missing  
Replace

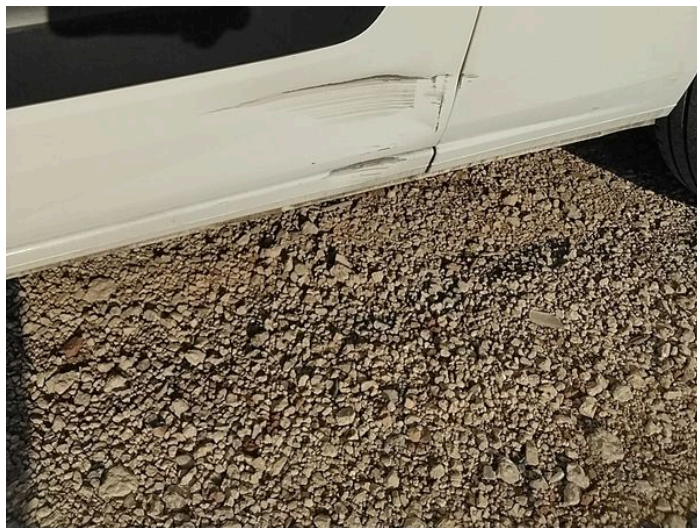
10: Door nsr  
Dented  
With Paint Damage

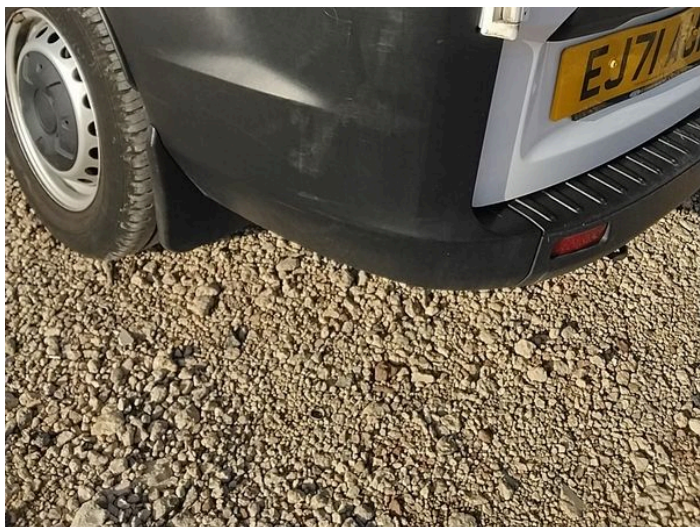
11: Bumper Rear Moulding  
Scuffed (Unpainted)  
Over 100mm

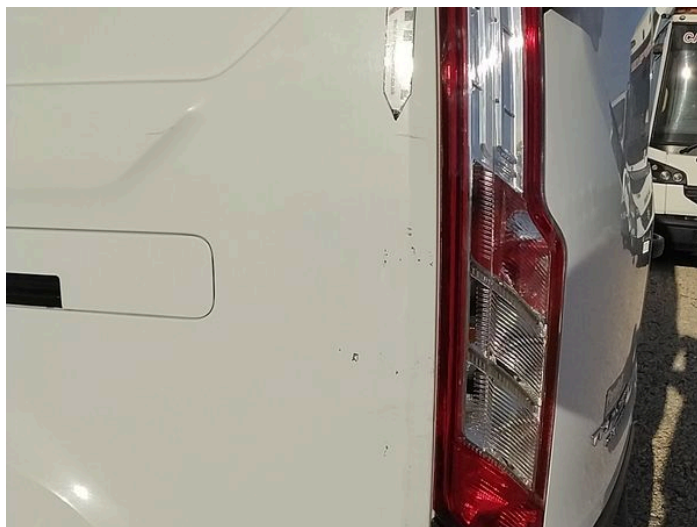
12: Qtr Panel nsr  
Scratched  
Over 25mm Thru Paint

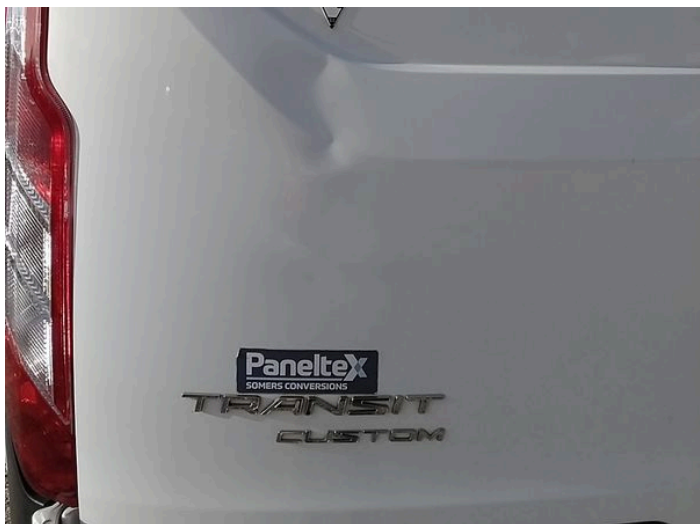
13: Door nsr  
Dented  
Between 10mm + 30mm

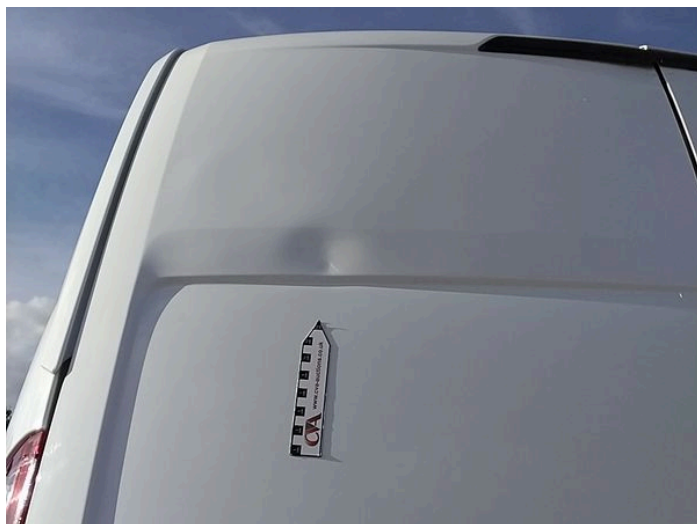
14: Door nsr  
Dented  
Between 10mm + 30mm

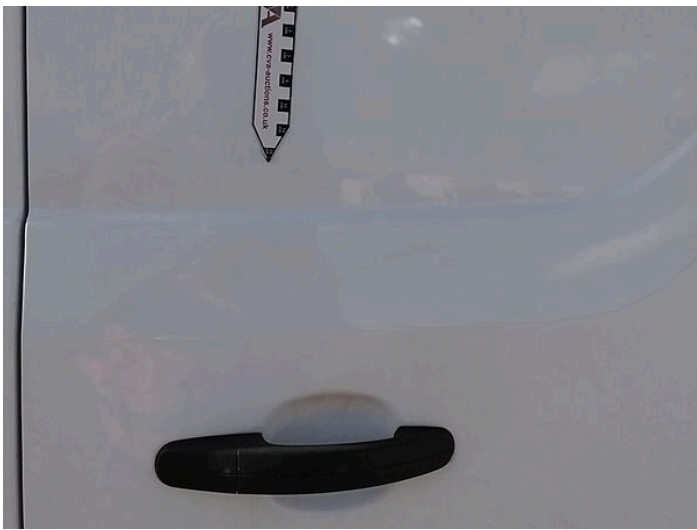
15: Door osr  
Dented  
Between 10mm + 30mm

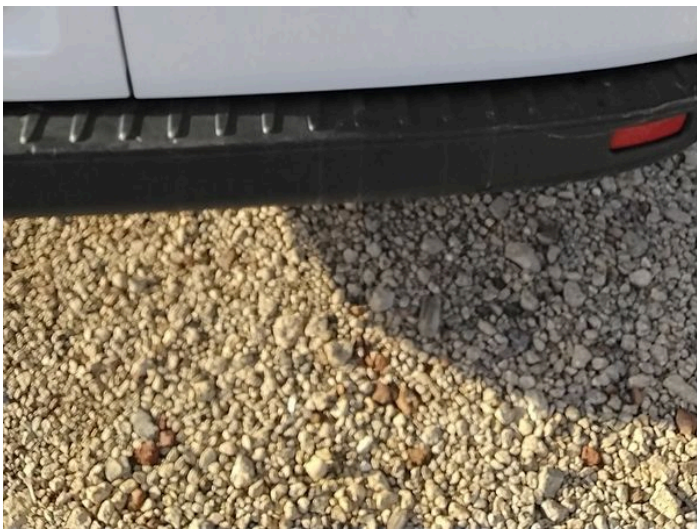
16: Door osr  
Scratched  
Over 25mm Not Thru Paint

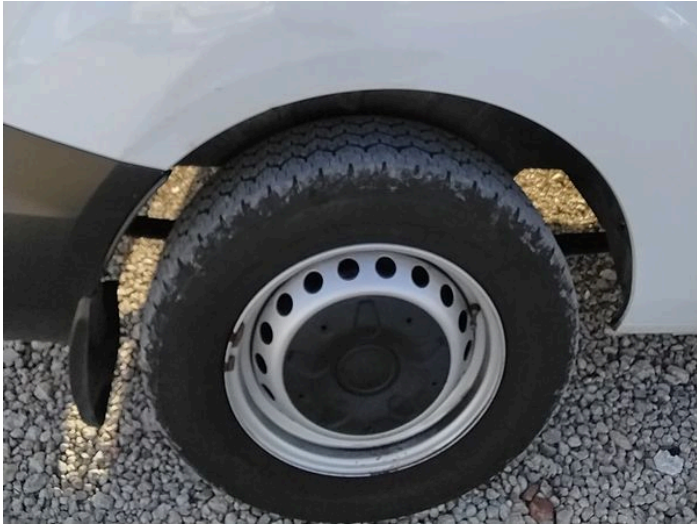
17: Qtr Panel osr  
Dented  
With Paint Damage

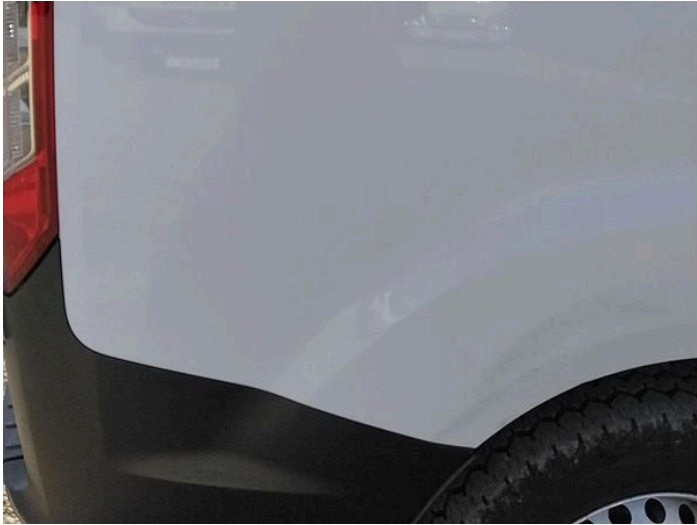
18: Qtr Panel osr  
Scratched  
Over 25mm Thru Paint

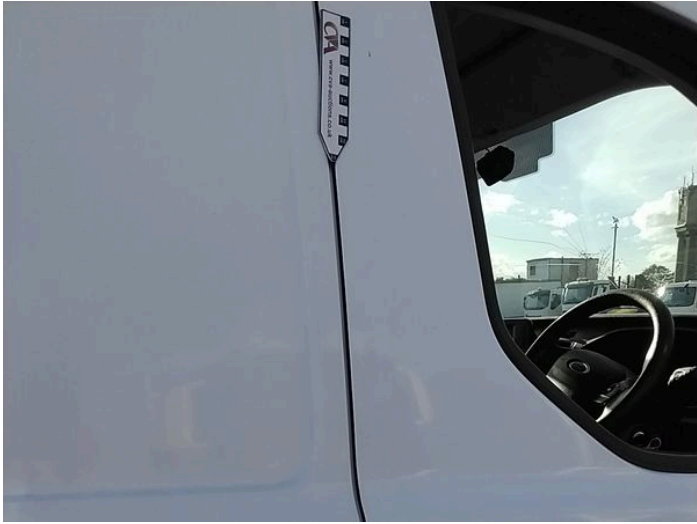
19: Door osf  
Chipped  
Edge Chip
