# VEHICLE INSPECTION REPORT

**PG66UFB**

## DAF CF 440

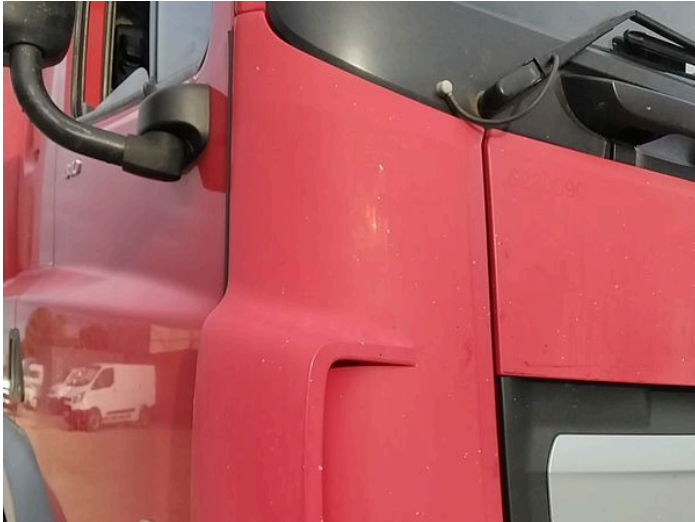
1: Wing of  
Chipped  
Multiple Chips

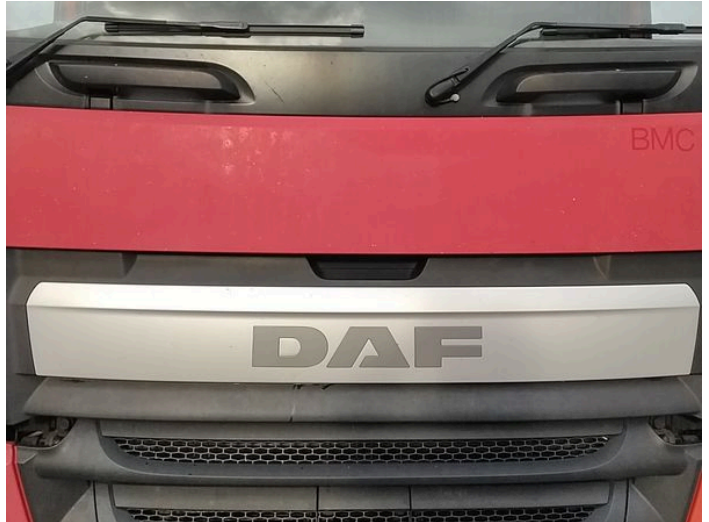
2: Bonnet  
Chipped  
Multiple Chips

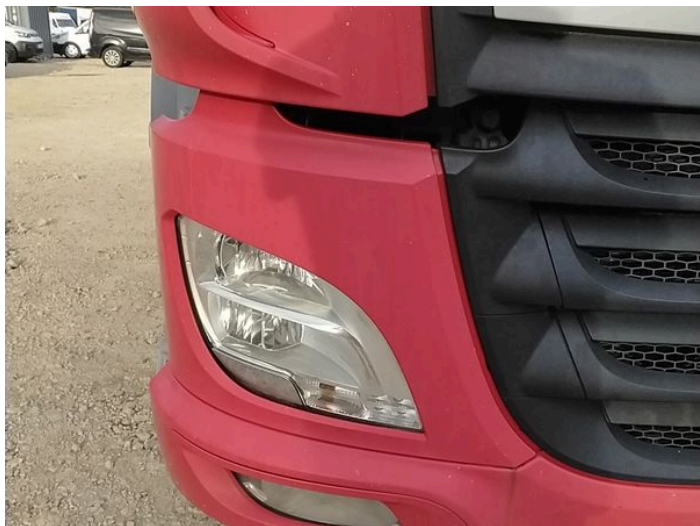
3: Fog Lamp Surround os  
Scratched (Painted)  
UpTo 25mm Thru Paint

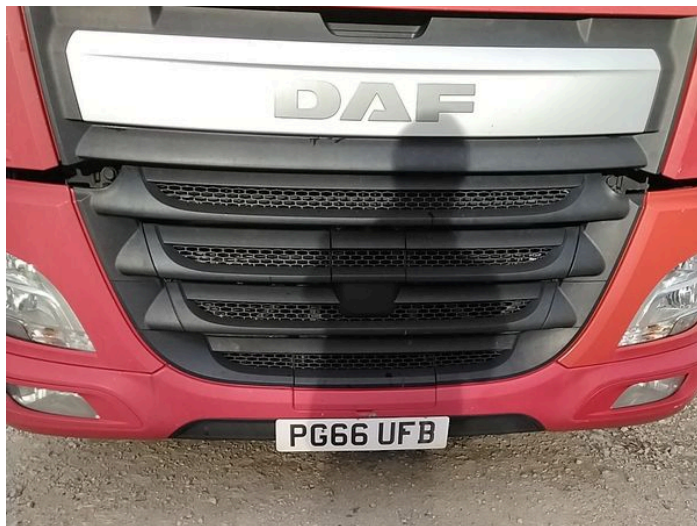
4: Bumper Front  
Chipped  
Multiple Chips

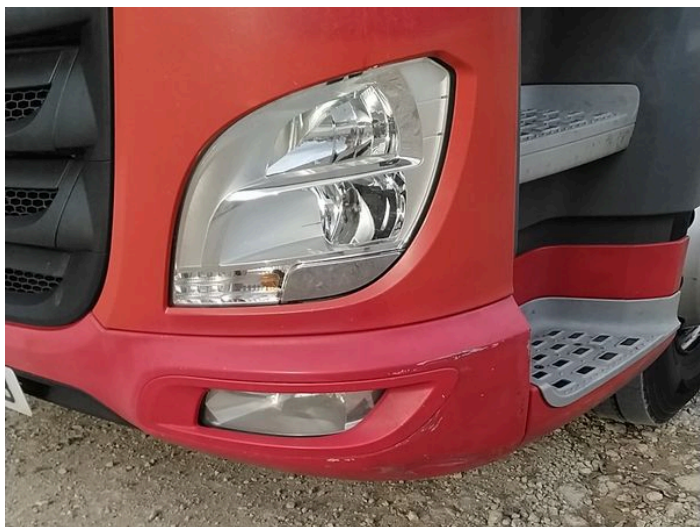
5: Bumper Front  
Dented  
With Paint Damage

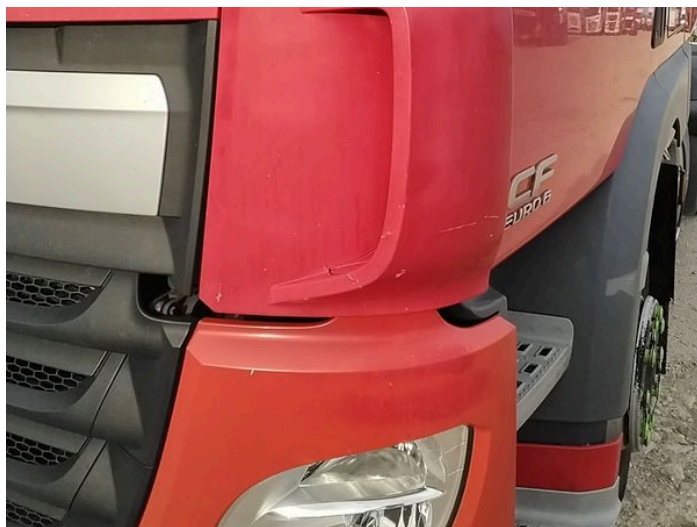
6: Wing nsf  
Cracked  
Replace

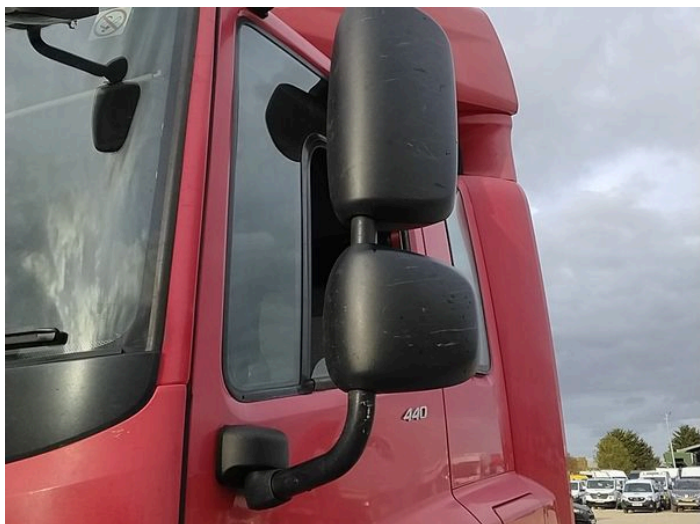
7: Door Mirror Assy nsf  
Scuffed (Unpainted)  
Over 100mm

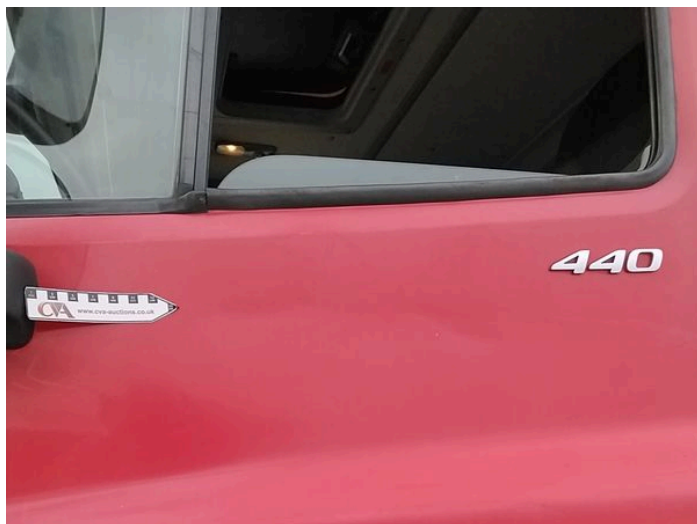
8: Door nsf  
Dented  
Over 30mm

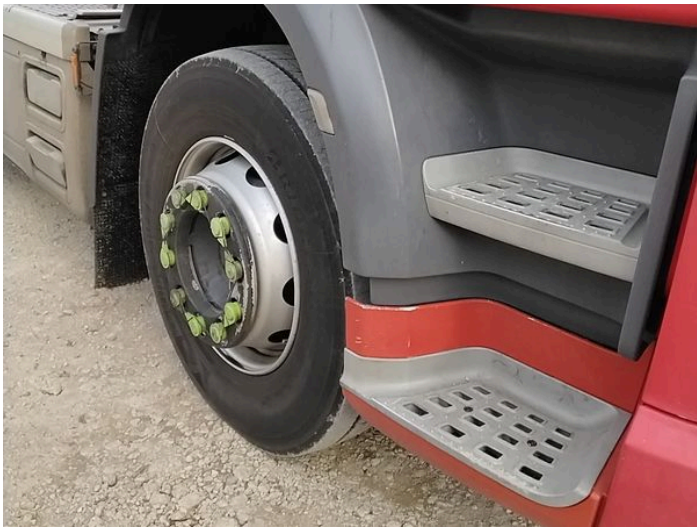
10: Wing Front Arch Extension os  
Scuffed (Unpainted)  
UpTo 100mm

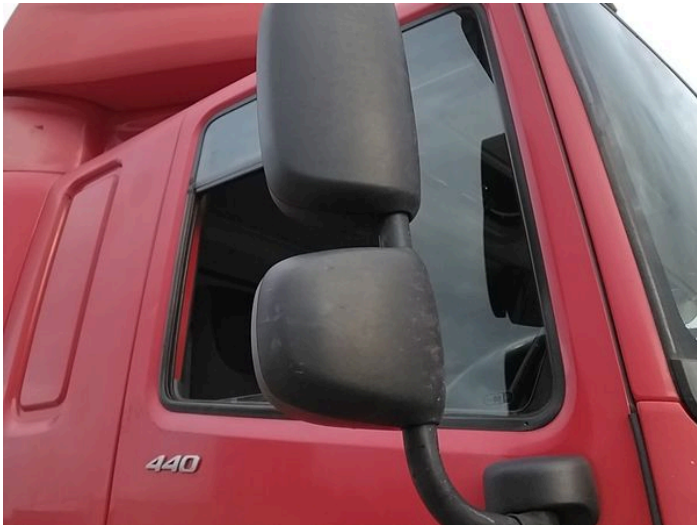
11: Door Mirror Assy osf  
Scuffed (Unpainted)  
UpTo 100mm

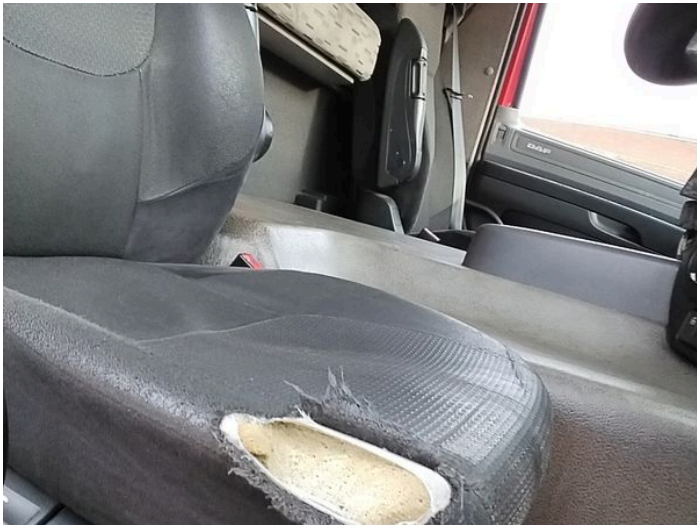
12: Seat Base Cover osf  
Holed  
Over 3mm
