**COMMERCIAL VEHICLE AUCTIONS LTD**  
THE UK'S MOST ESTABLISHED COMMERCIAL VEHICLE AUCTIONEERS

## VEHICLE INSPECTION REPORT

**PK23YNL**

### Volvo FH 500

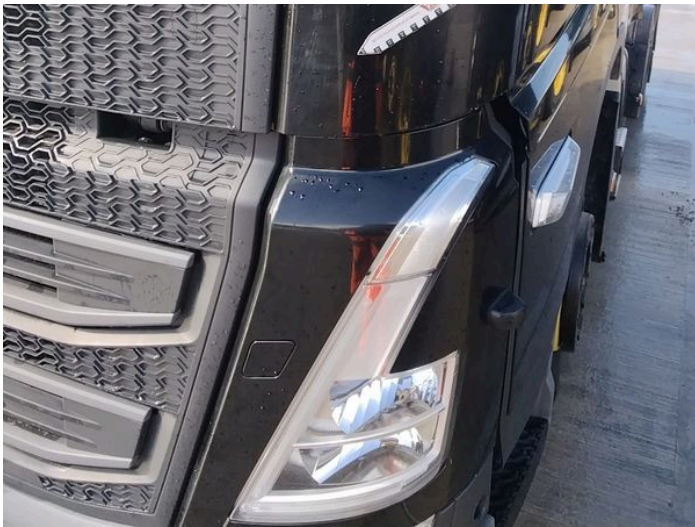
1: Wing nsf  
Scratched  
Over 25mm Thru Paint

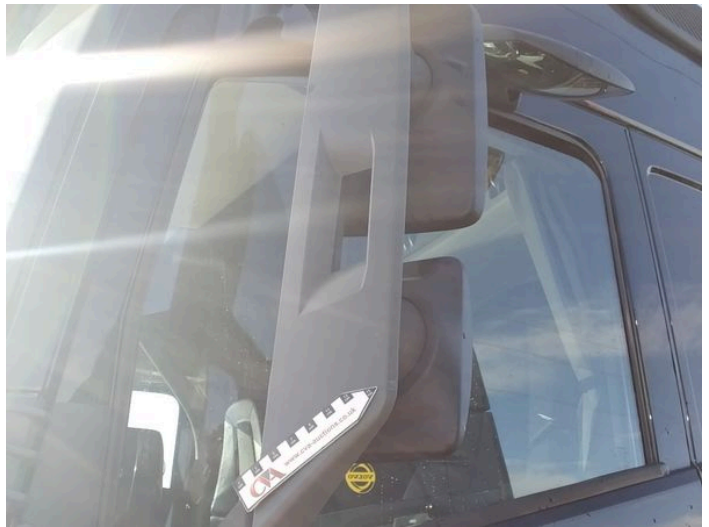
2: Door Mirror Assy nsf  
Scuffed (Unpainted)  
Over 100mm

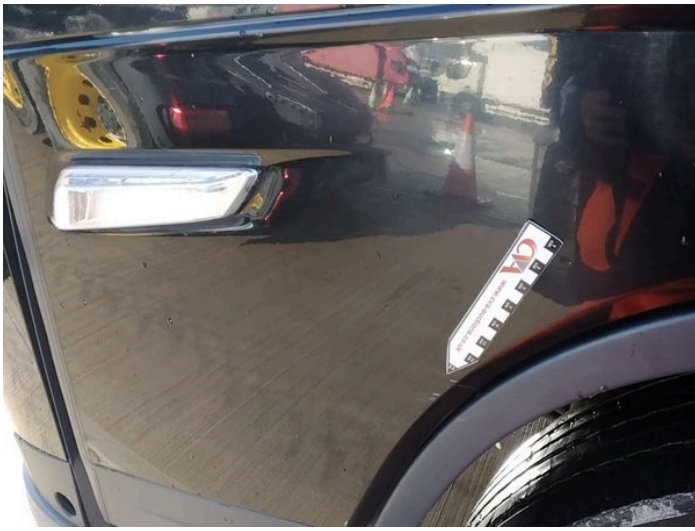
3: Door nsf  
Scratched  
UpTo 25mm Thru Paint

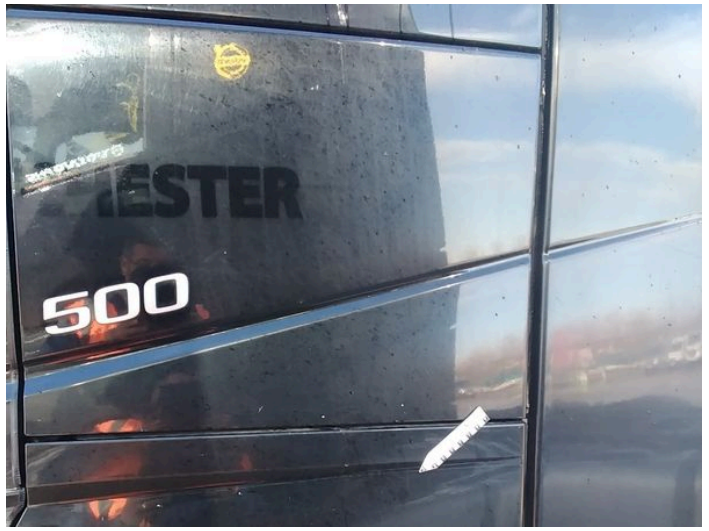
4: Qtr Panel nsr  
Scratched  
Over 25mm Not Thru Paint

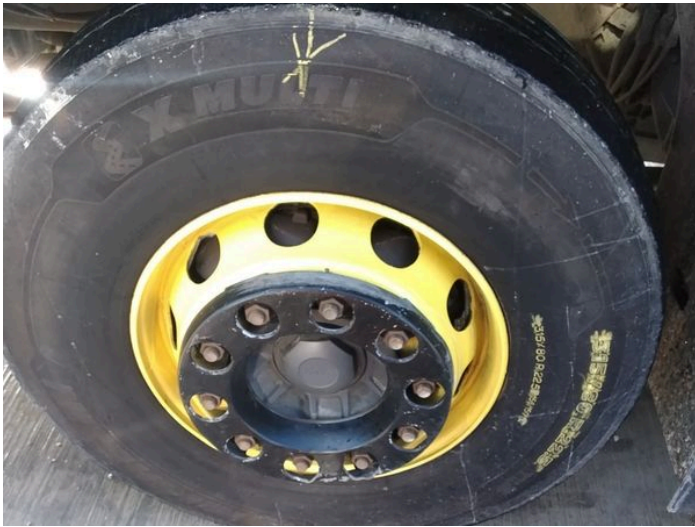
5: Wheel nsf  
Corroded  
Light

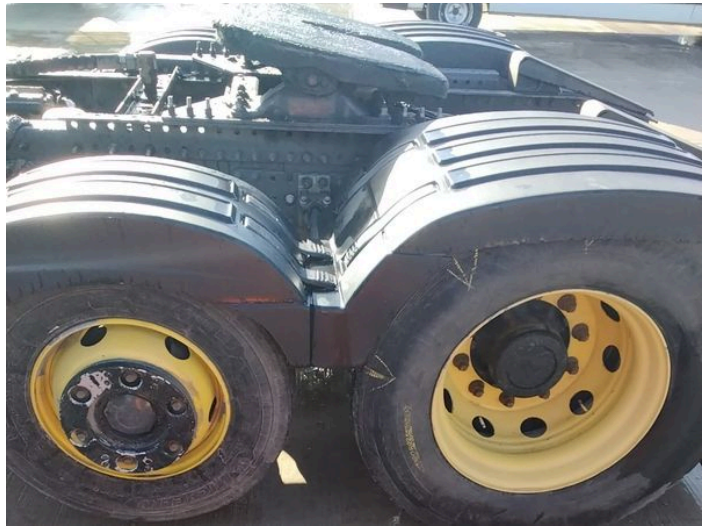
6: Wheel nsr  
Corroded  
Light

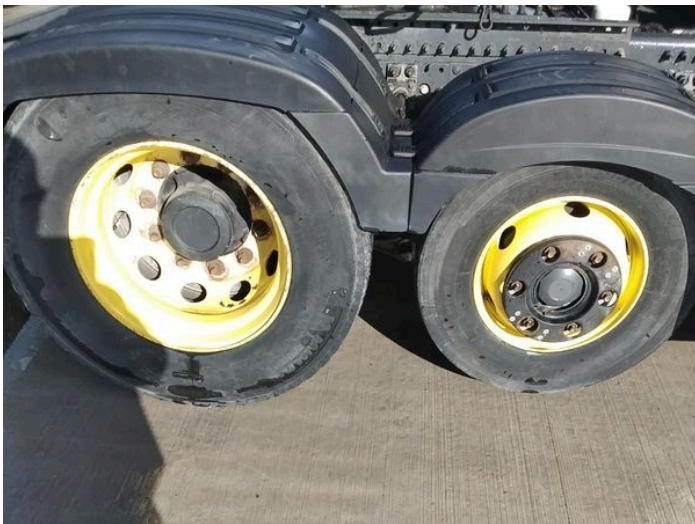
7: Wheel osr  
Corroded  
Light

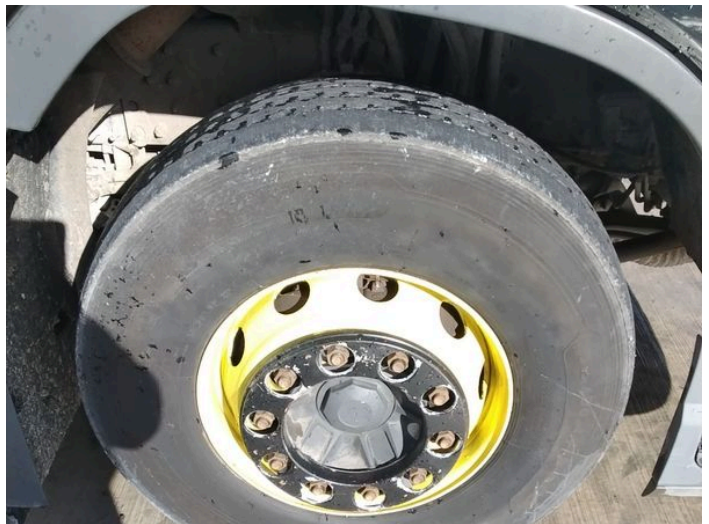
8: Wheel osf  
Corroded  
Light

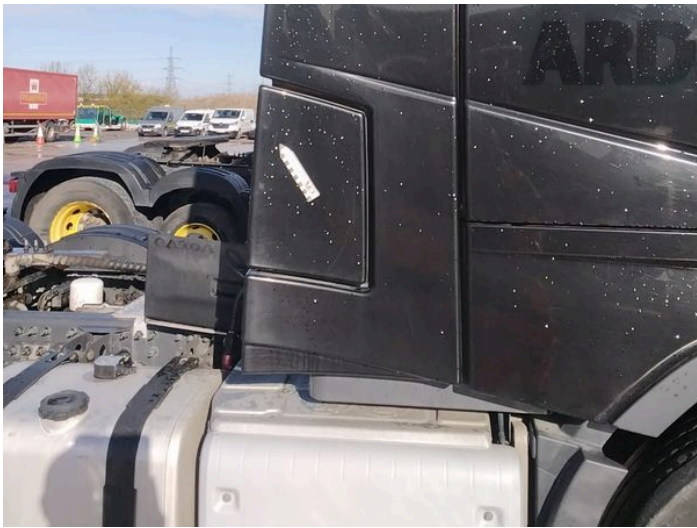
9: Qtr Panel osr  
Scratched  
Over 25mm Not Thru Paint

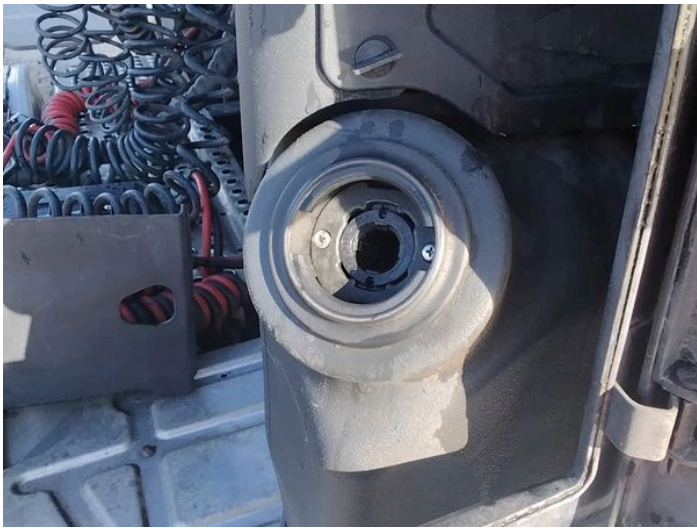
10: Fuel Flap  
Missing  
Replace

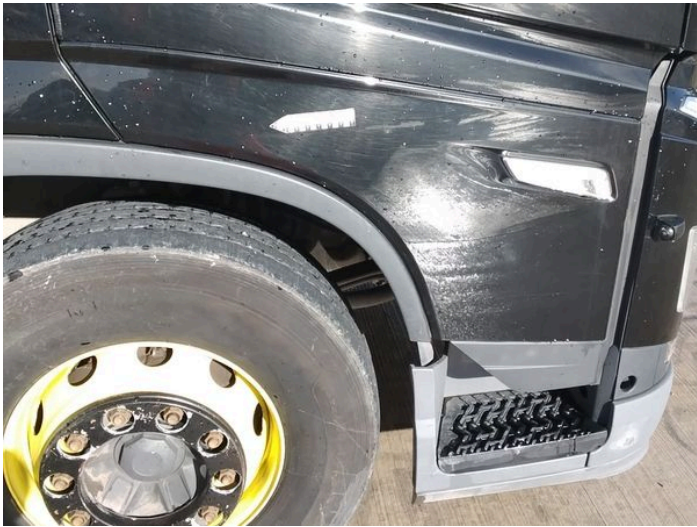
11: Door osf  
Scratched  
Over 25mm Not Thru Paint

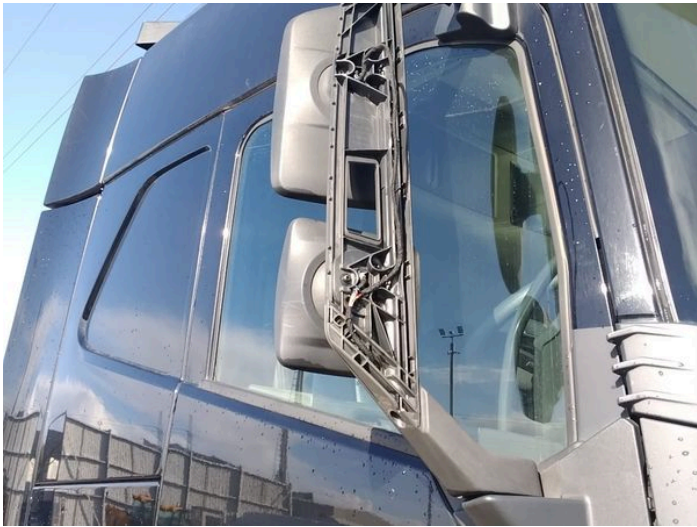
12: Door Mirror Assy osf  
Missing  
Replace

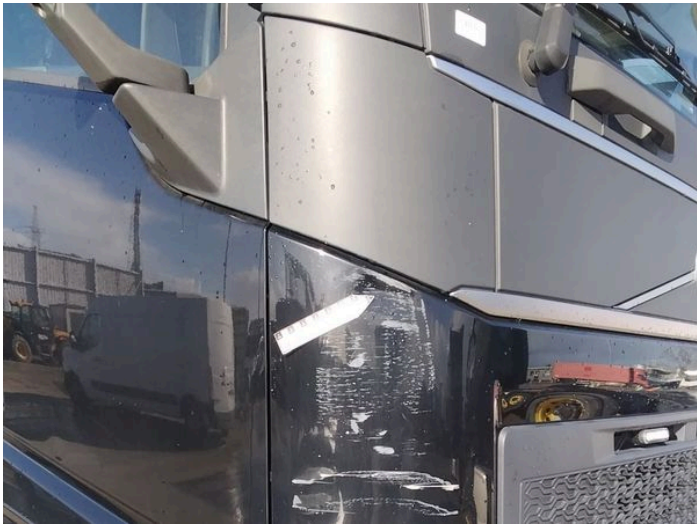
13: Wing osf  
Dented  
Over 30mm

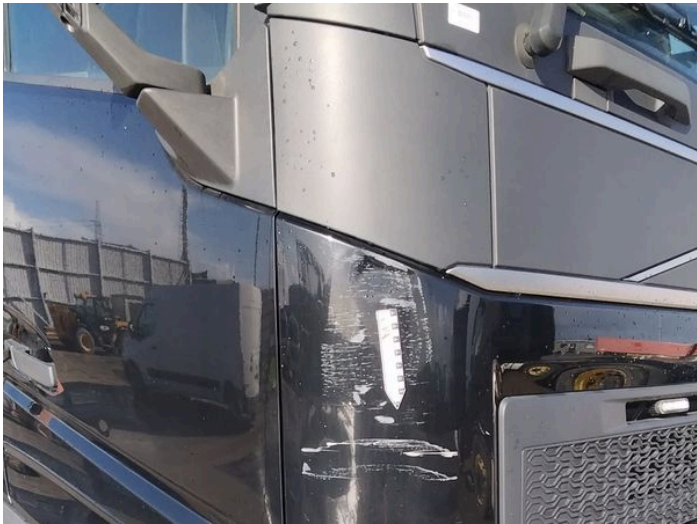
14: Wing osf  
Scratched  
Over 25mm Thru Paint

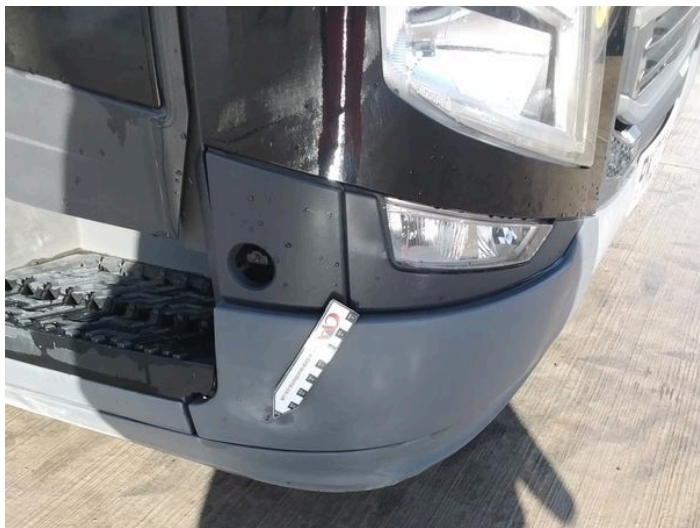
15: Bumper Front  
Hole  
Over 25mm

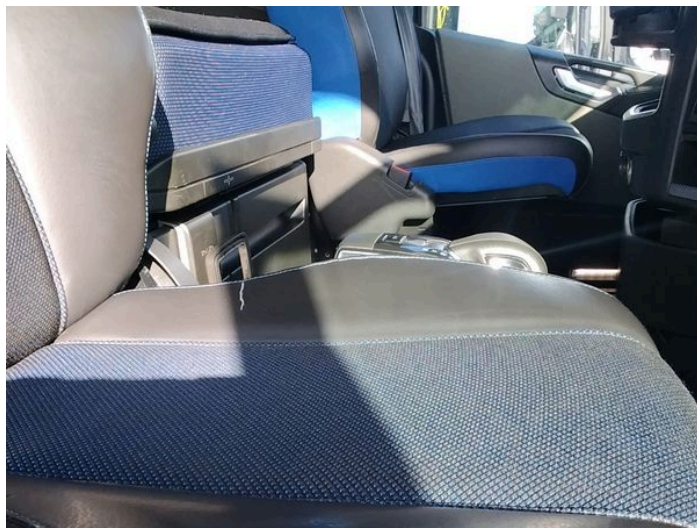
16: Seat Base Cover osf  
Torn  
Over 3mm
