## VEHICLE INSPECTION REPORT

**PN20EUA**

### Volvo FH 500

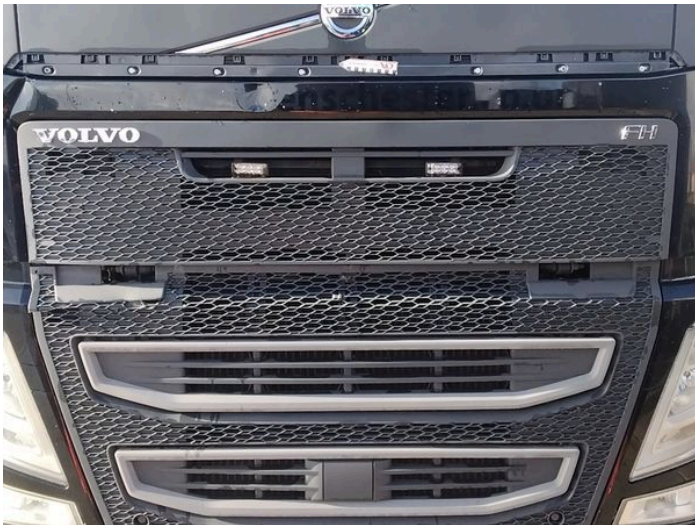
1: Panel Front  
Missing  
Replace

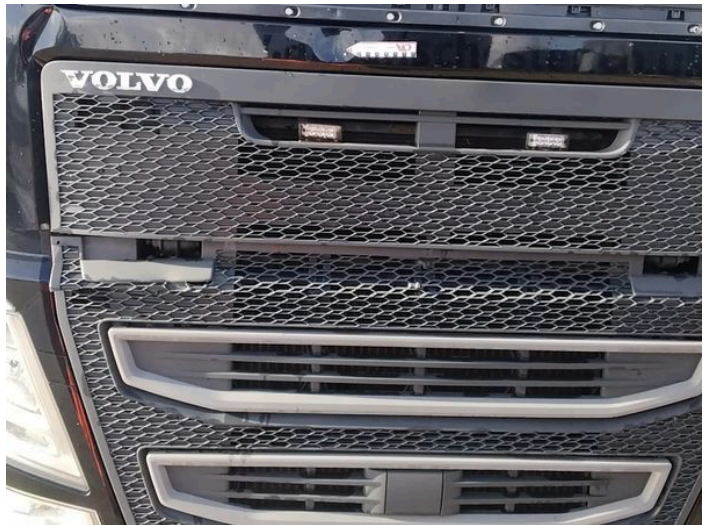
2: Panel Front  
Dented  
Over 30mm

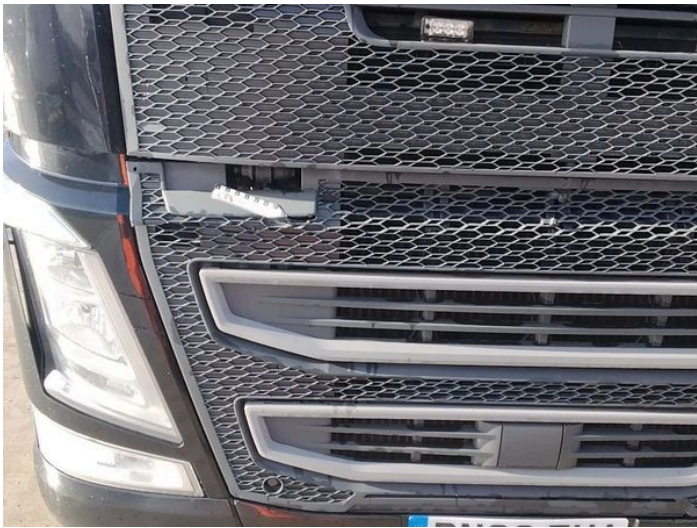
3: Grille Front  
Broken  
Replace

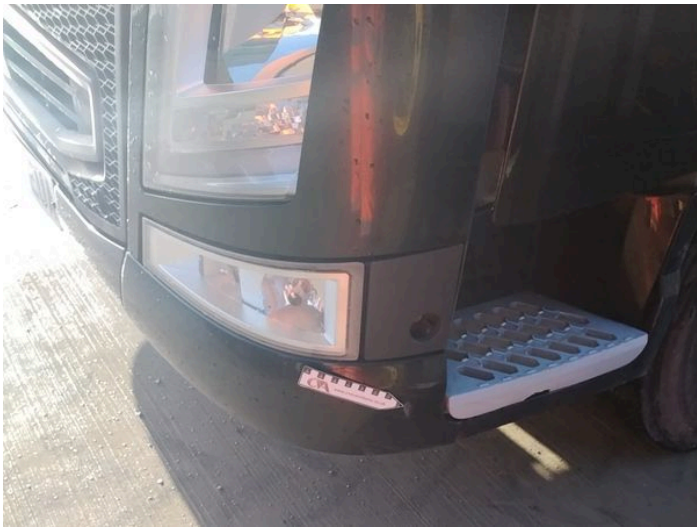
4: Bumper Front  
Scratched  
Over 100mm Thru Paint

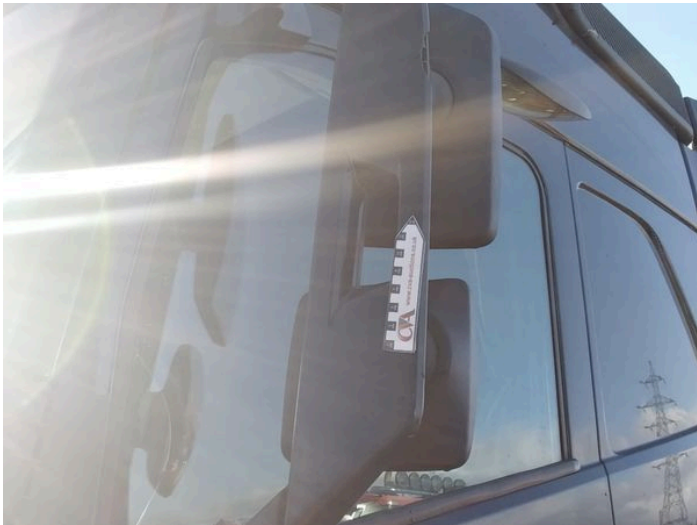
5: Door Mirror Assy nsf  
Broken  
Replace

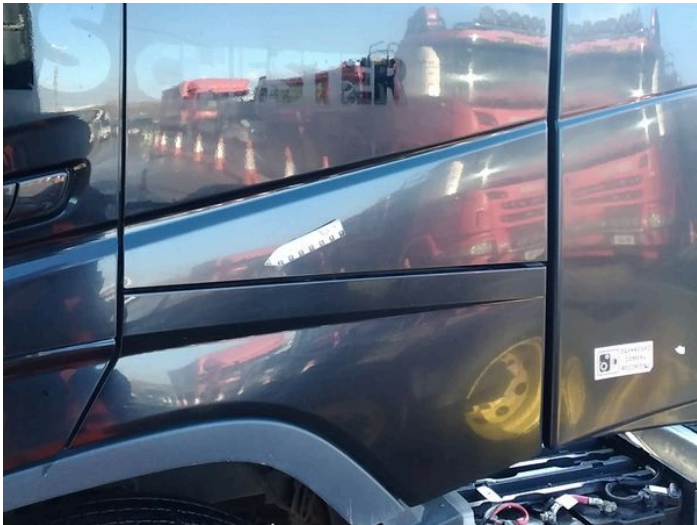
6: Qtr Panel nsr  
Scratched  
Over 25mm Not Thru Paint

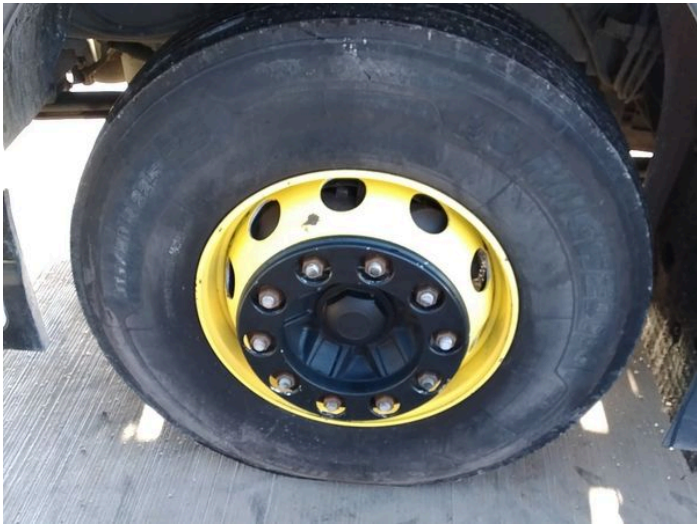
7: Wheel nsf  
Corroded  
Light

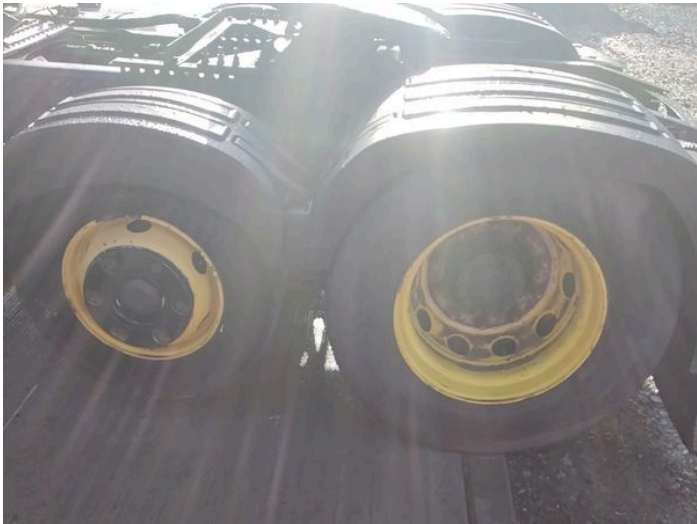
8: Wheel nsr  
Corroded  
Light

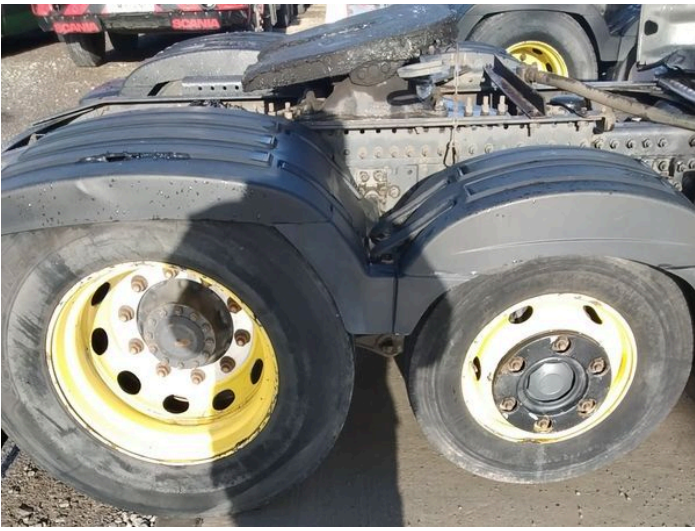
9: Wheel osr  
Corroded  
Light

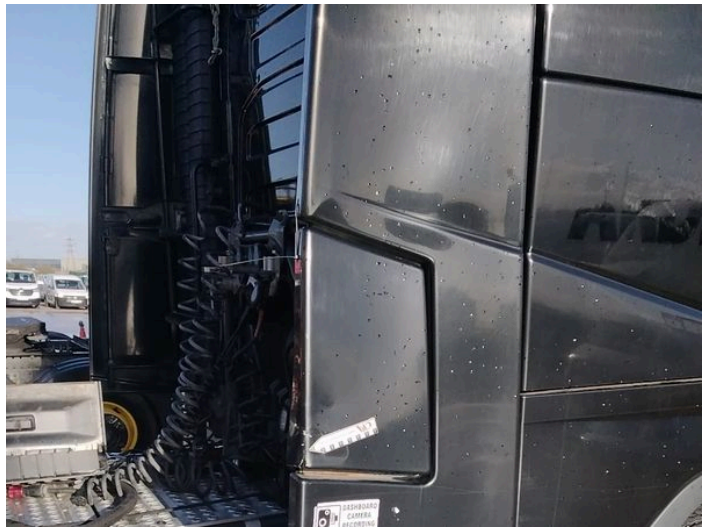
10: Qtr Panel osr  
Cracked  
Replace

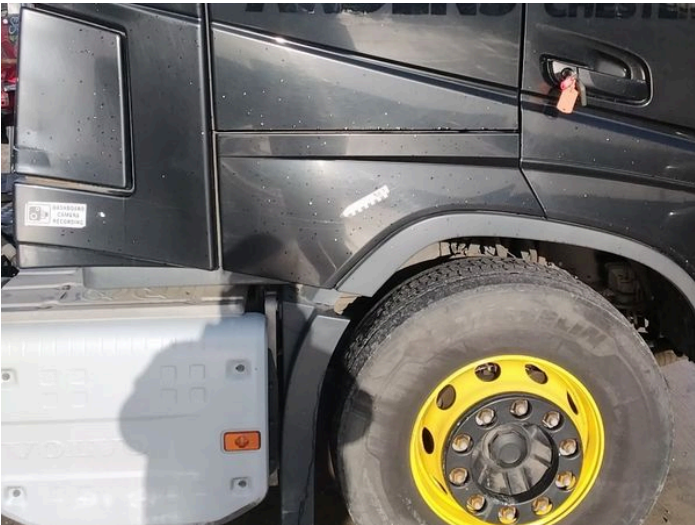
11: Qtr Panel osr  
Scratched  
Over 25mm Not Thru Paint

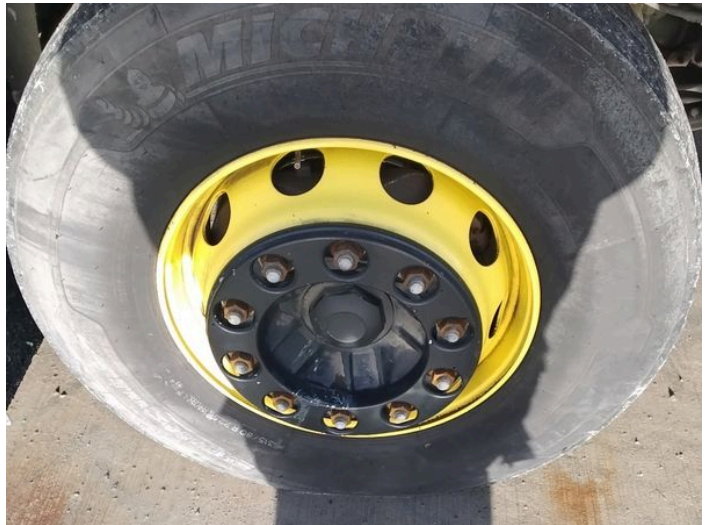
12: Wheel osf  
Corroded  
Light

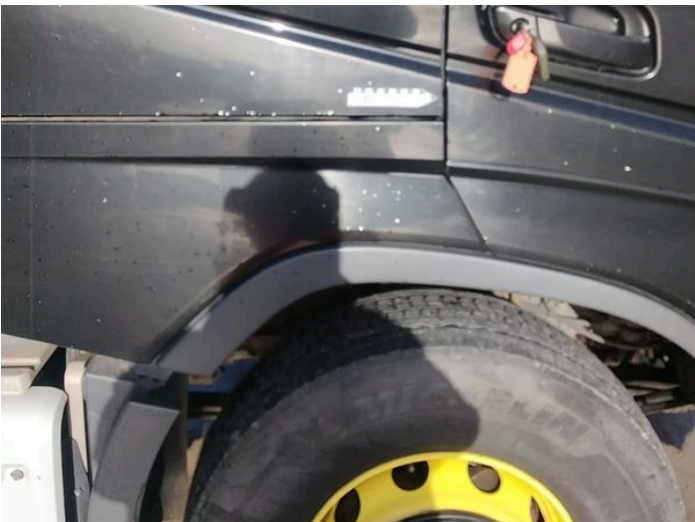
13: Qtr Panel osr  
Chipped  
Over 5mm

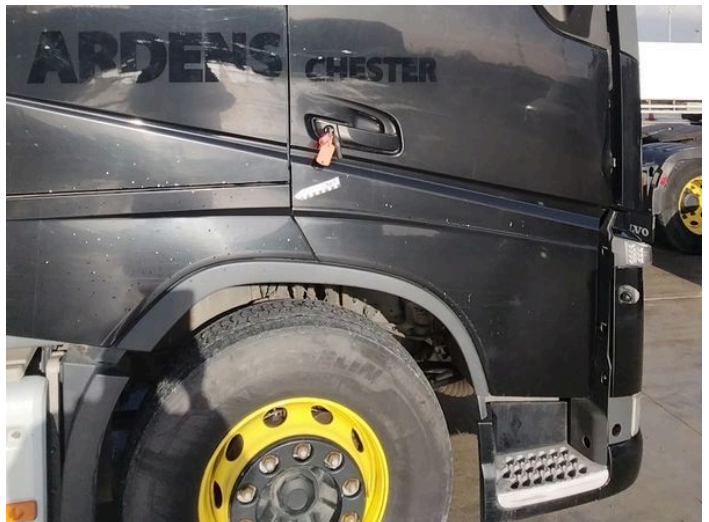
14: Door osf  
Chipped  
Edge Chip

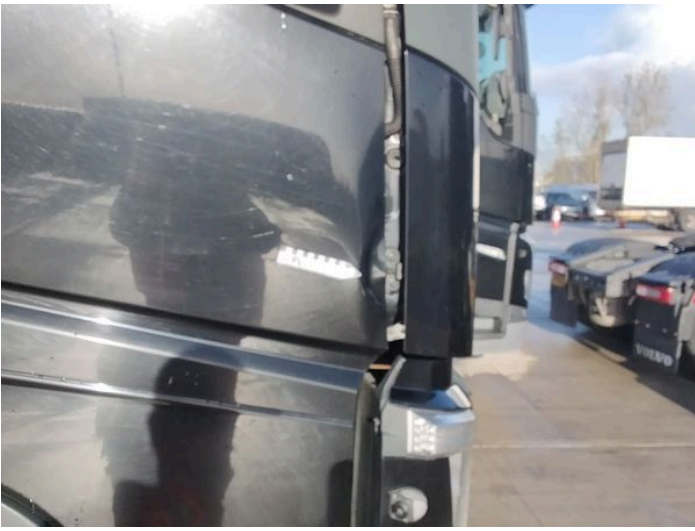
15: Door osf  
Dented  
Over 30mm

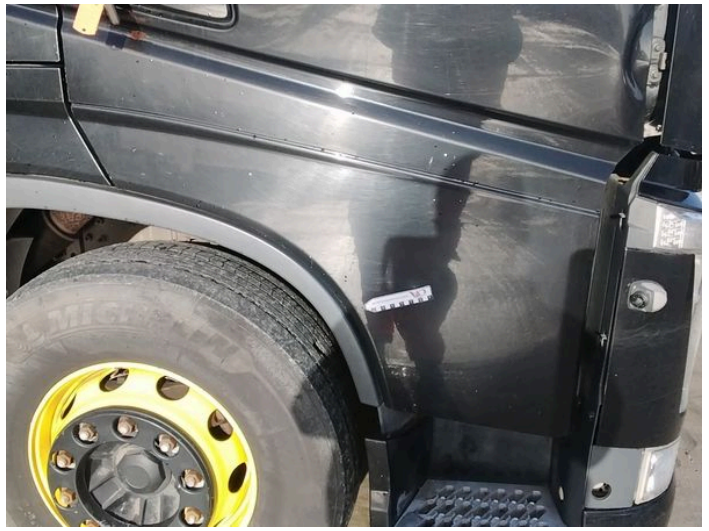
16: Door osf  
Scratched  
Over 25mm Thru Paint

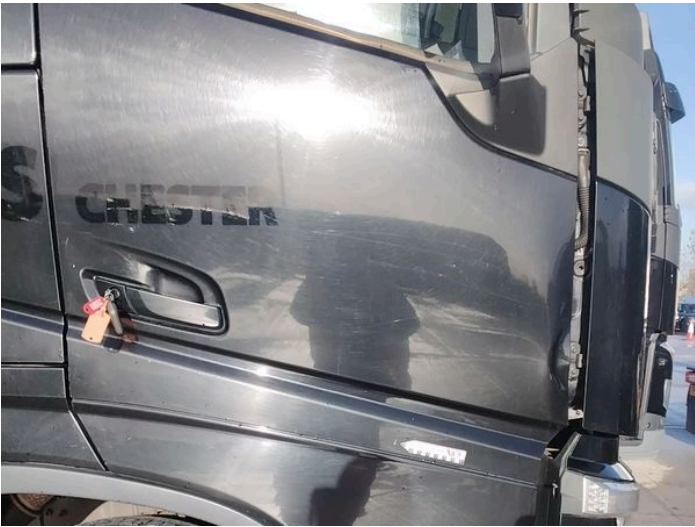
17: Door osf  
Chipped  
Over 5mm

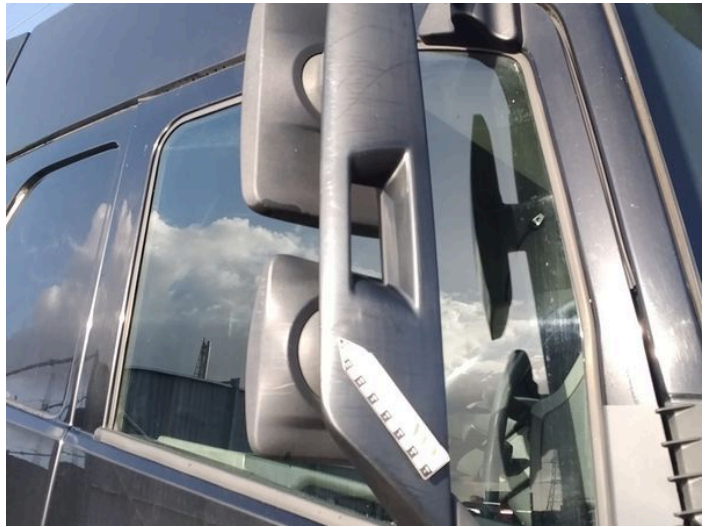
18: Door Mirror Assy osf  
Scuffed (Unpainted)  
Over 100mm

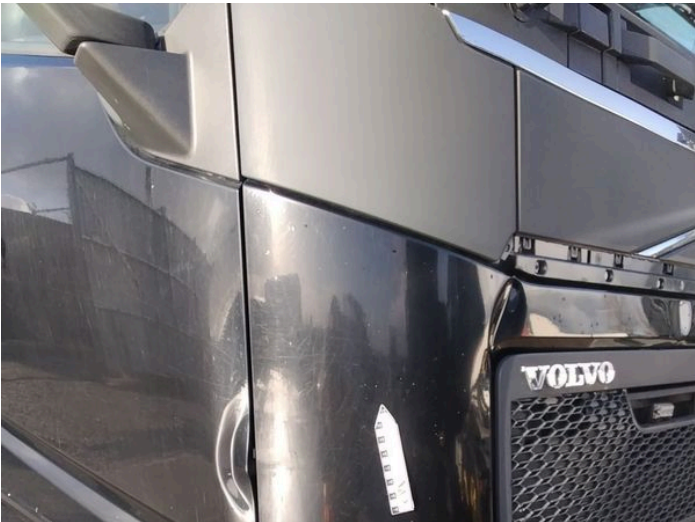
19: Wing osf  
Scratched  
Over 25mm Thru Paint

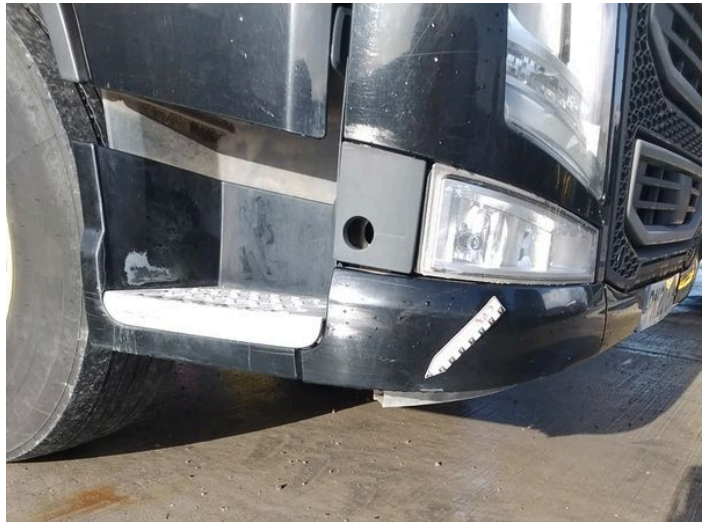
20: Bumper Front  
Scratched  
Over 100mm Thru Paint

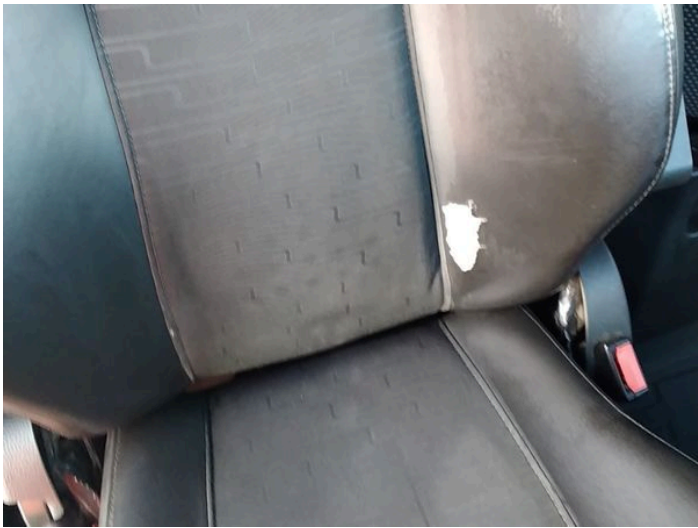
21: Seat Back Cover osf  
Torn  
Over 3mm

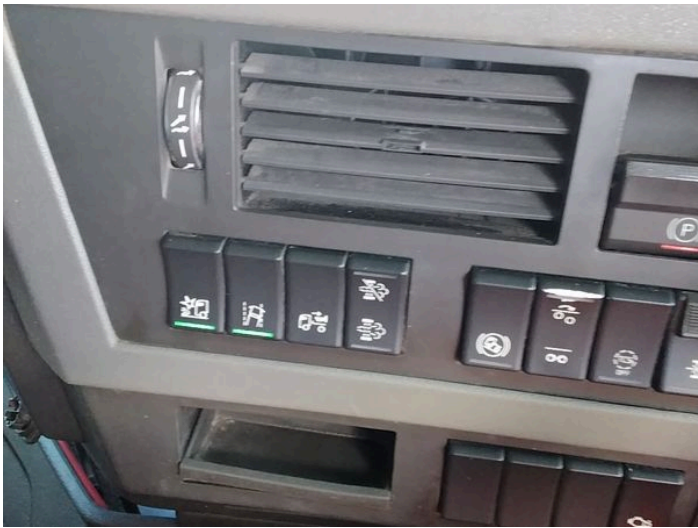
22: Air Vents osf  
Damaged  
Replace
