COMMERCIAL VEHICLE AUCTIONS LTD  
THE UK'S MOST ESTABLISHED COMMERCIAL VEHICLE AUCTIONEERS

# VEHICLE INSPECTION REPORT

PN21KKV

## Volvo FH 500

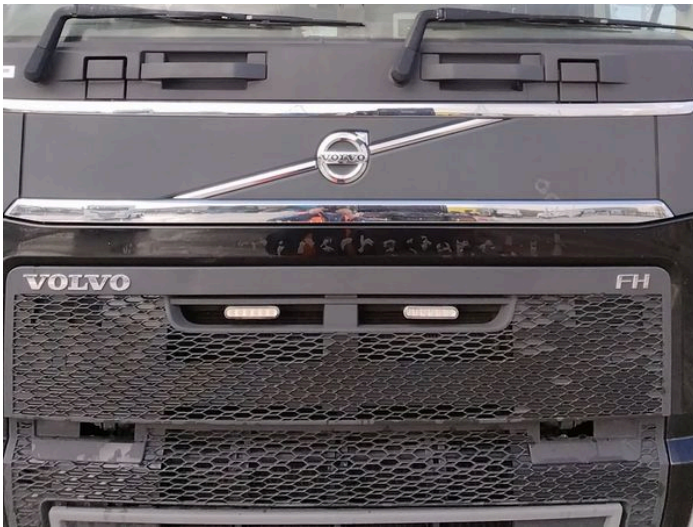
1: Screen Front  
Chipped  
Over 10mm

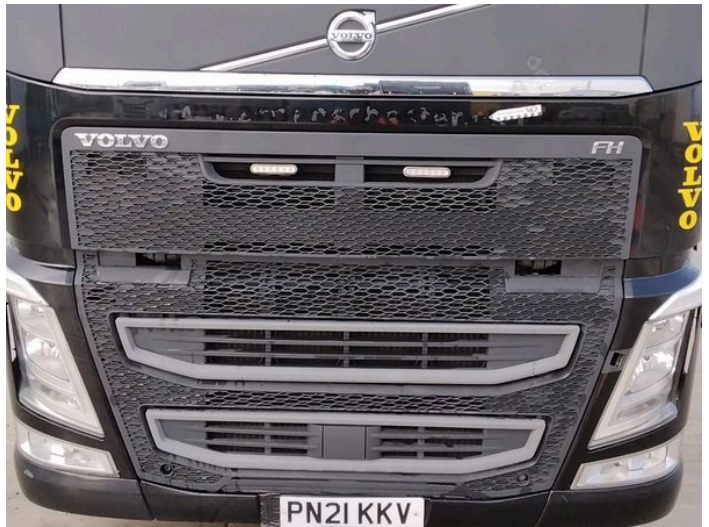
2: Panel Front  
Chipped  
Over 5mm

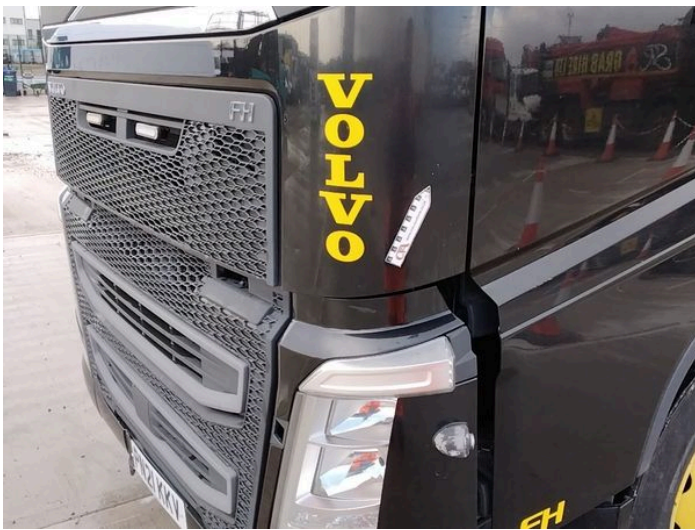
3: Wing nsf  
Chipped  
Over 5mm

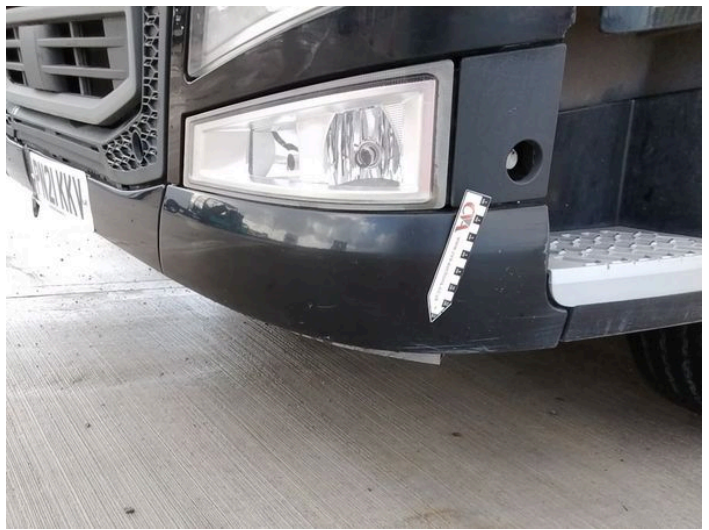
4: Bumper Front  
Scratched  
Over 100mm Thru Paint

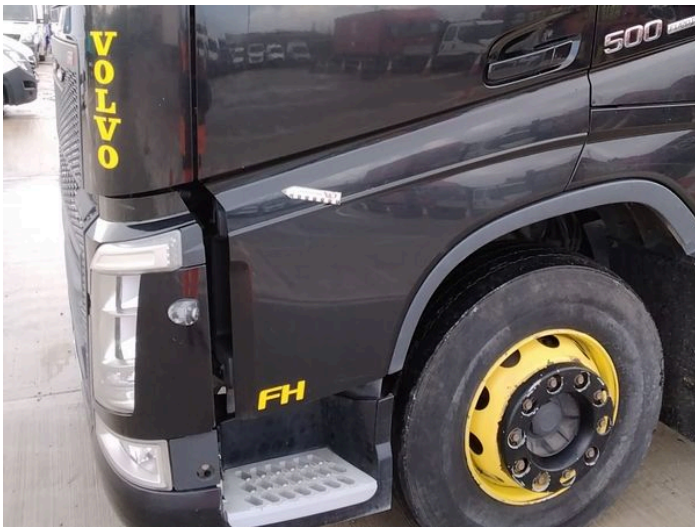
5: Door nsf  
Scratched  
Over 25mm Thru Paint

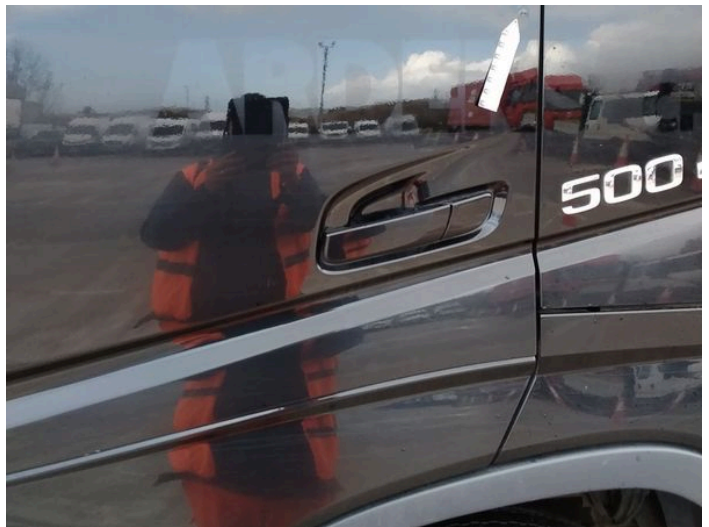
6: Door nsf  
Dented  
Over 30mm

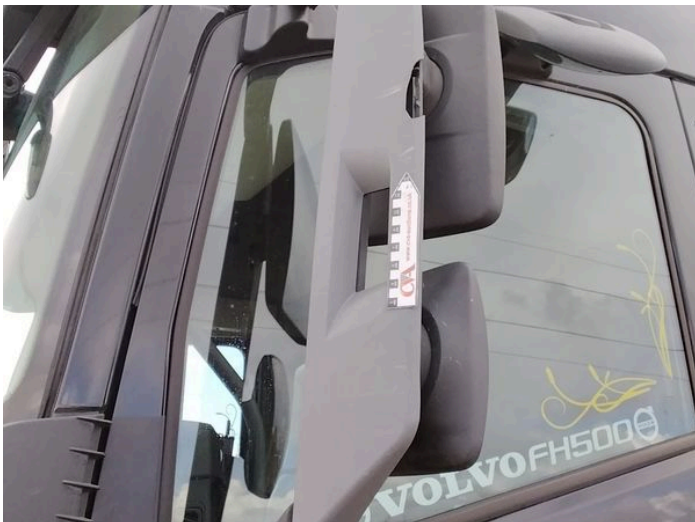
7: Door Mirror Assy nsf  
Broken  
Replace

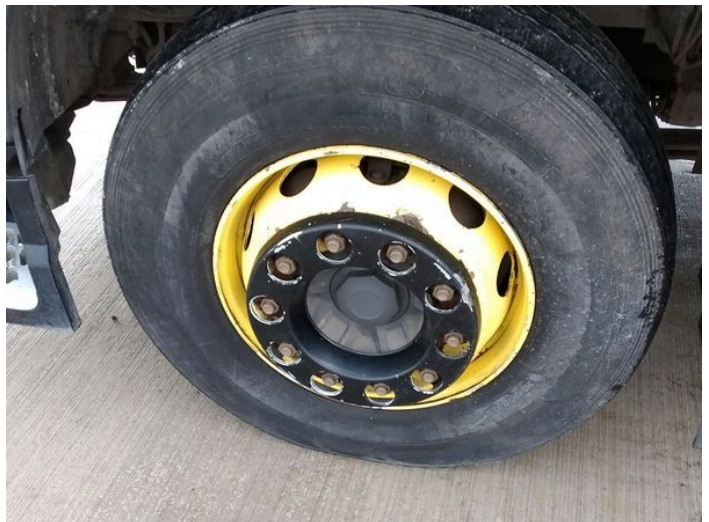
8: Wheel nsf  
Corroded  
Light

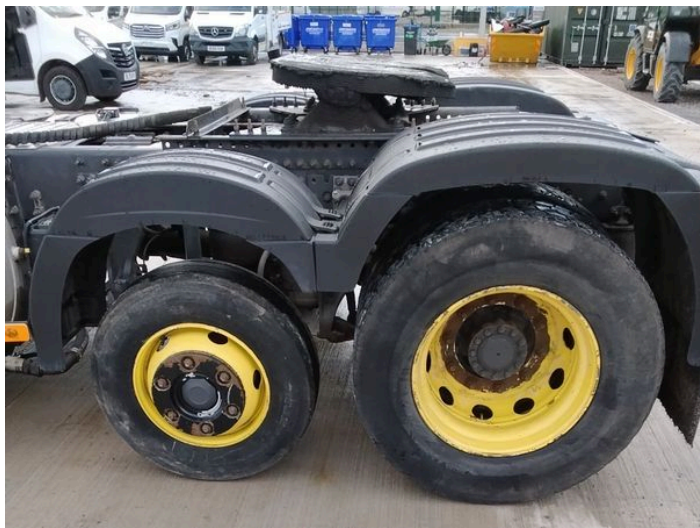
9: Wheel nsr  
Corroded  
Light

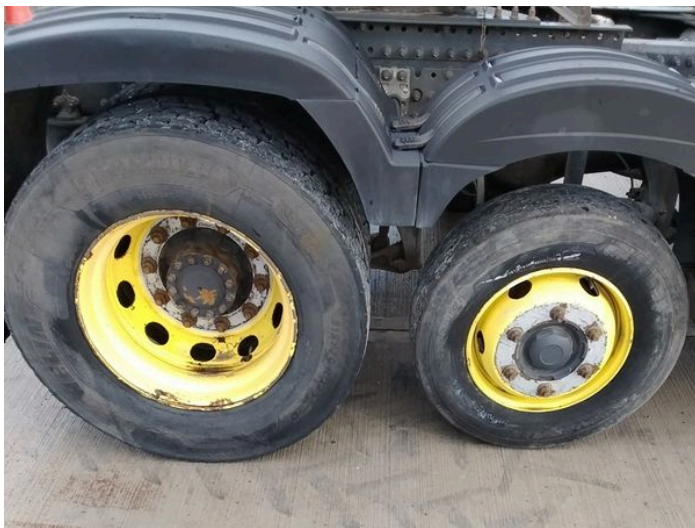
10: Wheel osr  
Corroded  
Light

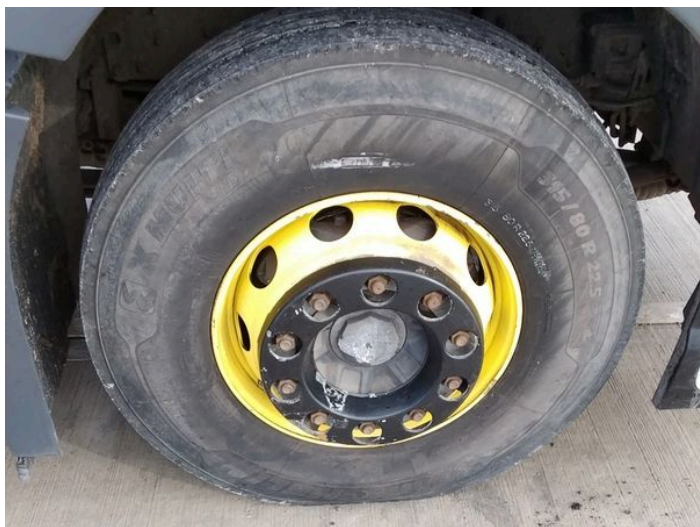
11: Wheel osf  
Corroded  
Light

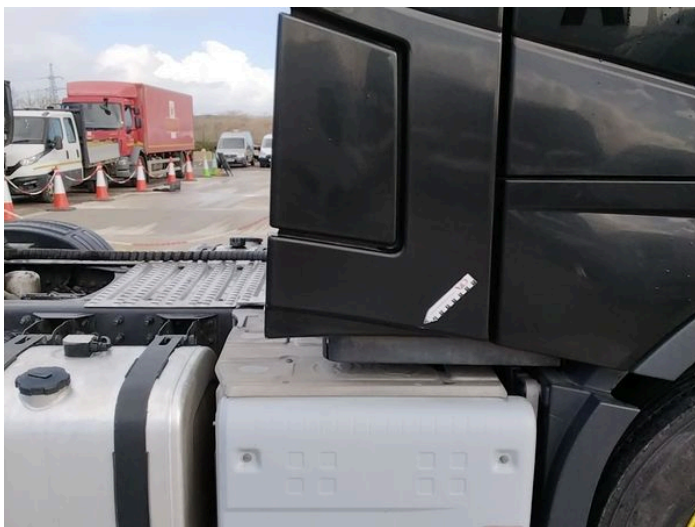
12: Qtr Panel osr  
Chipped  
Over 5mm

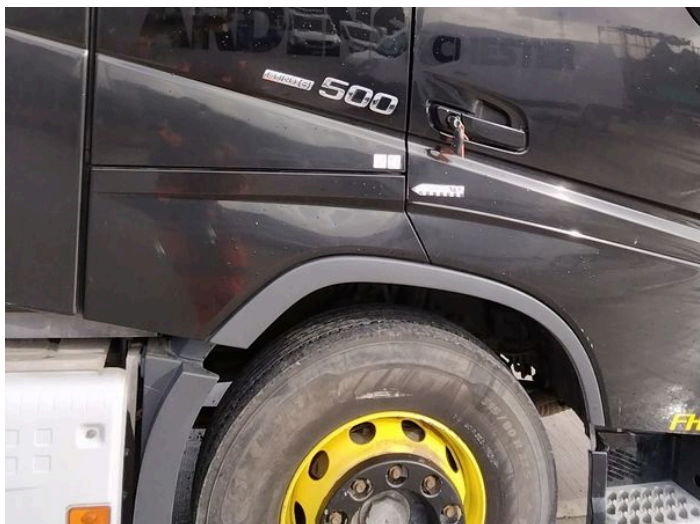
13: Door osf  
Chipped  
Edge Chip

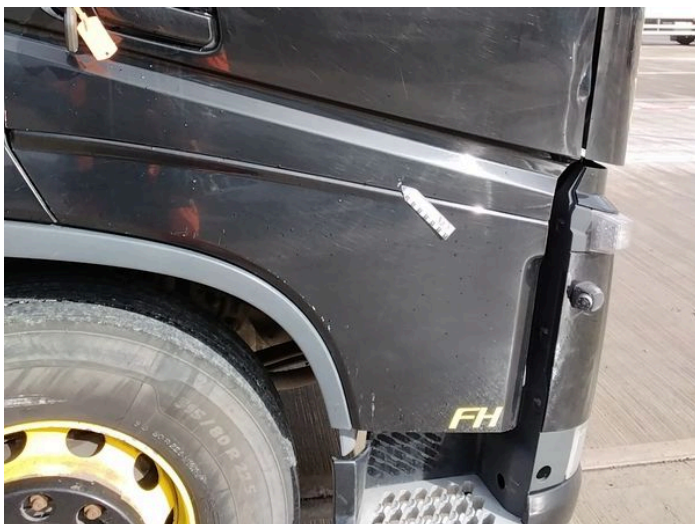
14: Door osf  
Chipped  
Over 5mm

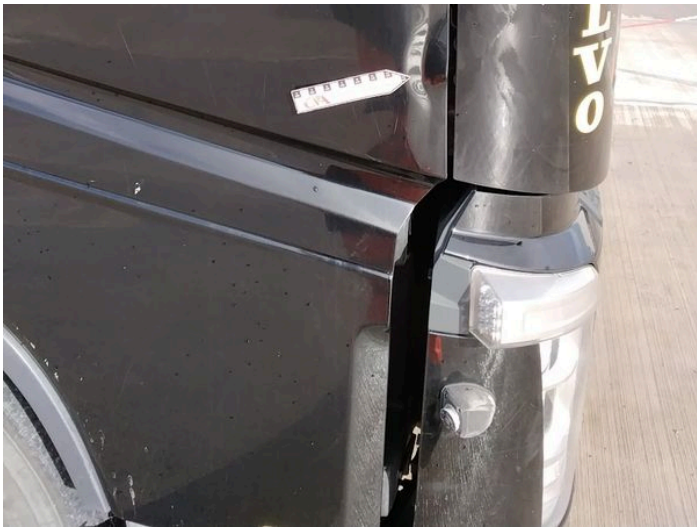
15: Door osf  
Dented  
Over 30mm

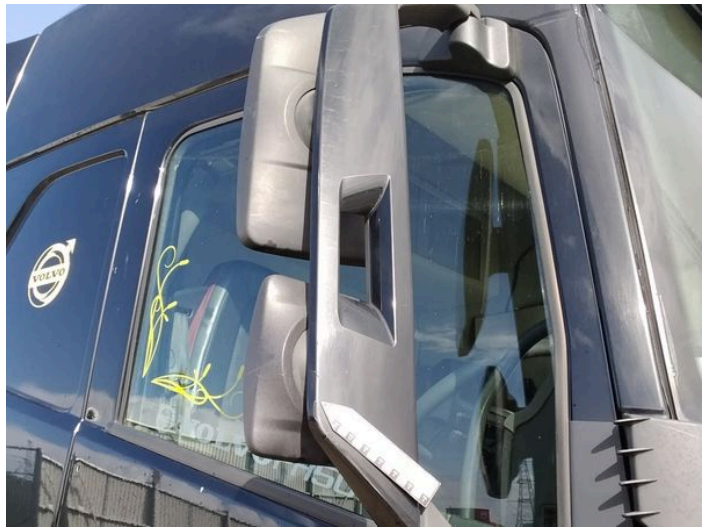
16: Door Mirror Assy osf  
Scratched (Painted)  
Over 25mm Thru Paint

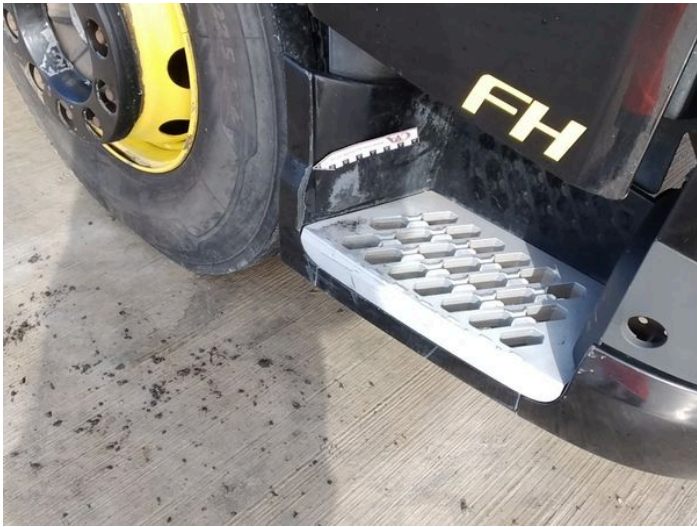
17: Wing Front Arch Extension os  
Scratched (Painted)  
Over 25mm Thru Paint

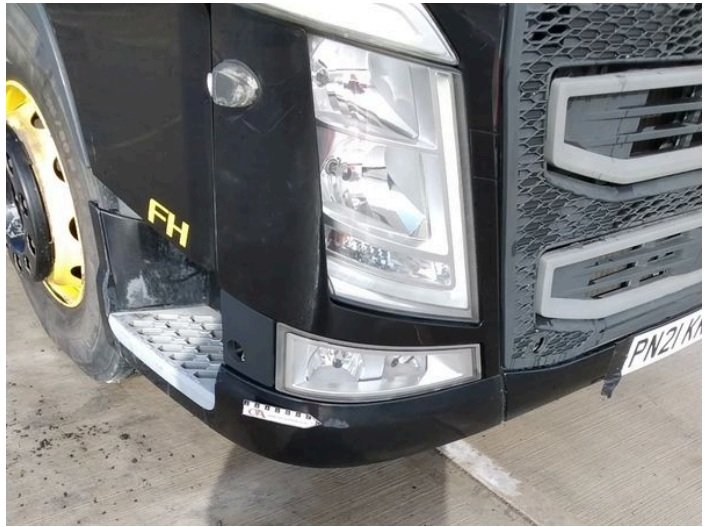
18: Bumper Front  
Scratched  
Over 100mm Thru Paint

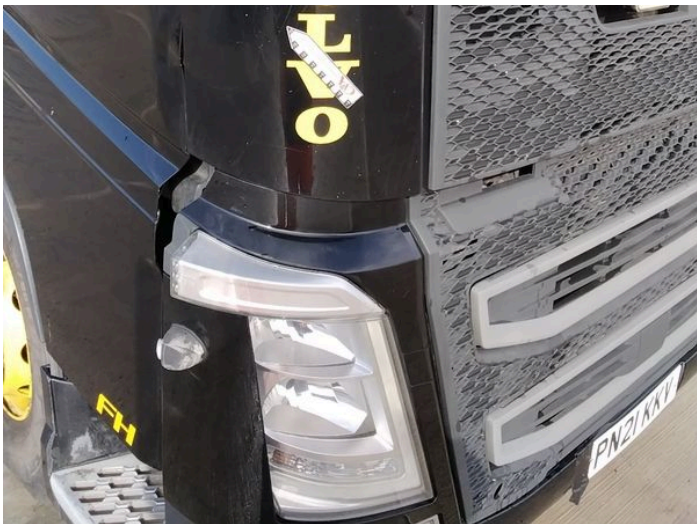
19: Panel Front  
Chipped  
Over 5mm

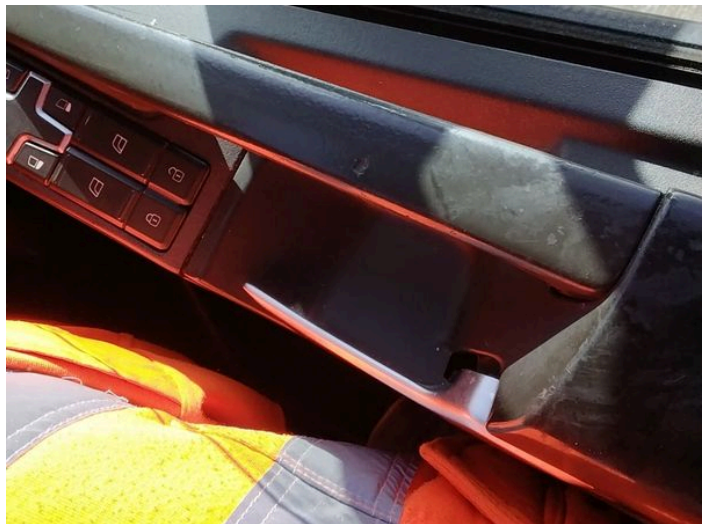
20: Handle Inner osf  
Damaged  
Replace

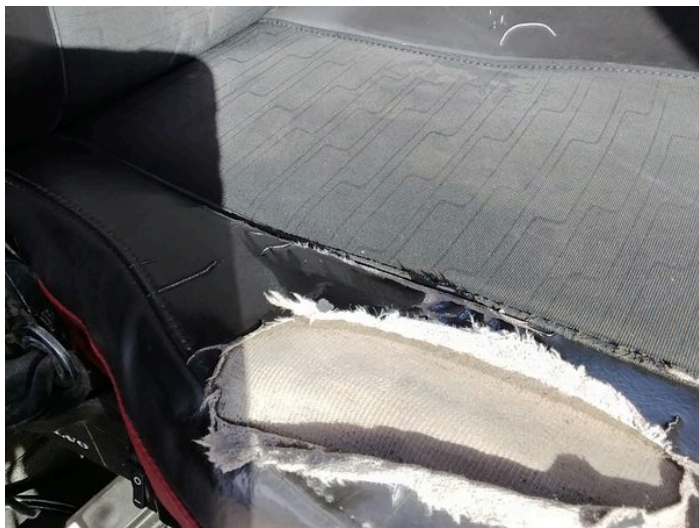
21: Seat Base Cover osf  
Torn  
Over 3mm

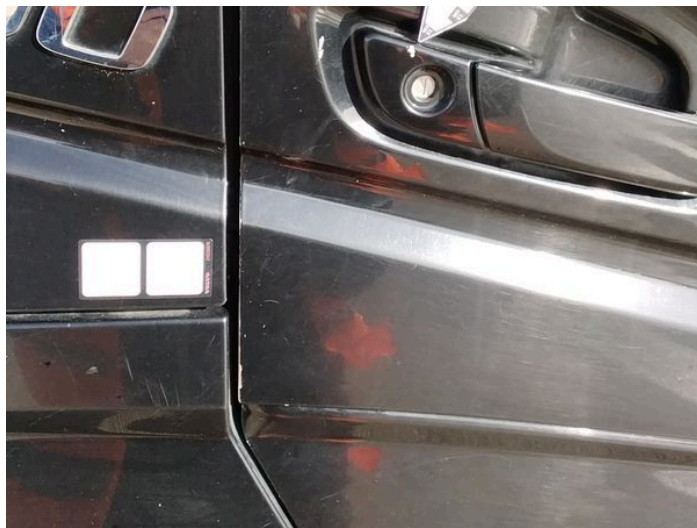
22: Handle Outer osf  
Scratched (Painted)  
Over 25mm Thru Paint
