# VEHICLE INSPECTION REPORT

**CN19WDK**

## Mercedes-Benz Sprinter 314 CDI

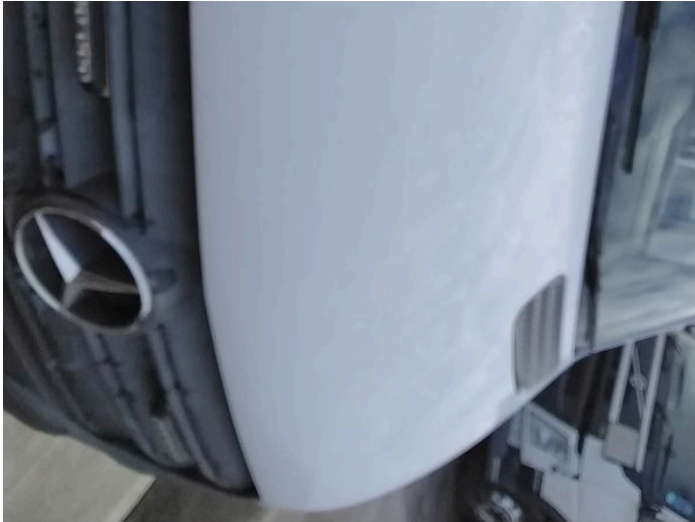
1: Bonnet  
Chipped  
Multiple Chips

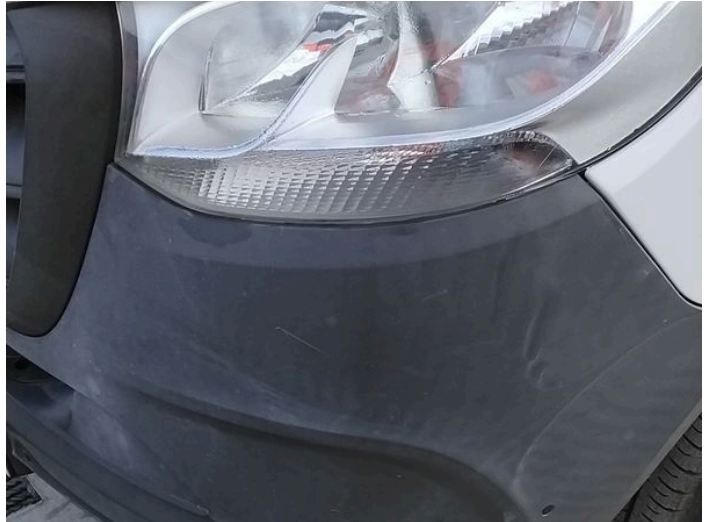
2: Bumper Front  
Scratched  
Over 100mm Thru Paint

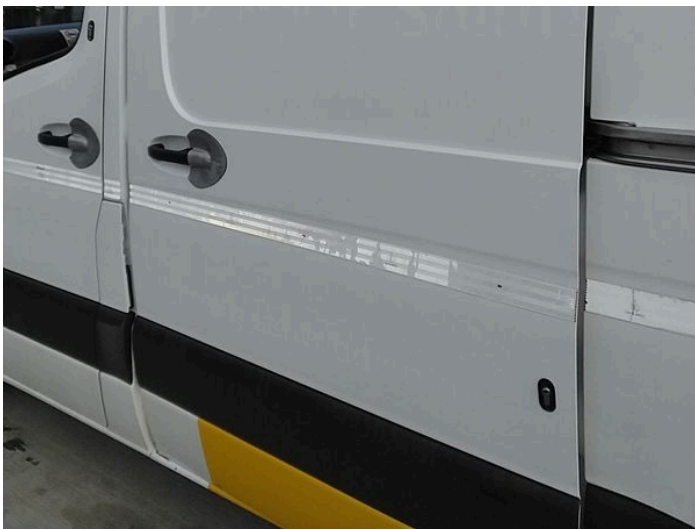
3: Other  
N/A  
N/A  
Sld does not close

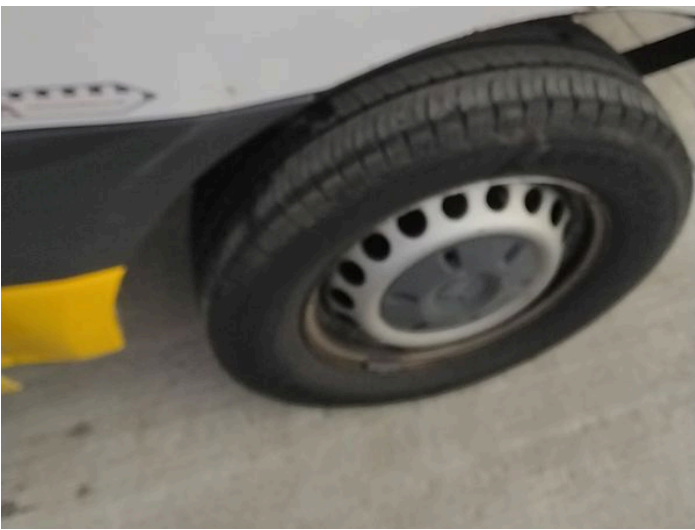
4: Qtr Panel nsr  
Dented  
With Paint Damage

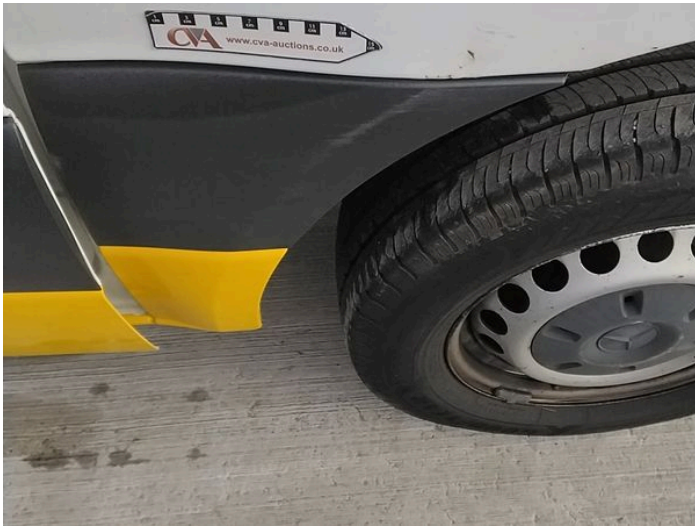
5: Qtr Panel Moulding ns  
Scuffed (Unpainted)  
Over 100mm

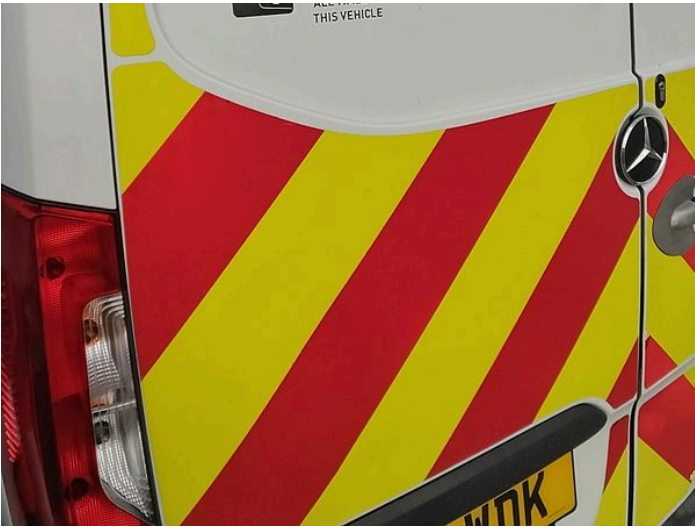
6: Door nsr  
Chipped  
Multiple Chips

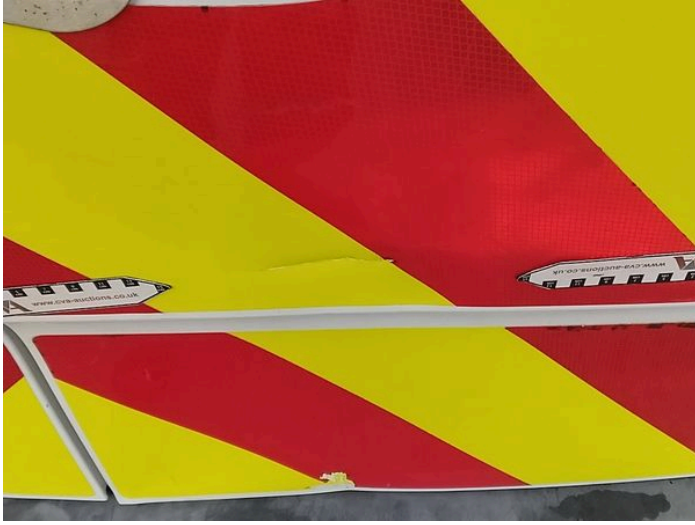
7: Door osr  
Dented  
With Paint Damage

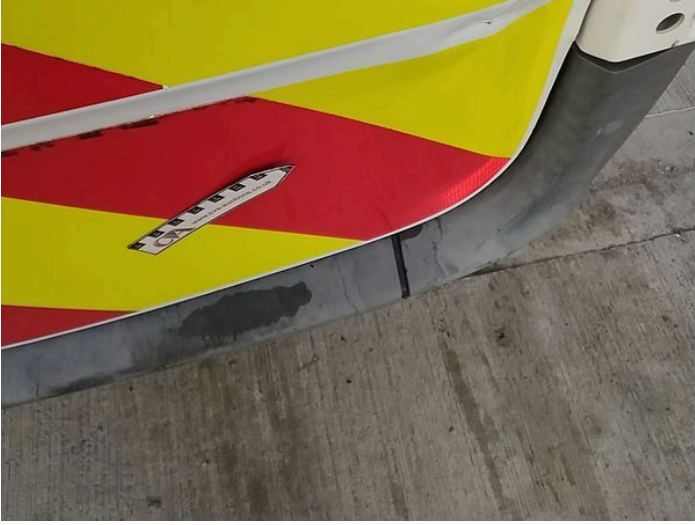
8: Door osr  
Dented  
Over 30mm

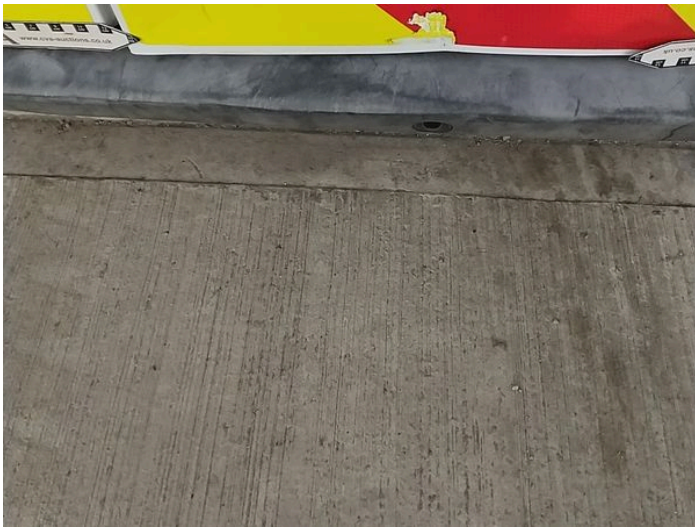
9: Door osr  
Dented  
With Paint Damage

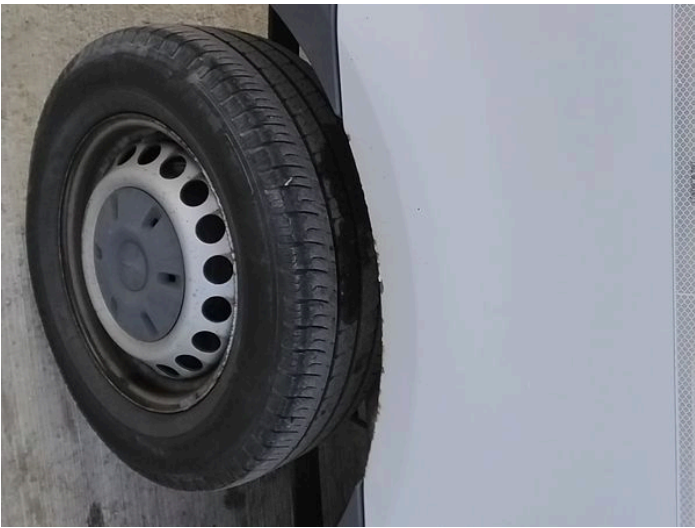
10: Qtr Panel osr  
Rusted  
Over 5mm

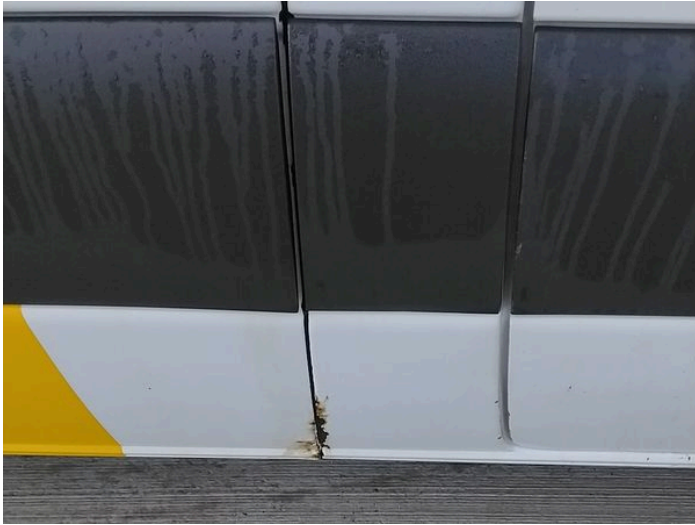
11: B Post os  
Rusted  
Over 5mm

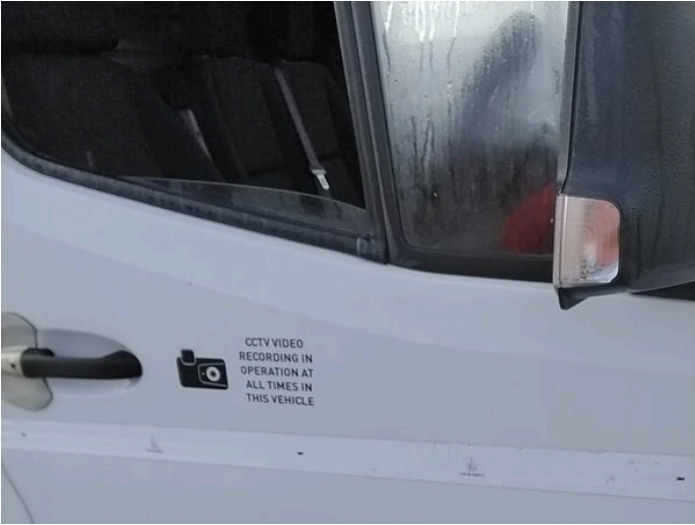
12: Door osf  
Chipped  
Multiple Chips

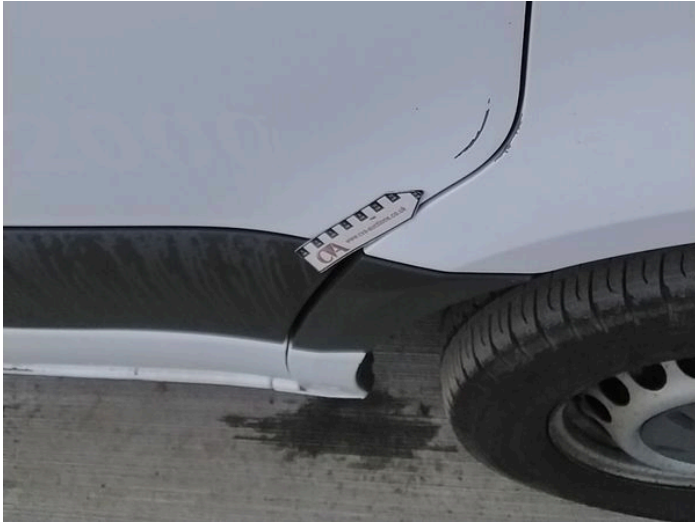
13: Door osf  
Dented  
With Paint Damage

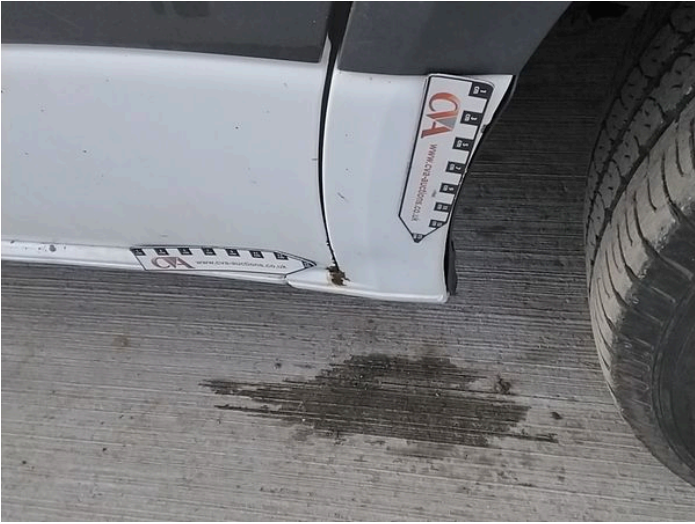
14: Wing osf  
Dented  
Over 30mm

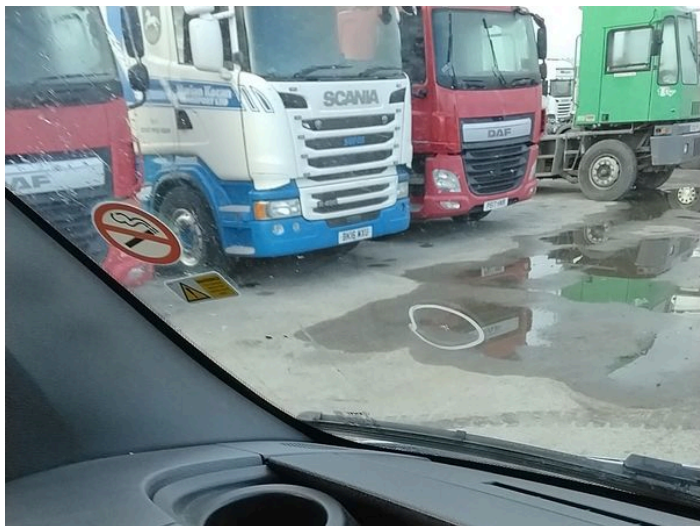
15: Screen Front  
Chipped  
Over 10mm
