**COMMERCIAL VEHICLE AUCTIONS LTD**  
THE UK'S MOST ESTABLISHED COMMERCIAL VEHICLE AUCTIONEERS

# VEHICLE INSPECTION REPORT

**PJ22GME**

## Volvo FH 500

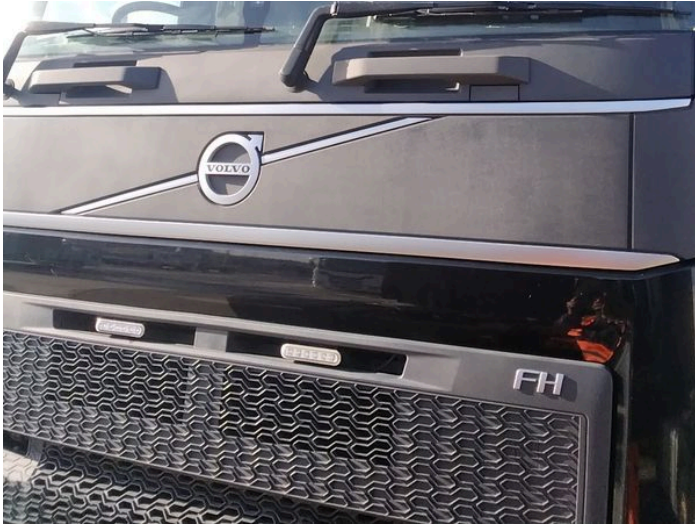
1: Screen Front  
Chipped  
Over 10mm

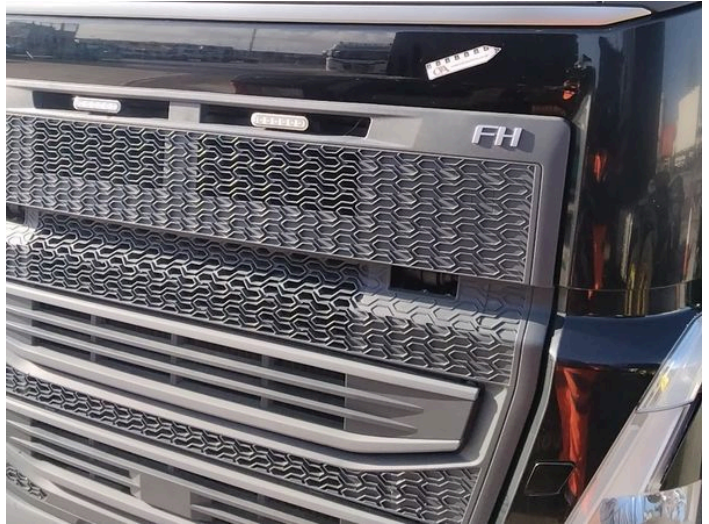
2: Panel Front  
Chipped  
Over 5mm

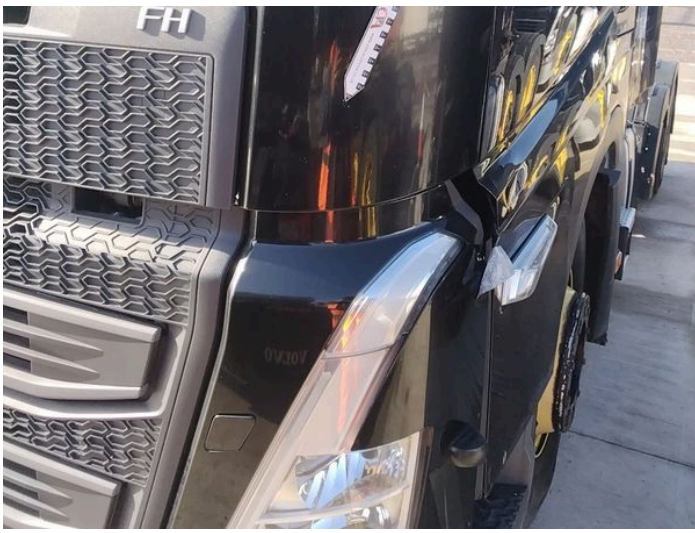
3: Wing nsf  
Chipped  
Over 5mm

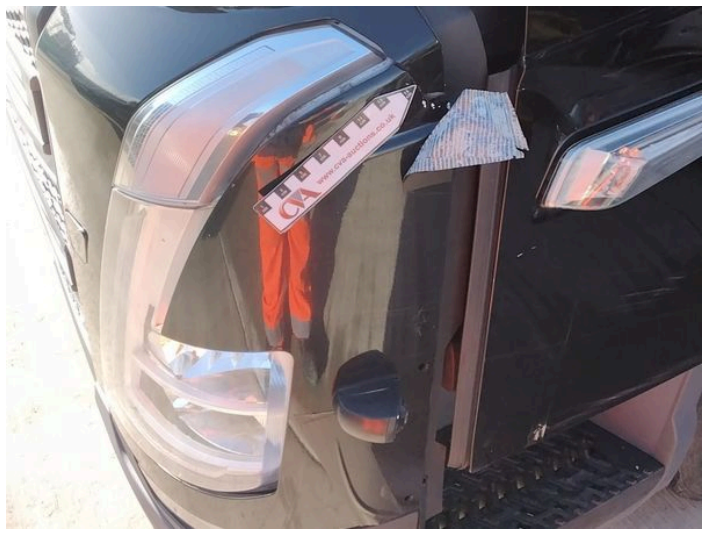
4: Wing nsf  
Cracked  
Replace

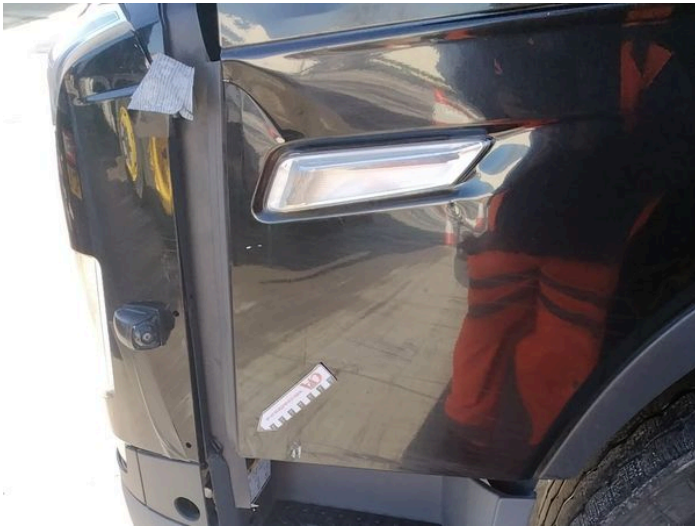
5: Door nsf  
Dented  
Over 30mm

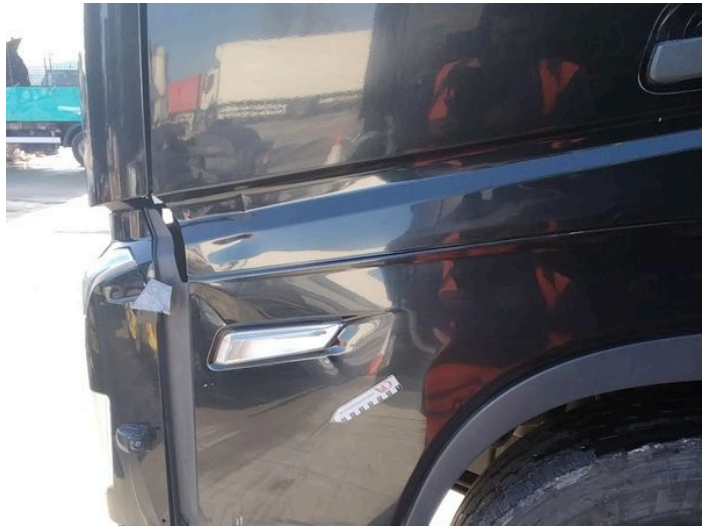
6: Door nsf  
Scratched  
Over 25mm Thru Paint

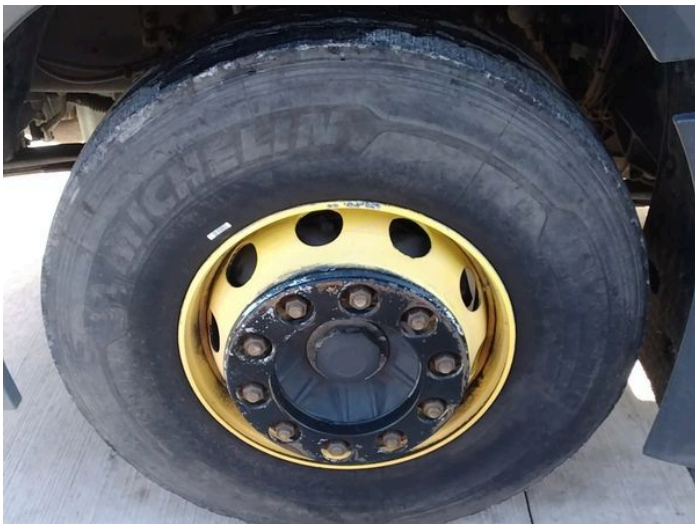
7: Wheel nsf  
Corroded  
Light

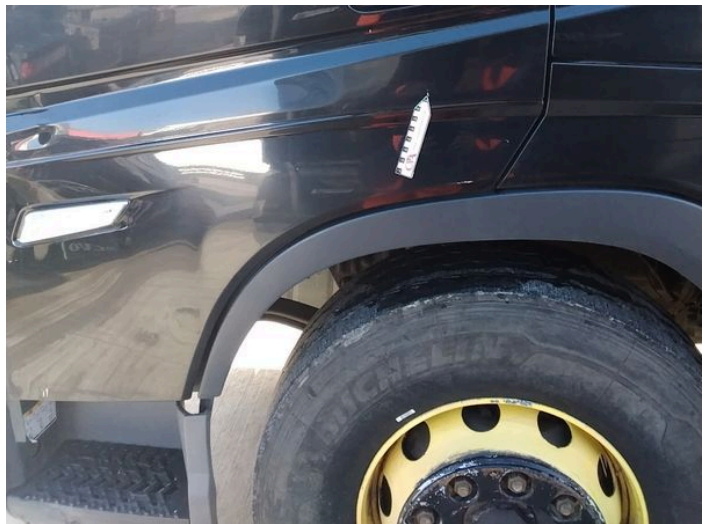
8: Door nsf  
Chipped  
Over 5mm

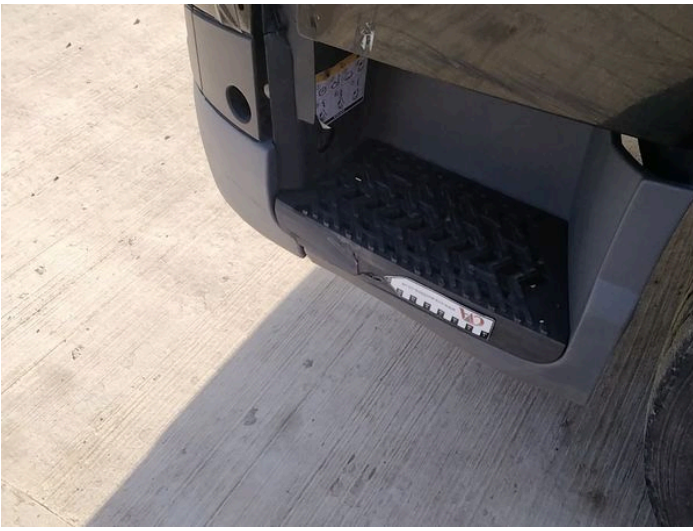
9: Bumper Front  
Cracked  
Over 25mm

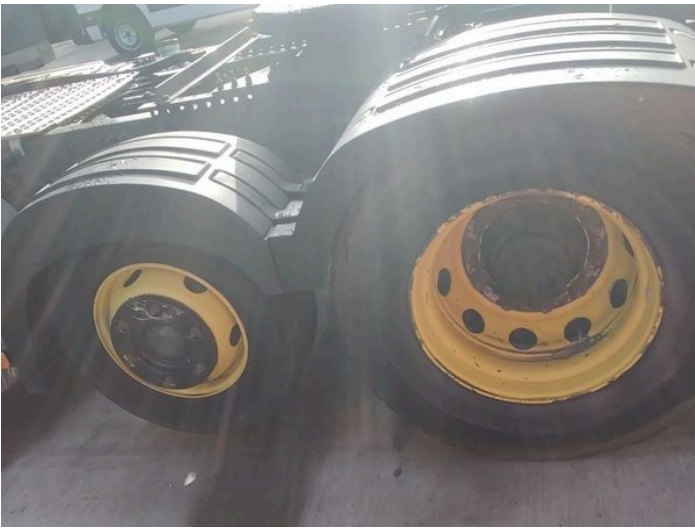
10: Wheel nsr  
Corroded  
Light

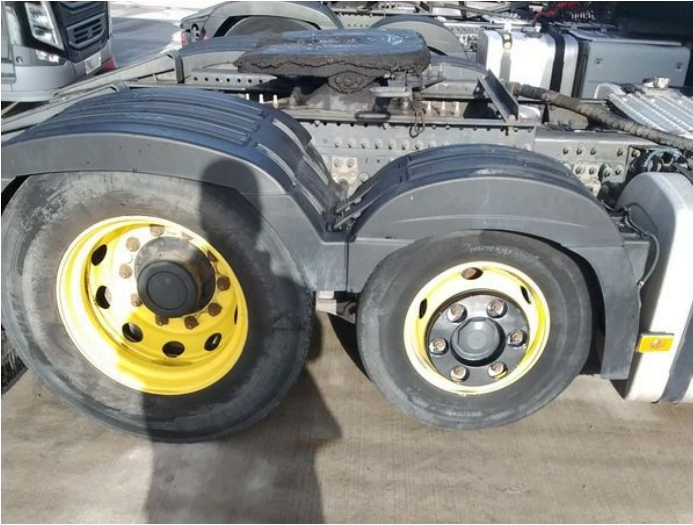
11: Wheel osr  
Corroded  
Light

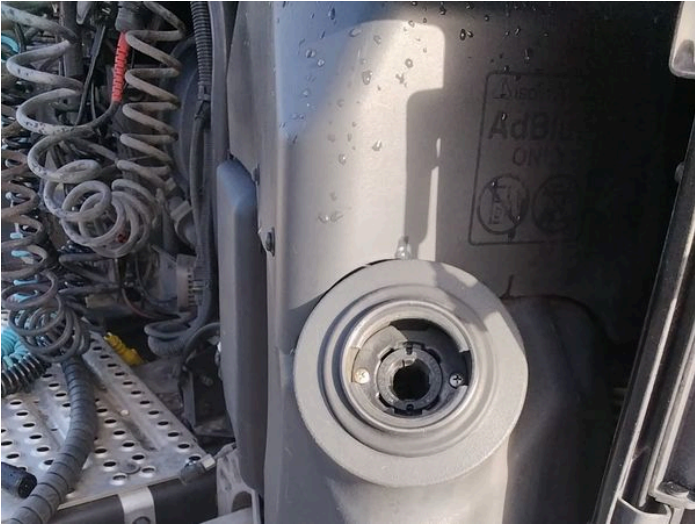
12: Fuel Flap  
Missing  
Replace

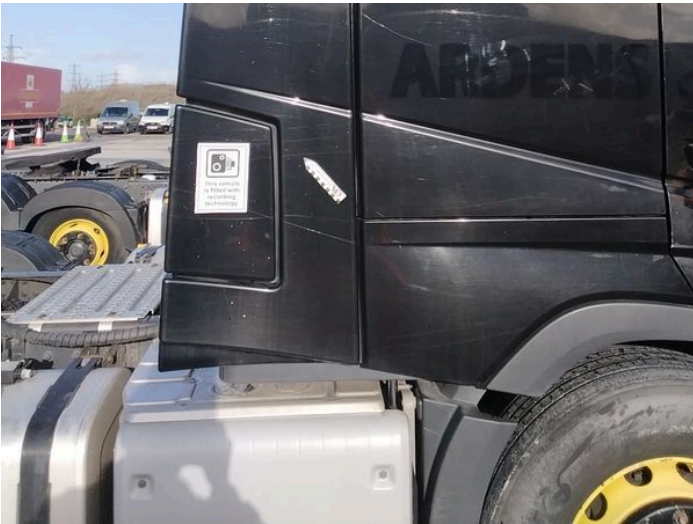
13: Qtr Panel osr  
Scratched  
Over 25mm Not Thru Paint

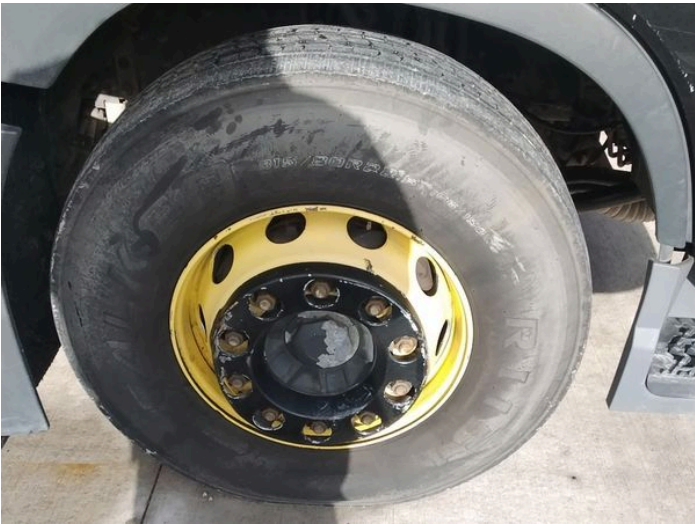
14: Wheel osf  
Corroded  
Light

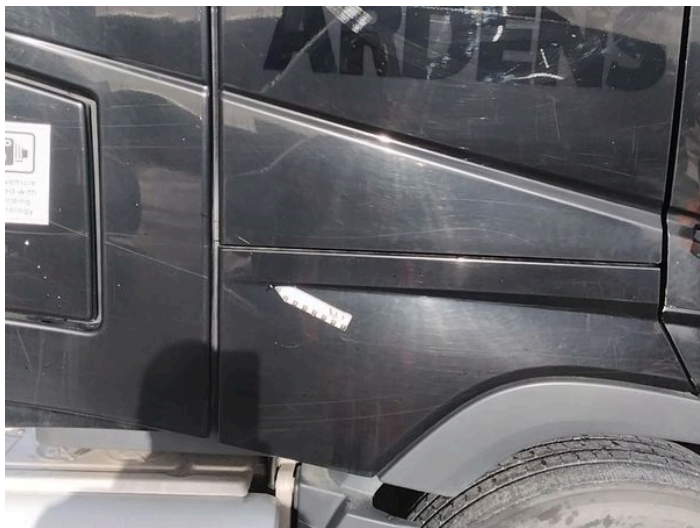
15: Qtr Panel osf  
Chipped  
Over 5mm

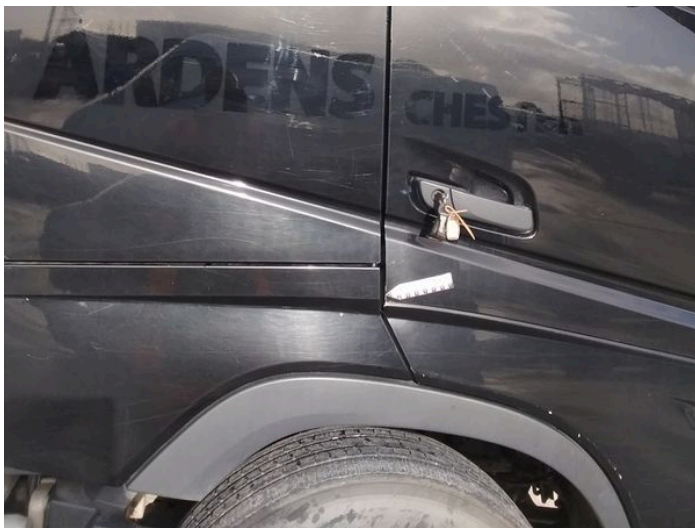
16: Door osf  
Chipped  
Edge Chip

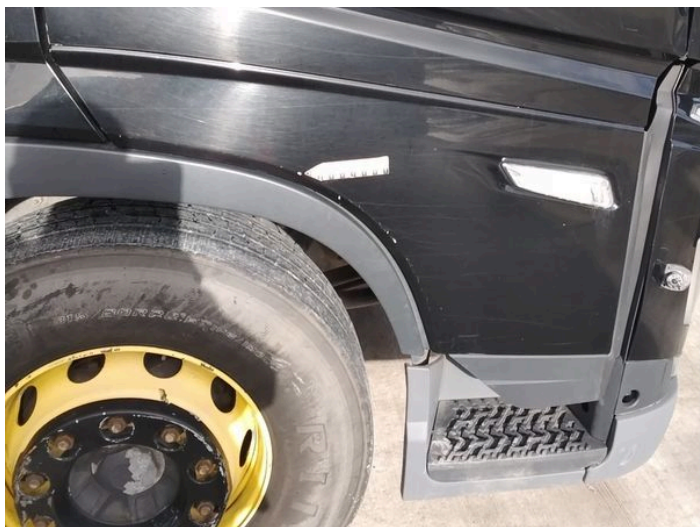
17: Door osf  
Chipped  
Over 5mm

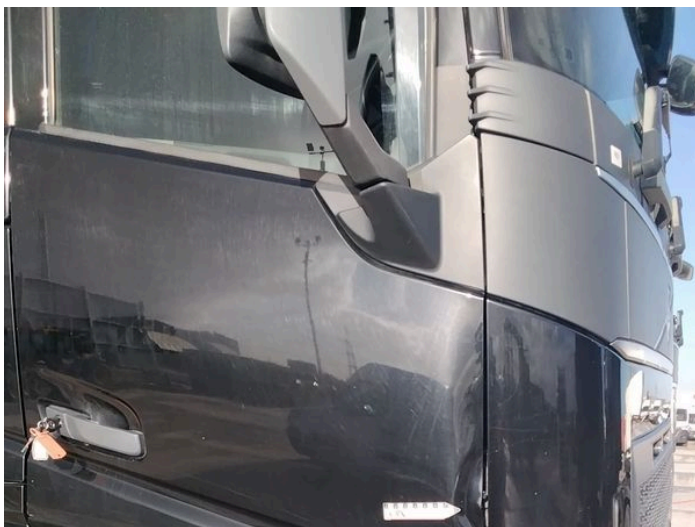
18: Door osf  
Dented  
Over 30mm

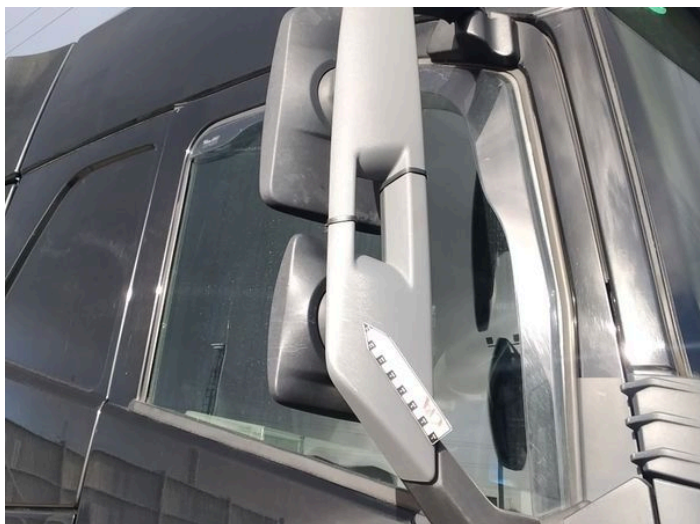
19: Door Mirror Assy osf  
Scuffed (Unpainted)  
Over 100mm

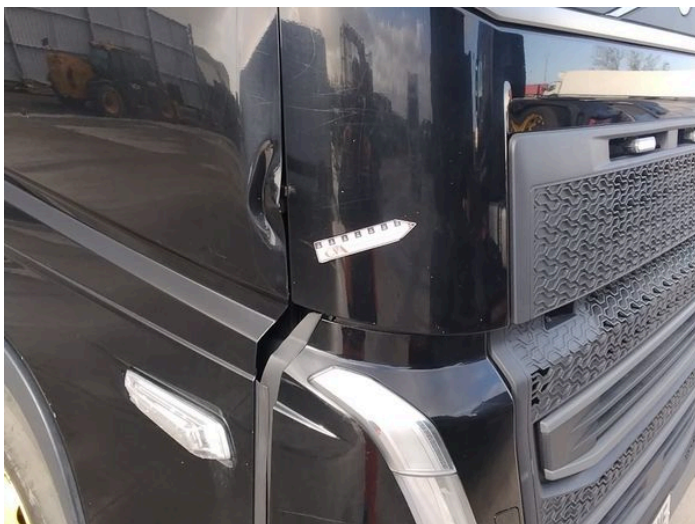
20: Wing osf  
Chipped  
Over 5mm

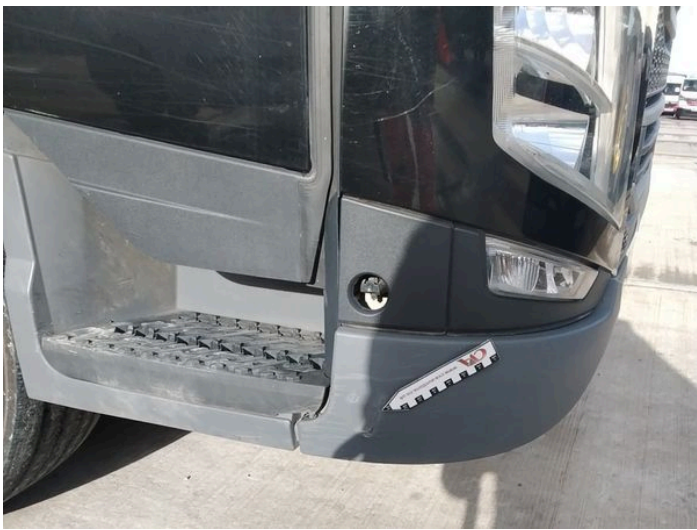
21: Bumper Front  
Cracked  
Over 25mm

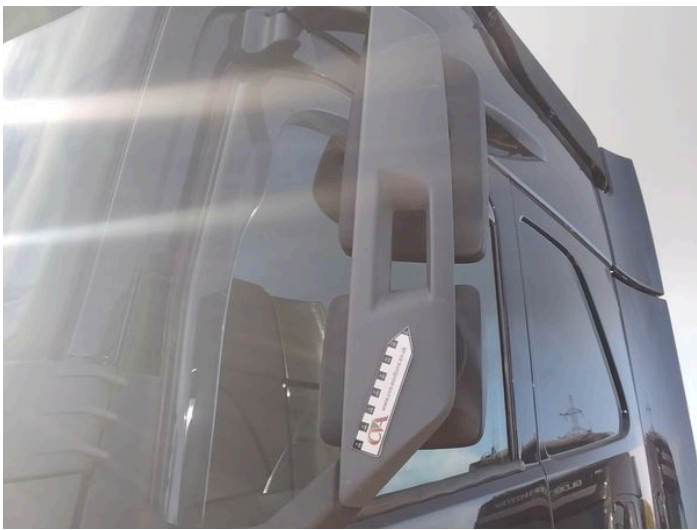
22: Door Mirror Assy nsf  
Scuffed (Unpainted)  
Over 100mm

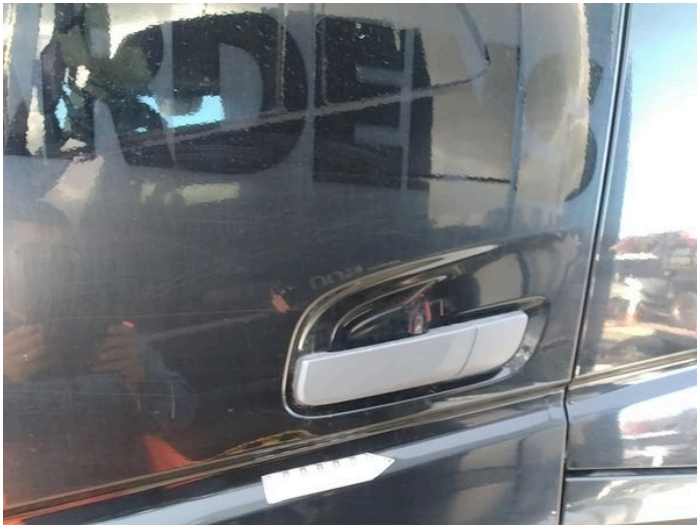
23: Door nsf  
Dented  
Over 30mm

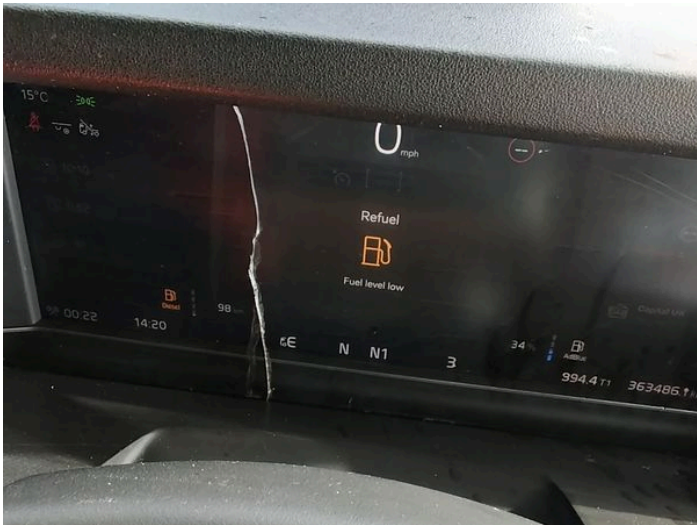
24: Switches And Controls  
Broken  
Replace

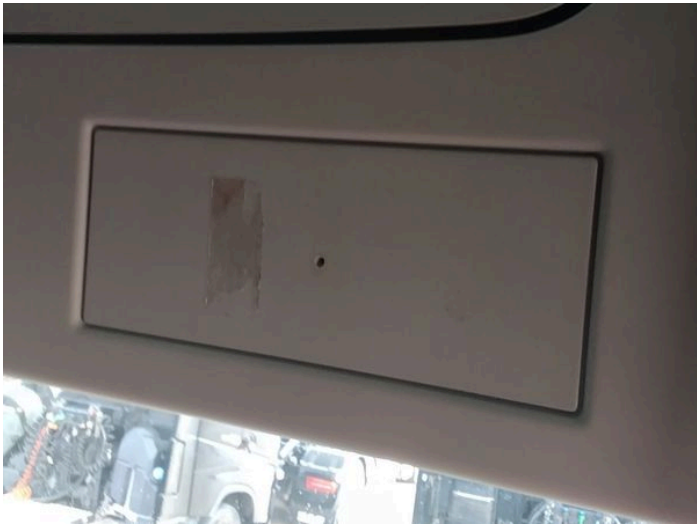
25: Centre Console Front  
Holed  
Over 3mm
