# VEHICLE INSPECTION REPORT

**DX20UKT**

## Daf XF 450

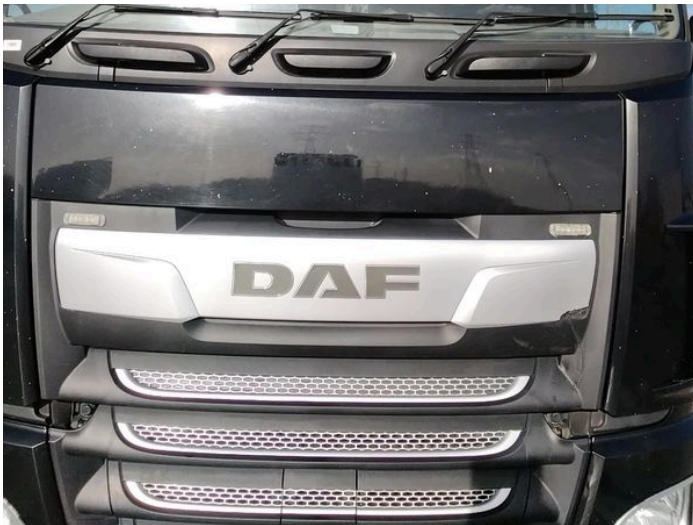
1: Screen Front  
Chipped  
Over 10mm

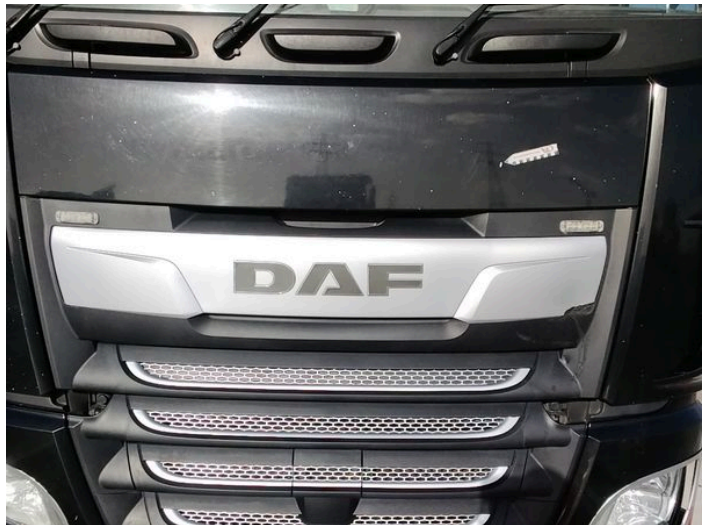
2: Panel Front  
Chipped  
Over 5mm

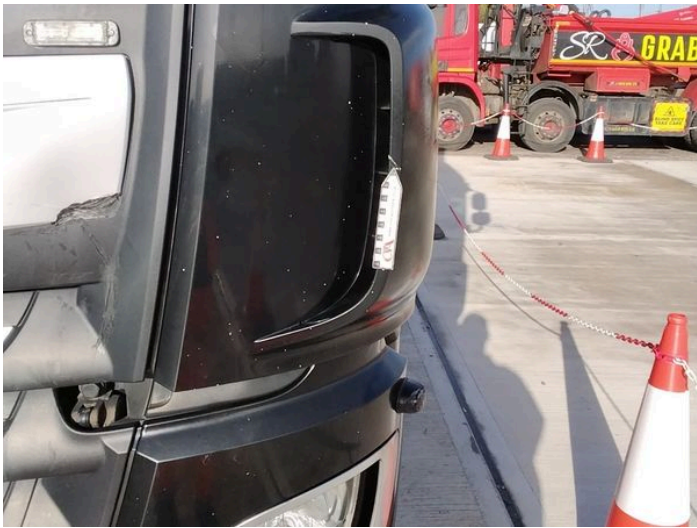
3: Wing nsf  
Cracked  
Replace

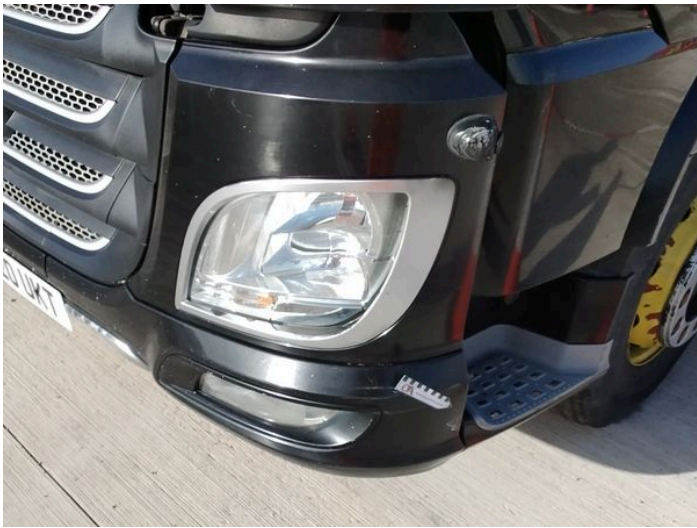
4: Bumper Front  
Scratched  
Over 100mm Thru Paint

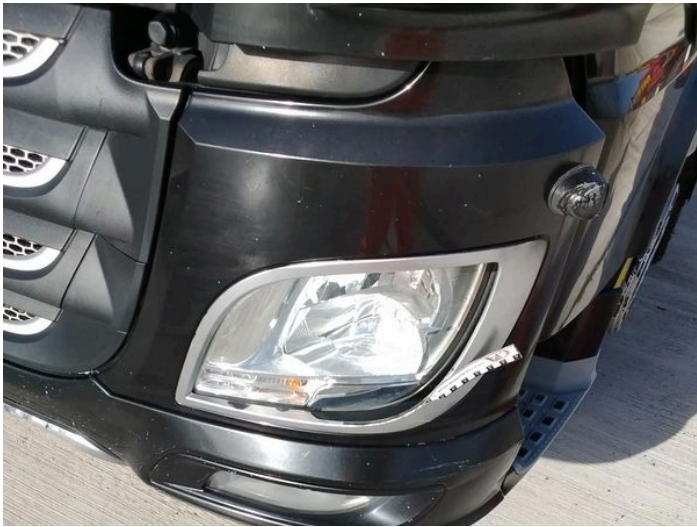
5: Fog Lamp Surround ns  
Scratched (Painted)  
Over 25mm Thru Paint

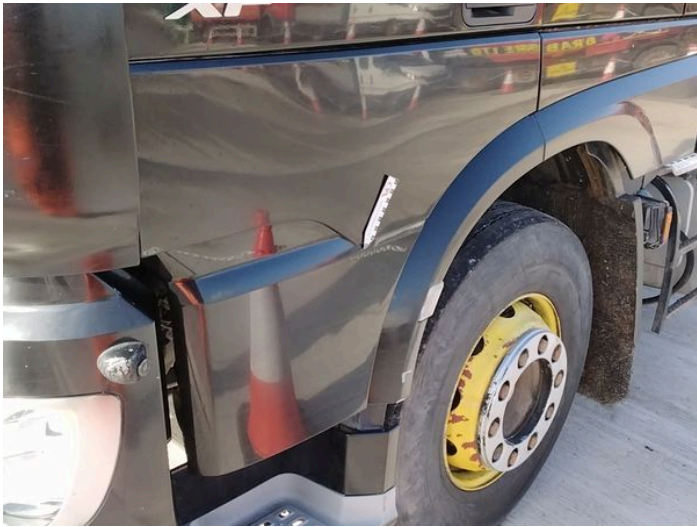
6: Door nsf  
Scratched  
Over 25mm Thru Paint

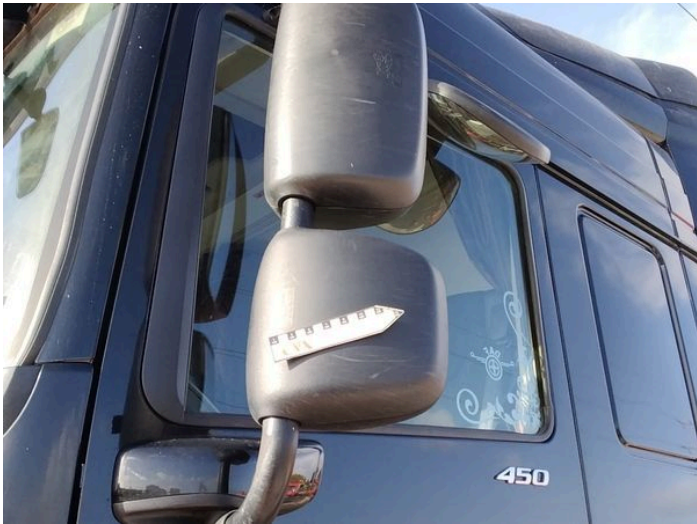
7: Door Mirror Assy nsf  
Scuffed (Unpainted)  
Over 100mm

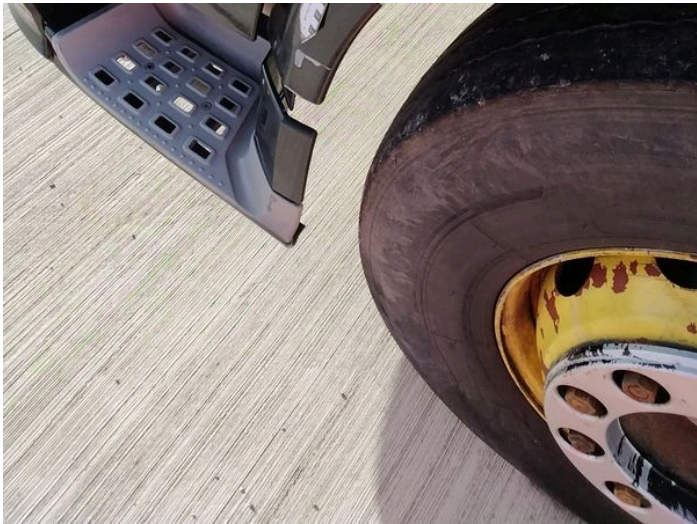
8: Wing Front Arch Extension ns  
Scratched (Painted)  
Over 25mm Thru Paint

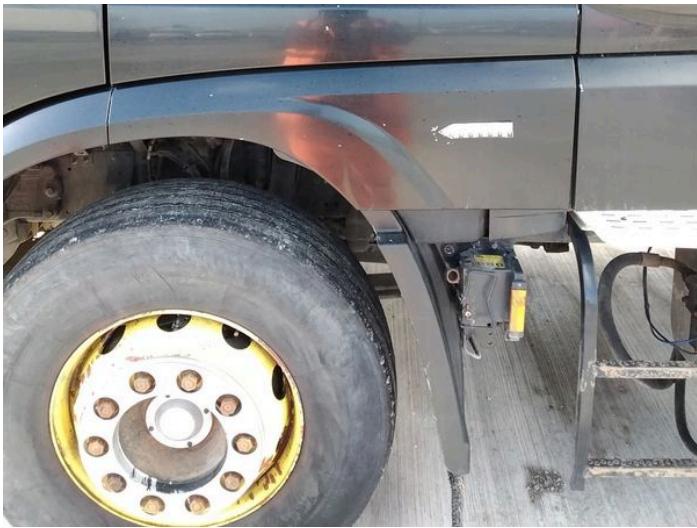
9: Qtr Panel Arch Extension ns  
Scratched (Painted)  
Over 25mm Thru Paint

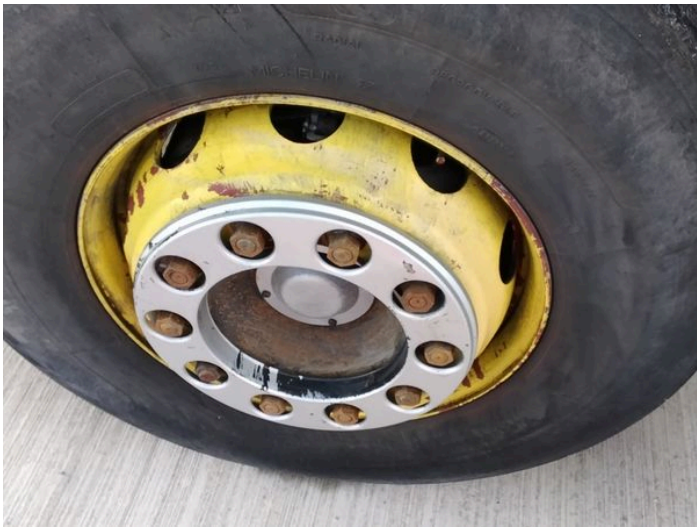
10: Wheel nsf  
Corroded  
Light

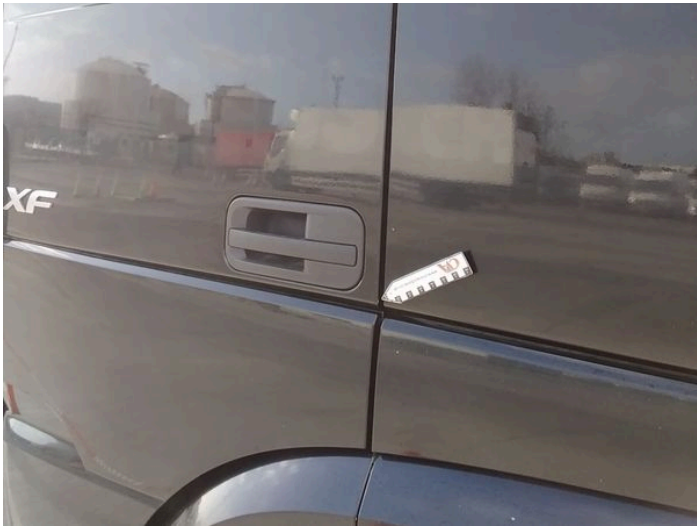
11: Door nsf  
Chipped  
Edge Chip

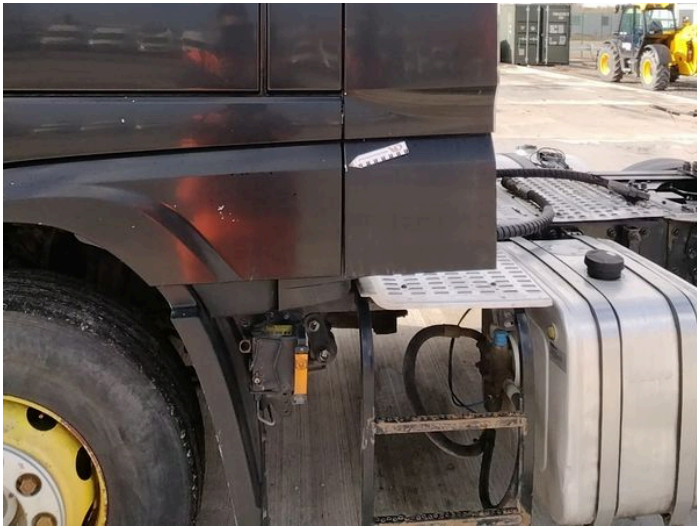
12: Qtr Panel nsr  
Chipped  
Over 5mm

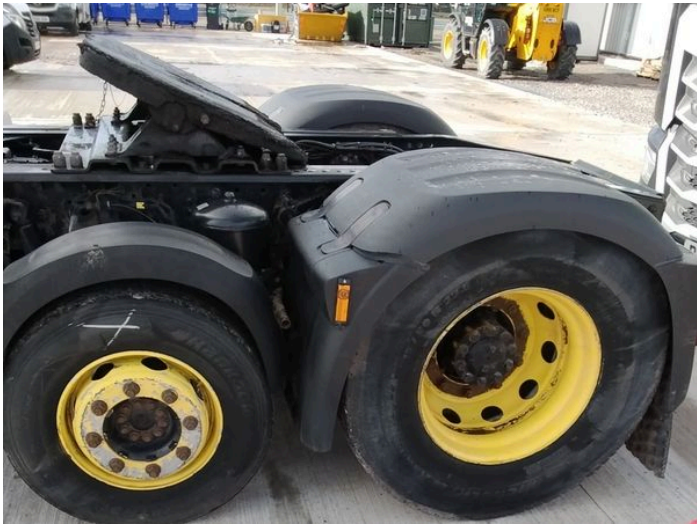
13: Wheel nsr  
Corroded  
Light

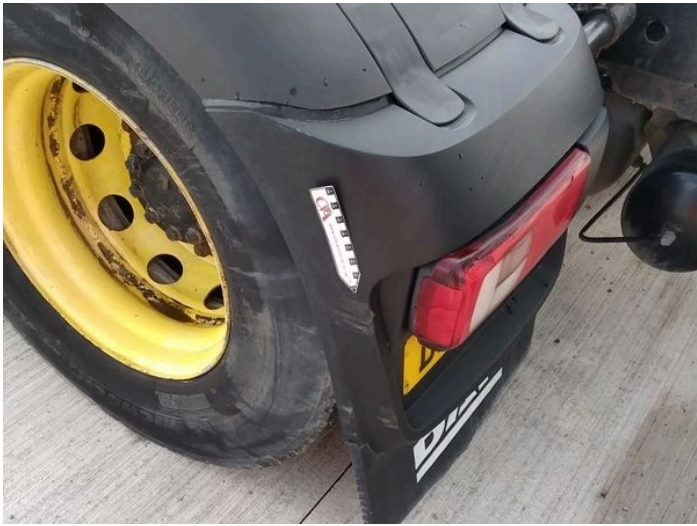
14: Qtr Panel Arch Extension ns  
Scuffed (Unpainted)  
Over 100mm

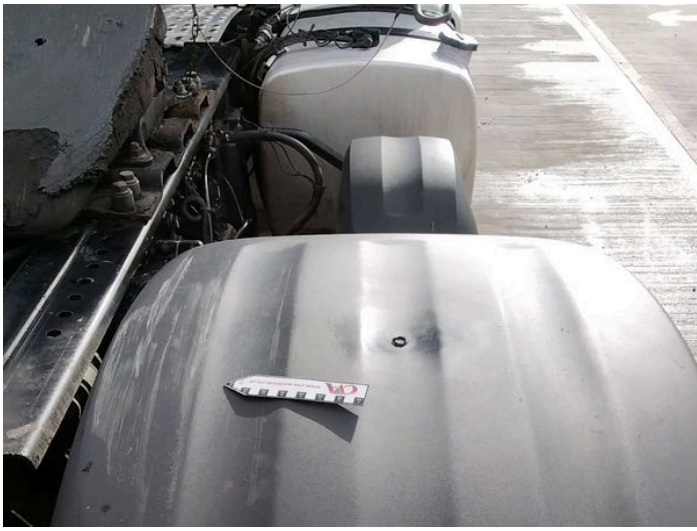
15: Qtr Panel Arch Extension os  
Scuffed (Unpainted)  
Over 100mm

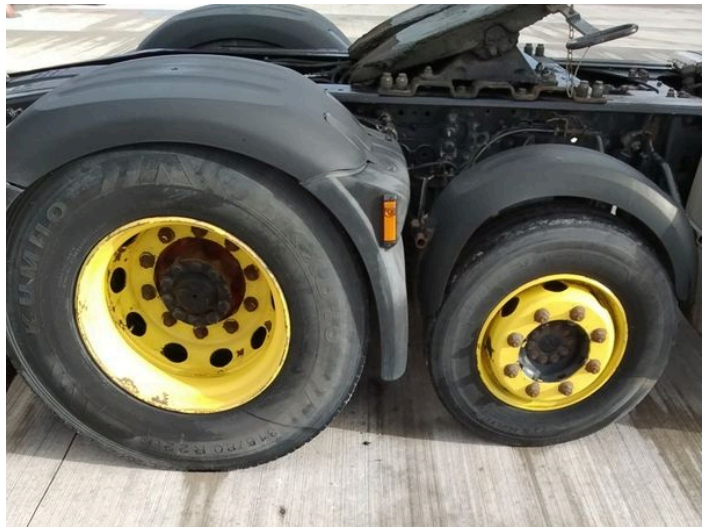
16: Wheel osr  
Corroded  
Light

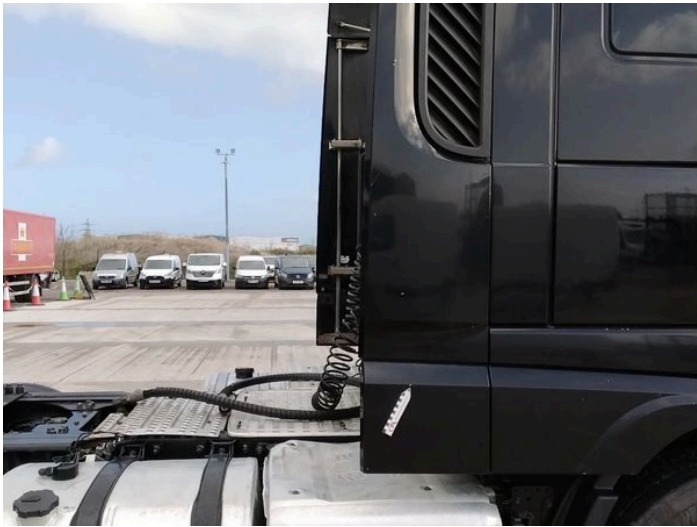
17: Qtr Panel osr  
Chipped  
Over 5mm

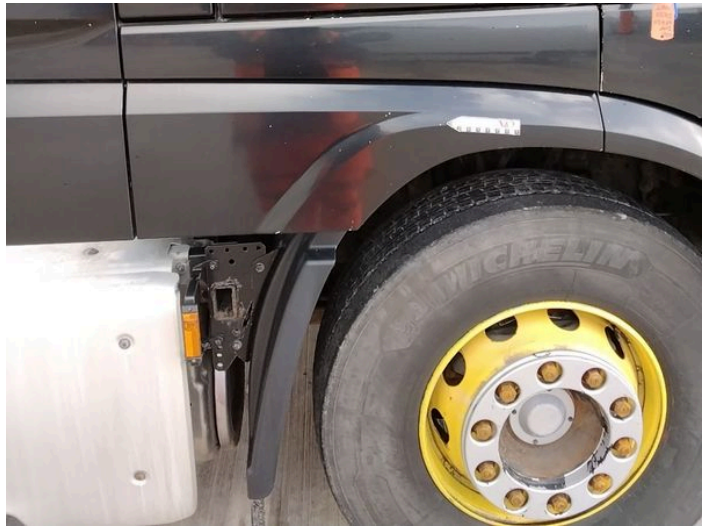
18: Wing Front Arch Extension os  
Scratched (Painted)  
Over 25mm Thru Paint

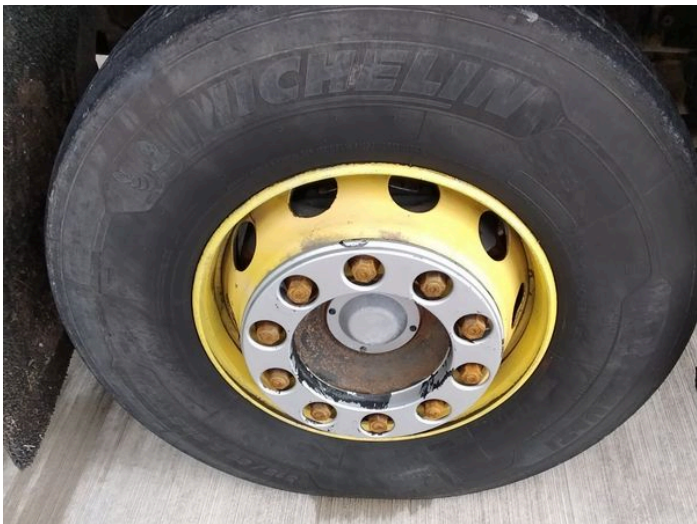
19: Wheel osf  
Corroded  
Light

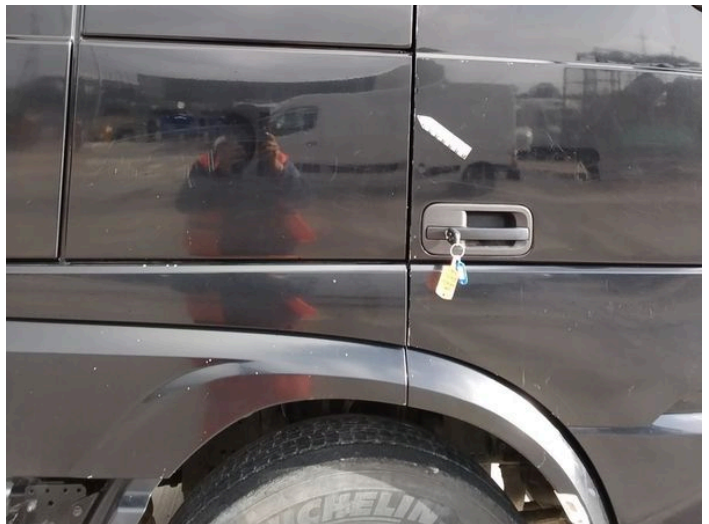
20: Door osf  
Chipped  
Edge Chip

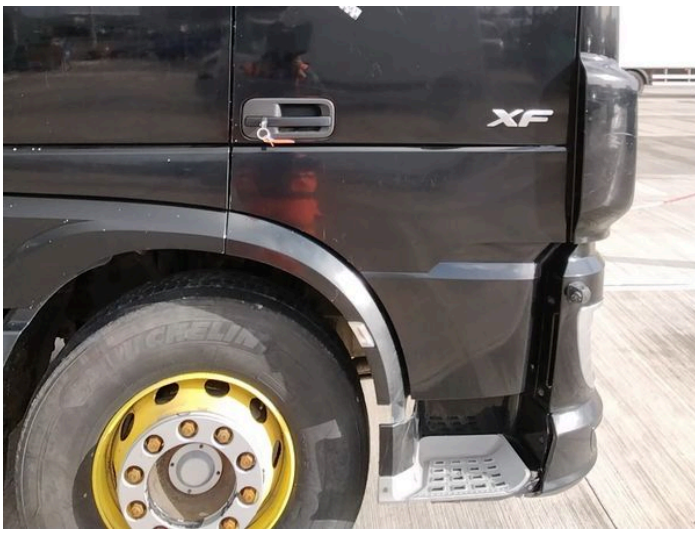
21: Door osf  
Chipped  
Over 5mm

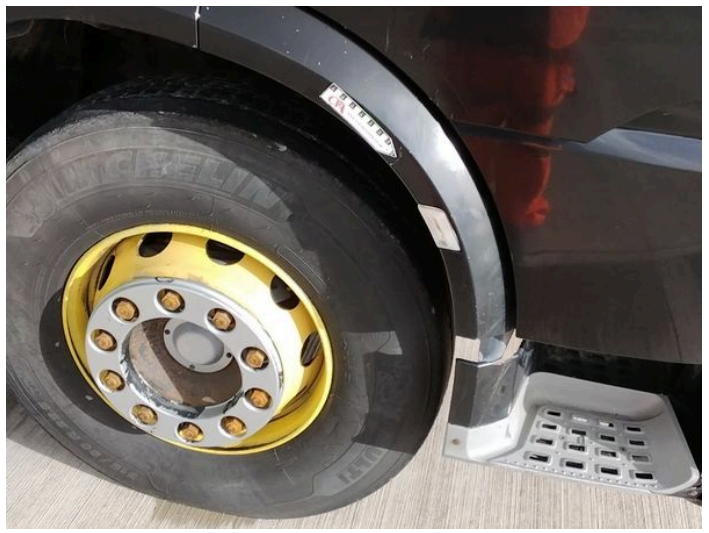
22: Wing Front Arch Extension os  
Broken  
Replace

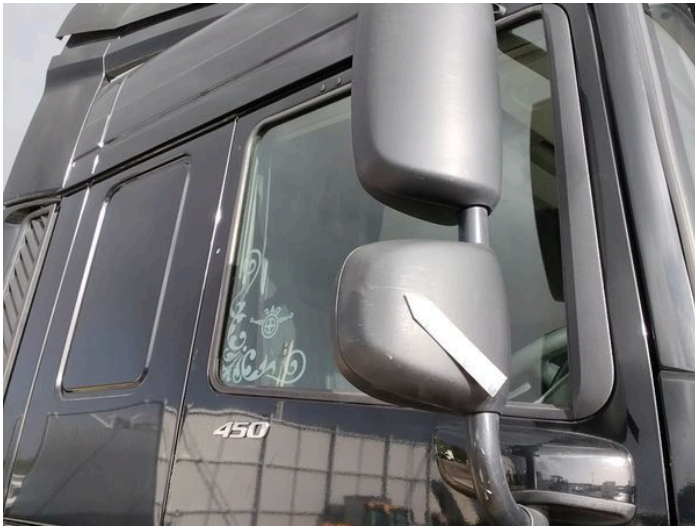
23: Door Mirror Assy osf  
Scuffed (Unpainted)  
Over 100mm

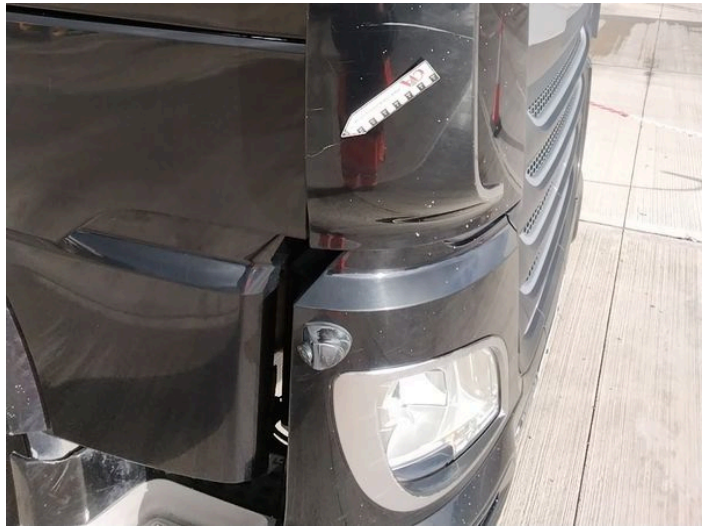
24: Wing osf  
Cracked  
Replace

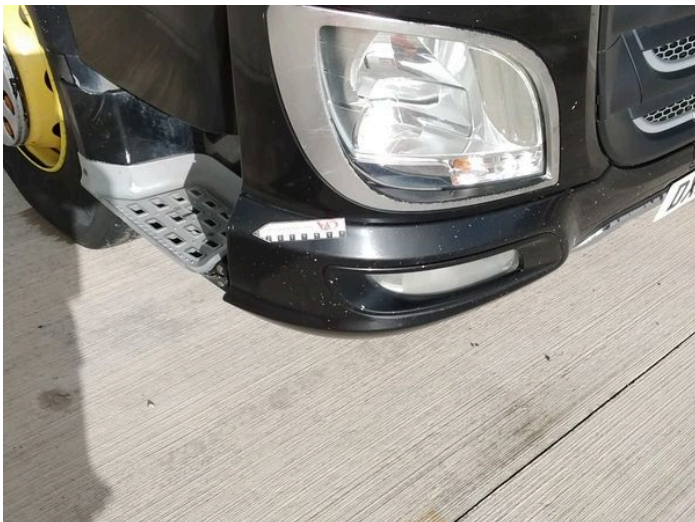
25: Bumper Front  
Chipped  
Over 5mm

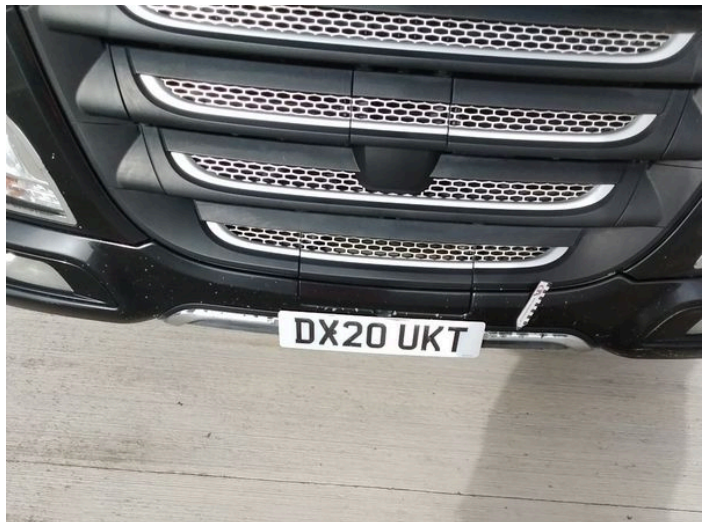
26: Bumper Front  
Chipped  
Over 5mm

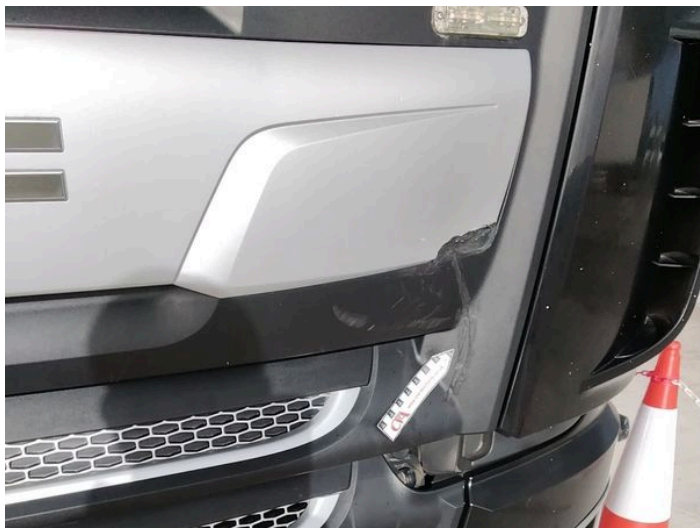
27: Grille Front  
Broken  
Replace

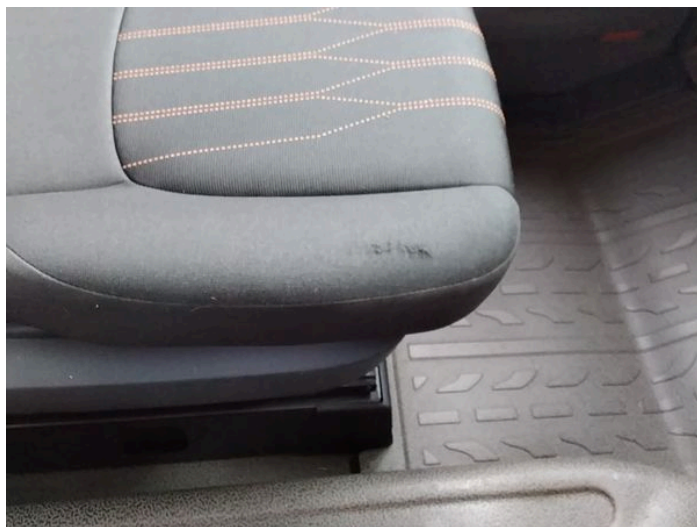
30: Seat Base Cover nsf  
Torn  
Over 3mm
