VEHICLE INSPECTION REPORT

Mercedes-Benz Sprinter 3.5t Progressive

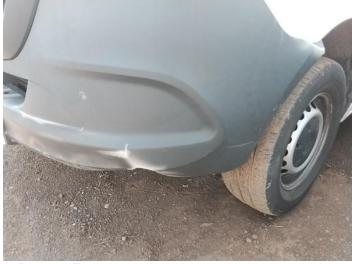
1: Bumper Front Dented With Paint Damage

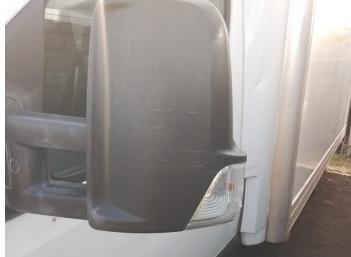
2: Door Mirror Assy nsf Scuffed (Unpainted) Over 100mm

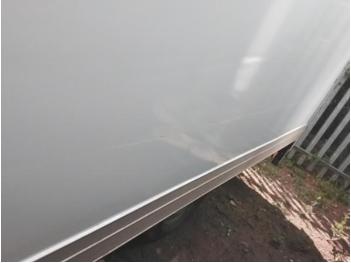
3: Qtr Panel nsr Scratched Over 25mm Thru Paint

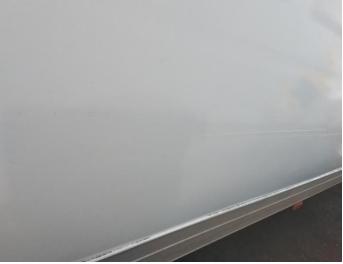
4: Qtr Panel osr Scratched Over 25mm Thru Paint

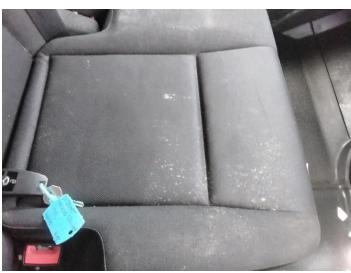
5: Seat Base Cover nsf Soiled Heavy
