VEHICLE INSPECTION REPORT

GM19VNJ

Daf CF 260

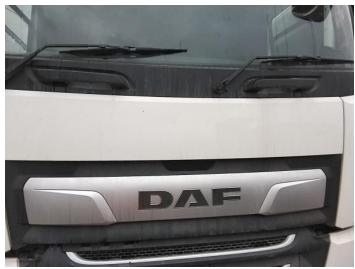
1: Bonnet Chipped Multiple Chips

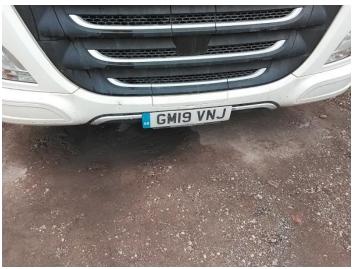
2: Bumper Front Chipped Multiple Chips

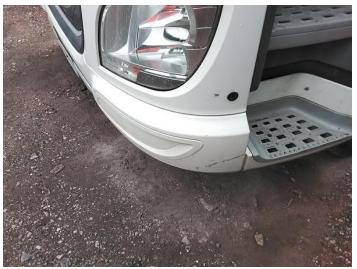
3: Bumper Front Scratched Over 100mm Thru Paint

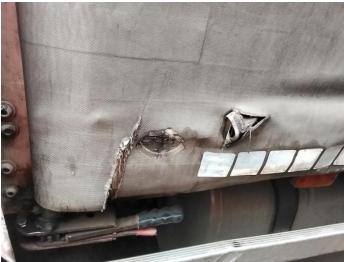
4: Qtr Panel nsr Hole Over 10mm

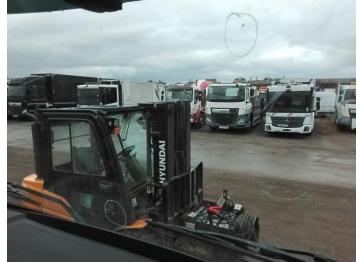
5: Screen Front Chipped Over 10mm

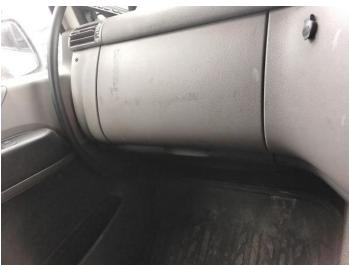
6: Fascia Panel Soiled Heavy
