VEHICLE INSPECTION REPORT

BD73VSY

Peugeot Boxer 2.2 BlueHDi H2 140ps Professional

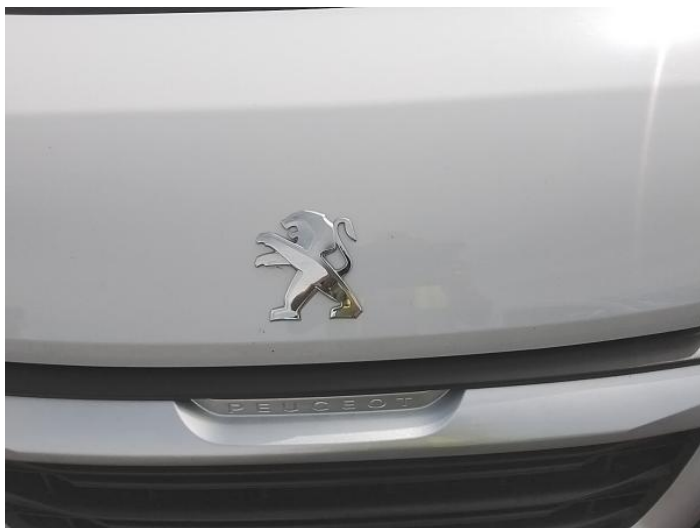
1: Bonnet
Chipped
Multiple Chips

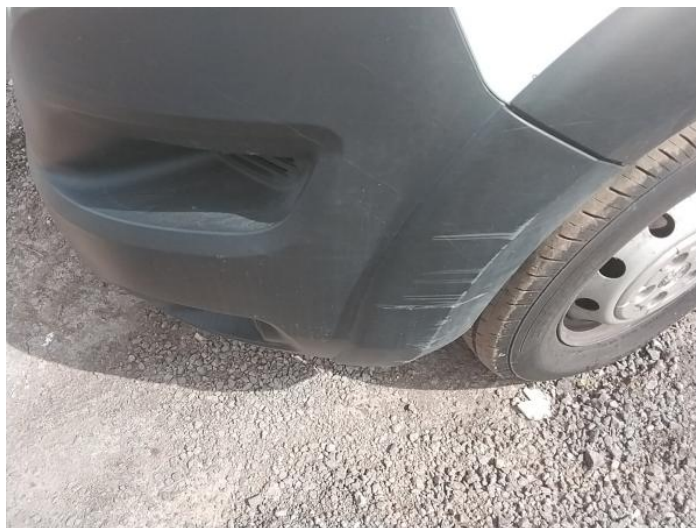
2: Bumper Front Moulding
Scuffed (Unpainted)
Over 100mm

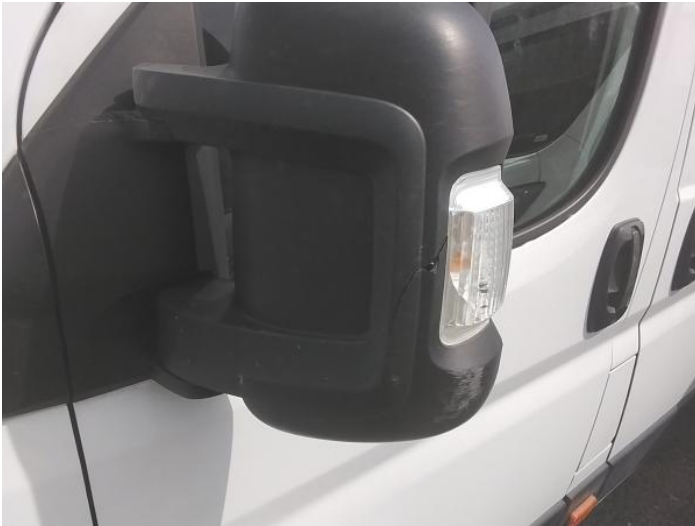
3: Door Mirror Assy nsf
Broken
Replace

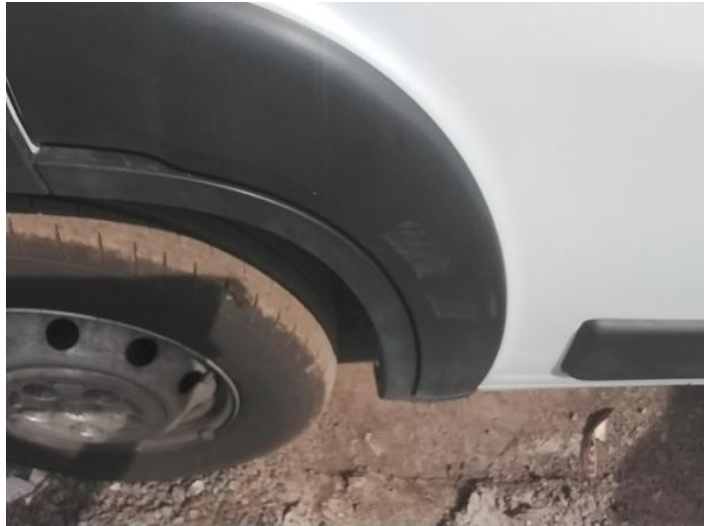
4: Door Moulding nsf
Scuffed (Unpainted)
Over 100mm

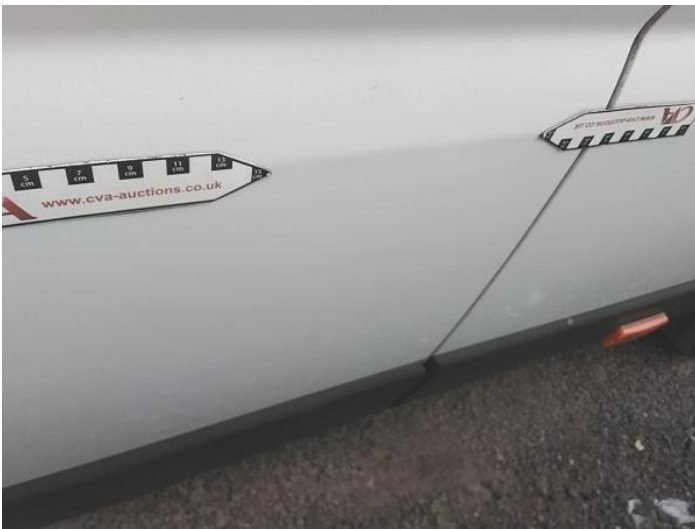
5: Qtr Panel nsr
Dented
Over 30mm

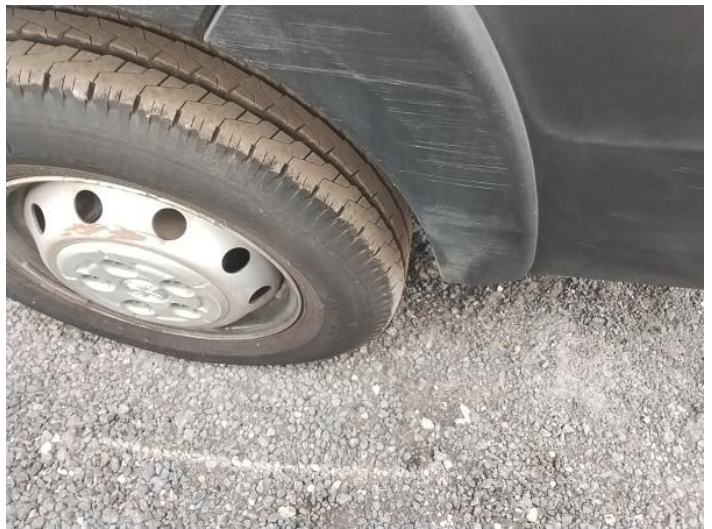
6: Qtr Panel Moulding ns
Scuffed (Unpainted)
Over 100mm

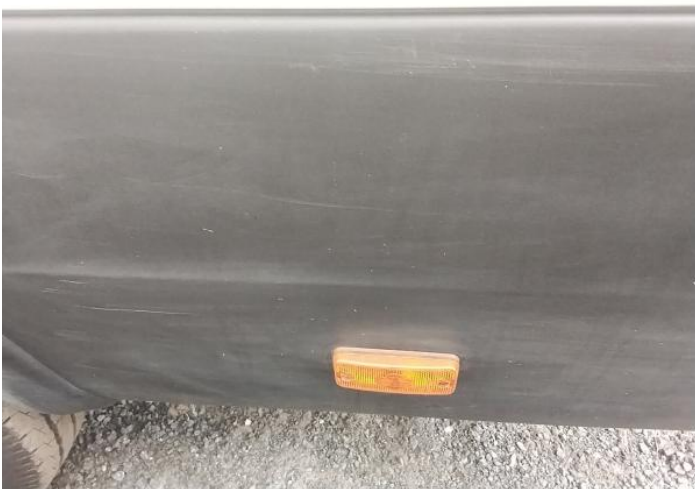
7: Qtr Panel Moulding ns
Scuffed (Unpainted)
Over 100mm

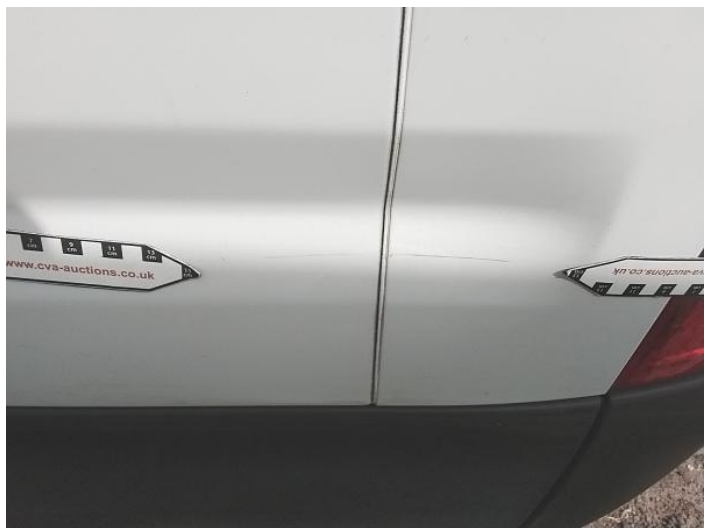
8: Qtr Panel nsr
Scratched
UpTo 25mm Not Thru Paint

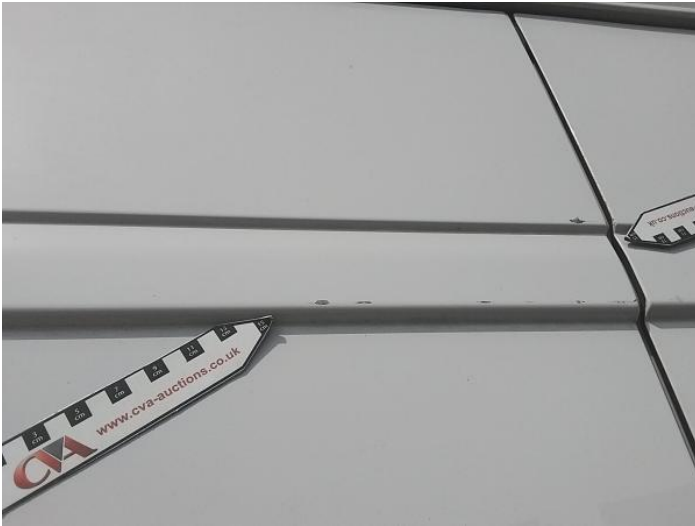
9: Door nsr
Scratched
Over 25mm Thru Paint

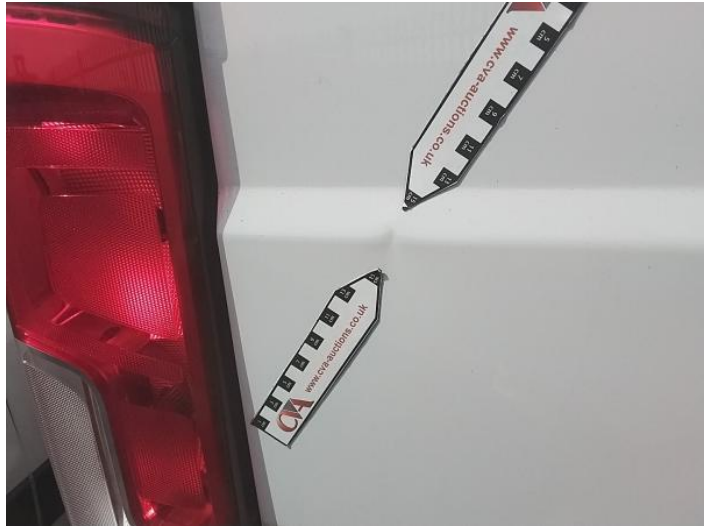
10: Door nsr
Dented
Over 30mm

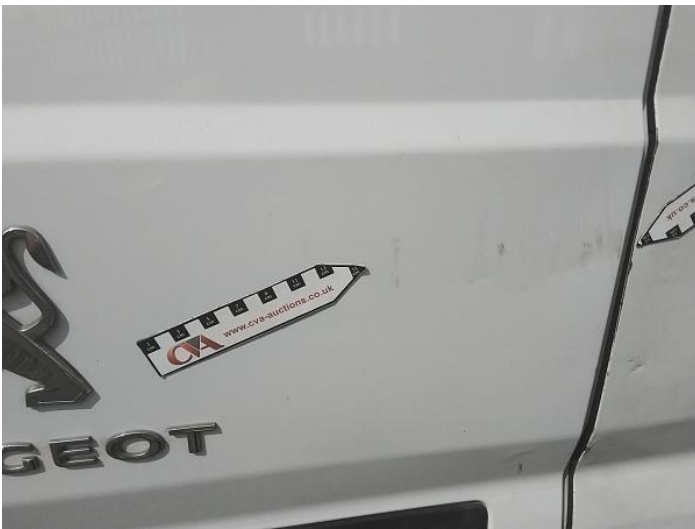
11: Door nsr
Dented
With Paint Damage

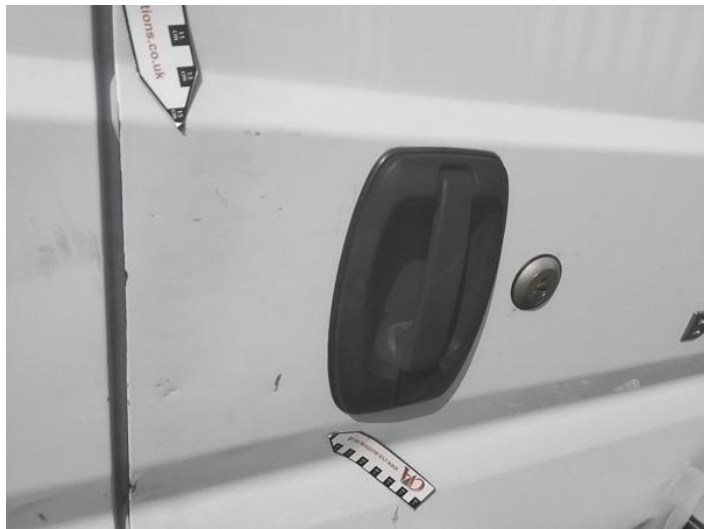
12: Door osr
Dented
With Paint Damage

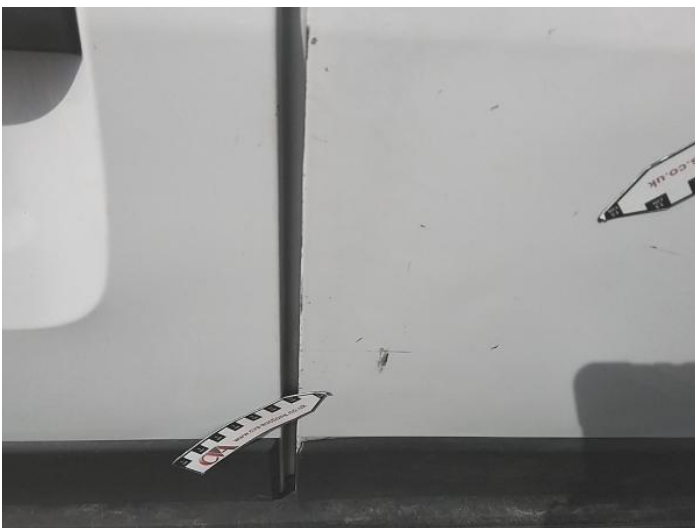
13: Door osr
Scratched
Over 25mm Thru Paint

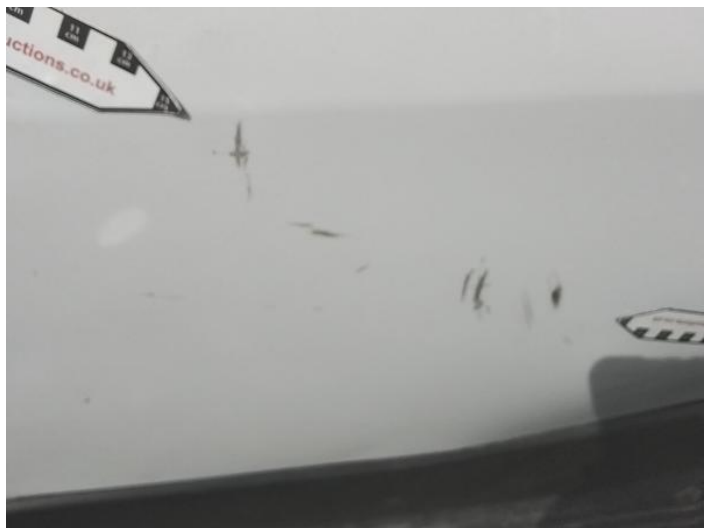
14: Door osr
Dented
With Paint Damage

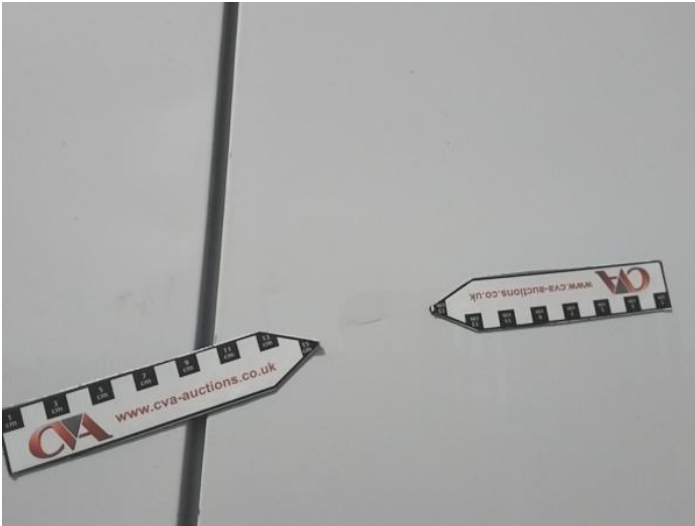
15: Door osr
Dented
With Paint Damage

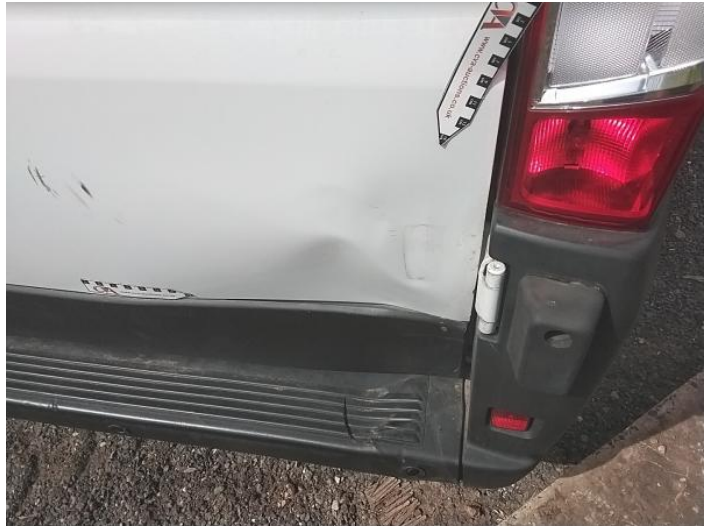
16: Door osr
Dented
Over 30mm

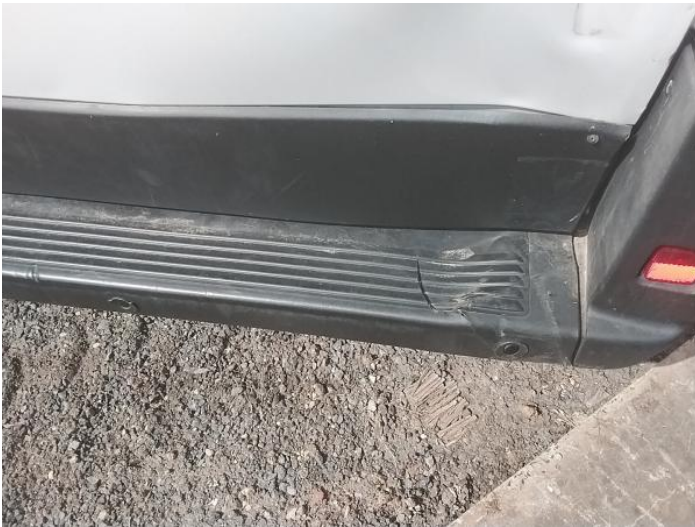
17: Bumper Rear
Cracked
Over 25mm

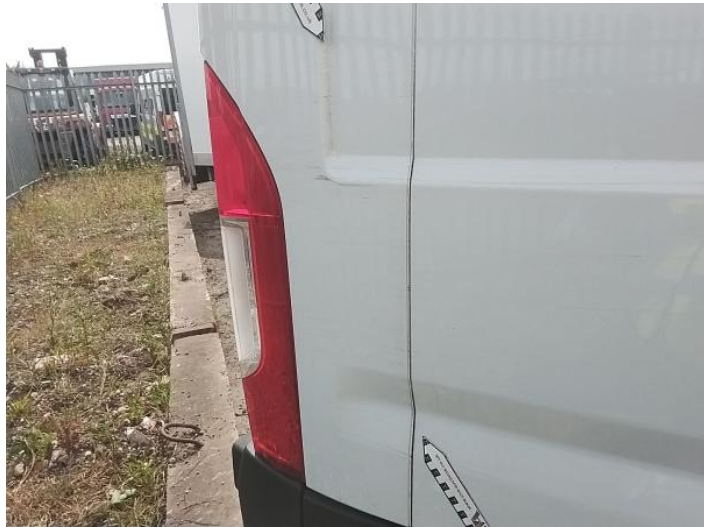
18: C Post os
Scratched
Over 25mm Thru Paint

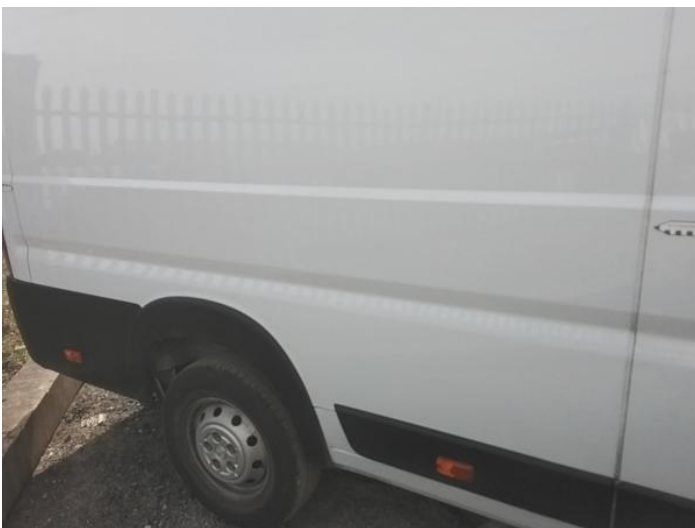
19: Qtr Panel osr
Scratched
Over 25mm Not Thru Paint

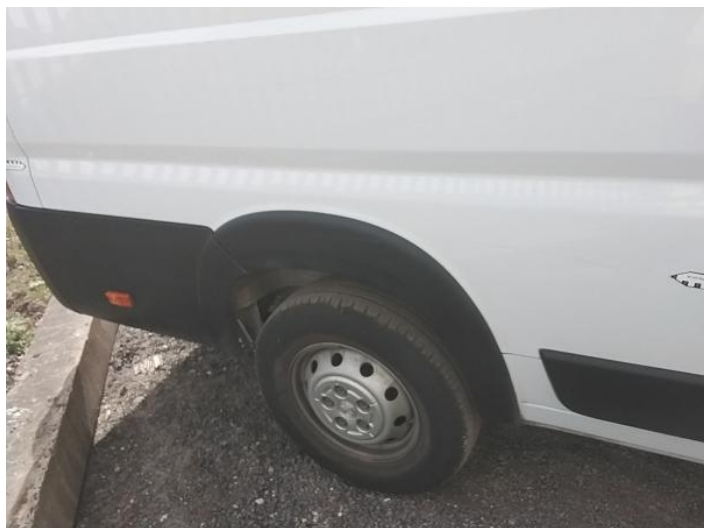
20: Qtr Panel osr
Scratched
Over 25mm Thru Paint

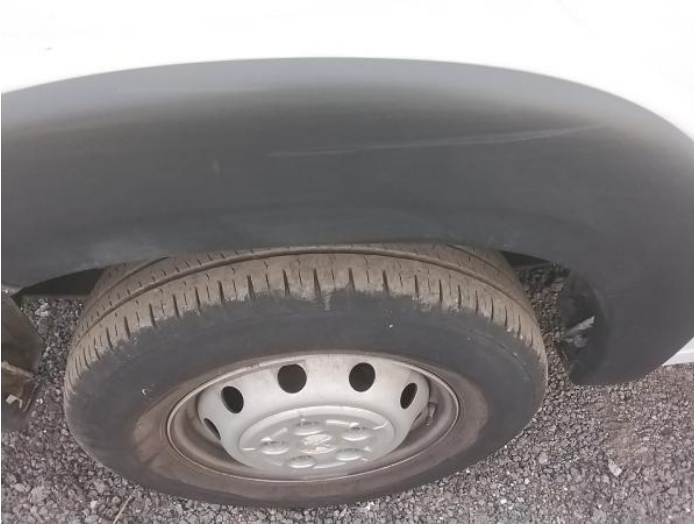
21: Qtr Panel Moulding os
Scuffed (Unpainted)
Over 100mm

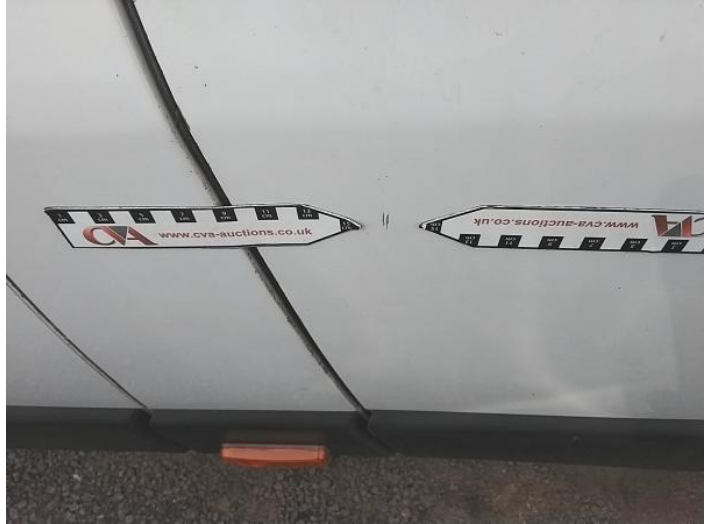
22: Door osf
Dented
With Paint Damage

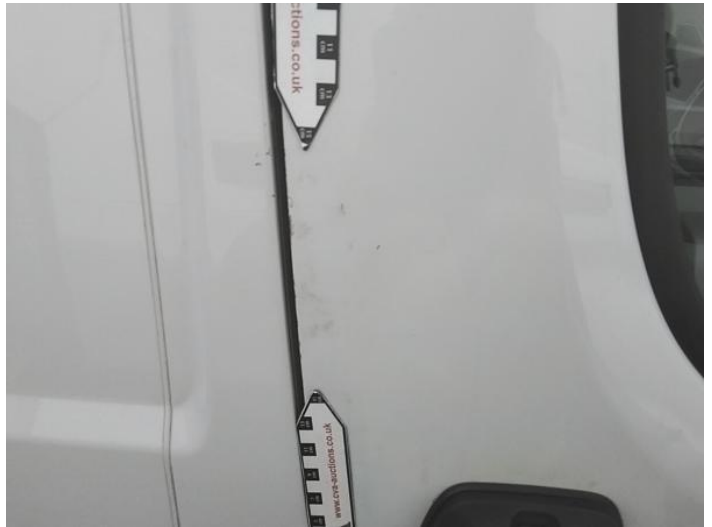
24: Door osf
Dented
With Paint Damage

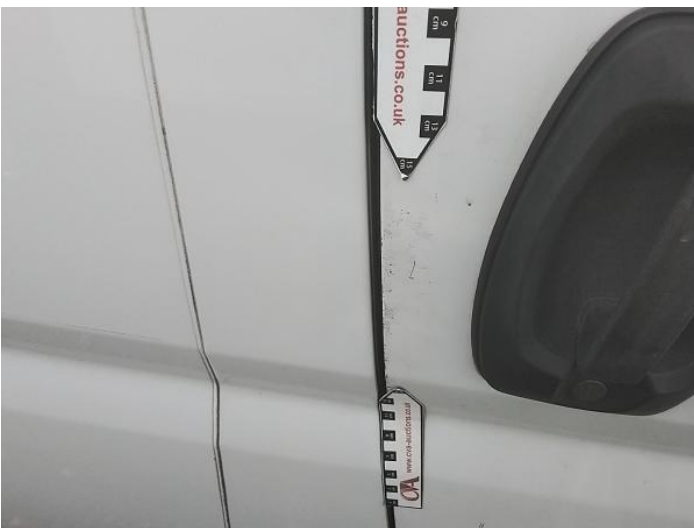
25: Door osf
Dented
With Paint Damage

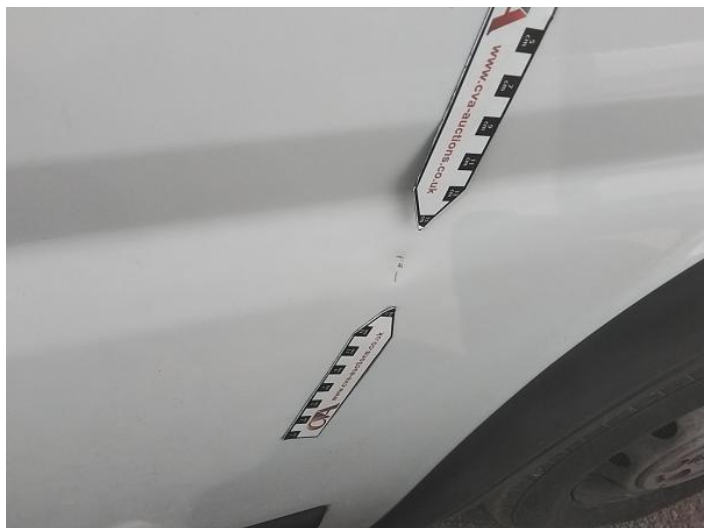
26: Door osf
Dented
With Paint Damage

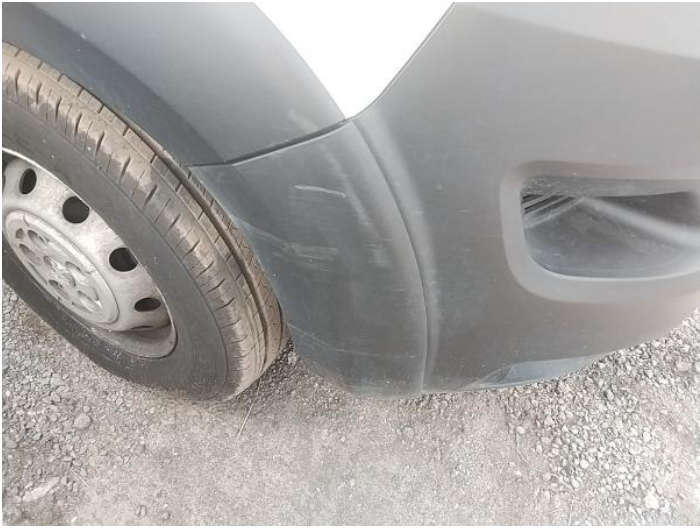
27: Bumper Front Moulding
Scuffed (Unpainted)
Over 100mm

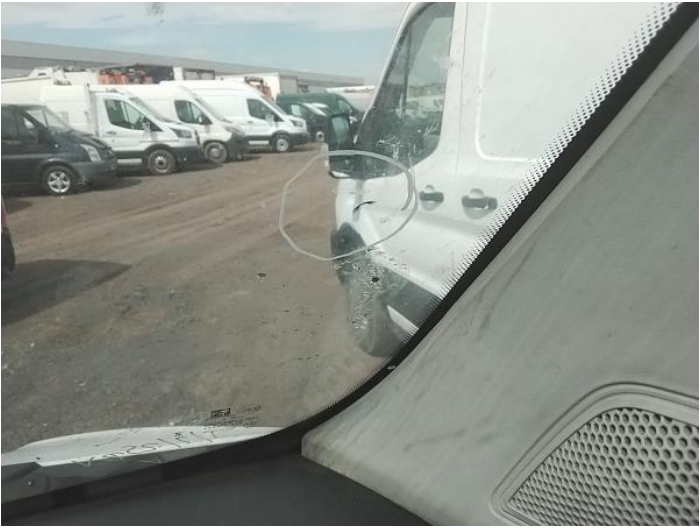
28: Screen Front
Chipped
Over 10mm
